October 13, 1978
C 7606

Re: Groundwater Monitoring
Onalaska Sanitary Landfill

Discussed below are the water quality results of the groundwater monitoring program for the Onalaska Sanitary Landfill. The attached data include the results of the organic analyses sampled on July 19, 1978 relative to possible groundwater contamination due to naphtha disposal at the subject site. Also discussed are recent groundwater flow directions measured at the site since the submittal of the In-Field Conditions Report as well as available information requested by the DNR regarding construction details on two private wells.

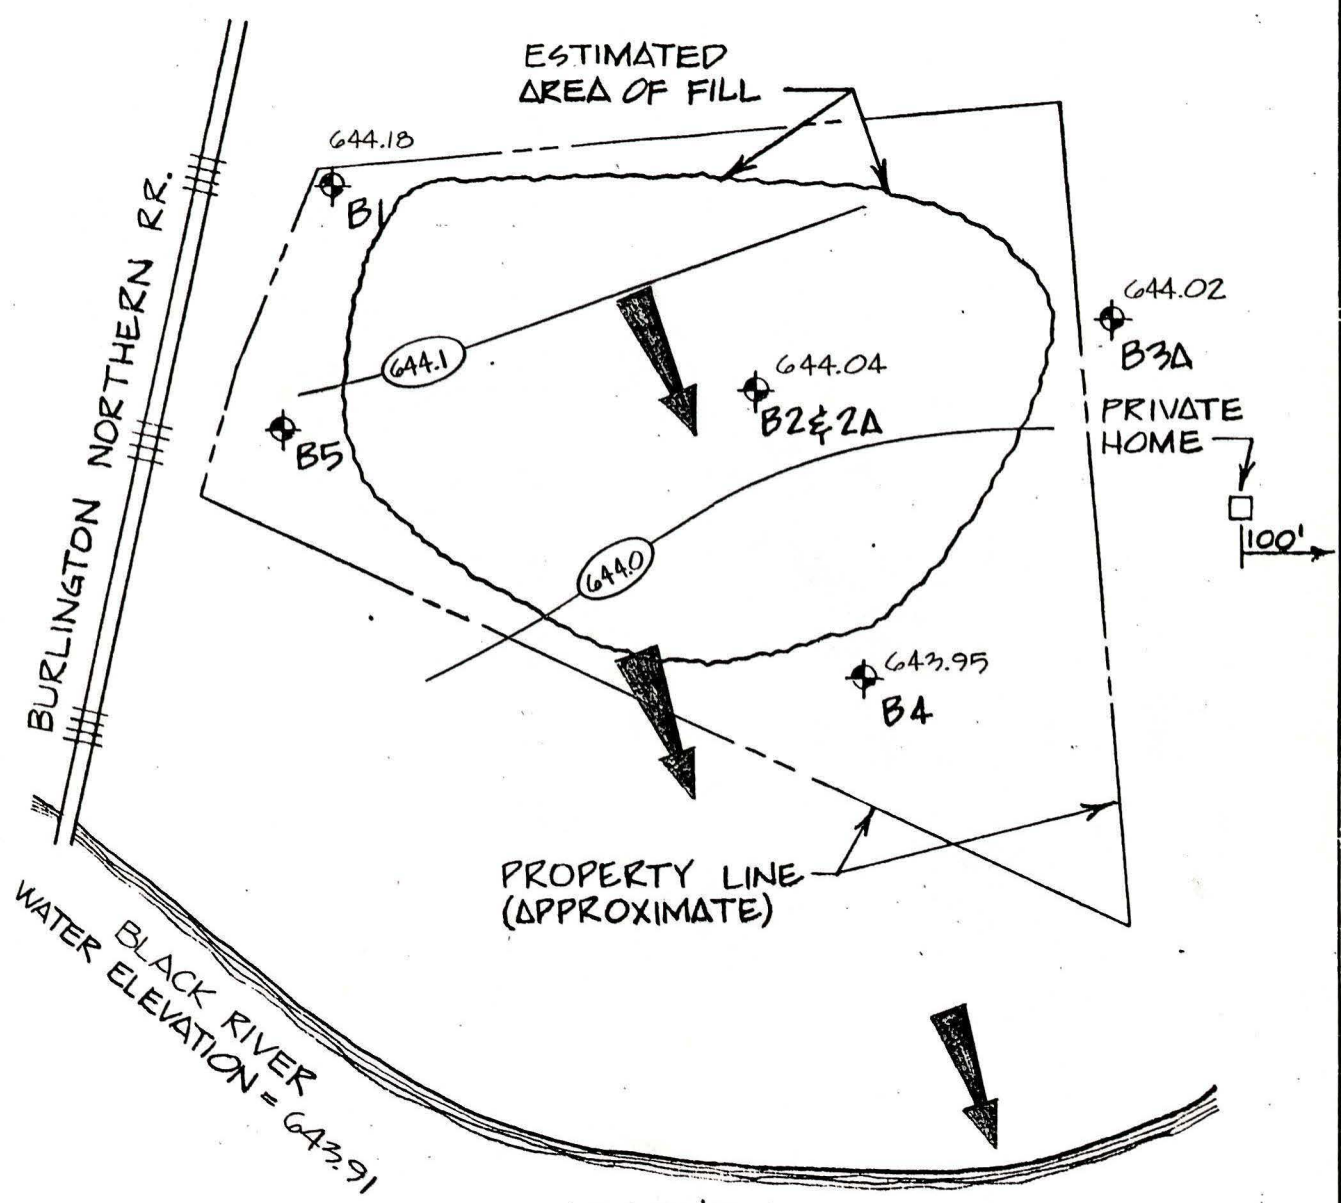
GROUNDWATER CONTOUR MAP 7/19/78 DATA		
	ONALASKA SANITARY LANDFILL ONALASKA, WISCONSIN		
DWN TDH	CHK'D CGK	APP'D <i>Robert J. Kennen</i>	DATE 10/13/78
			C7606-A12

Measurements of water levels in the observation wells indicated some shifts in the direction of groundwater flow under the site. The attached Drawings C 7606-A12 and A13 illustrate the configuration of the water table on July 19, 1978, and August 28, 1978, respectively.

Since submittal of the In-Field Conditions Report on April 17, 1978, the direction of groundwater flow has shown considerable variability. These changes are directly related to elevation changes of the Black River which either recharges the adjacent sand and gravel aquifer or receives groundwater discharge as the river level fluctuates. When the Black River recharges the sand and gravel aquifer, the direction of groundwater flow occurs in a south to southeast orientation (Drawing C 7606-A13). On July 19, 1978, the surface water level was below the adjacent groundwater levels and groundwater was discharging into the Black River. Under these conditions, groundwater flows towards the river in a more southwest orientation (Drawing C 7606-A12). Vertical gradients remained very slightly downward on the order of 10^{-3} during July and August.

The attached groundwater contour maps for July and August, 1978 do not include measurements taken from Well No. B5 in that we believe this particular well may have been tampered with. Partial plugging of the well is indicated by a very slow recovery rate when bailed even though the boring logs indicate the screen is in sand and gravel type deposits. Furthermore, reduction in depth to water readings from this well indicate a distinct groundwater mound in this area which we believe is related to a possible change in the casing elevation and not the water elevation. We would recommend that Well No. B5 be re-surveyed to confirm this during the next quarter.
