March 22, 1979
C 7606W

Re: Groundwater Monitoring -
Onalaska Sanitary Landfill

ENGINEERING INC	GROUNDWATER CONTOUR MAP 12/20/78 DATA		
	ONALASKA SANITARY LANDFILL ONALASKA, WISCONSIN		
DWN TDH	CHK'D CGK	APP'D <i>Robert Komarowski</i>	DATE 3/22/79
			C7606-A14

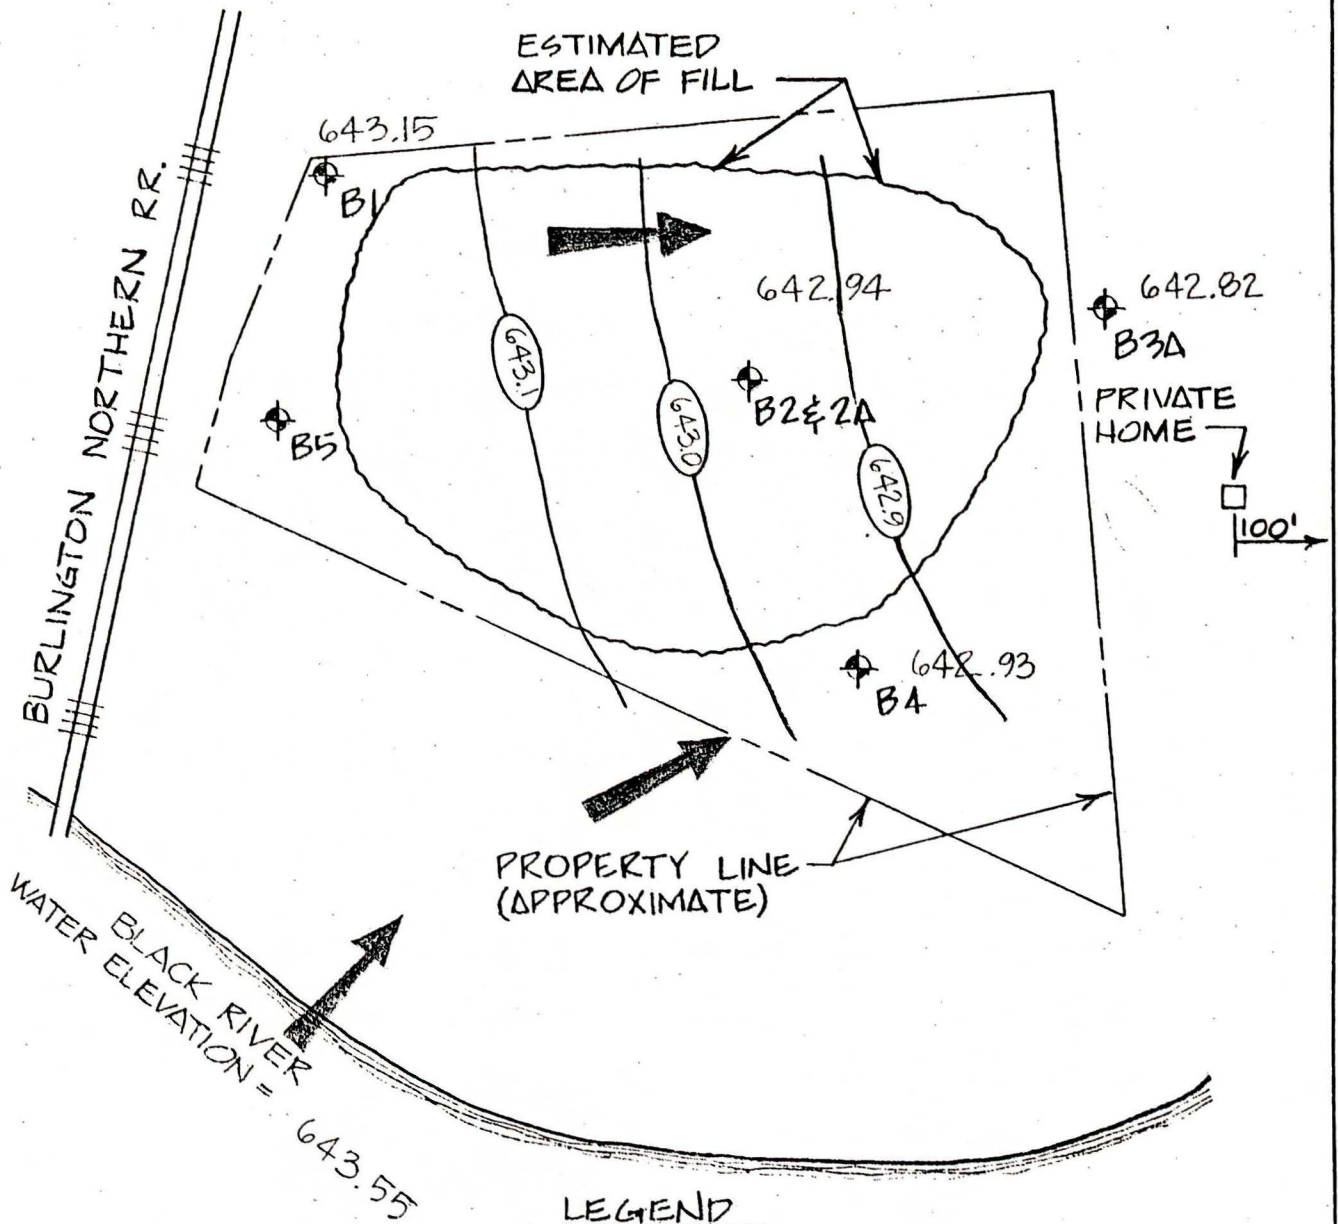
Measurements of groundwater levels in the observation wells indicate groundwater flow directions similar to those observed in October, 1978. The Black River is recharging the adjacent sand and gravel aquifer resulting in a southerly direction of groundwater flow. As shown on the attached Drawings C 7606-A14 and A15, the Cecil Miller residence is downgradient of the Onalaska Sanitary Landfill. Vertical gradients have remained very slightly downward at approximately 10^{-3} to 10^{-4} . Groundwater elevations remain within approximately 1' of previously reported levels.
