Re: Groundwater Monitoring-Town of Onalaska Sanitary Landfill

May 1, 1979
C 7606

Re: Groundwater Monitoring
Onalaska Sanitary Landfill

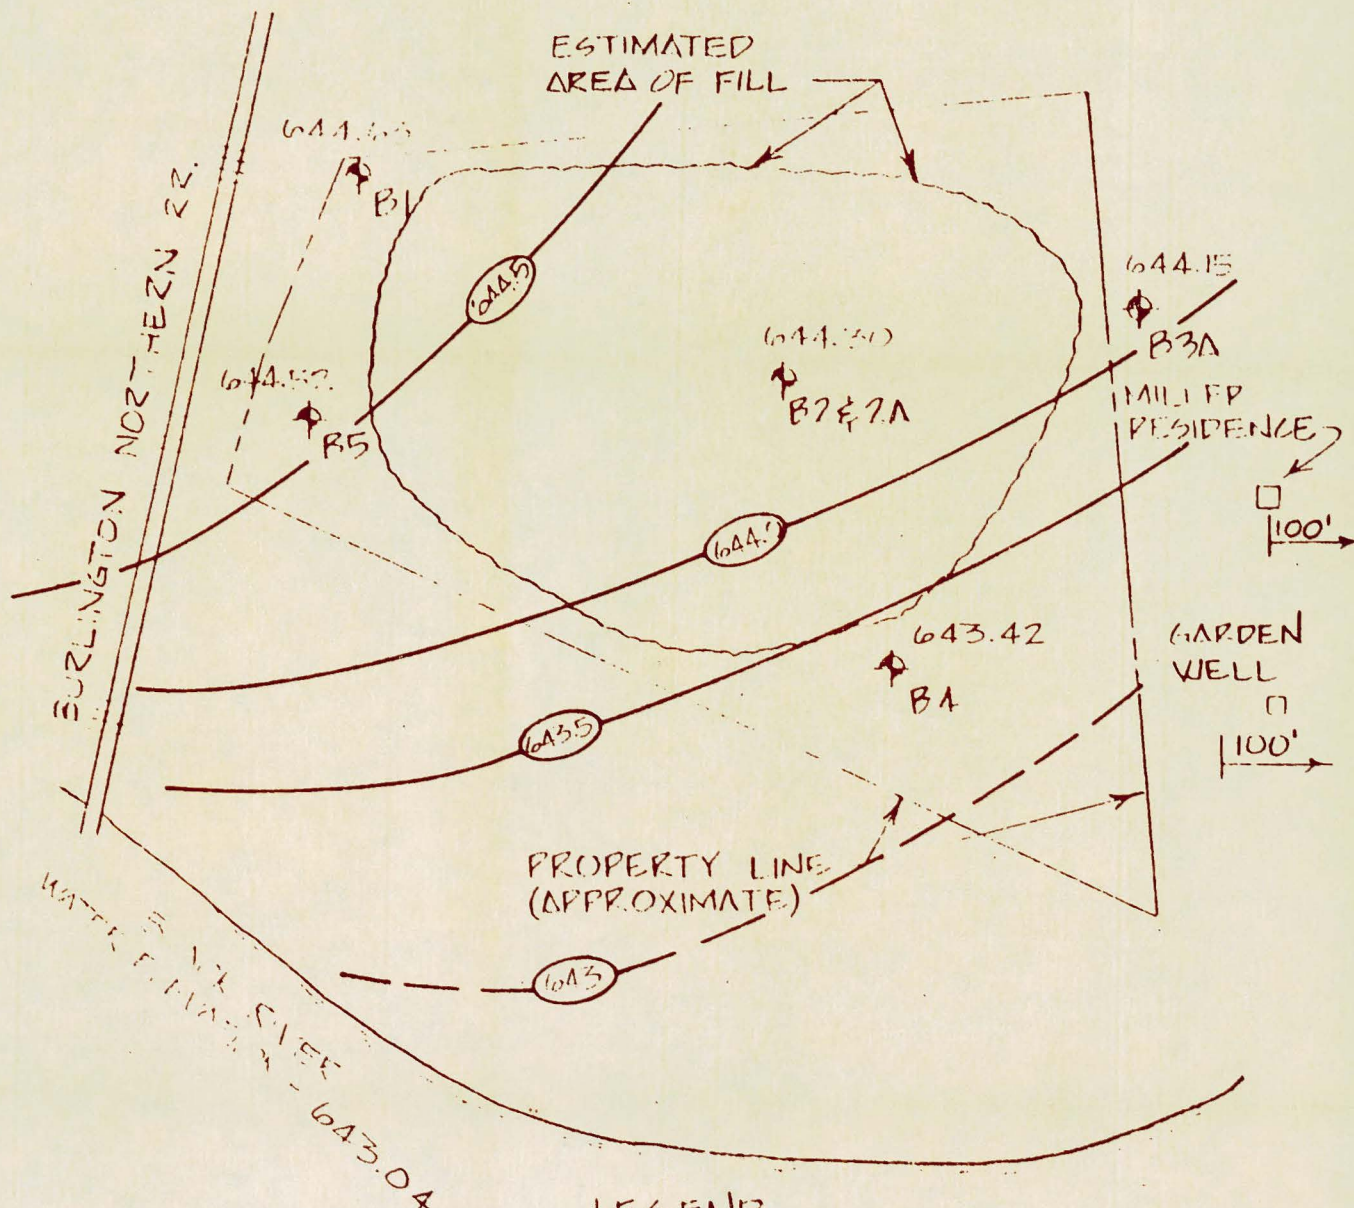
GROUNDWATER CONTOUR MAP 3/21/79 DATA		
	TOWN OF ONALASKA SANITARY LANDFILL ONALASKA, WISCONSIN		
DWN ITPH	CHK'D CLK	APP'D <i>Robert J. Kowalski</i>	DATE 5-1-79
			C 11606-A16

Groundwater elevations measured in the observation wells indicate a change in horizontal flow directions between March and April, 1979. In March, because of the relatively lower water level,

the Black River was receiving groundwater discharge from the aquifer resulting in a southwesterly direction of groundwater flow. Associated with the surface water level decline is a somewhat more steep horizontal gradient towards the river. April increases in the water level of the Black River have modified the flow direction to a more southerly orientation with groundwater being recharged through river infiltration. Based on past groundwater measurements, it appears this latter flow pattern is present for most of the year.

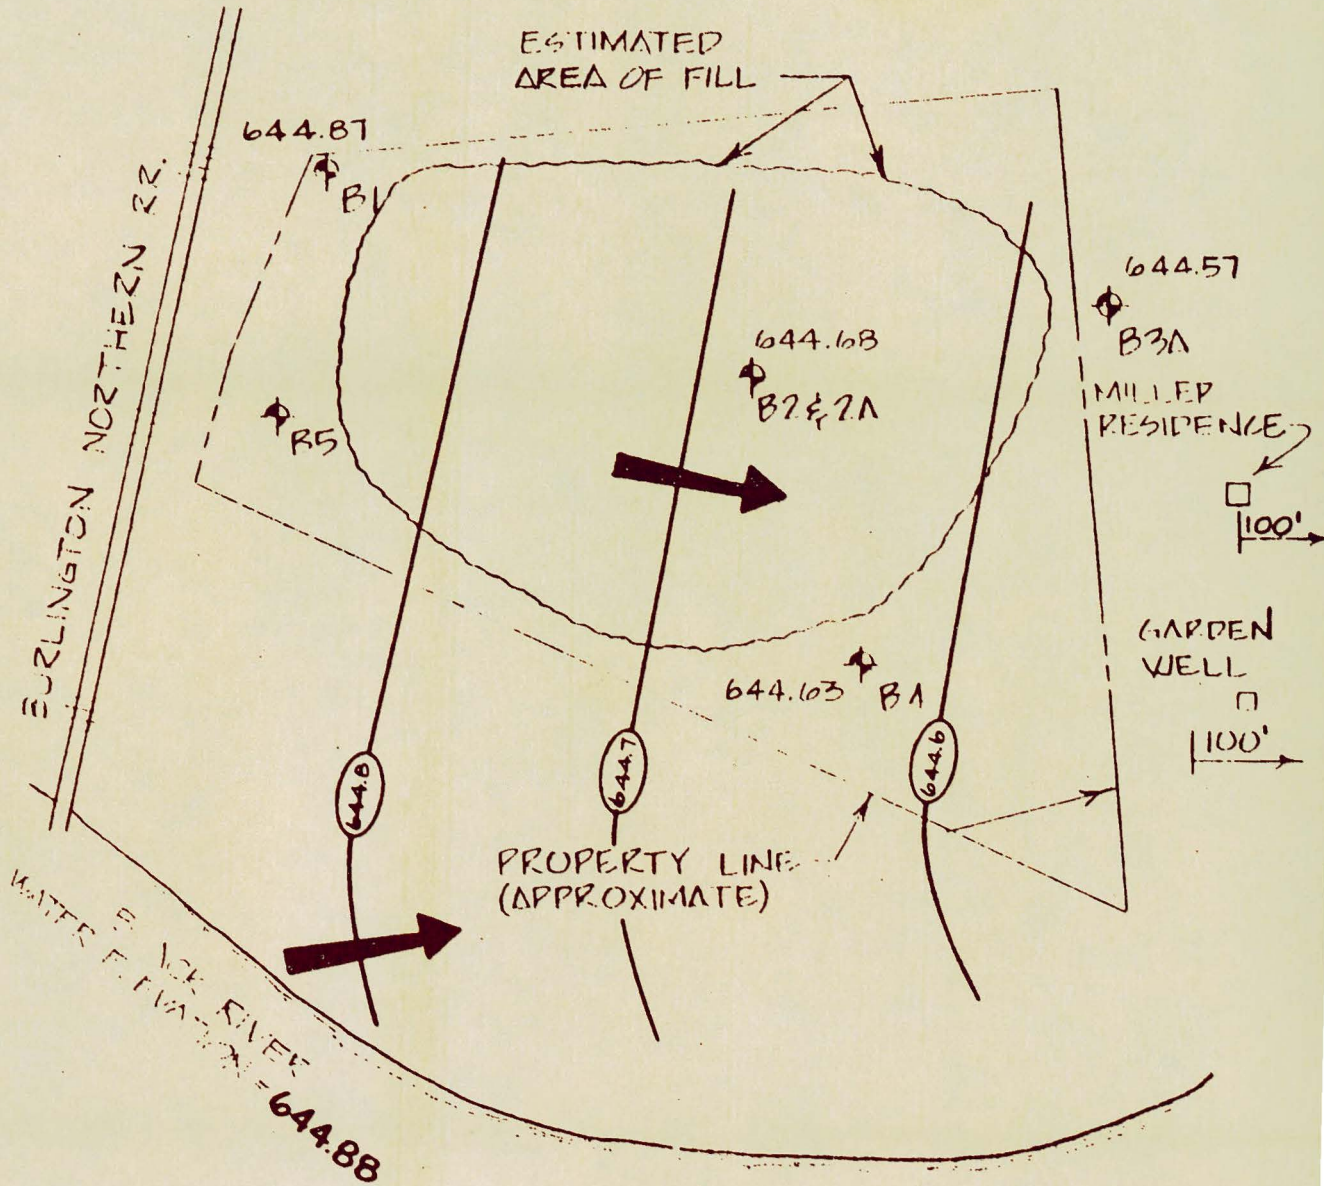
GROUNDWATER CONTOUR MAP 4/19/79 DATA		
	TOWN OF ONALASKA SANITARY LANDFILL ONALASKA, WISCONSIN		
DWN IDH	CHK'D CGK	APP'D <i>Robert J. K...</i>	DATE 5-1-79
			C7606-A17

With respect to the Miller private wells, both the Miller residence well and the garden well were located directly downgradient of the landfill at the time of the April measurements, however the garden well may be approaching the fringe of possible contaminant flow paths. Data obtained in March, 1979 also indicates both Miller wells were downgradient of the landfill with the home well possibly on the margin of possible contaminant flow path.
