December 12, 1979  
C 7606W

Re: Groundwater Monitoring  
Onalaska Sanitary Landfill

**GROUNDWATER CONTOUR MAP**

ONALASKA SANITARY LANDFILL  
 ONALASKA, WISCONSIN

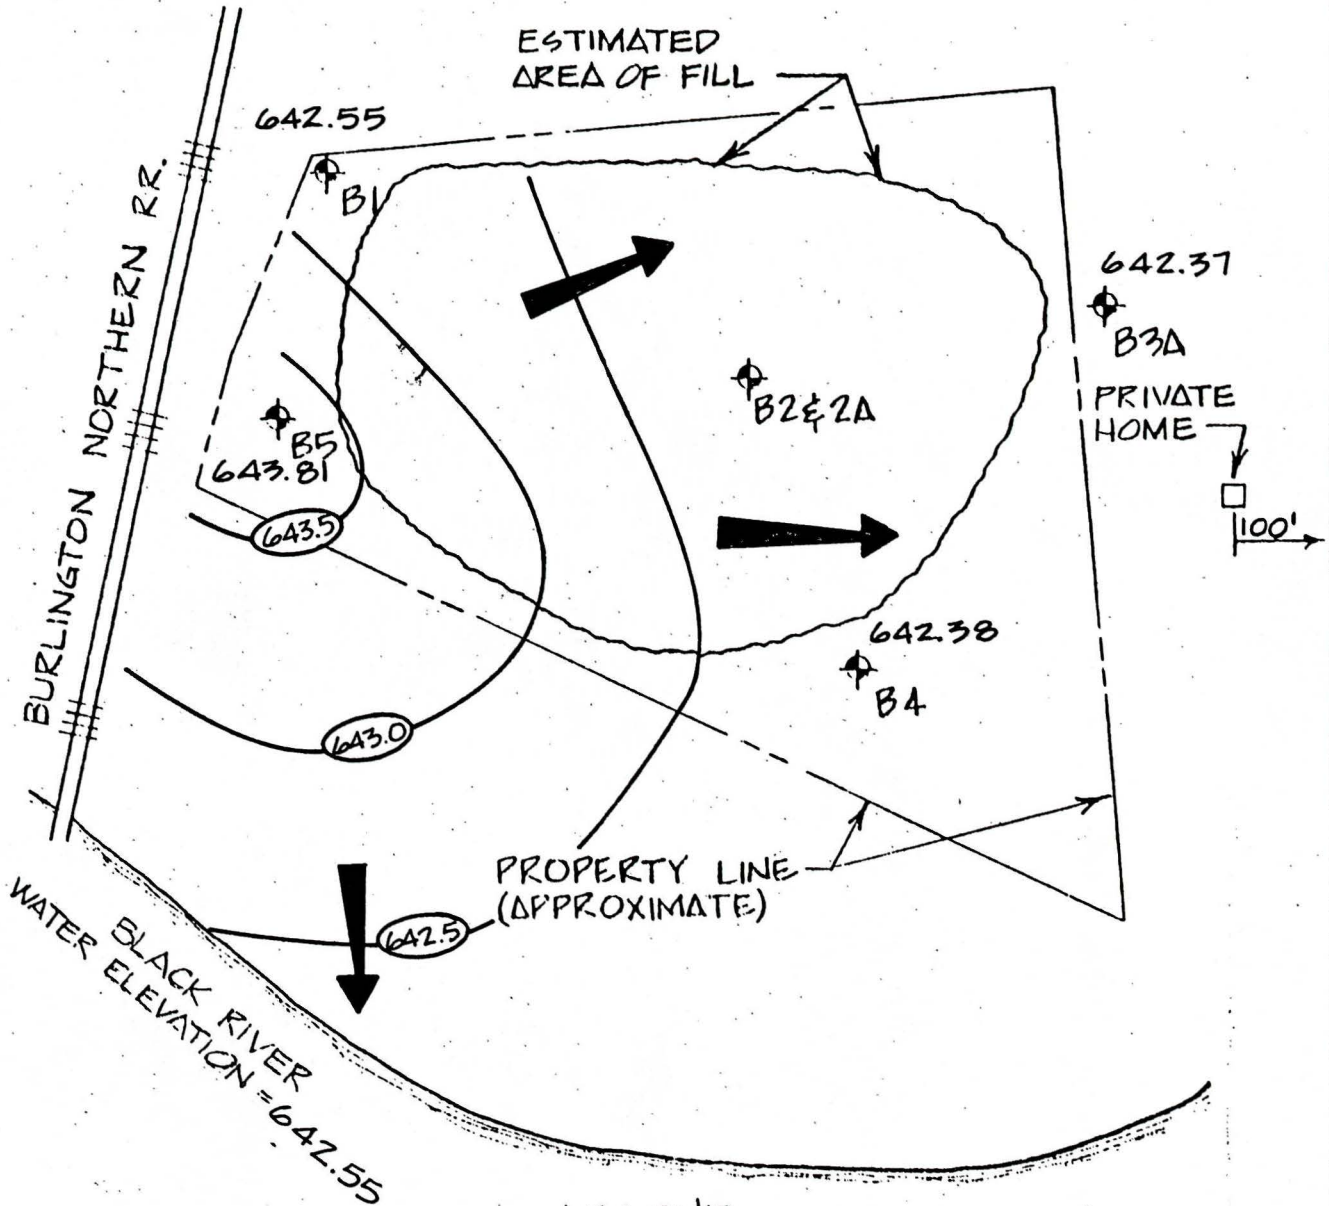
C71606-A19

Horizontal groundwater flow directions were generally to the south and southwest with groundwater discharging into the Black River. The data indicate the existence of a groundwater high in the vicinity of Well No. 5. Based on the horizontal flow directions shown on Drawing C 7606-A19, the Miller wells are downgradient at the landfill.
