January 30, 1980
C 7606W

Re: Groundwater Monitoring
Onalaska Sanitary Landfill

GROUNDWATER CONTOUR MAP 12/05/79 DATA		
	TOWN OF ONALASKA SANITARY LANDFILL ONALASKA, WISCONSIN		
DWN TDH	CHK'D CGK	APP'D <i>James A. Pin</i>	DATE 1/30/80
			C71606-A20

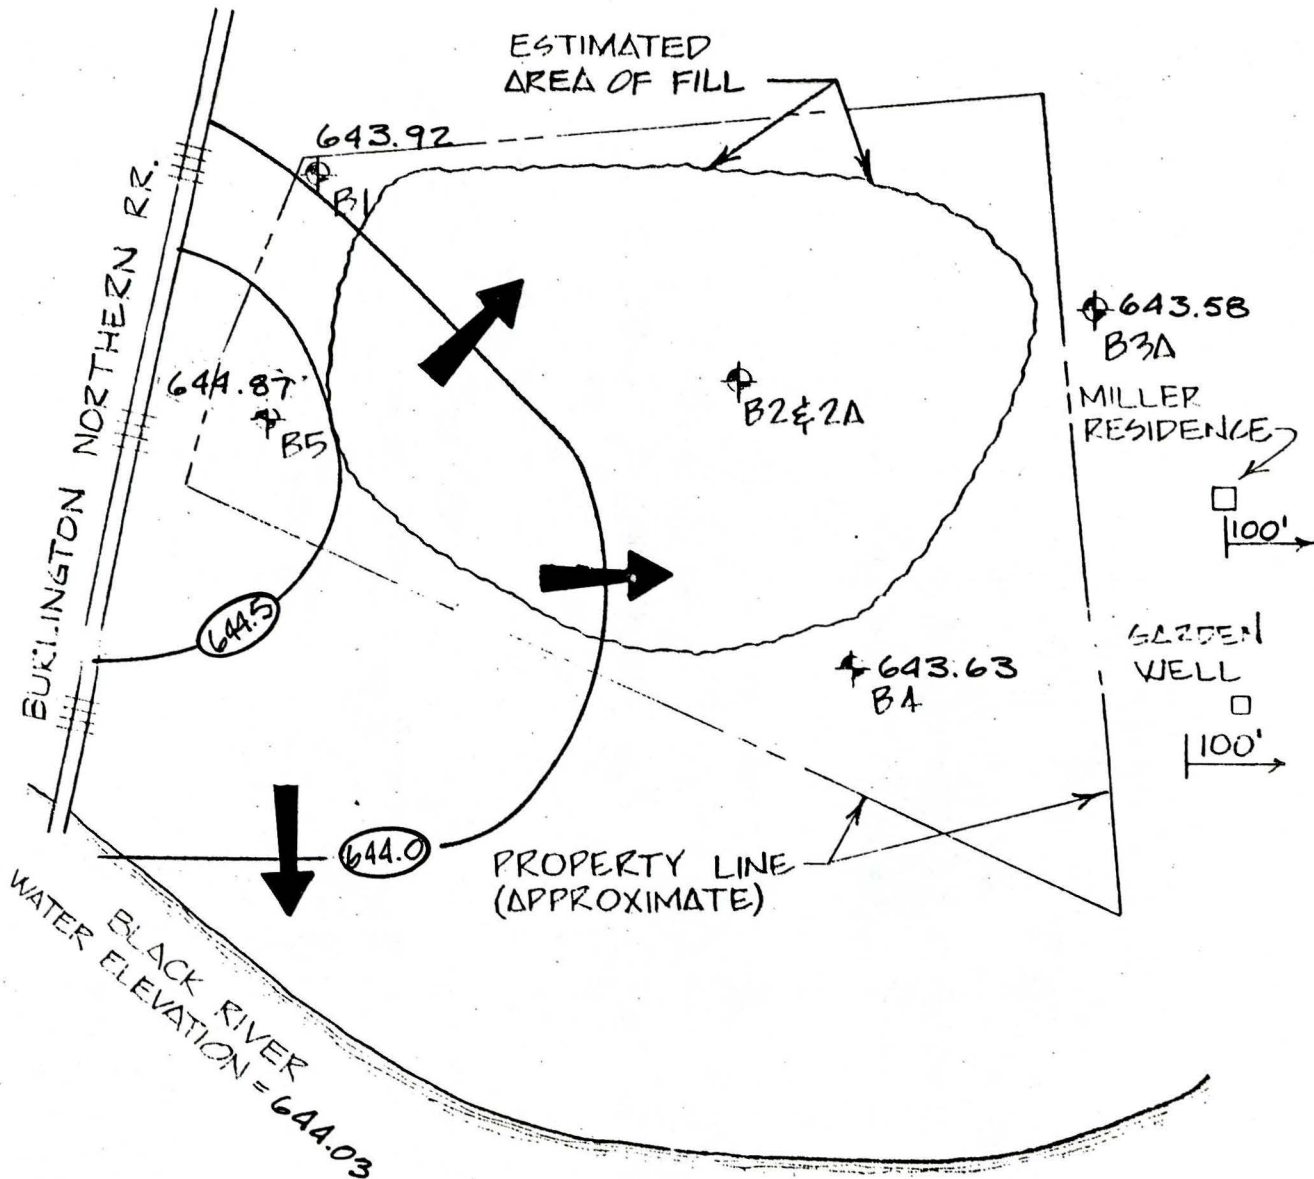
Groundwater elevations have increased over a foot in all wells from the previous sampling (September 19, 1979), but groundwater still appears to flow in a generally southerly direction toward the Miller property and the Black River.
