April 22, 1980
C 7606 W

Enclosed are the ^{First}~~second~~ quarter 1980 groundwater monitoring results for the Onalaska Sanitary Landfill. You will note that sulfates have been dropped from the list of parameters analyzed. Consistently low readings do not provide sufficient information to justify continuation of analyses for sulfate.

GROUNDWATER CONTOUR MAP 3-12-80 DATA		
	TOWN OF ONALASKA SANITARY LANDFILL ONALASKA, WISCONSIN		
DWN TDH	CHK'D CGK	APP'D <i>James A. Dan</i>	DATE 4-24-80
			C7606-A22

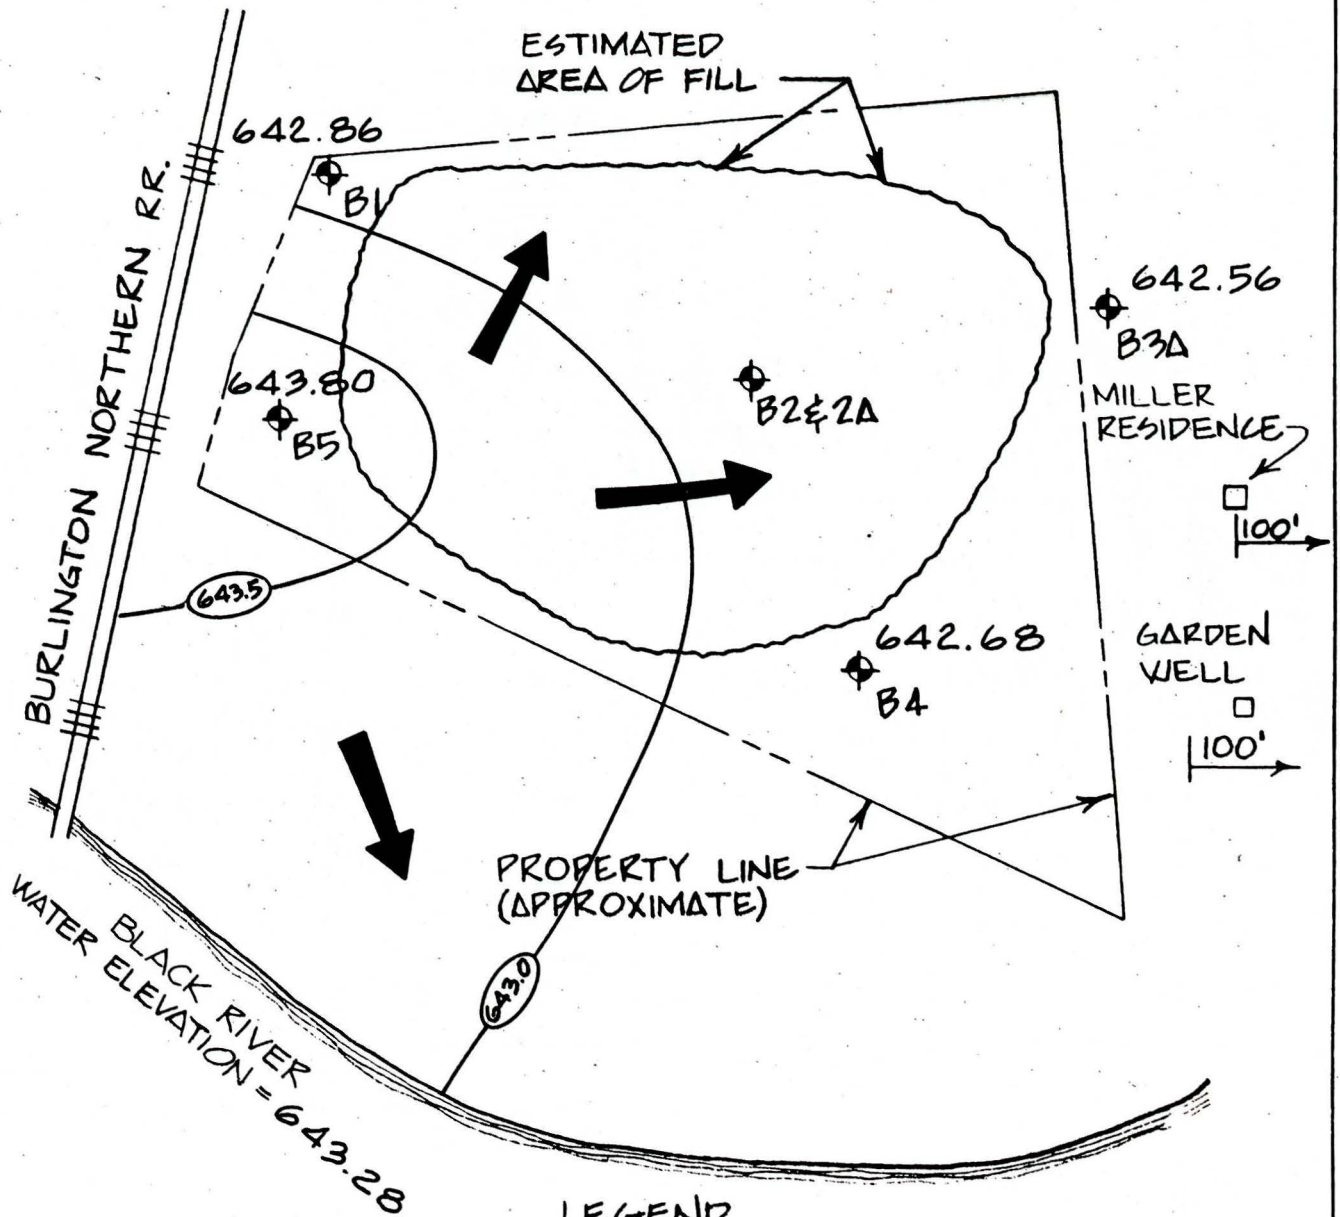
Groundwater elevations indicate a southerly direction of flow across Onalaska Sanitary Lanfill. Due to casing extensions at wells B2 and B2A, groundwater elevations are not shown. These wells will be surveyed in the near future to obtain top of casing elevations. Groundwater is generally one foot below the previous quarter's elevations. A decrease in water table elevations is typical of the late winter. Mr. Miller's home continues to be downgradient of the landfill.
