August 11, 1980  
C 7606 W

## ANALYTICAL LABORATORY RESULTS

Project Town of Onalaska Sanitary Landfill  
 \_\_\_\_\_  
 Location Onalaska, Wisconsin

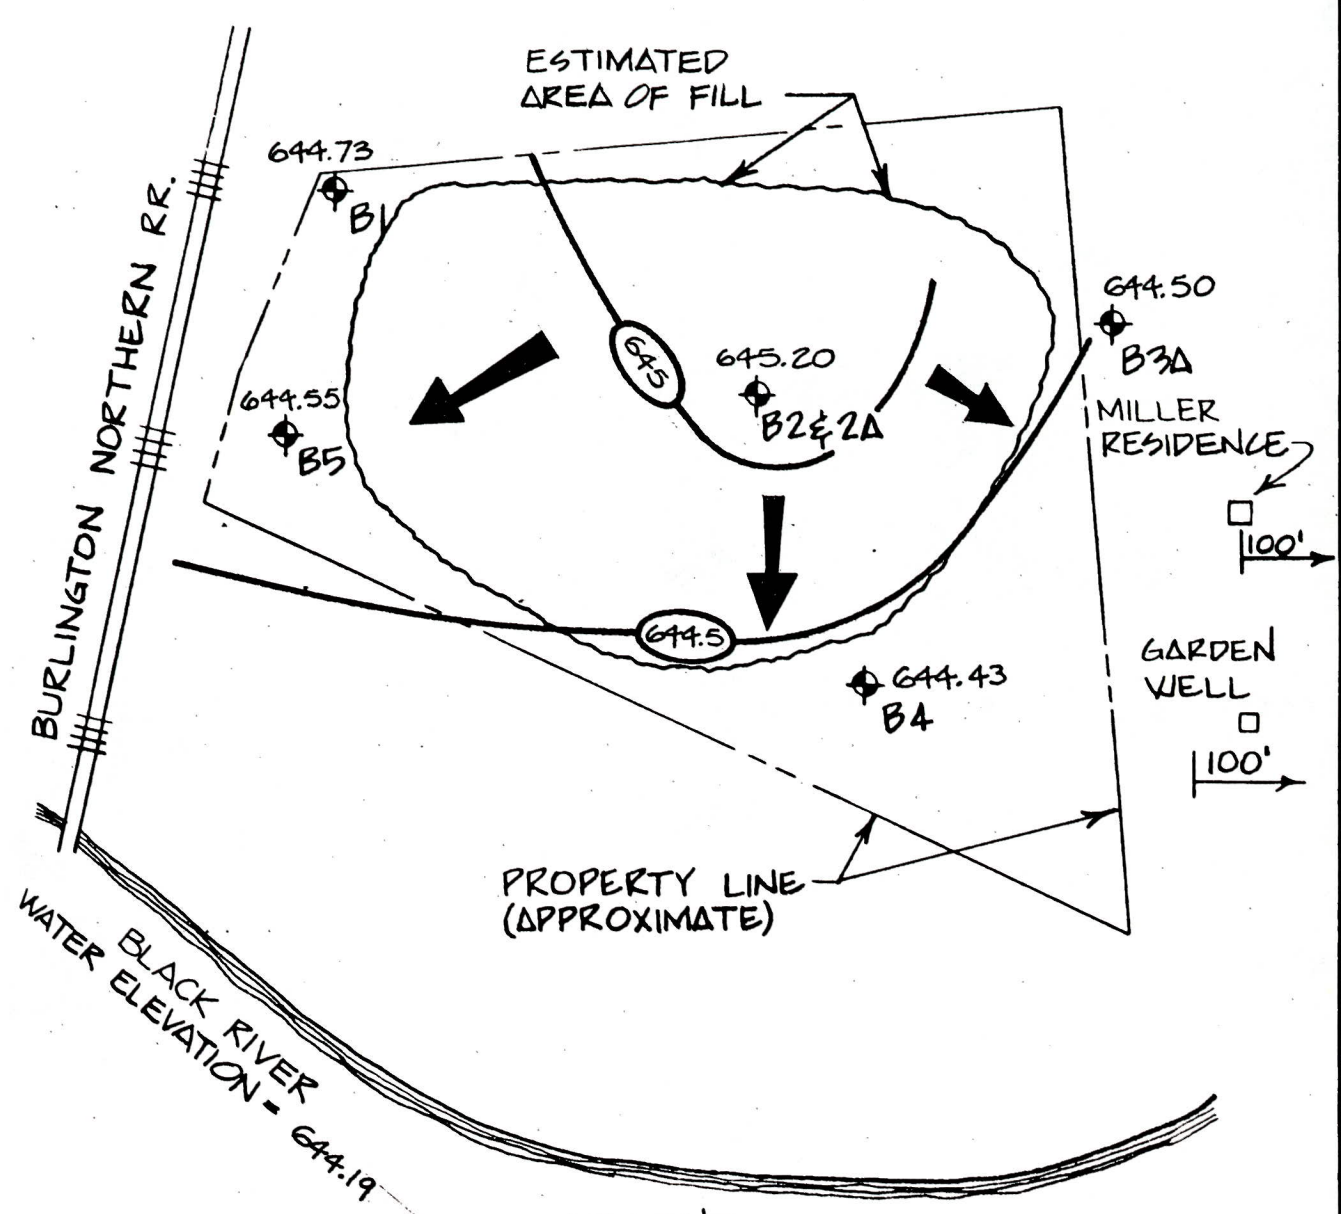
<b>GROUNDWATER CONTOUR MAP</b> 6-17-80 DATA		
	TOWN OF ONALASKA SANITARY LANDFILL ONALASKA, WISCONSIN		
DWN TDH	CHK'D CGK	APP'D <i>Rolney Kawas...</i>	DATE 8/11/80
			C7606-A23

Groundwater elevations increased in all monitoring wells compared to the previous sampling (March 12, 1980). The increases ranged from between 1.75 feet at Monitoring Well B4 and 2.88 feet at Monitoring Well B2A. Groundwater flow appears to be somewhat different from past observations in that groundwater is now discharged into the Black River. There appears to be a groundwater high at the center of the landfill area. Flow appears to be primarily towards the west with some components of flow towards the northwest and the southwest. There remains an upward gradient at the piezometer (Monitoring Wells B2 and B2A).

Hydrogeologic conditions appear to be somewhat changed at Onalaska Sanitary Landfill. Groundwater flow direction has changed to more of a radial pattern away from the landfill than noted previously. As a result of this apparent change in flow direction, Monitoring Well B5 is no longer upgradient from the landfill. The analysis for Monitoring Well B2A indicates a significant increase in concentrations of analyzed parameters has occurred in the groundwater system at depth. All of the above observation are the result of this quarter's groundwater monitoring only. Monitoring results from future quarters are needed to discern if the trends noted above are permanent changes in the hydrogeologic conditions in and around Onalaska Sanitary Landfill.
