**RE: Former Koppers Inc. Facility, Superior Wisconsin
WDNR DNR BRRTs No: 0216000484
WDNR Facility ID: 816009810**

Subject: 2016 On-Property Corrective Measures Monitoring & Maintenance Report

Site Inspection Form - 10/6/16

Post Construction Site Inspection Form
Beazer East, Inc.
Koppers Inc. Facility, Superior, Wisconsin

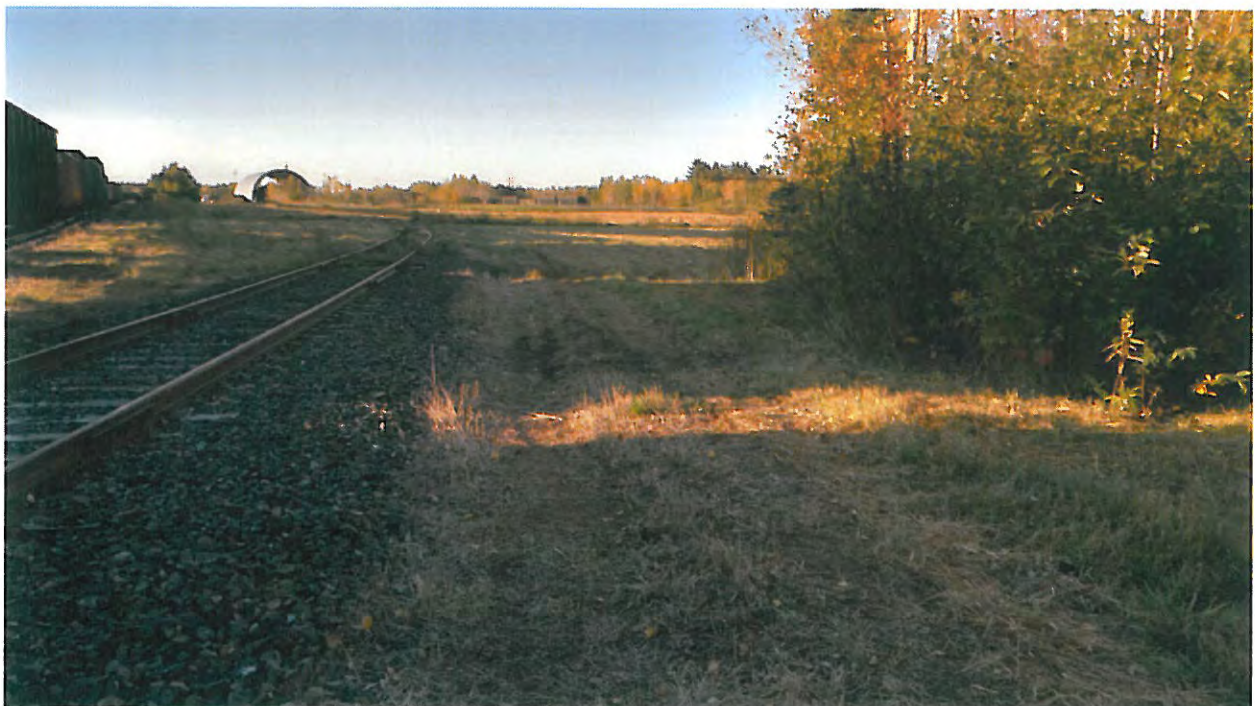
(check one)	No	Yes	If yes, provide description and take photos
Excessive erosion	X		
Evidence of excessive settling or ponding		X	<u>finding due to ruts formed by heavy machinery</u>
Areas lacking well-established vegetation		X	<u>Railroad track maintenance activities left areas w/ sparse vegetation, ruts, and ponding</u>

Area B Photo 4, looking Southwest at Western portion of cover area (Sparse vegetation and small ruts):

Action Items: Repair disturbed soils and sparsely vegetated areas; continue to monitor

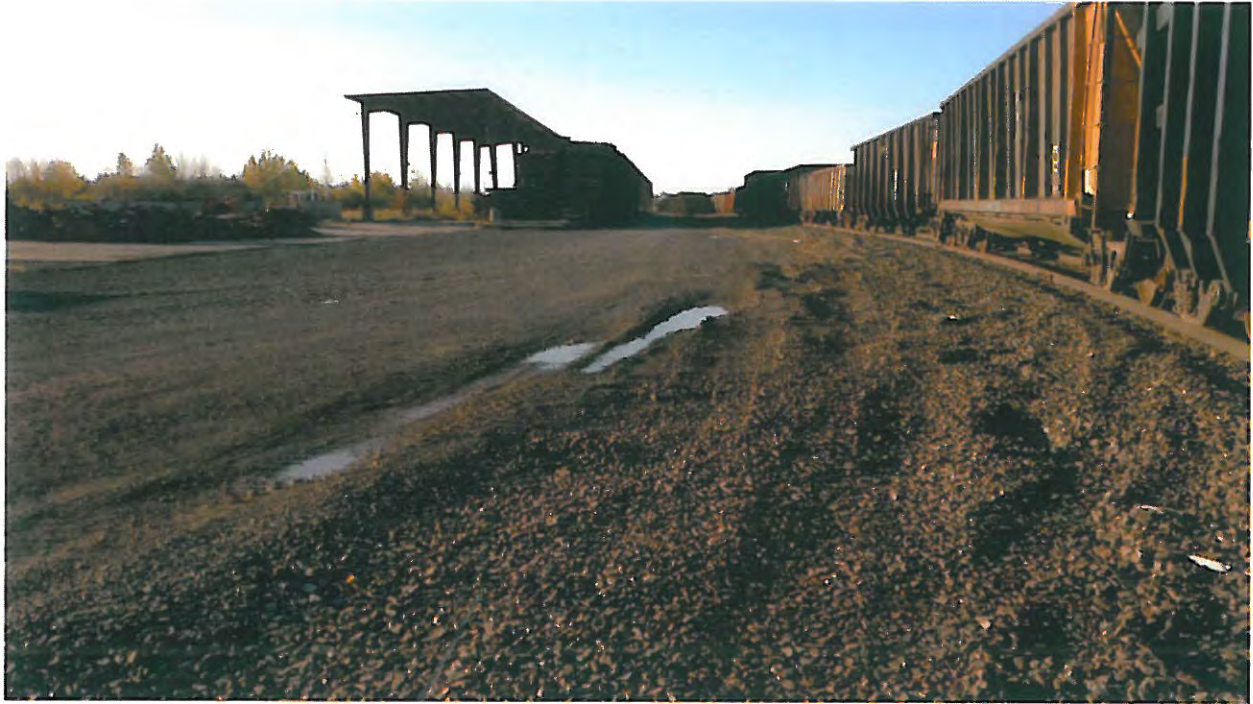
Area B Photo 8, looking South at area along East side of railroad tracks (ponding and disturbed soil):

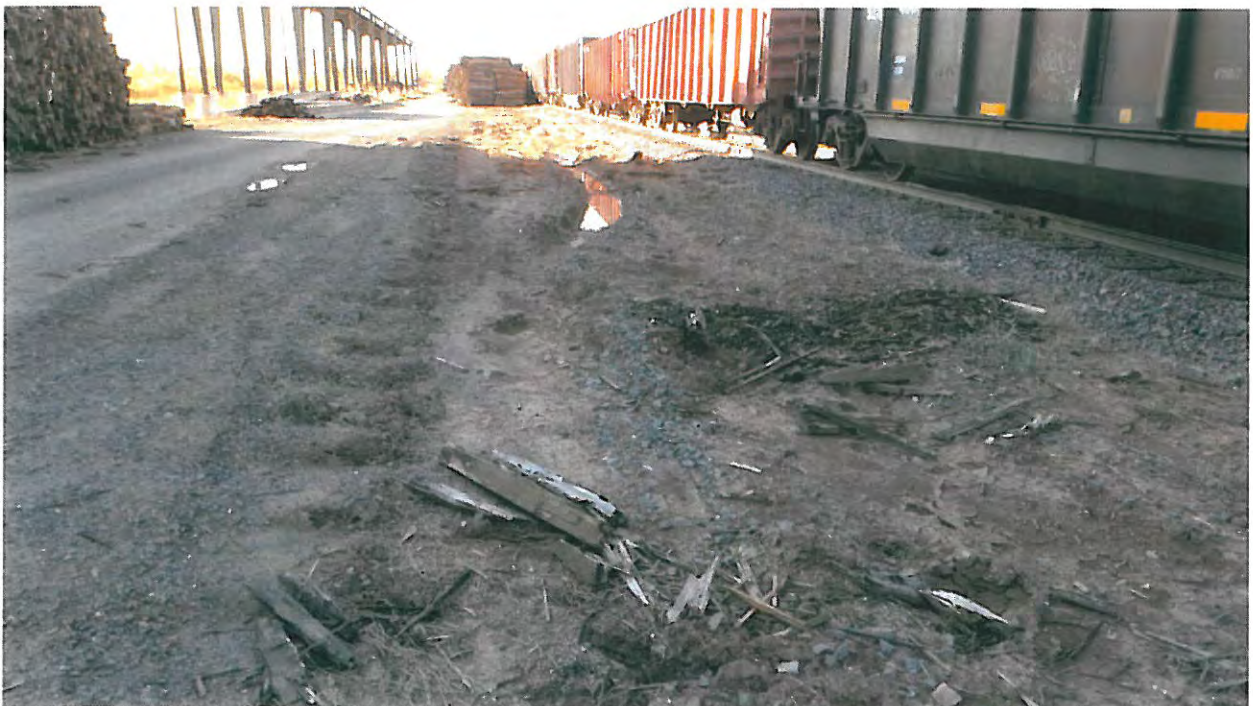
Area B Photo 9, looking South at area along East side of railroad tracks (ponding and ruts):

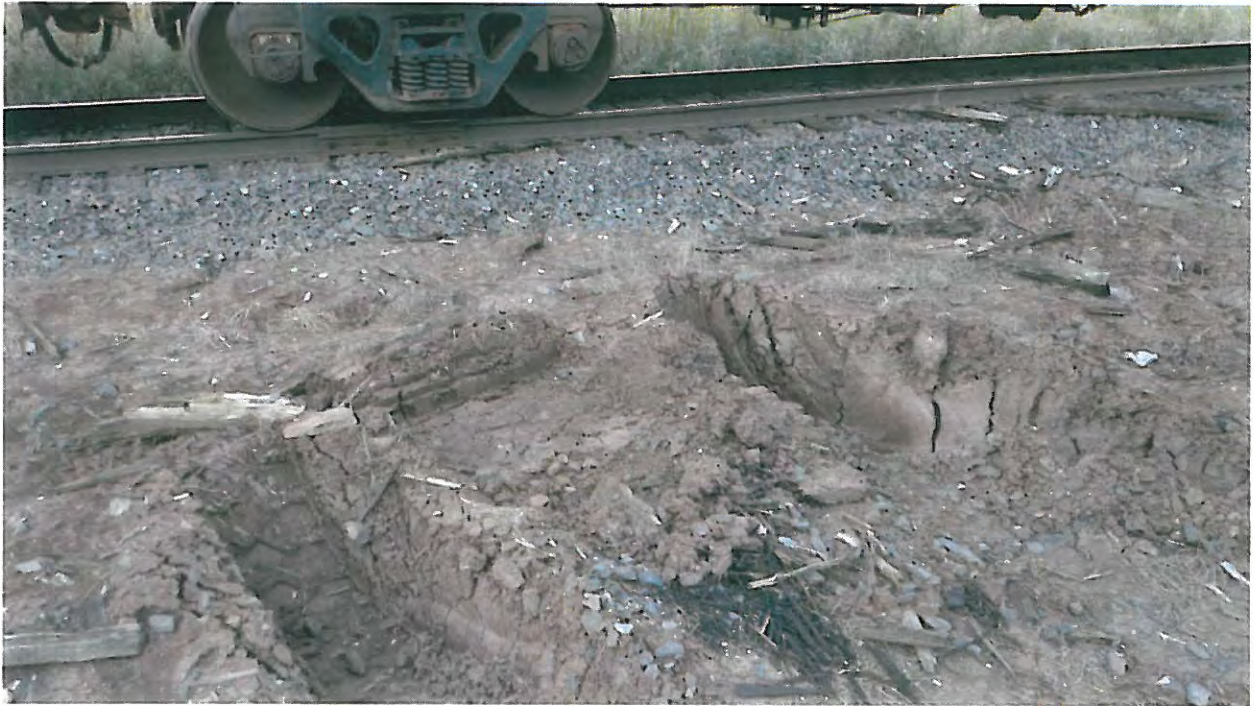
Area B Photo 10, Close up of ruts from Photo 9 (Apx 2.5' deep ruts):

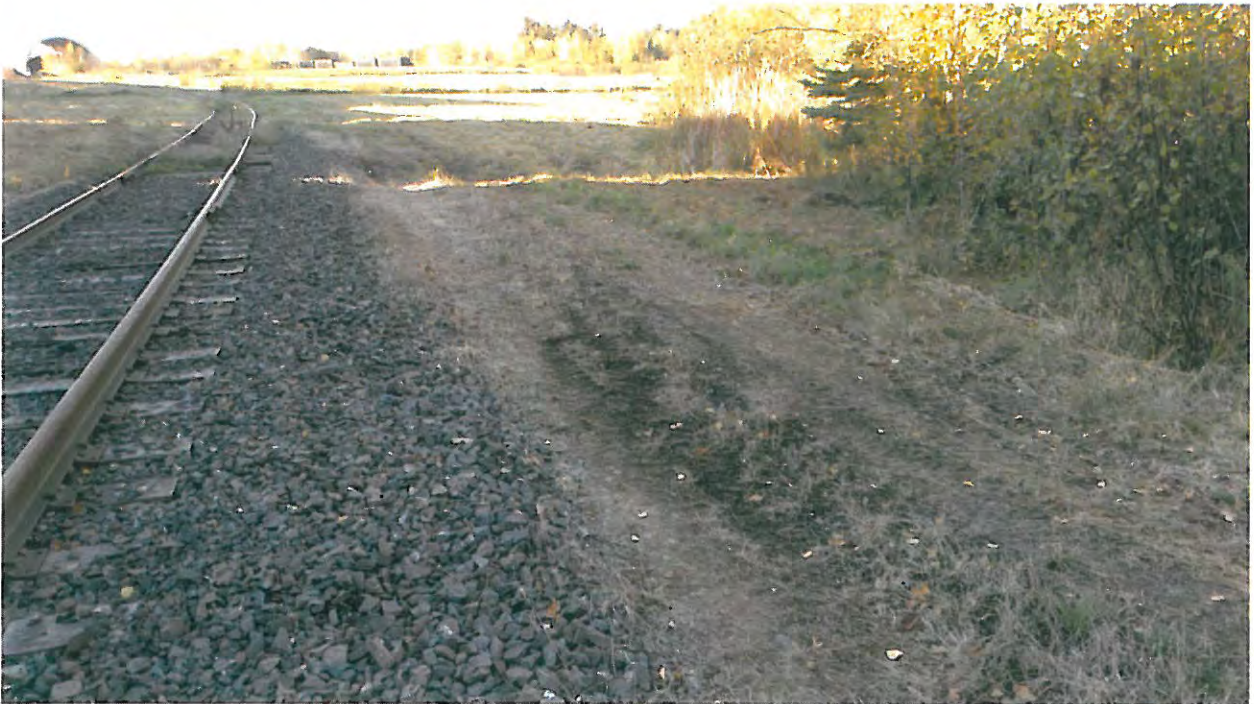
Area B Photo 11, Close up of ruts/sparse vegetation from Photo 4:

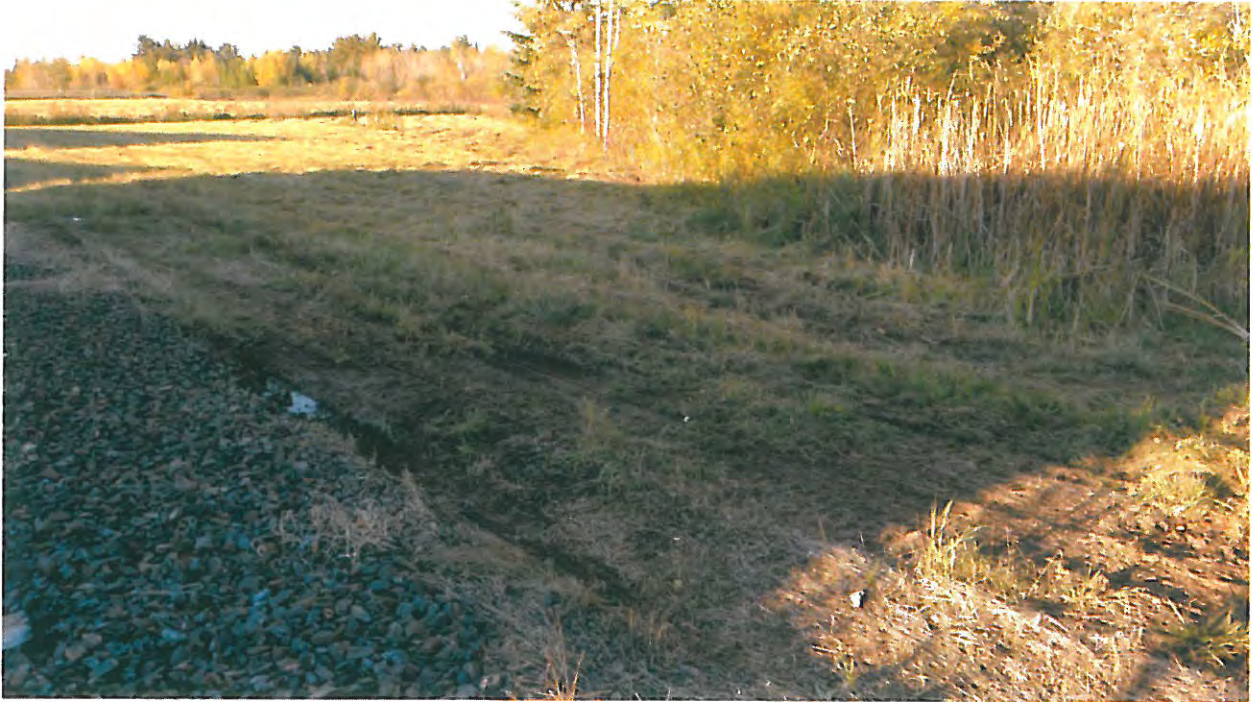
Area B Photo 12, Close up of ruts from Photo 4:

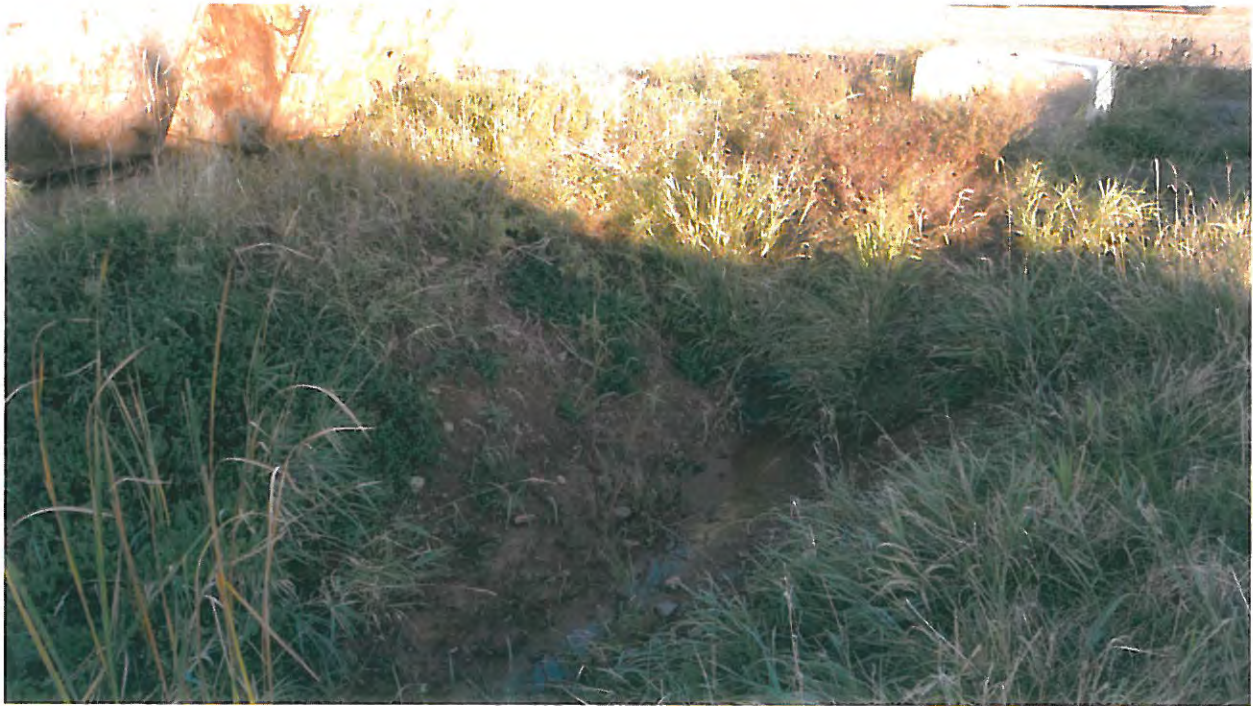
(check one)	No	Yes	If yes, provide description and take photos
Excessive erosion	X		
Evidence of excessive settling or ponding	X		
Areas lacking well-established vegetation		X	Small 2x3ft area with sparse vegetation

Area F1 Photo 2, looking Northwest from South end (Small sparse vegetated area):

Action Items: Small sparse vegetated area

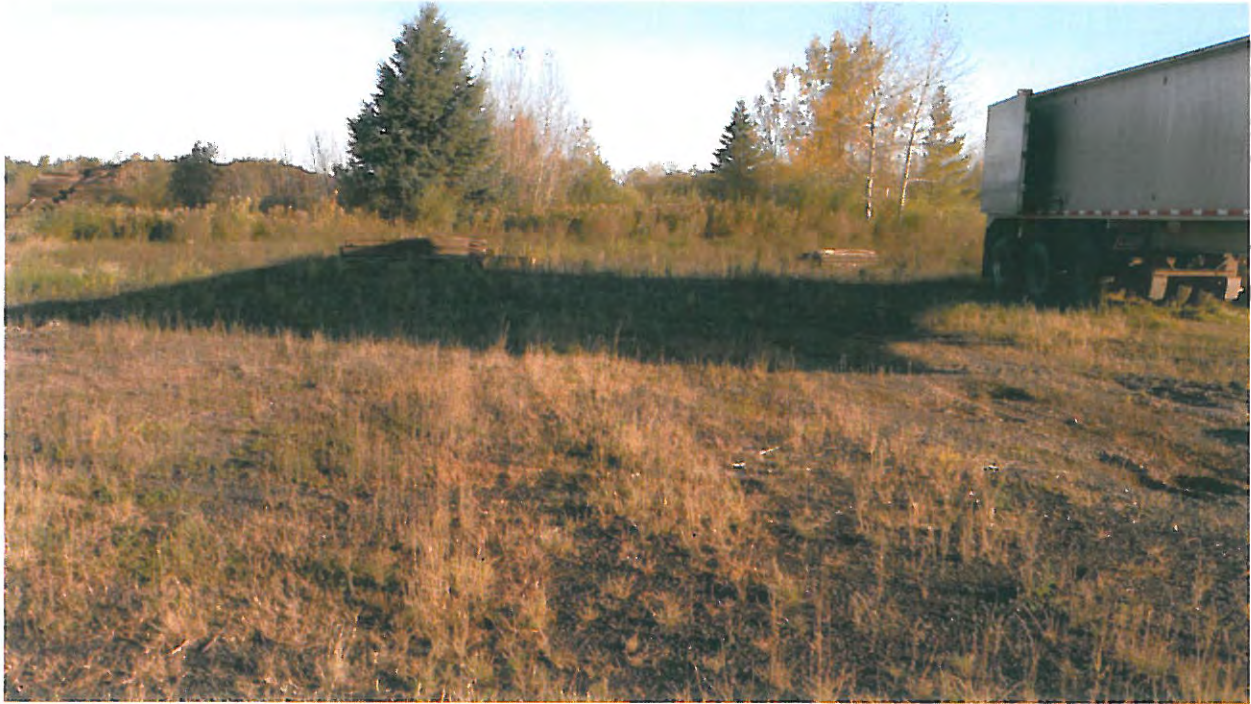
Action Items: minor ruts

Area F2 Photo 1, Looking North from South side:

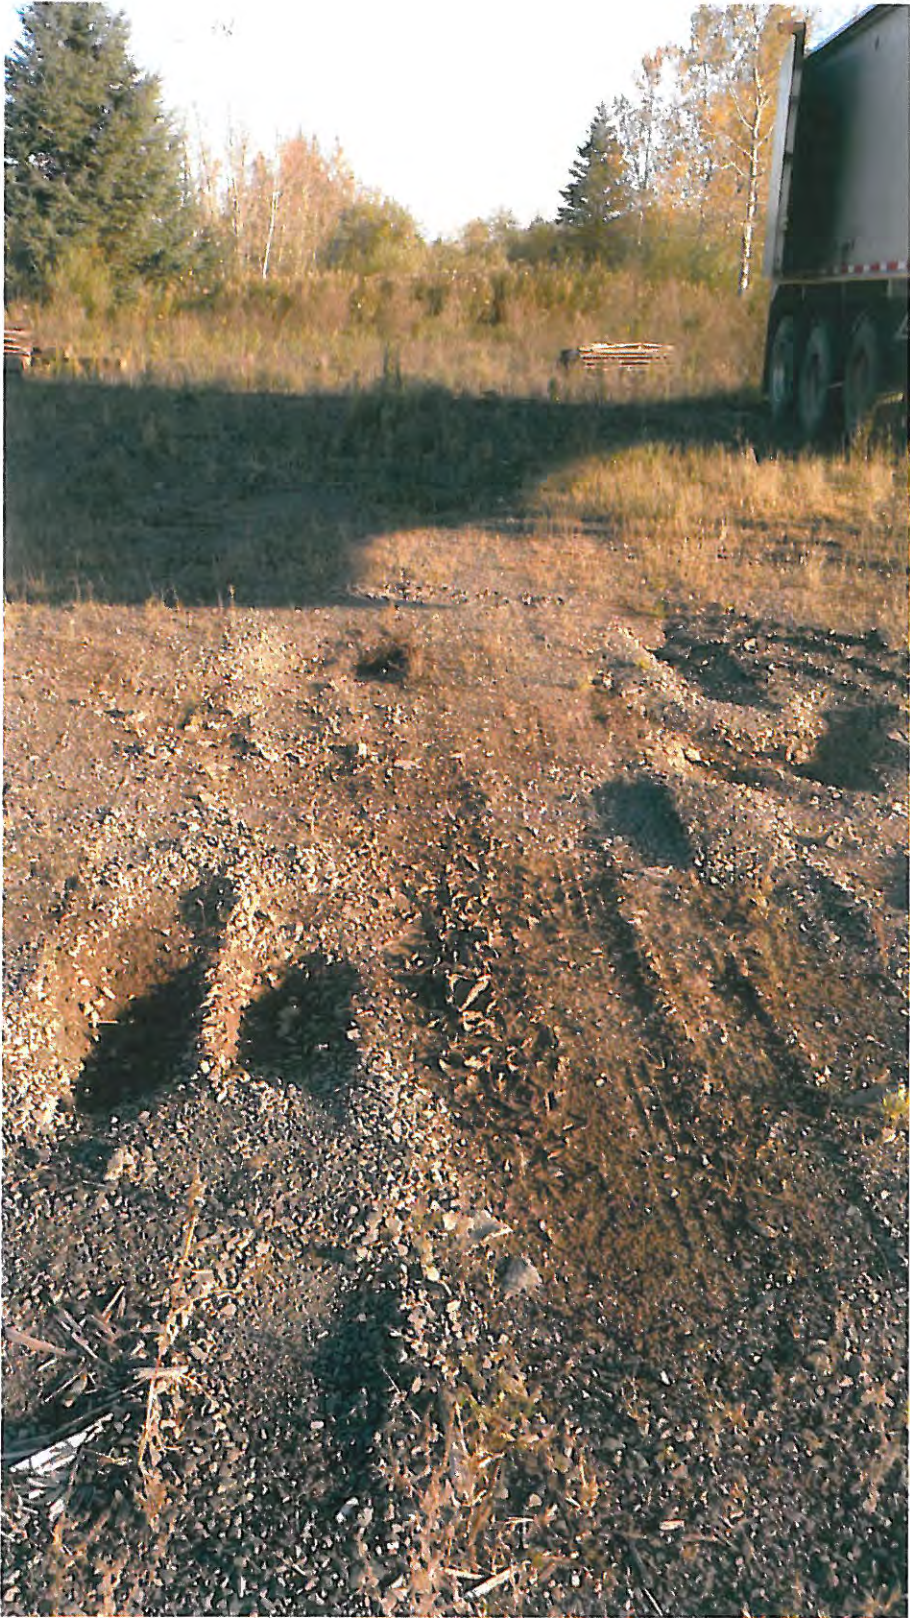
Area F2 Photo 2, Close up of ruts from Photo 1:
