Beazer East, Inc.

CRAWFORD CREEK (SUB-AREA D) SUPPLEMENTAL SEDIMENT INVESTIGATION FINDINGS

Former Koppers Inc. Facility
Superior, Wisconsin

August 2017

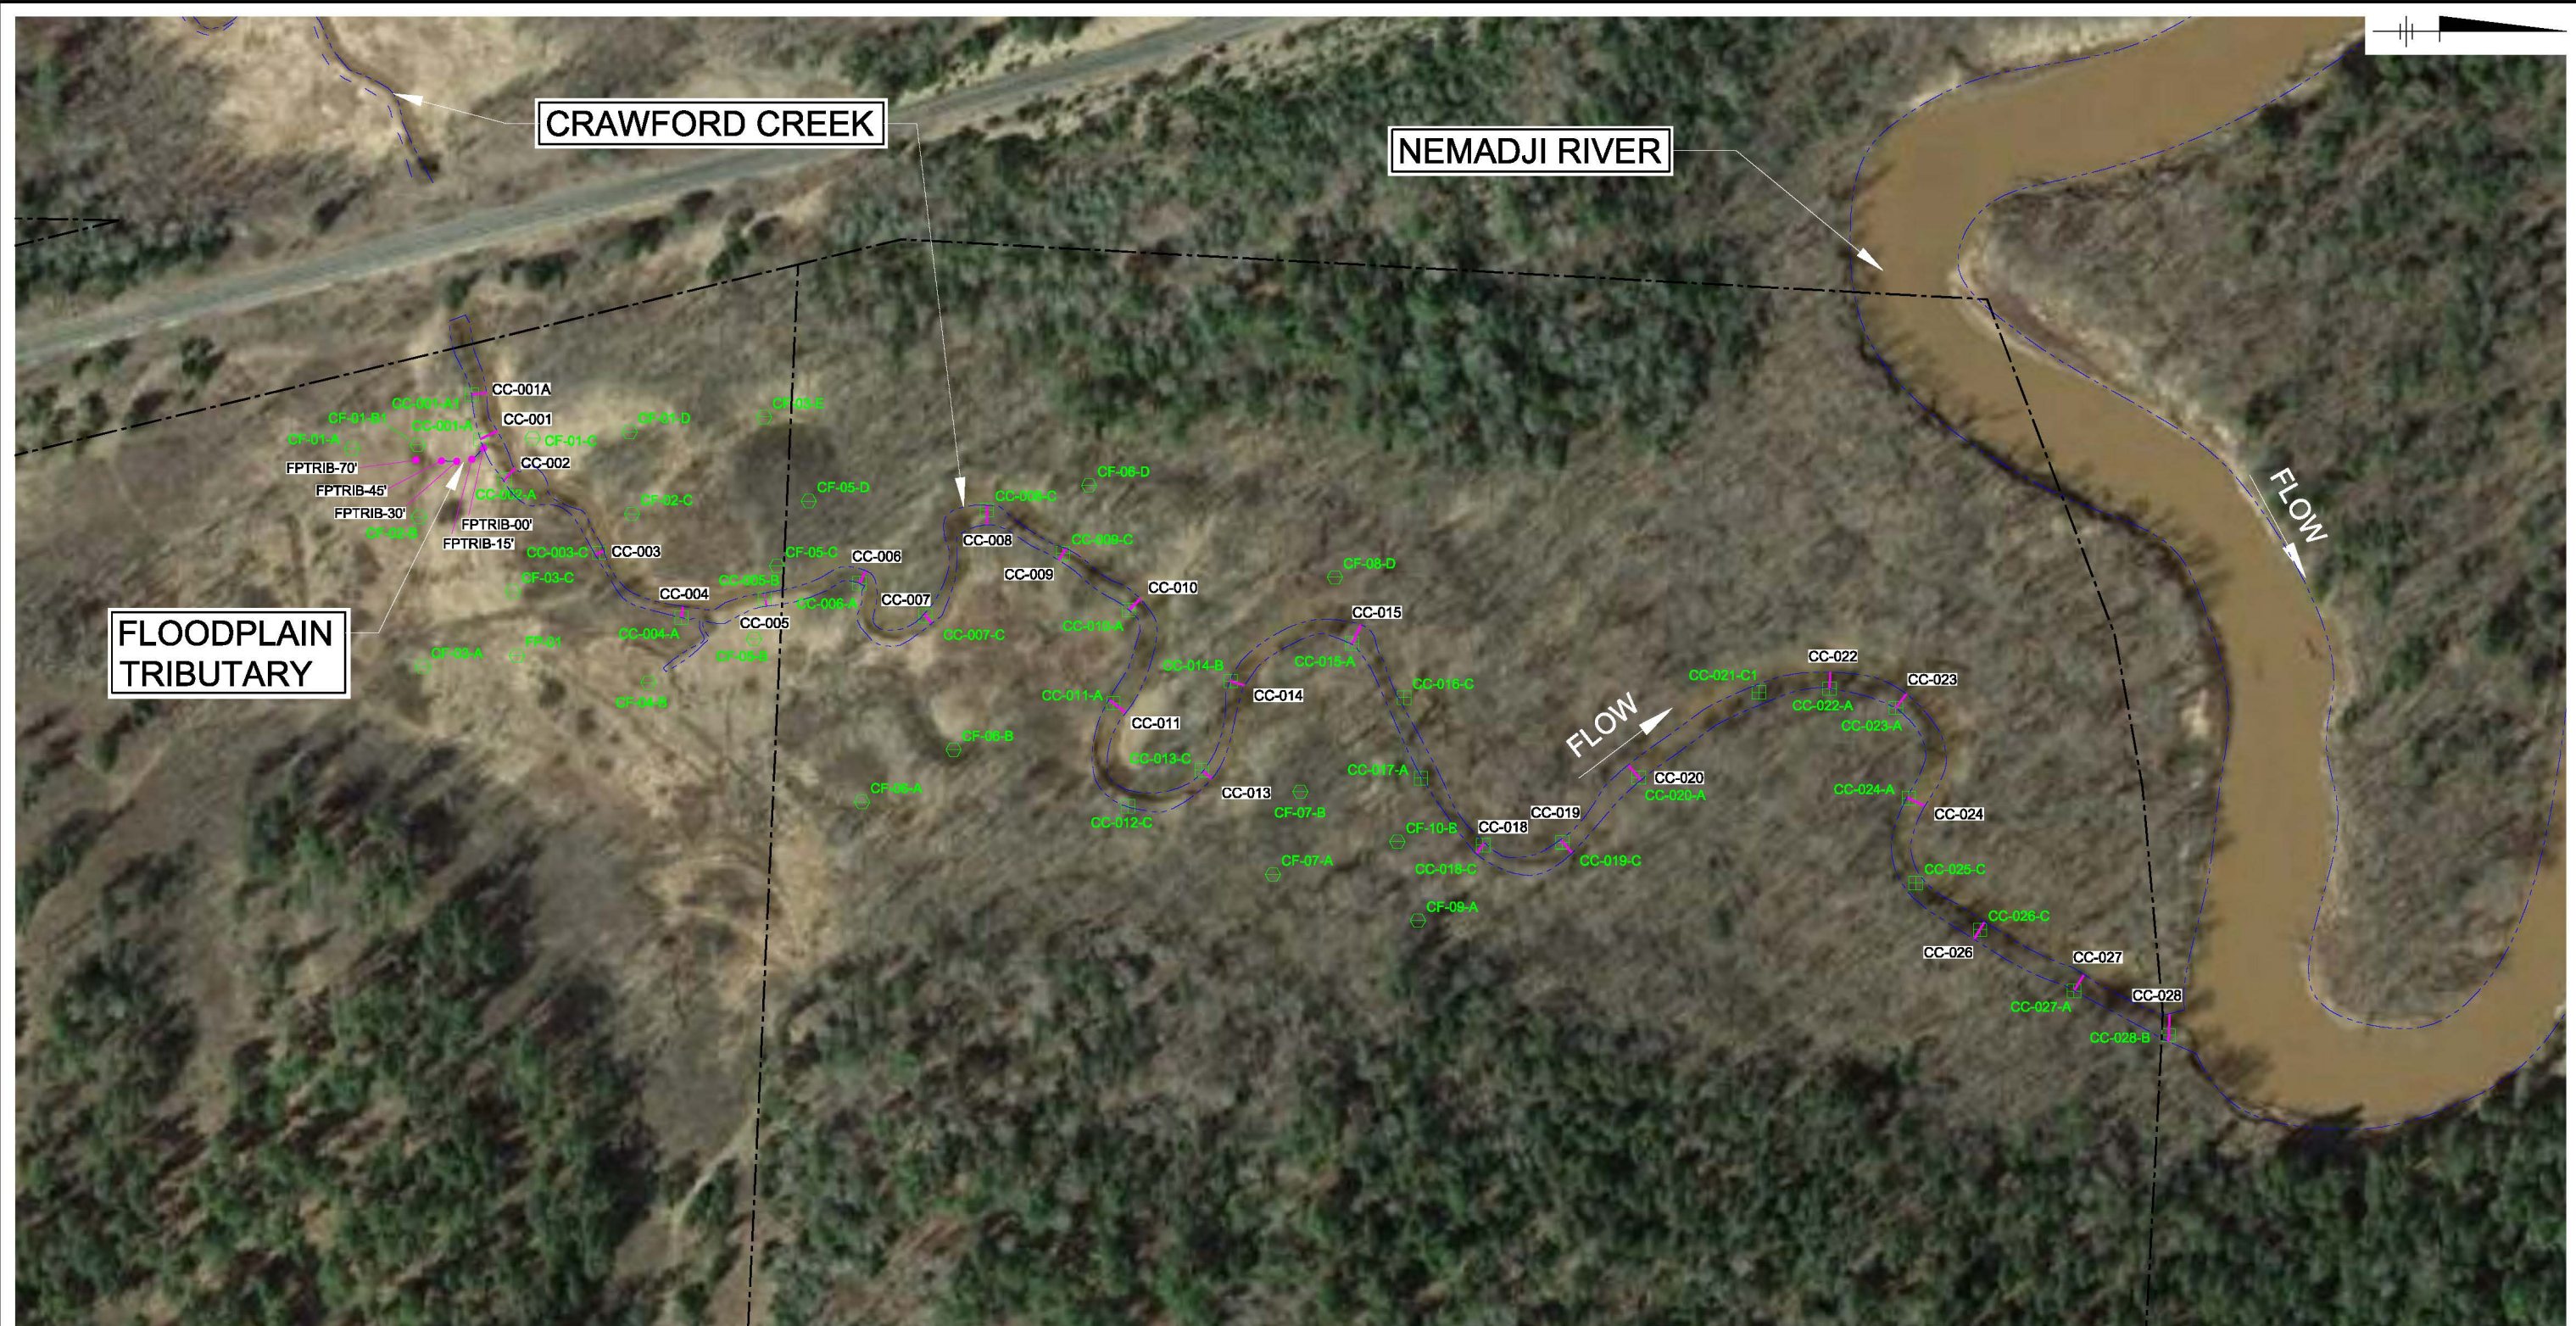
The supplemental sediment investigation work was conducted by Arcadis, on behalf of Beazer, from November 7 to 11, 2016, and consisted of sediment probing/coring at 116 locations along 24 transects within Crawford Creek, and sediment probing/coring at 5 locations within a floodplain tributary. The sediment probing/coring locations are shown on Figure 2.

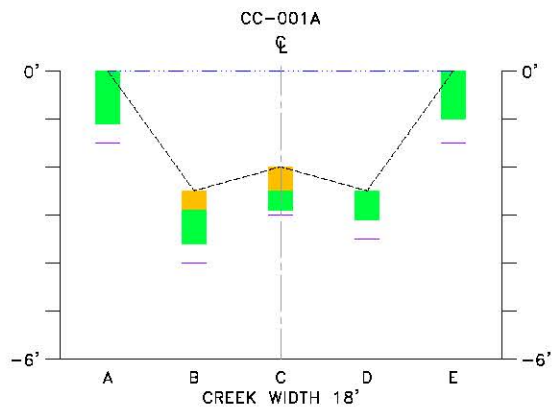
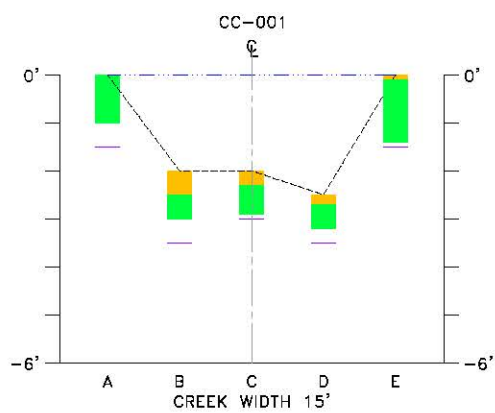
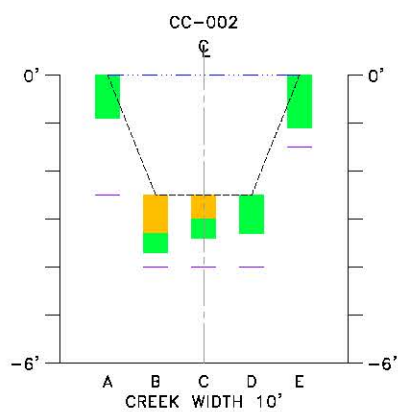
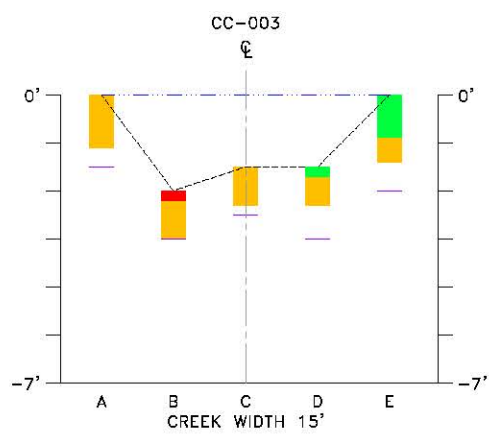
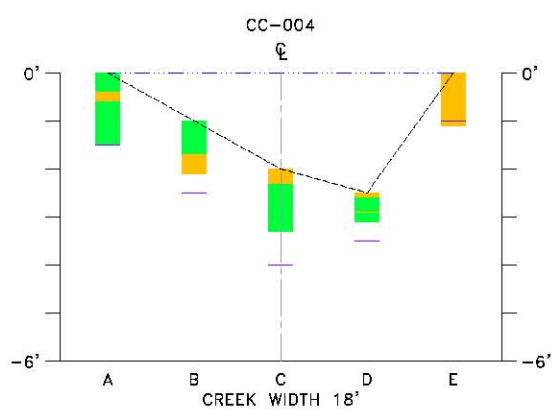
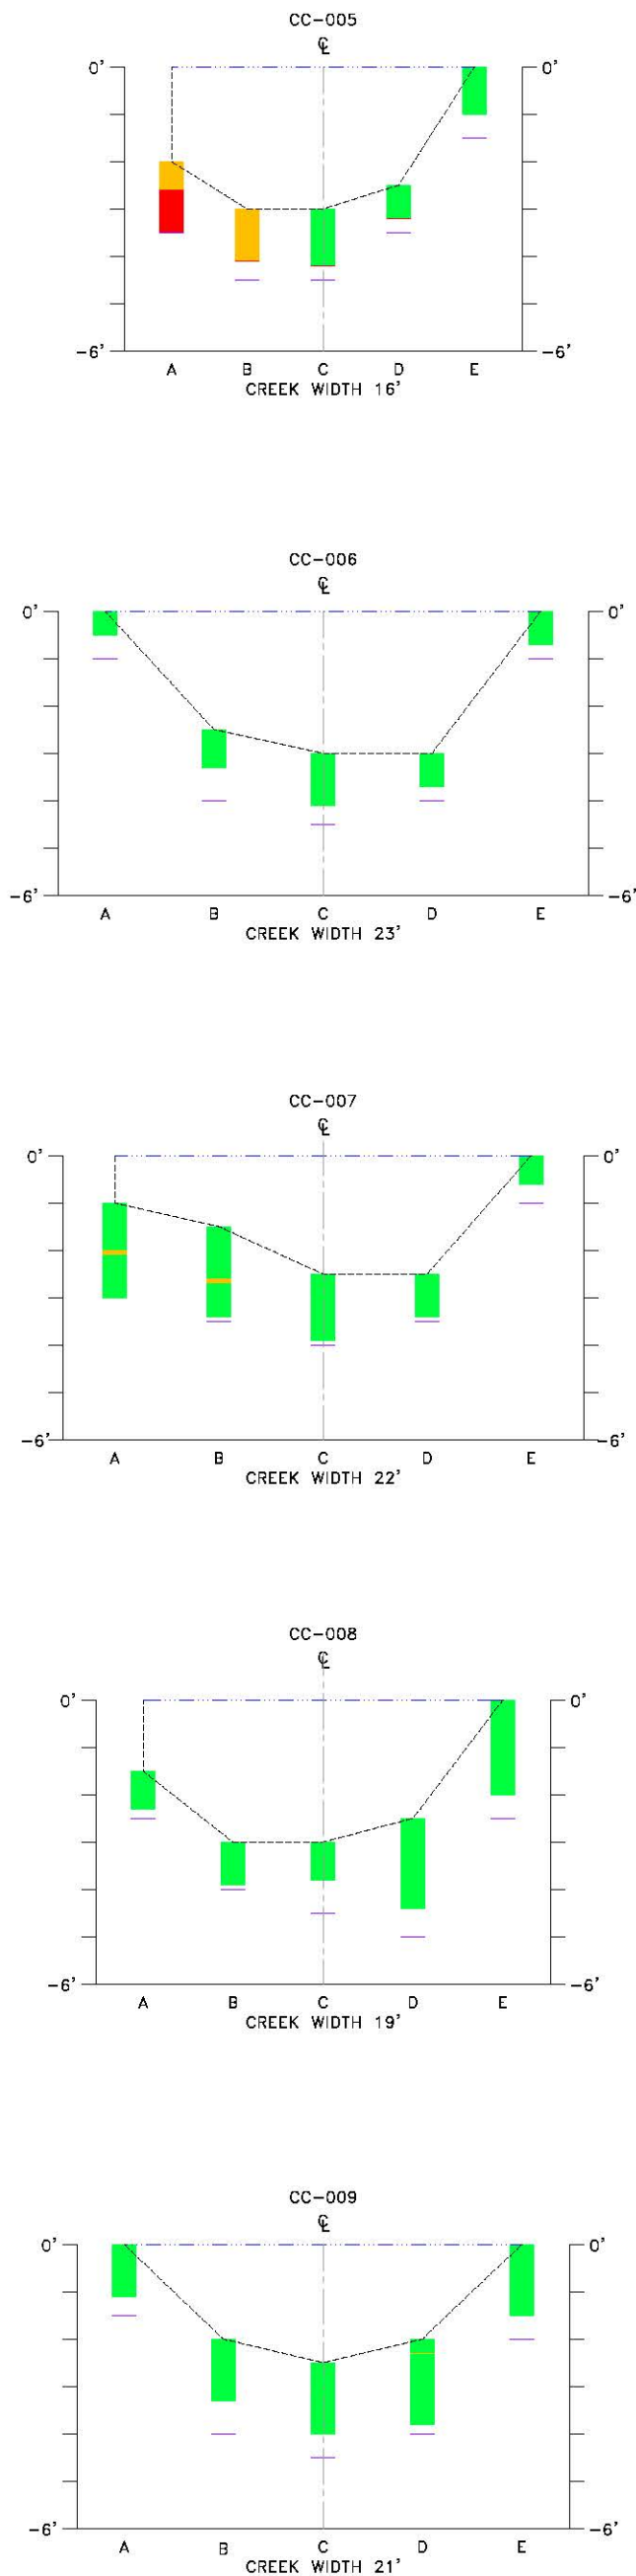
CRAWFORD CREEK
 (LOOKING DOWNSTREAM)

- 85% of the shallow (0-0.5') sediments and 89% of the deeper (>0.5') sediments were characterized as Type 3 (no visible impacts or odor).
- Only 1% of the shallow (0-0.5') sediments and 2% of the deeper (>0.5') sediments were characterized as Type 1 (visible NAPL).

- For the 0-0.5' depth interval, Type 1 sediments were observed in only 2 of 116 cores.
- For the 0-0.5' depth interval, Type 1 and 2 sediments were primarily observed within the first approximately 500 feet downstream of the railroad embankment, with Transects CC-001A through CC-005 exhibiting Type 1 or 2 sediments in 2-4 of 5 cores per transect. Downstream of CC-005, Type 1 or 2 sediments were observed at 7 of 18 transects, and where present, at only 1 of 5 cores per transect.

- For the >0.5' depth interval, Type 1 and 2 sediments were primarily observed from approximately 250 to 500 feet downstream of the railroad embankment (Transects CC-003, CC-004, and CC-005) and just upstream from the confluence with the Nemadji River (Transect CC-028). At these four transects, Type 1 or 2 sediments were observed in at least 3 of 5 cores per transect. Upstream of CC-003 and between CC-005 and CC-028, Type 1 or 2 sediments were observed at 8 of 20 transects, and where present, at only 1-2 of 5 cores per transect.

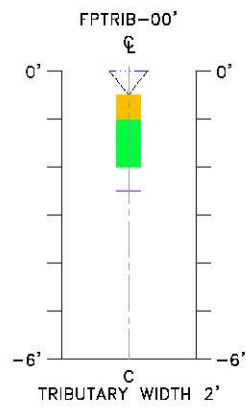
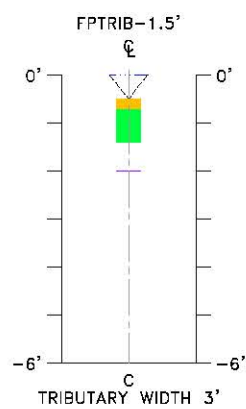
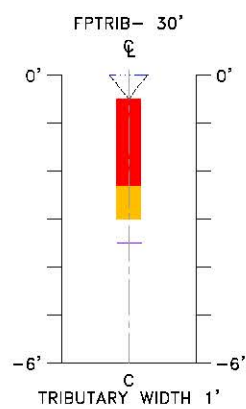
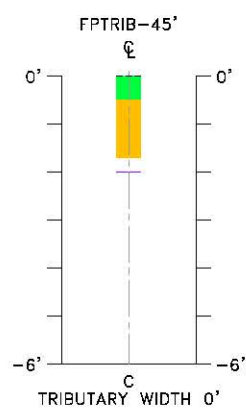
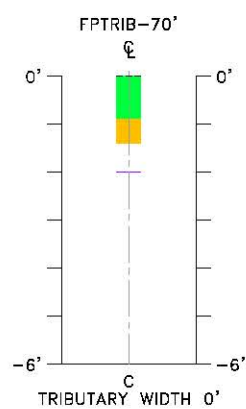
(LOOKING DOWNSTREAM)

- Type 1 sediment was observed at 1 of 5 cores (FPTRIB-30' from 0-1.8' below the sediment surface).
- Shallow (0-0.5') sediments had visible impacts at the first three core locations closest to the creek (FPTRIB-00' – Type 2, FPRIB-15' – Type 2, and FPRIB-30' – Type 1); whereas the last two core locations farthest from the creek did not have visible impacts in the 0-0.5' depth interval.

- Deeper (>0.5') sediments had visible impacts at the three core locations farthest from the creek (FPTRIB-30' – Type 2, FPTRIB-45' – Type 2, and FPTRIB-70' – Type 2); whereas the first two core locations closest to the creek did not have visible impacts at depths greater than 0.5 feet.
