Site Inspection - 10/3/18

# Former Koppers Inc. Facility – Superior, WI

**Post Construction Site Inspection Form**  
**Beazer East, Inc.**  
**Koppers Inc. Facility, Superior, Wisconsin**

Inspection Date: 10/3/18

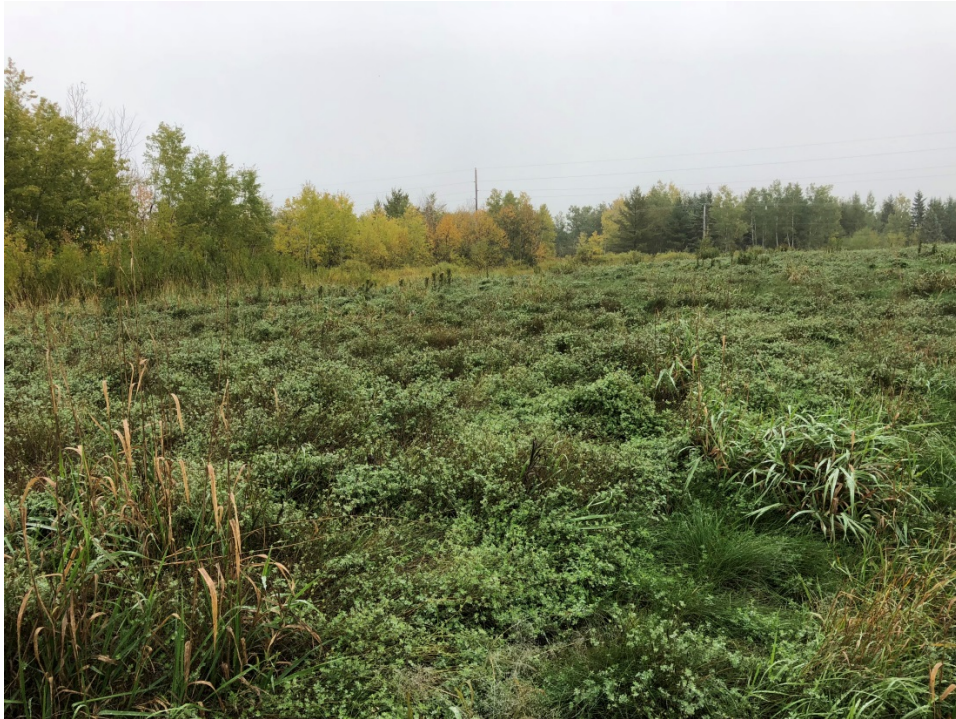
Area A Photo 1, looking Northeast from West side:

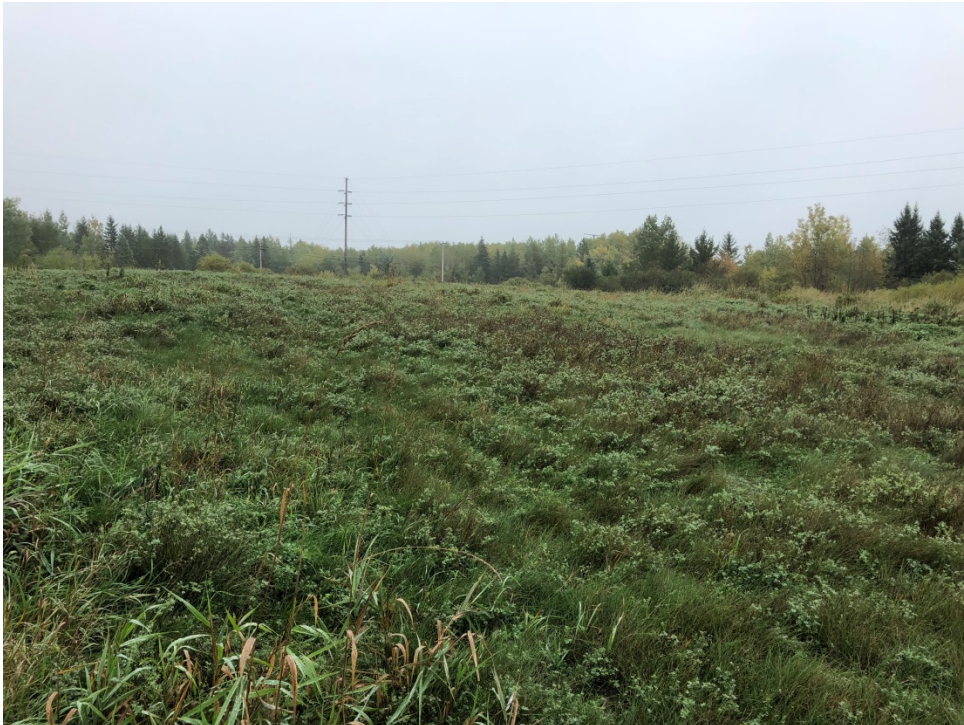
Area A Photo 2, looking East from West side:

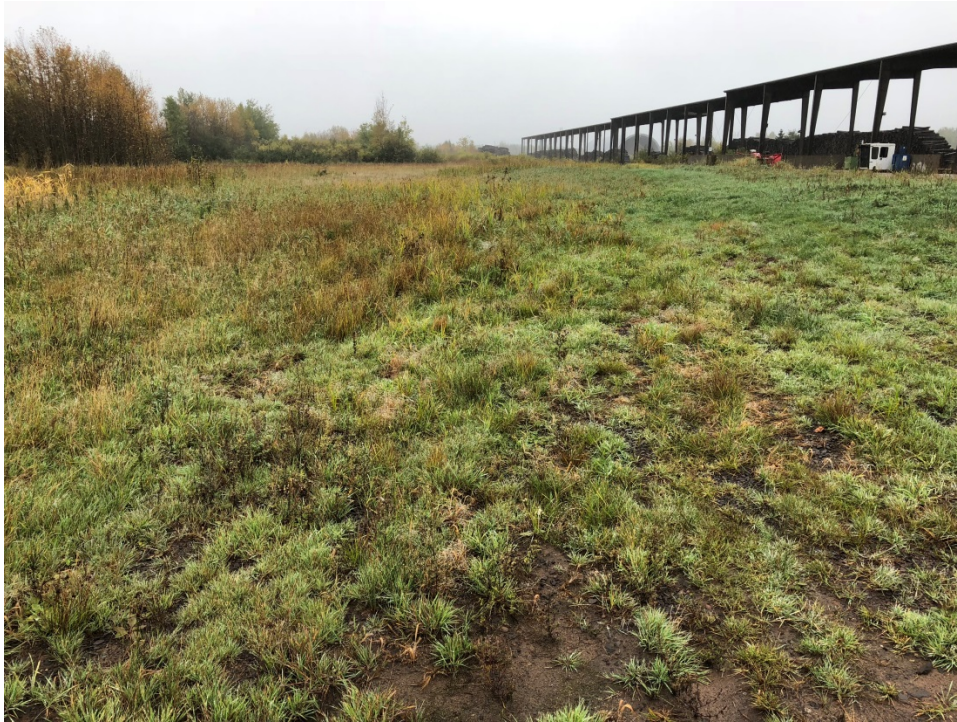
Area B Photo 1, looking South from North East central area:

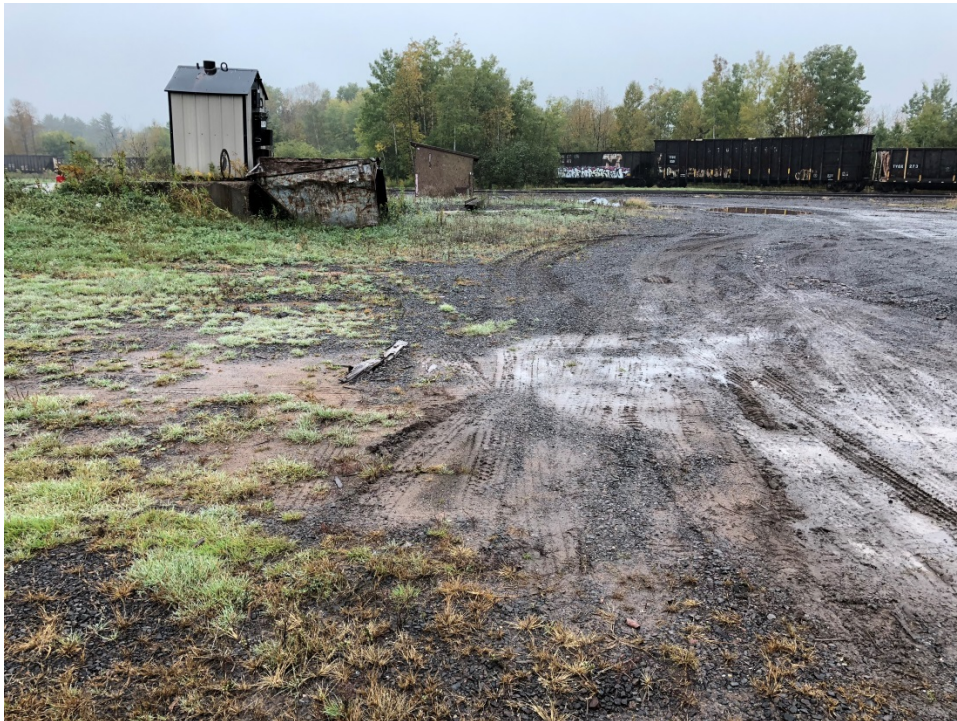
Area B Photo 2, looking West from Eastern edge:

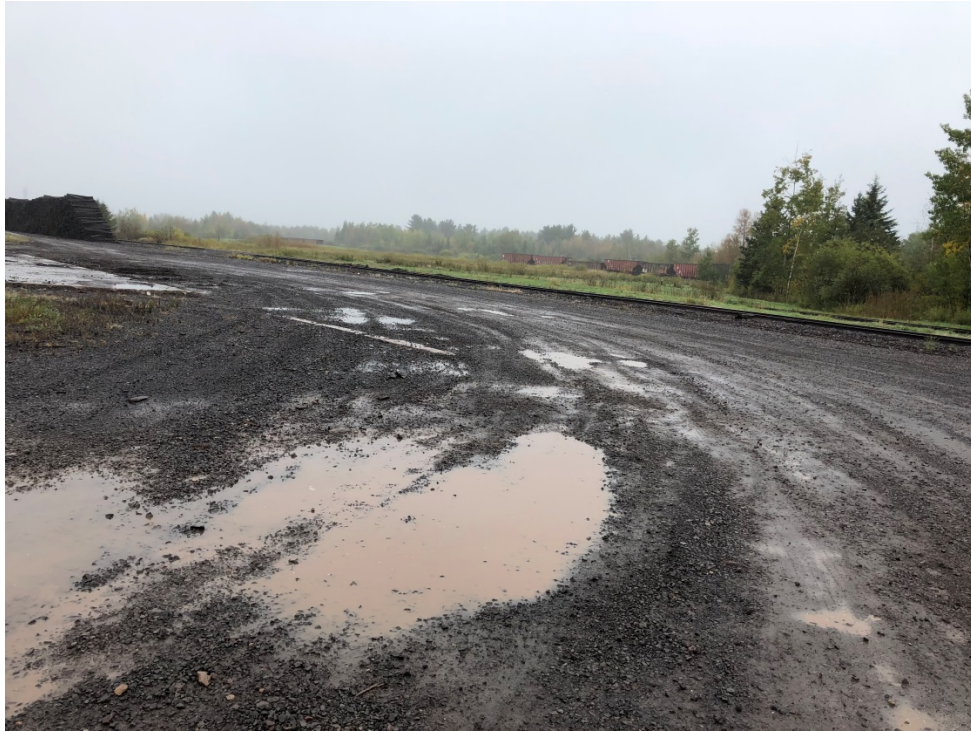
Area B Photo 3, looking South from North Central area:

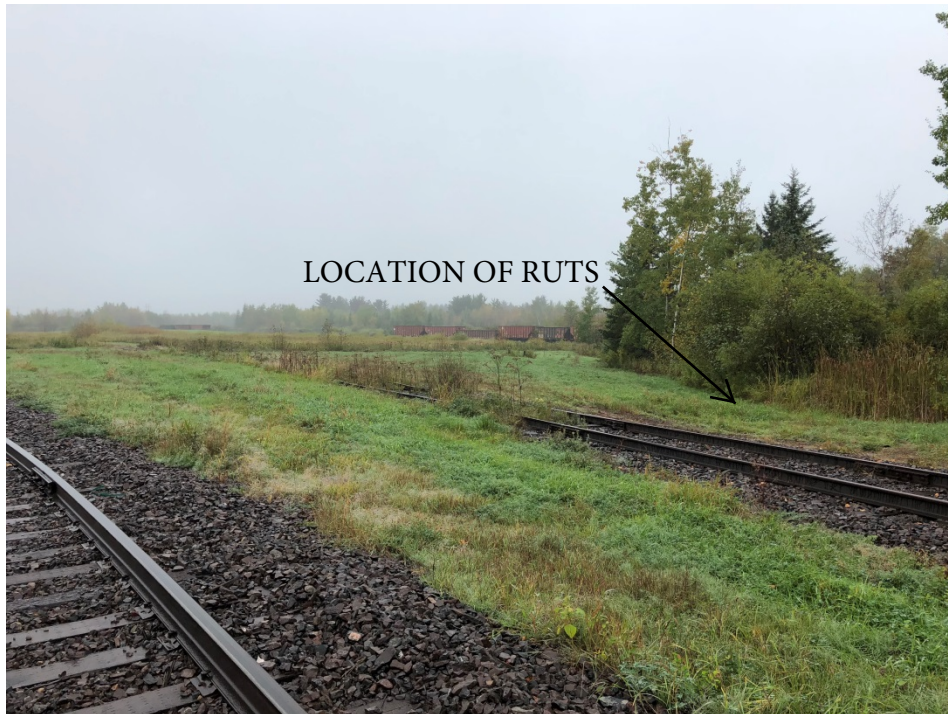
Area B Photo 4, looking South from North West along (ruts in grass along gravel):

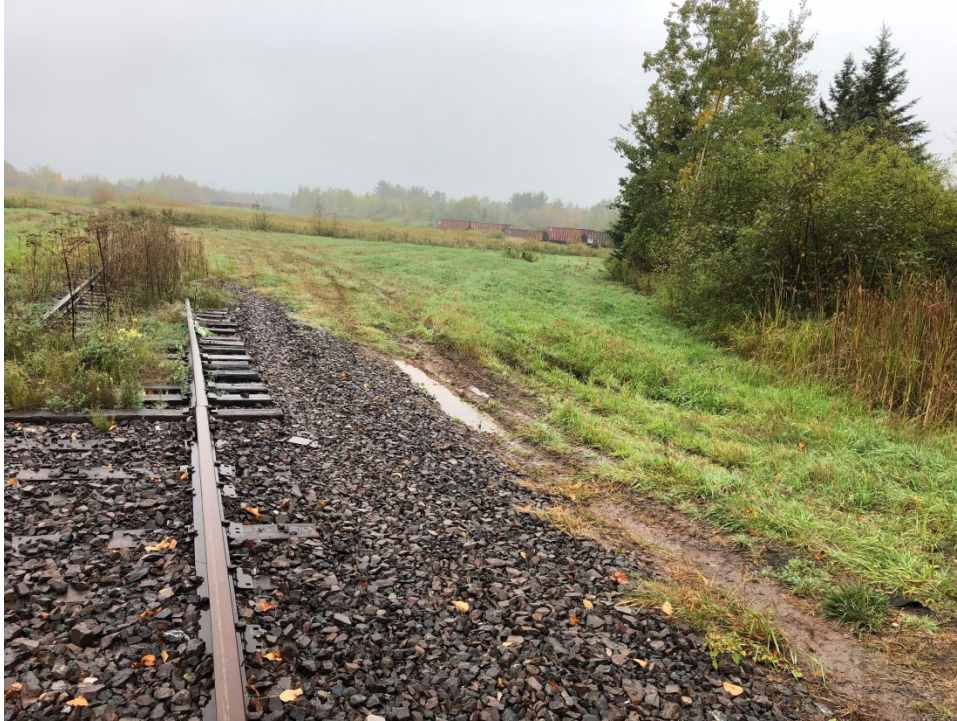
(check one)	No	Yes	If yes, provide description and take photos
Excessive erosion	X		
Evidence of excessive settling or ponding		X	<u>ruts on western area, photos 5+6</u>
Areas lacking well-established vegetation	X

Area B Photo 5, Close up of ruts from photo 4:

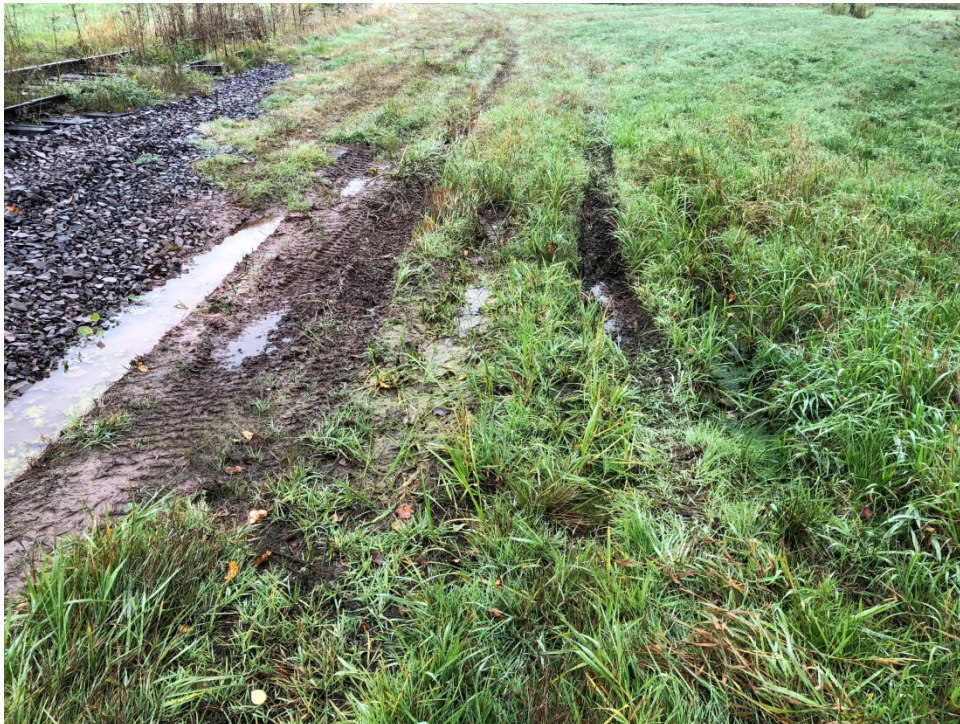
Area B Photo 6, Close up of ruts from photo 4:

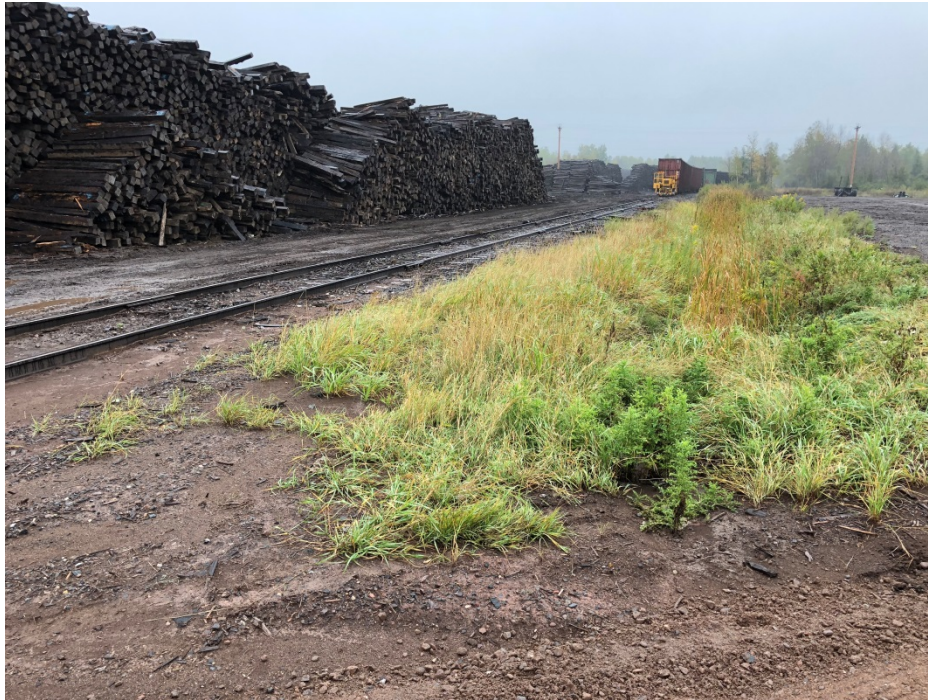
Area F1 Photo 1, looking South from North end:

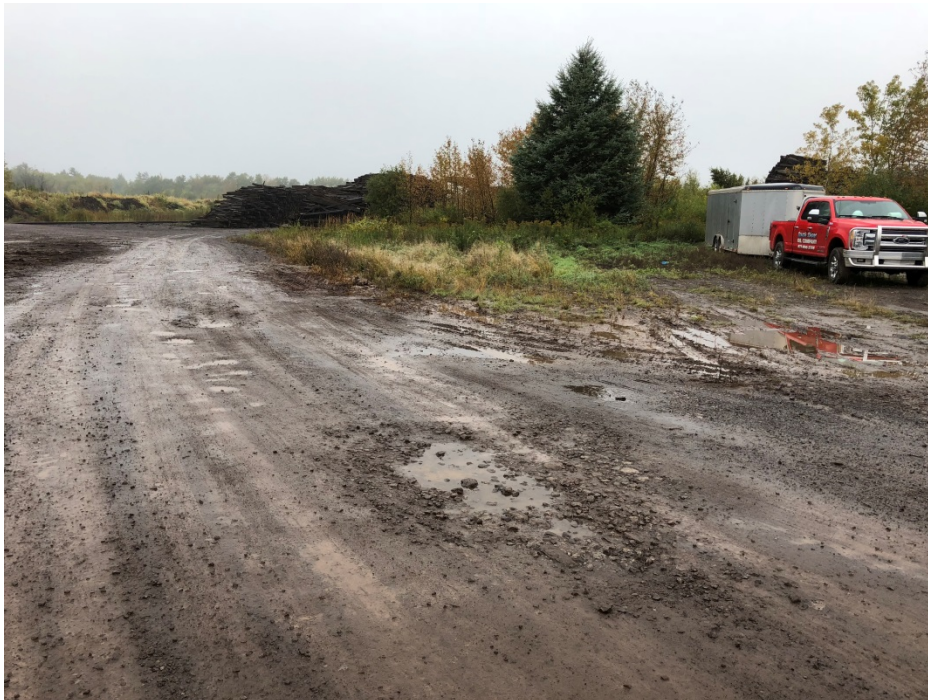
Area F2 Photo 1, Looking Northeast from Southwest:

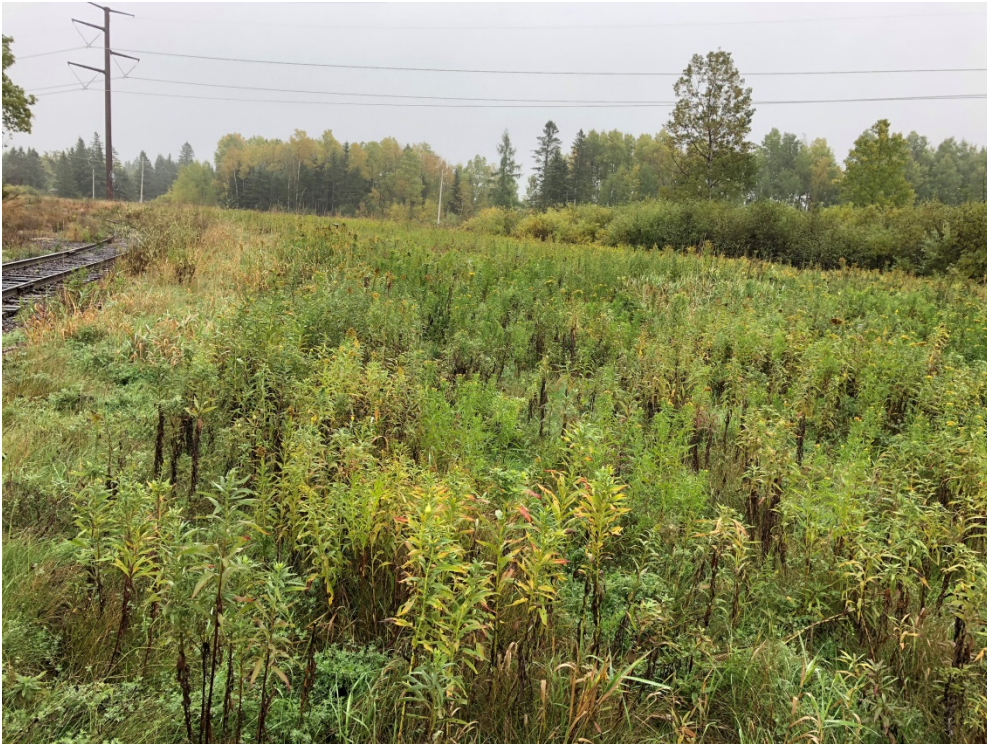
Area G Photo 1, looking Southeast from Northwest corner:

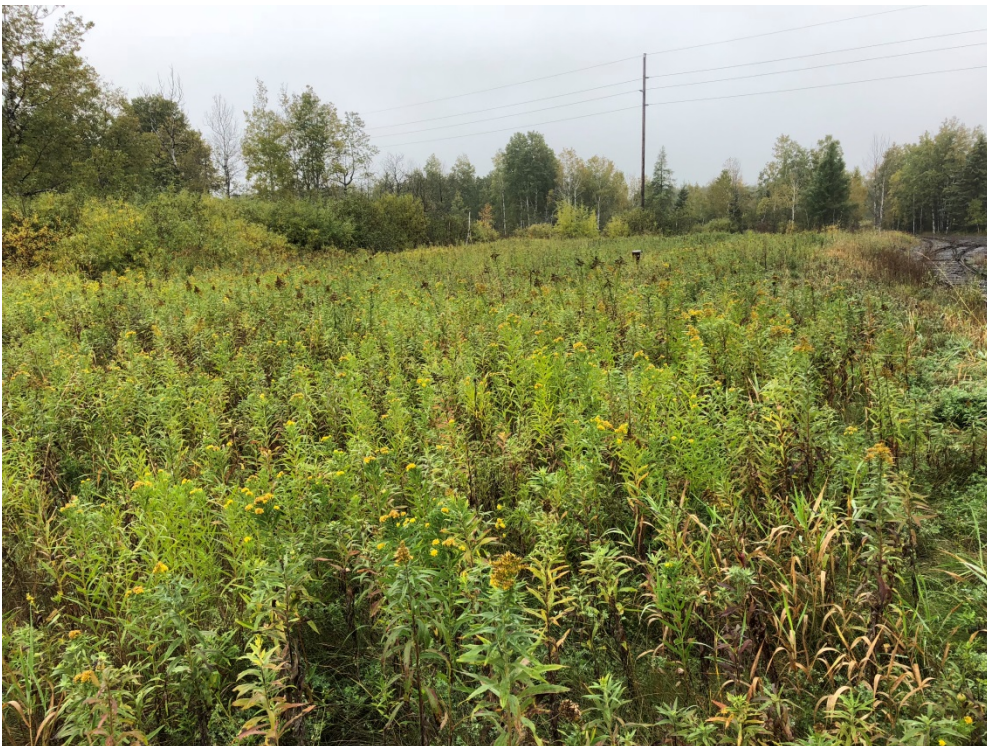
Area G Photo 2, looking Northwest from Southeast corner:

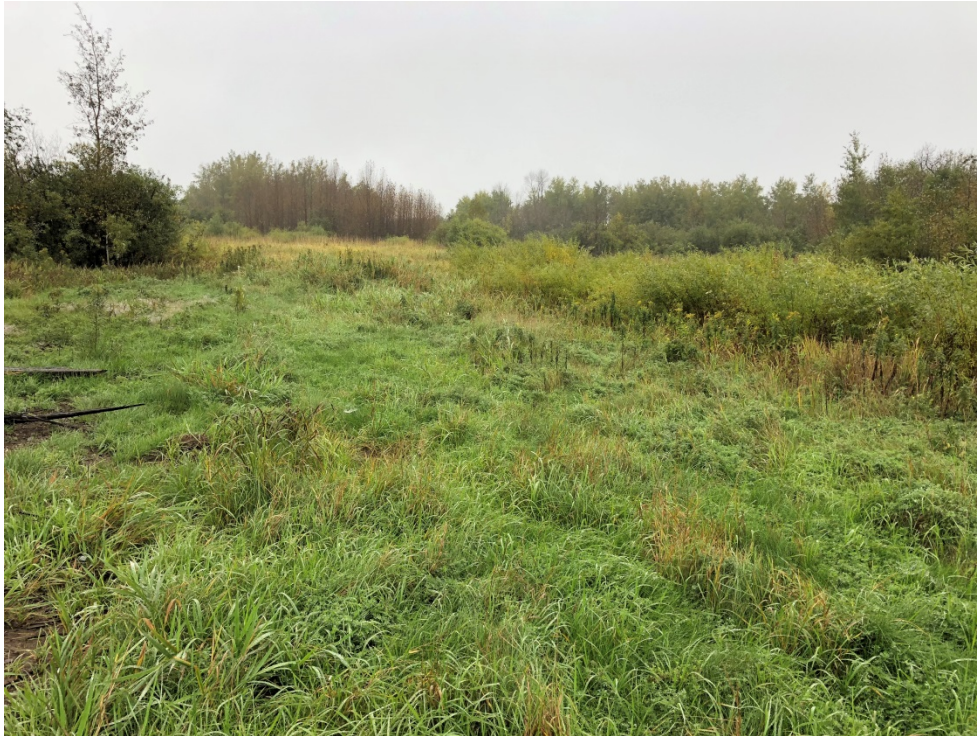
Area H Photo 1, (East side of RR tracks) looking Southwest from Eastern side:

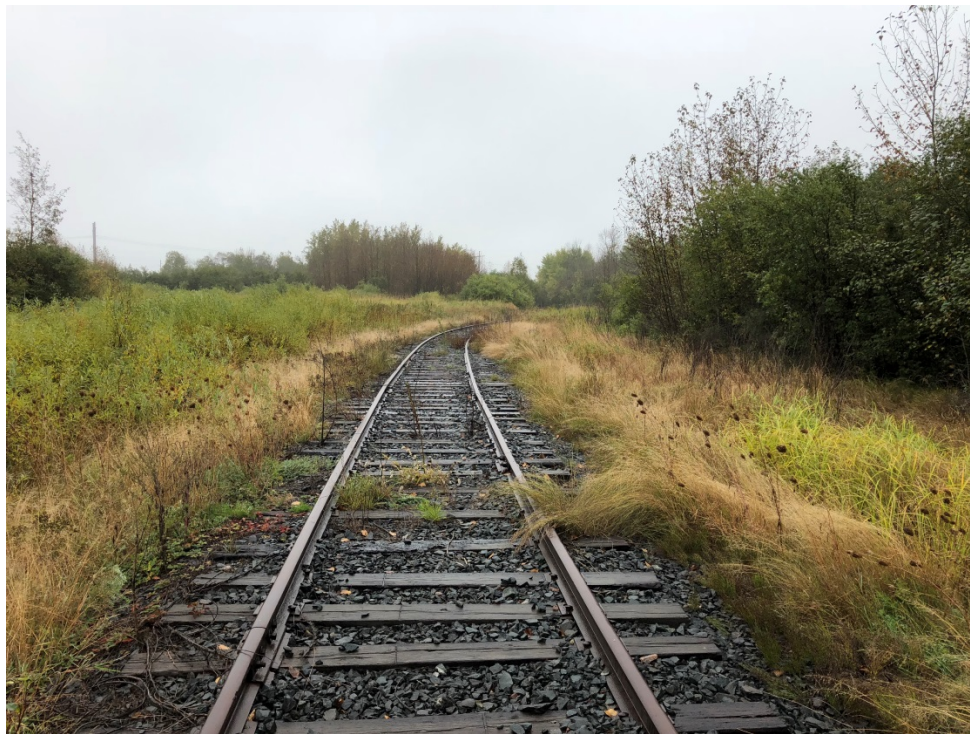
Area H Photo 2, (West side of RR tracks) looking Southwest from western side:

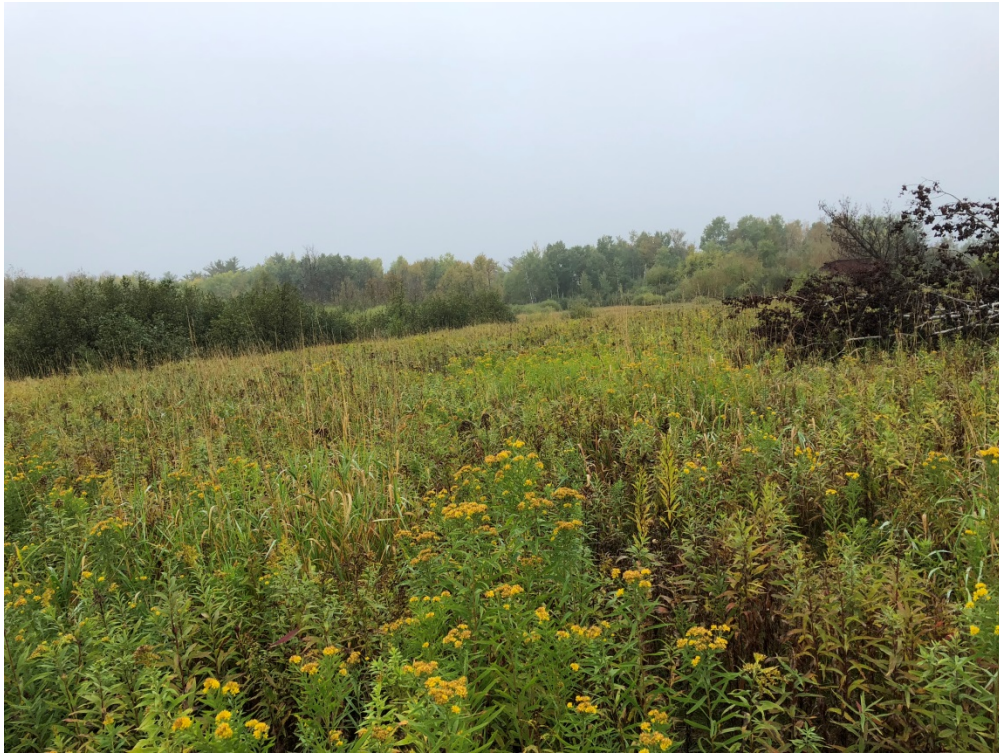
Area S Photo 1, looking North from center of area:

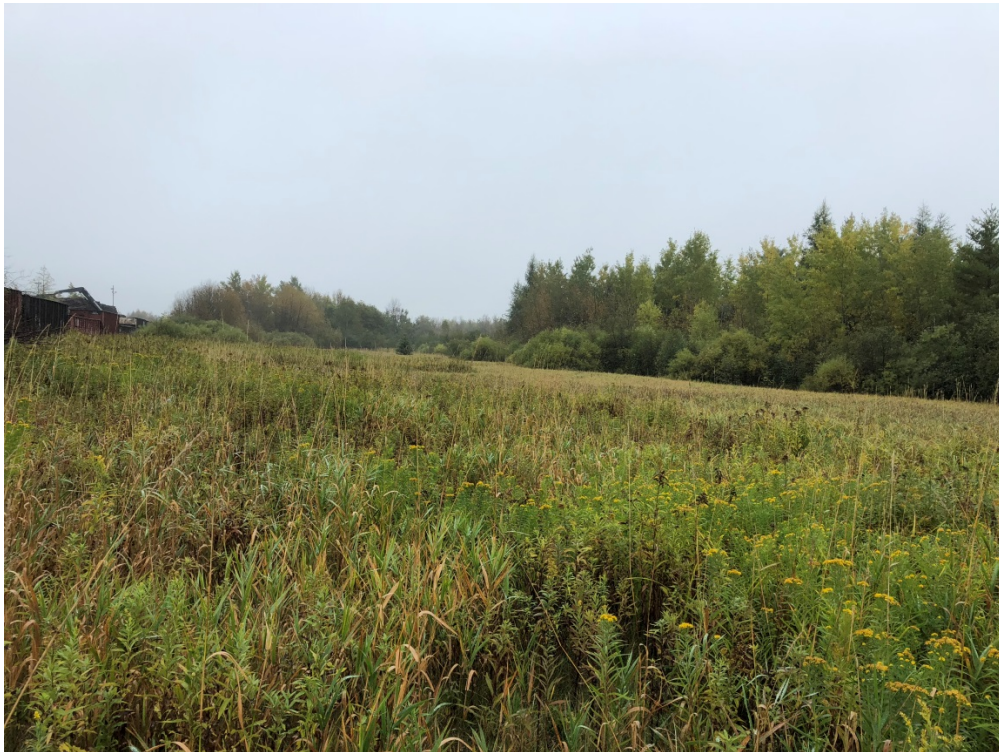
Area S Photo 2, looking South from center of area:

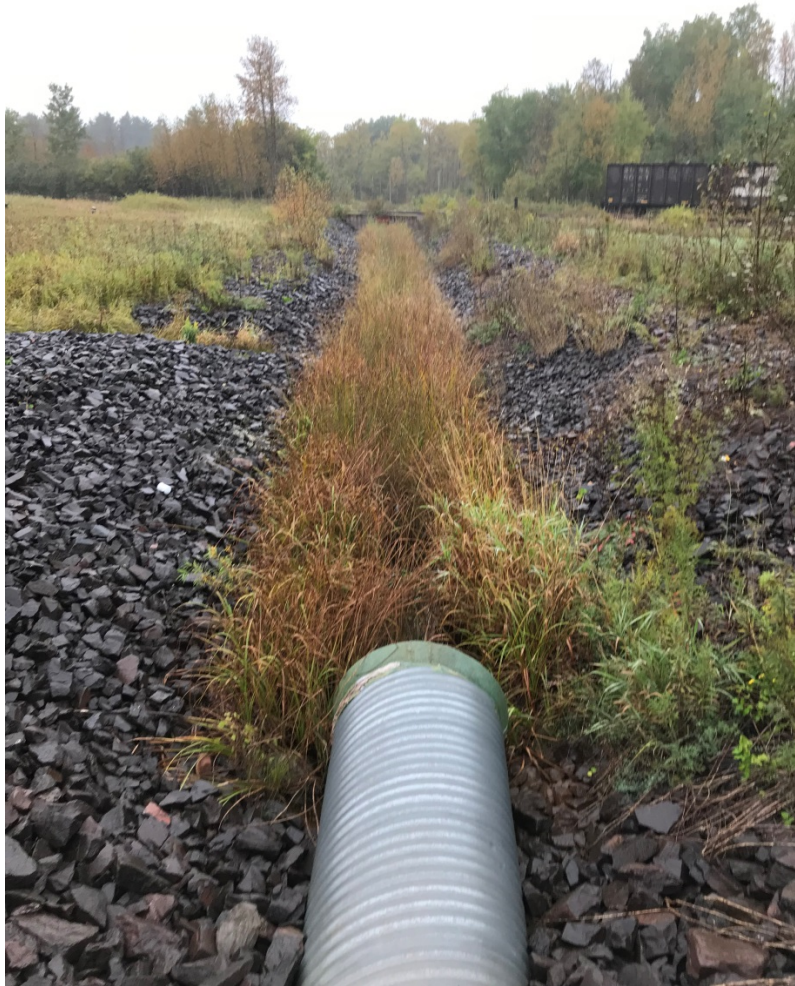
Outfall 001 Drainage Ditch Photo 1, looking West from eastern edge:

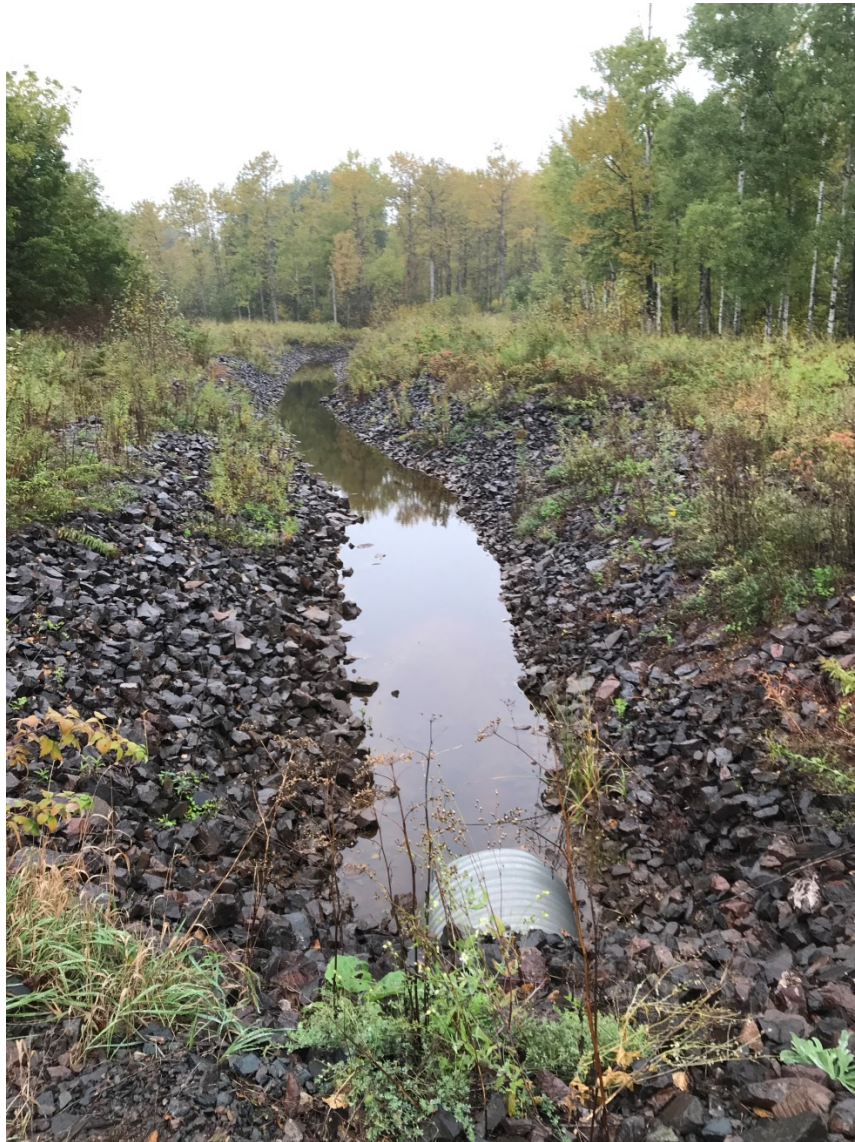
Outfall 001 Drainage Ditch Photo 2, looking west from center:
