**RE: Former Koppers Inc. Facility, Superior Wisconsin
WDNR DNR BRRTs No: 0216000484
WDNR Facility ID: 816009810**

Subject: 2019 On-Property Corrective Measures Monitoring & Maintenance Report

Site Inspection – 10/16/19

Former Koppers Inc. Facility – Superior, WI

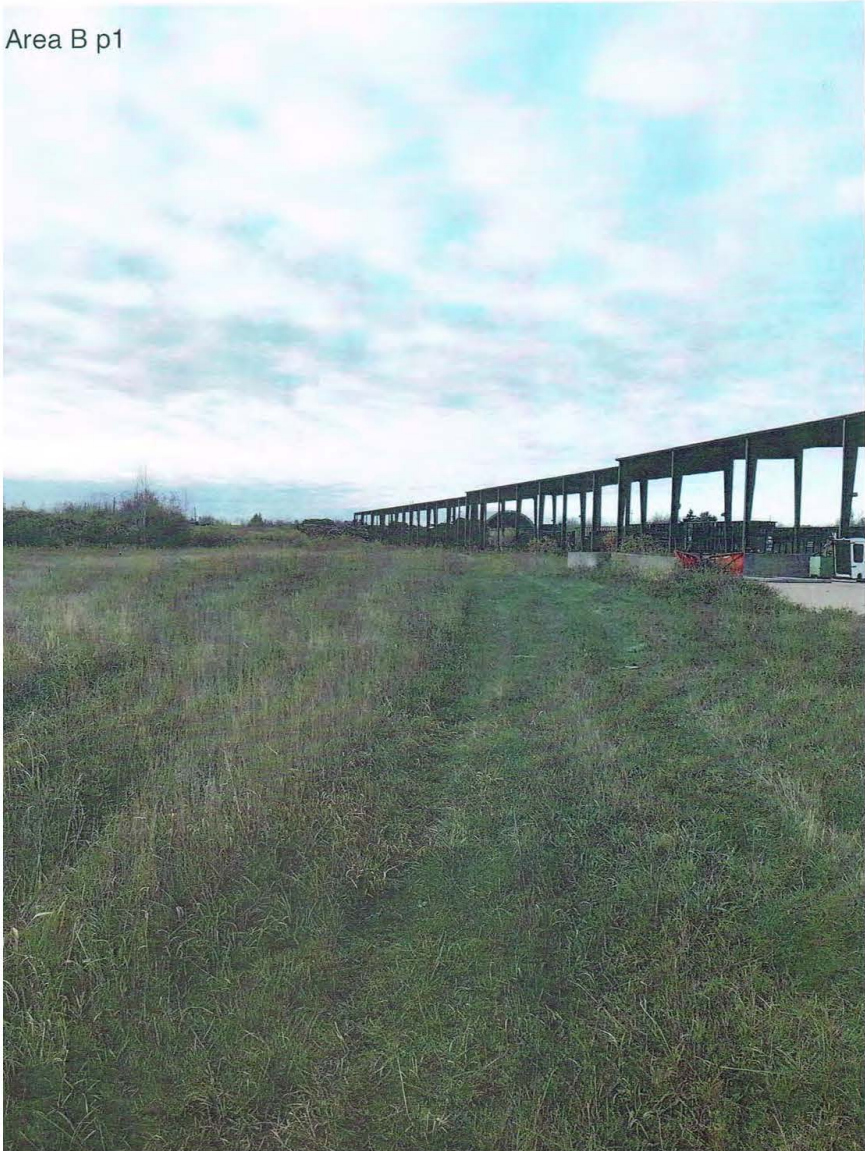
Area B Photo 1, looking South from North East central area:

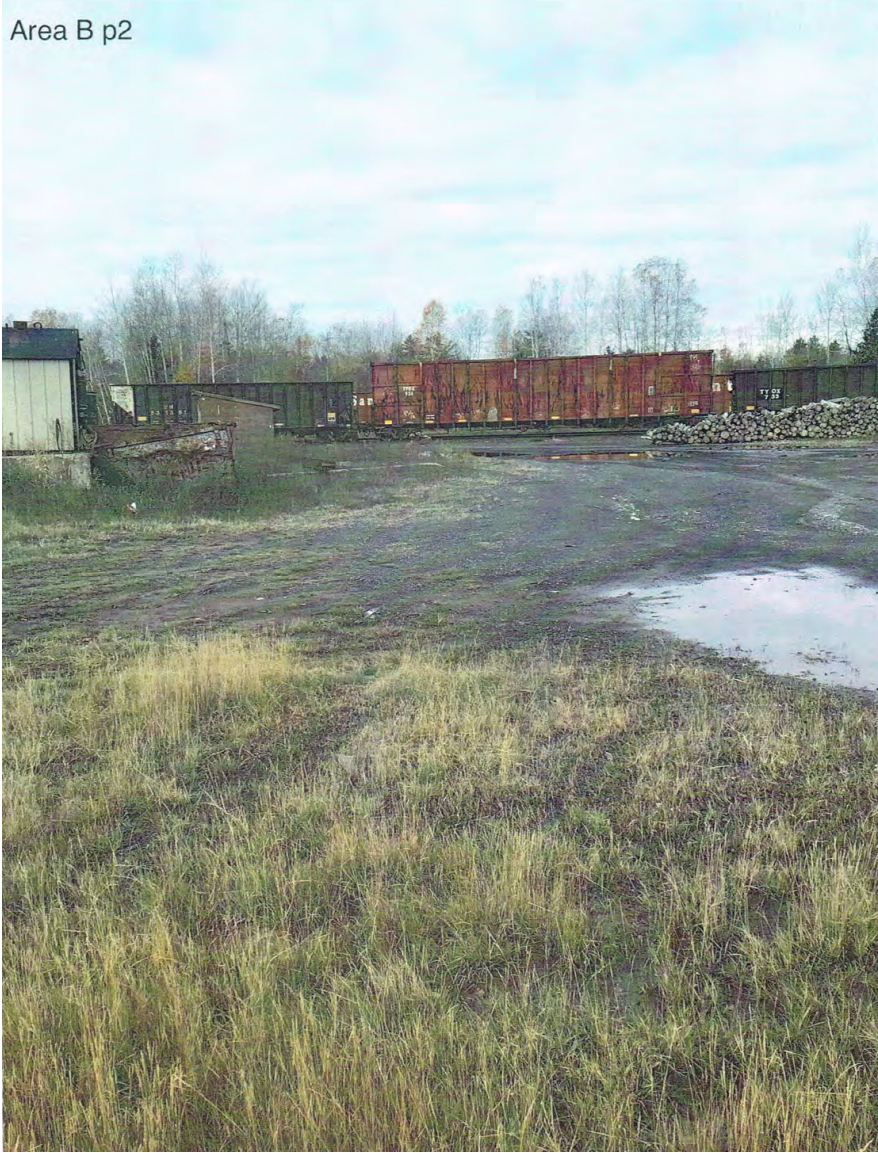
Area B Photo 2, looking West from Eastern edge:

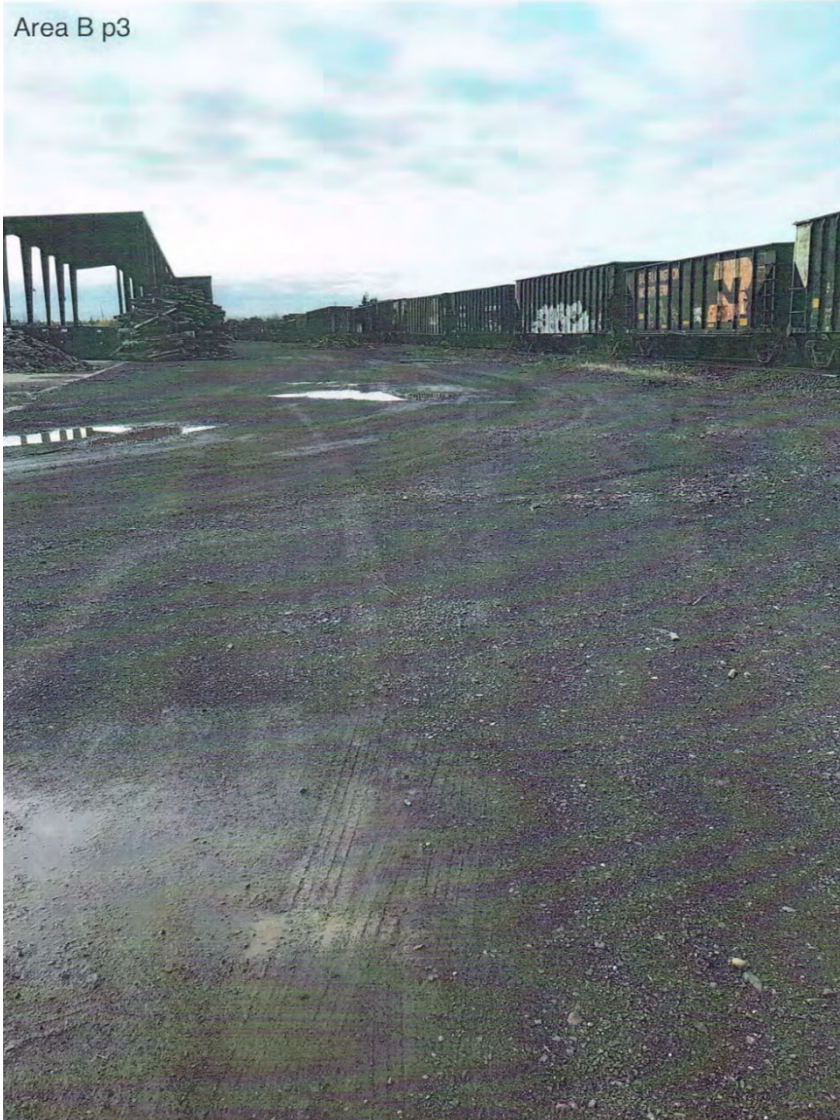
Area B Photo 3, looking South from North Central area:

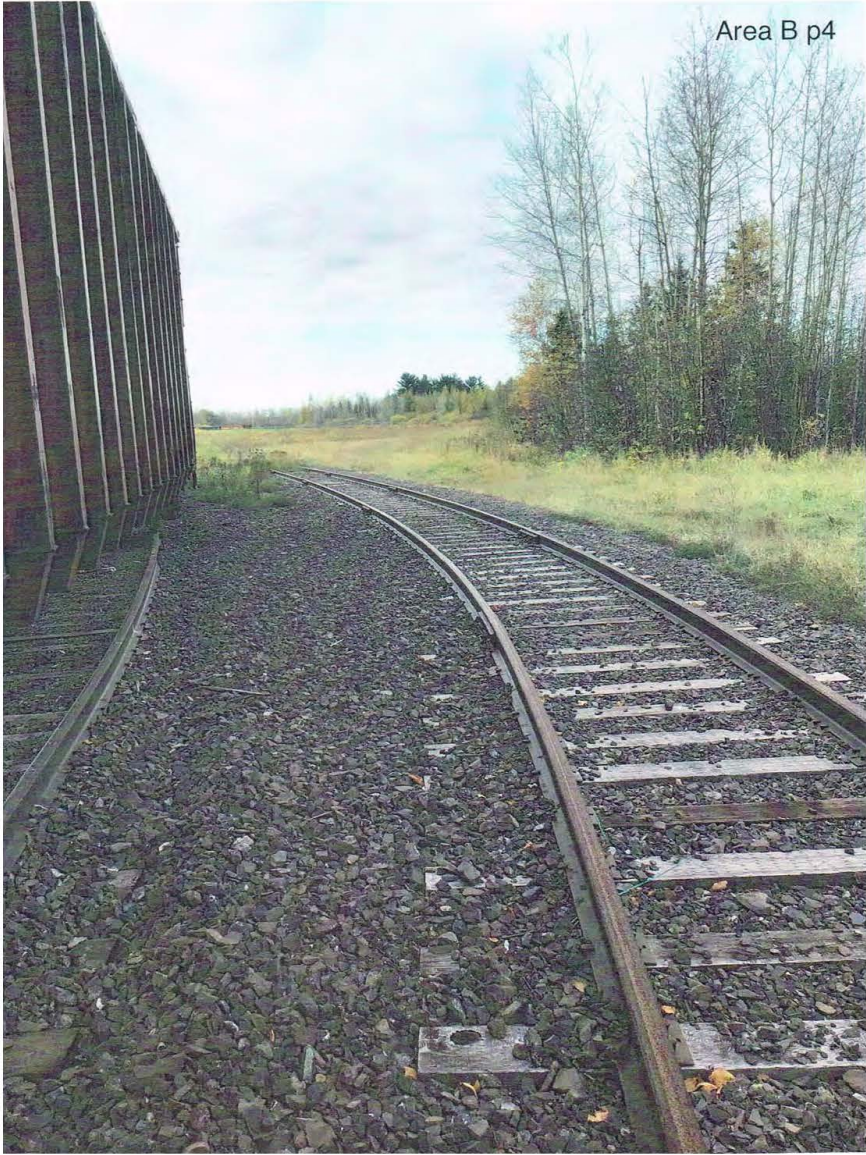
Area B Photo 4, looking South from North West along (ruts in grass along gravel):

Photo: 4 : South from North West

Areas where surface cover issues were noted during the October 2019 inspection will be addressed in 2020.

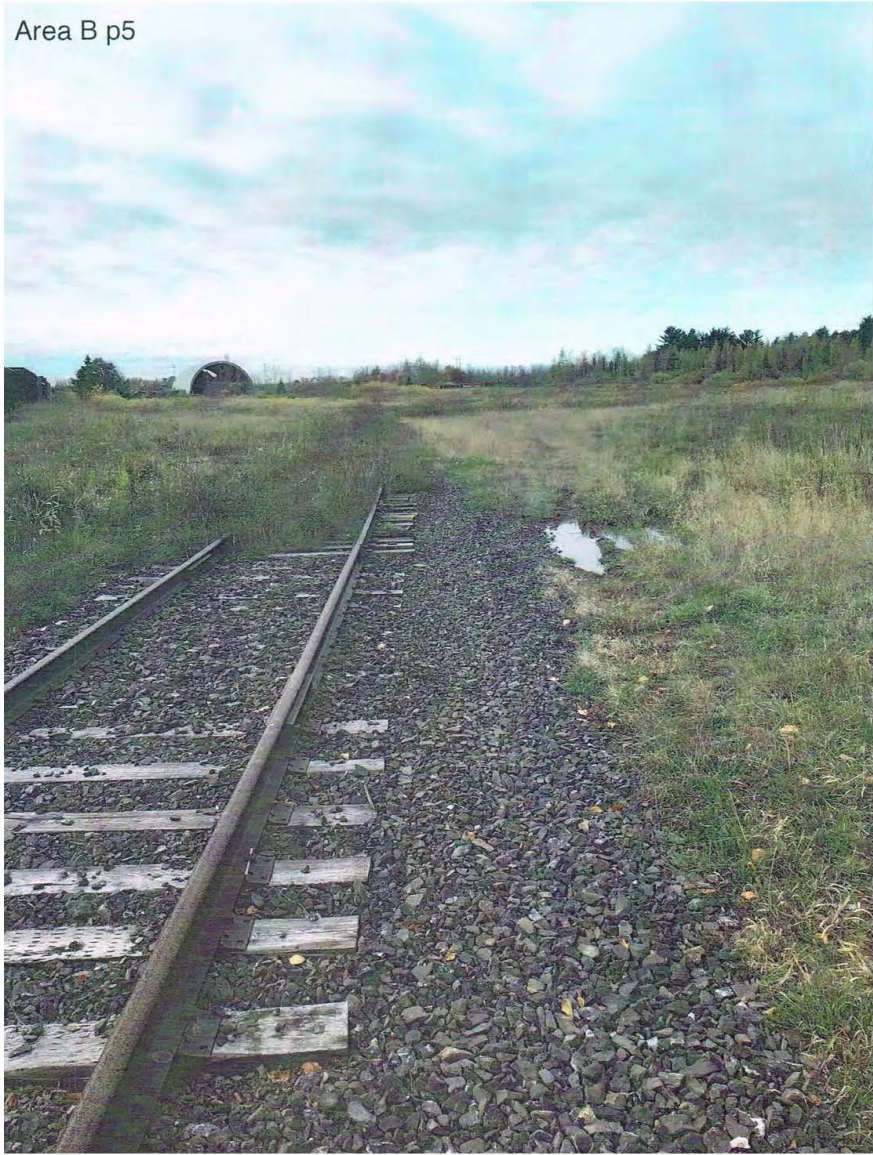
The October 16, 2019 inspection observations and photographs are presented in a Site Inspection Form in Attachment 1. As noted in Attachment 1, areas of the engineered surface covers were noted and requiring repairs in Area B. No issues were observed in Areas A, F1, F2, G, H, or S or at Outfall 001 drainage ditch during the October 2019 inspection.

Area B Photo 5, Close up of ruts from photo 4:

(check one)	No	Yes	If yes, provide description and take photos
Excessive erosion	x		
Evidence of excessive settling or ponding		x	<u>Cuts on western area, photos 5 & 6</u>
Areas lacking well-established vegetation	x

Photo: 5 & 6 : Close up of rats

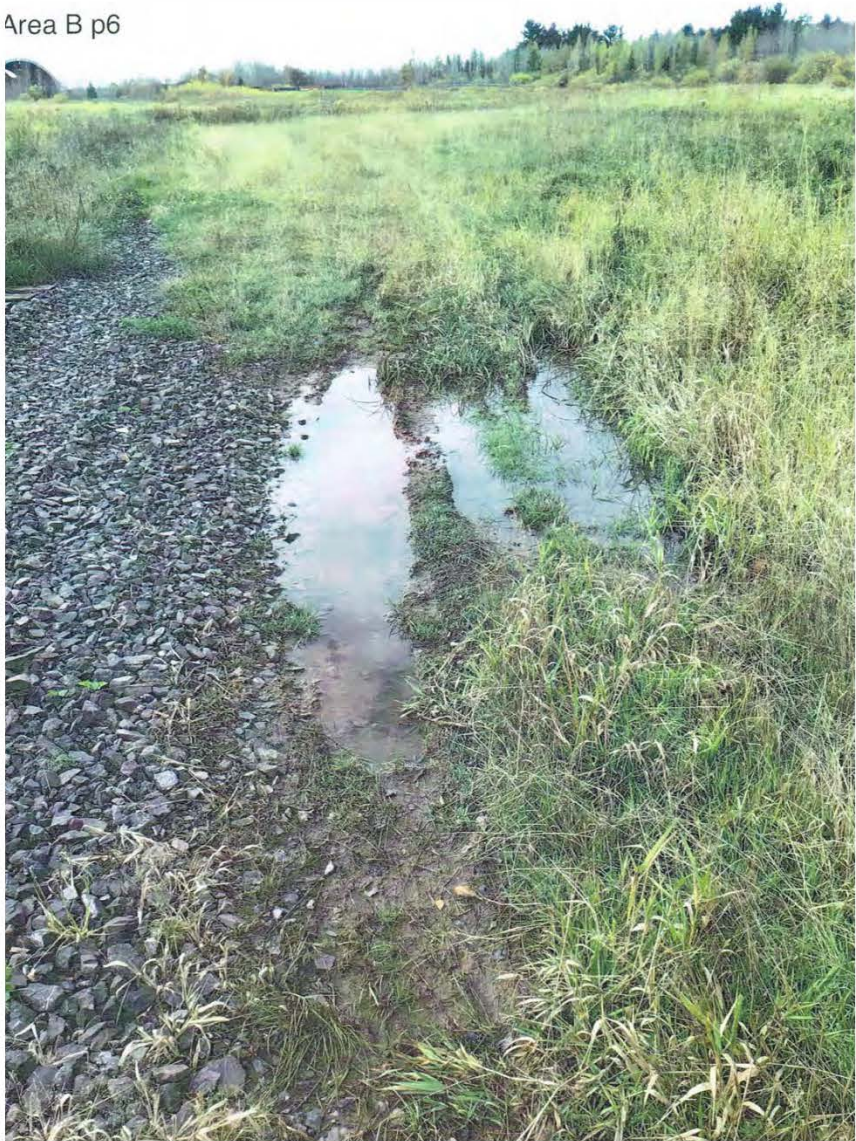
Area B p6

Area B Photo 6, Close up of ruts from photo 4:
