**RE: Former Koppers Inc. Facility, Superior Wisconsin
WDNR DNR BRRTs No: 0216000484
WDNR Facility ID: 816009810**

Subject: 2020 On-Property Corrective Measures Monitoring & Maintenance Report

Site Inspection – 10/14/20

Former Koppers Inc. Facility – Superior, WI

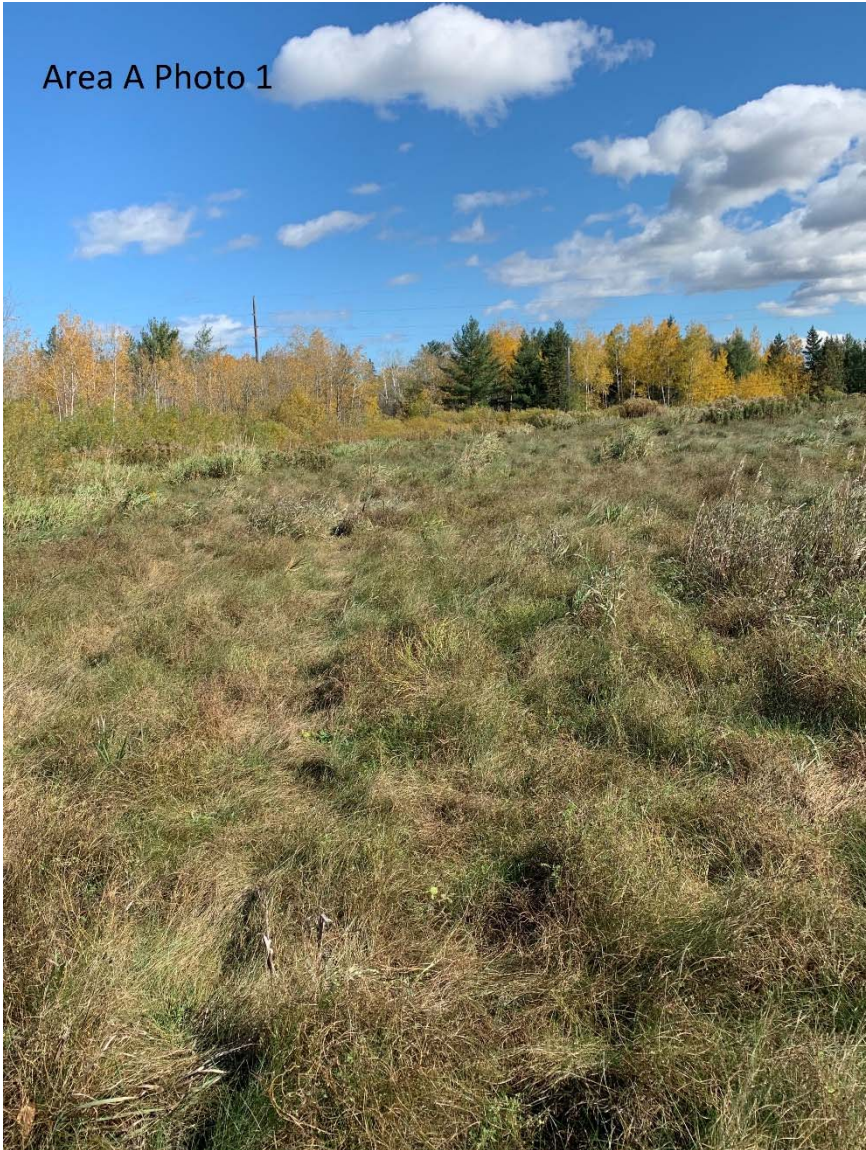
Area A Photo 1, looking Northeast from West side:

Photographs: Photo: 1 ; Looking NE from west side of area

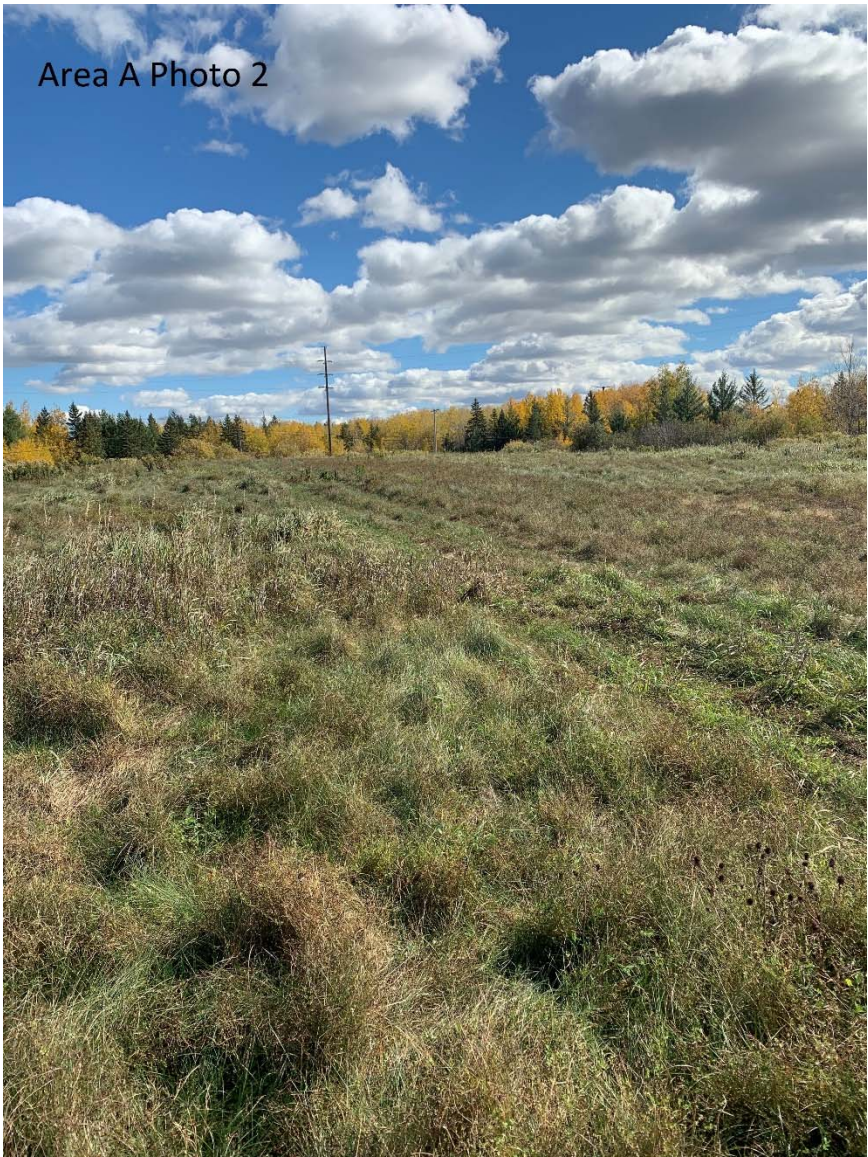
Area A Photo 2, looking East from West side:

Photo: 2 ; Looking E from west side of area

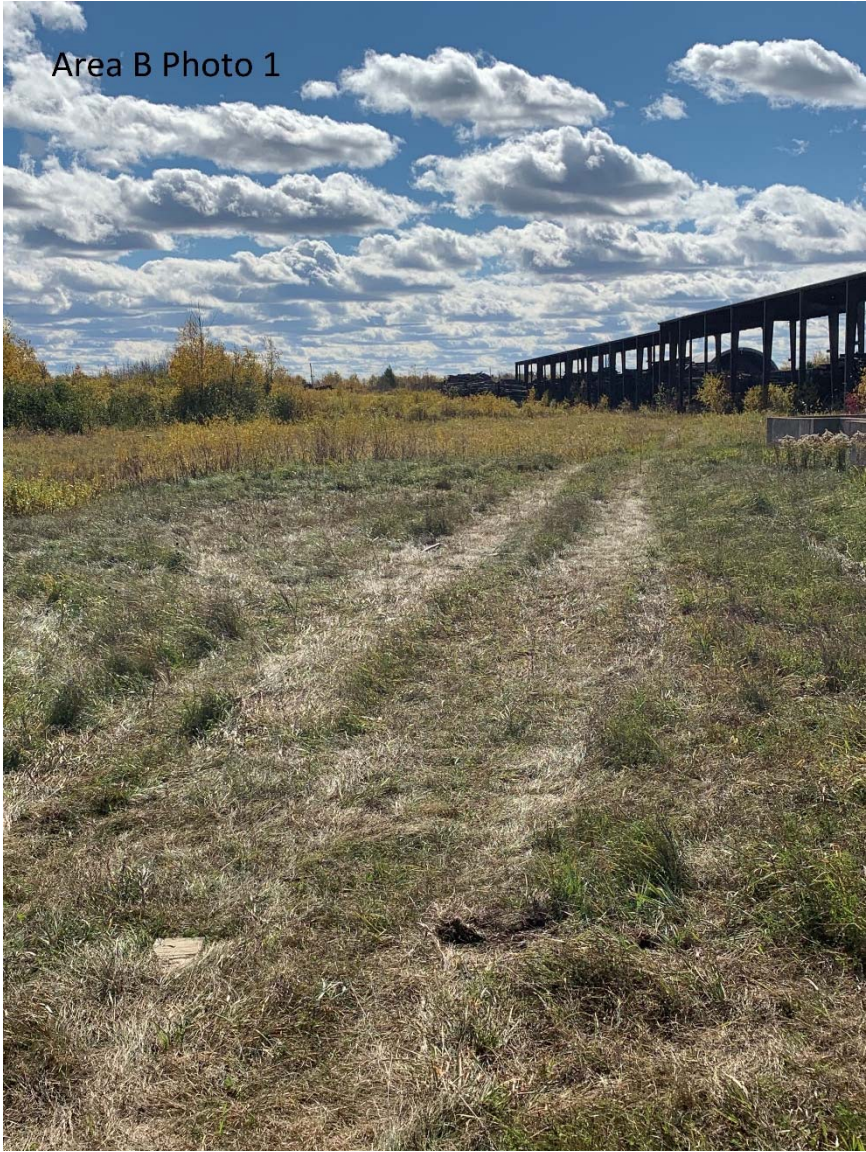
Area B Photo 1, looking South from North East central area:

Photographs: Photo: 1 ; Looking S from north east central area

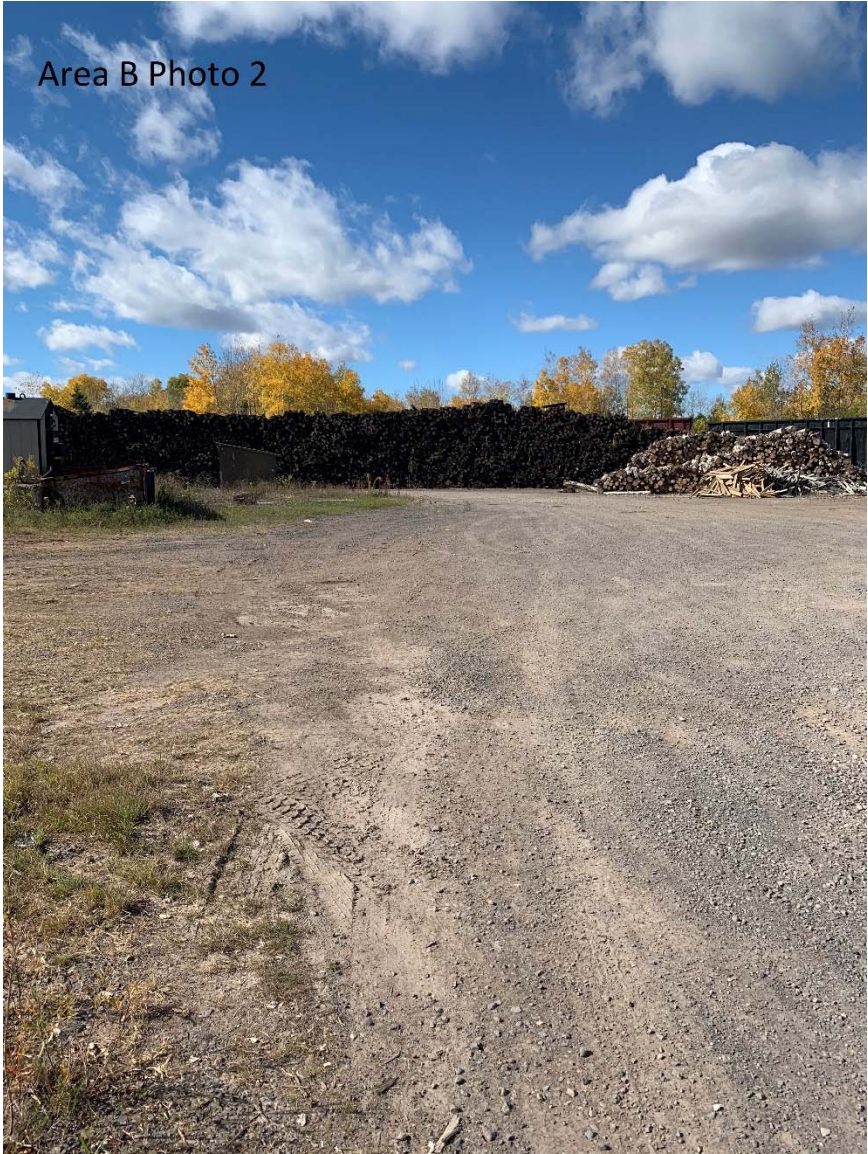
Area B Photo 2, looking West from Eastern edge:

Photo: 2 ; Looking W from eastern edge

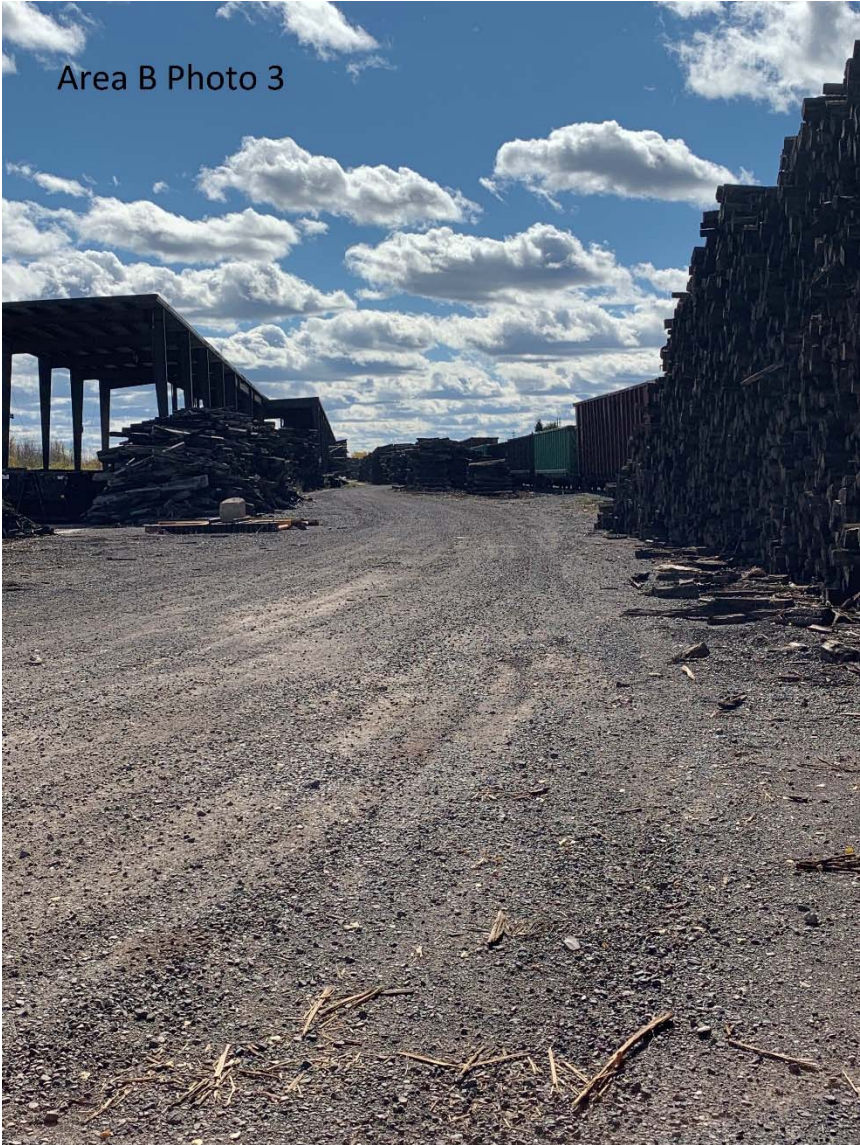
Area B Photo 3, looking South from North Central area:

Photo: 3 ; Looking S from north central section

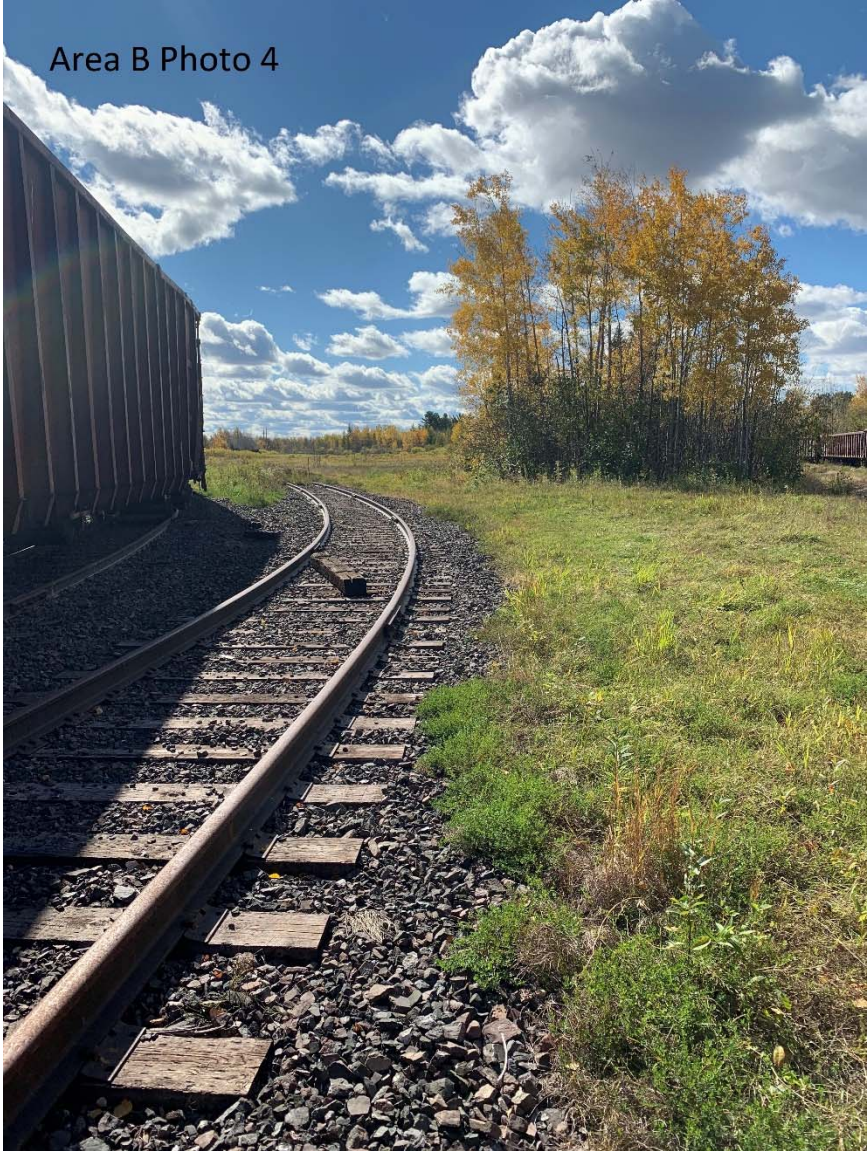
Area B Photo 4, looking South from North West:

Photo: 4 ; Looking S from north west

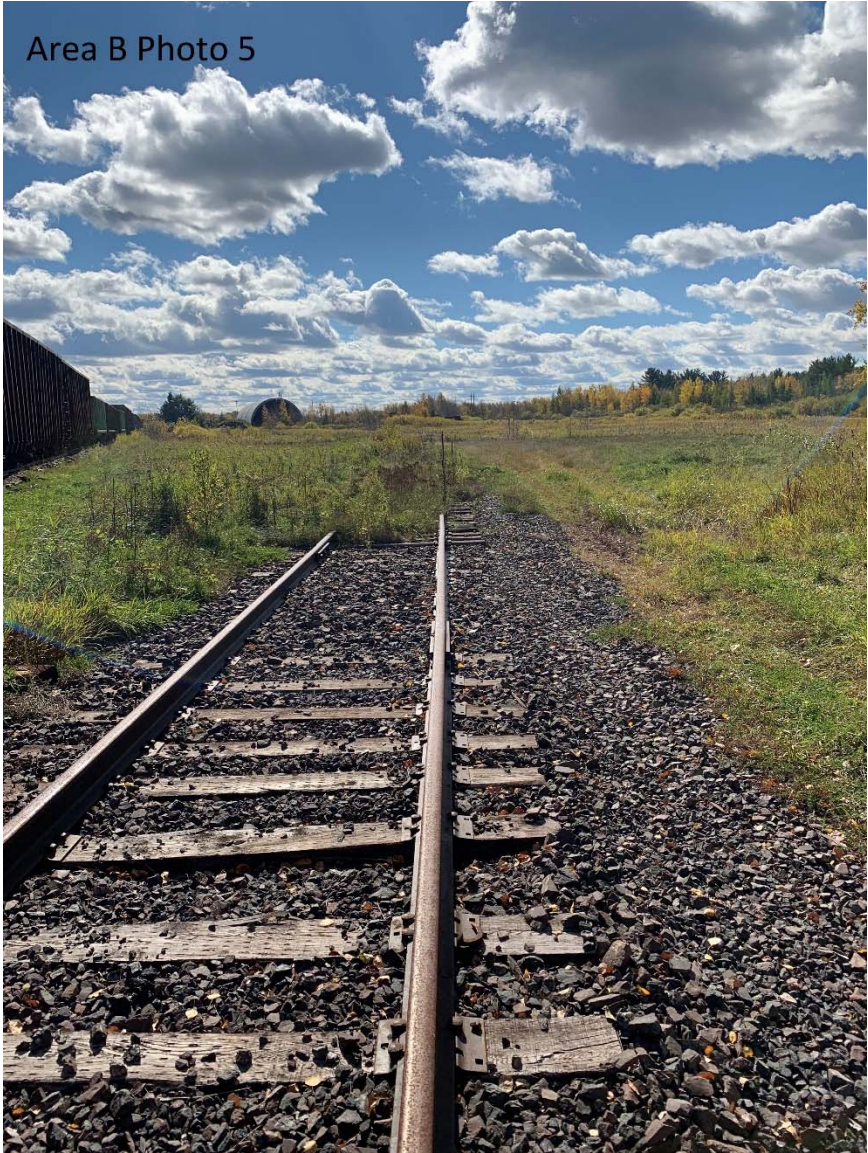
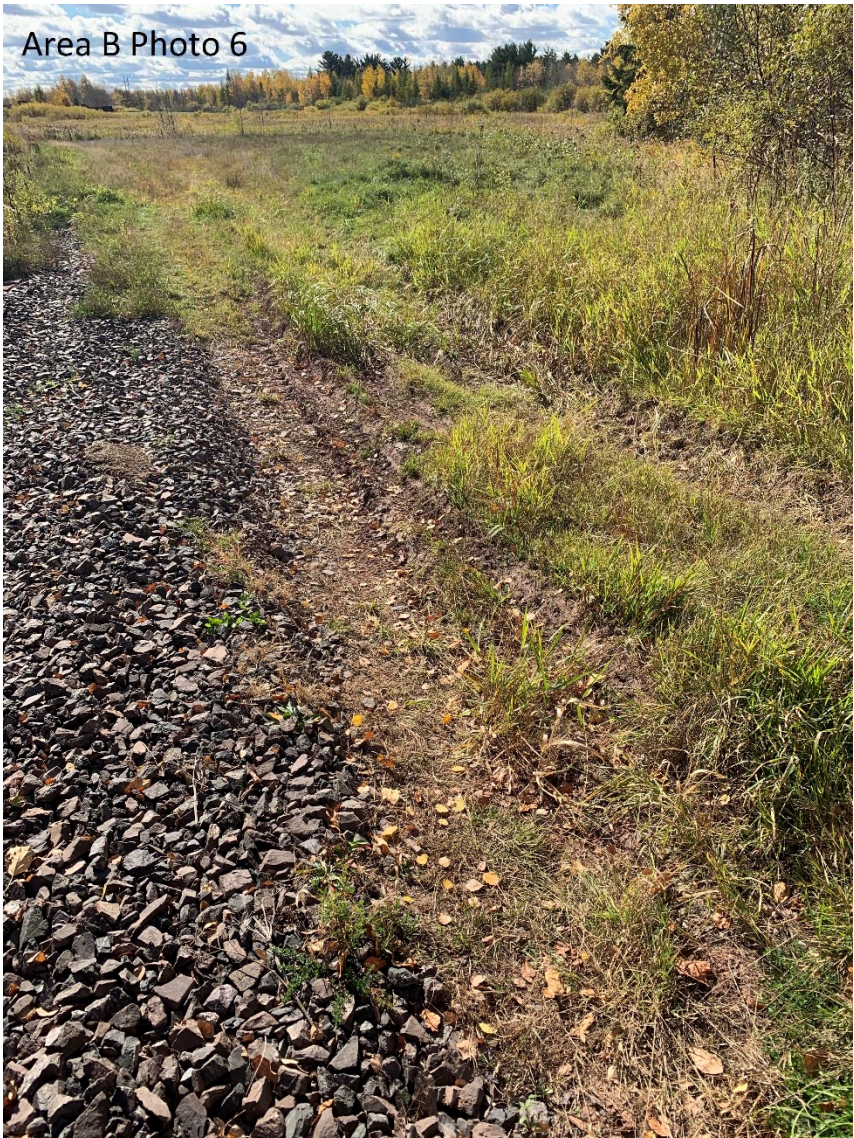
Area B Photo 5, Close up of photo 4:

Area B Photo 6, Close up of photo 4:

Photo: 5+6 ; Close up of slight depressions

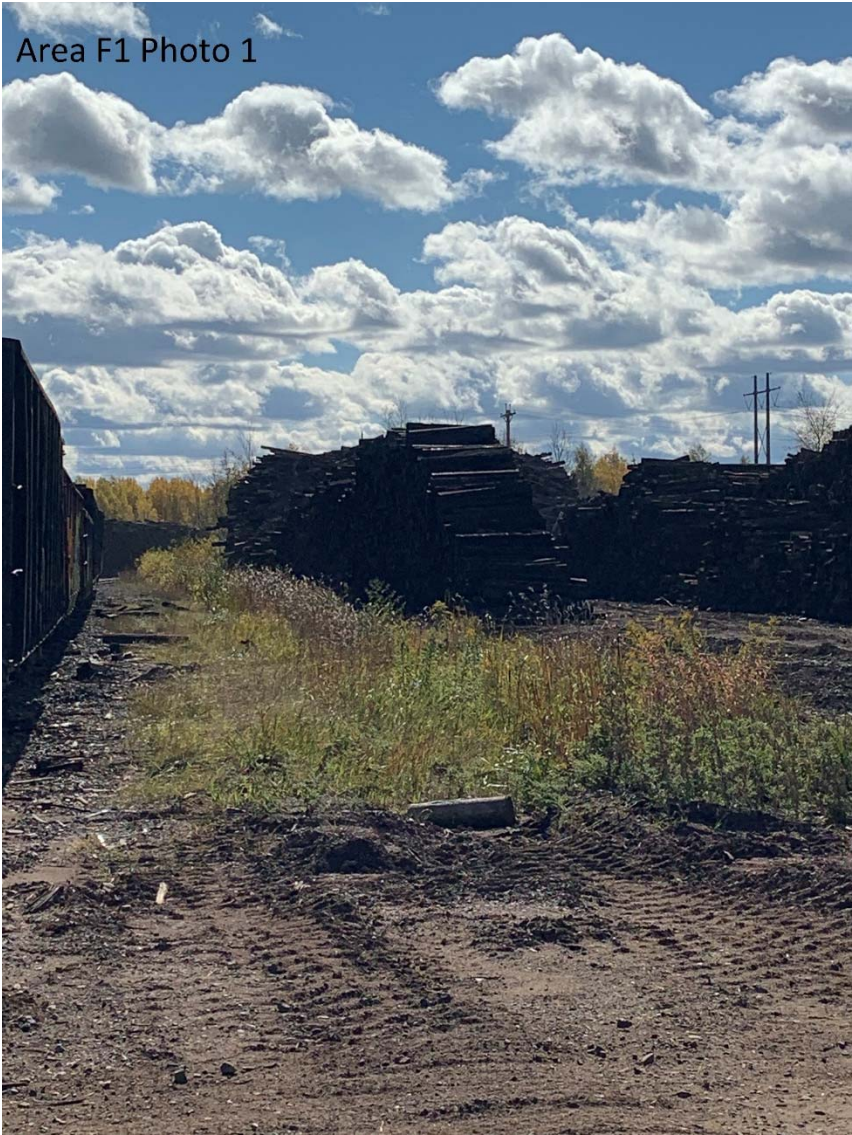
Area F1 Photo 1, Looking South from North end:

Photographs: Photo: 1; Looking S from North edge on E side of tracks
 Photo: _____;
 Photo: _____;
 Photo: _____;
 Photo: _____;

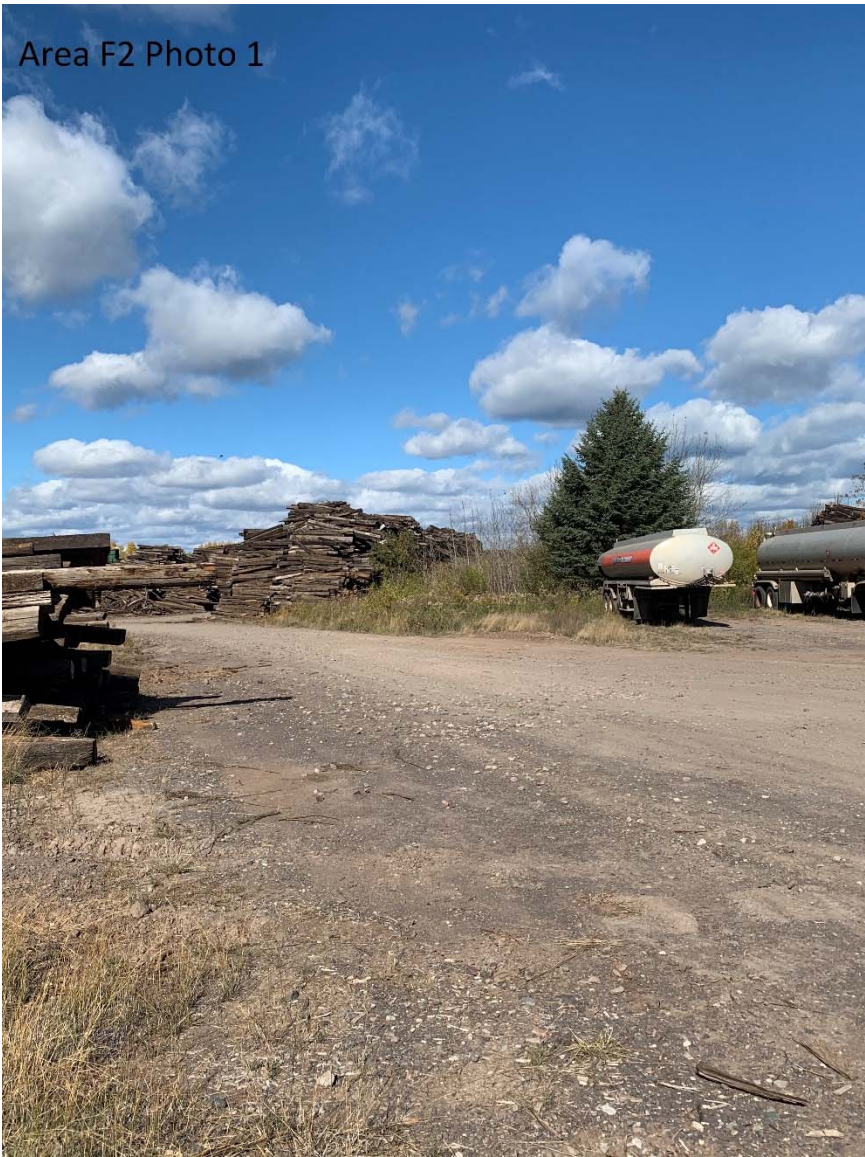
Area F2 Photo 1, Looking Northeast from Southwest:

Photographs: Photo: 1; Looking NE from SW area
 Photo: _____;
 Photo: _____;
 Photo: _____;
 Photo: _____;

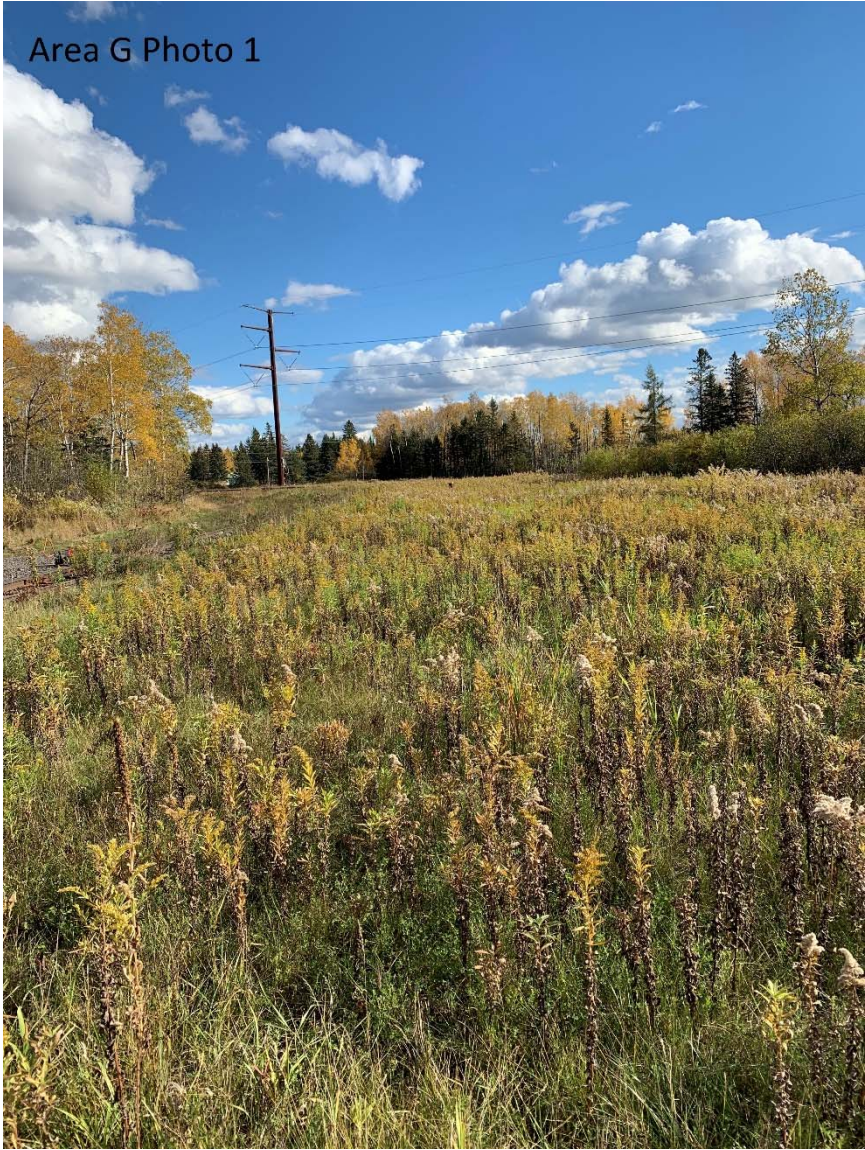
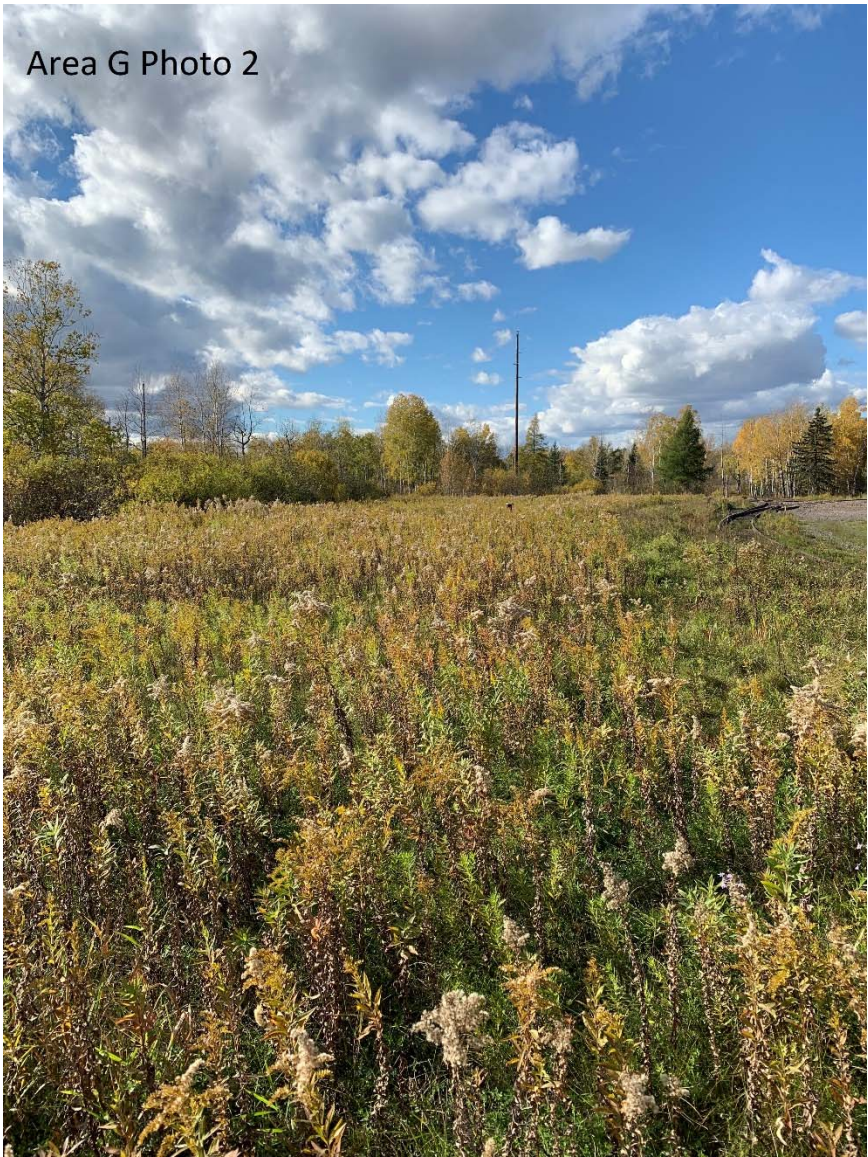
Area G Photo 1, looking Southeast from Northwest corner:

Area G Photo 2, looking Northwest from Southeast corner:

Photographs: Photo: 1 ; Looking SE from North West
 Photo: 2 ; Looking NW from South East
 Photo: _____ ; _____
 Photo: _____ ; _____
 Photo: _____ ; _____

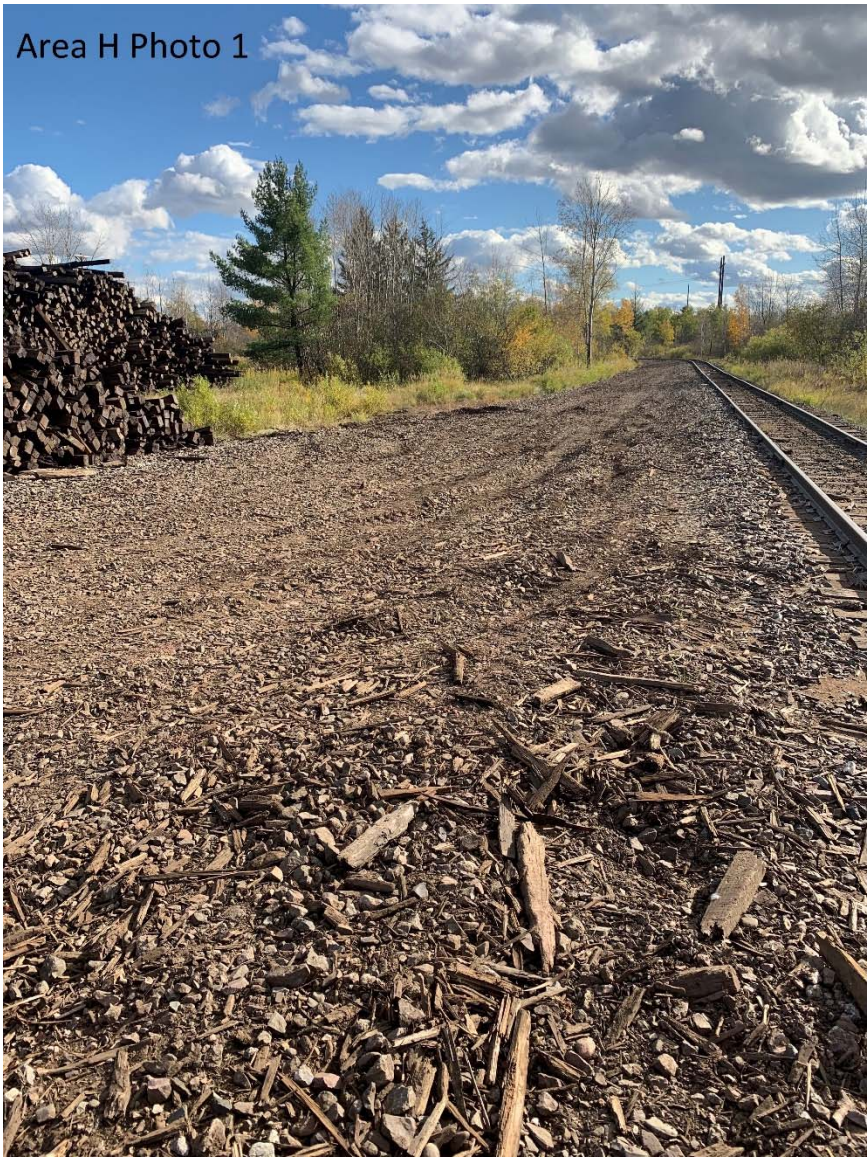
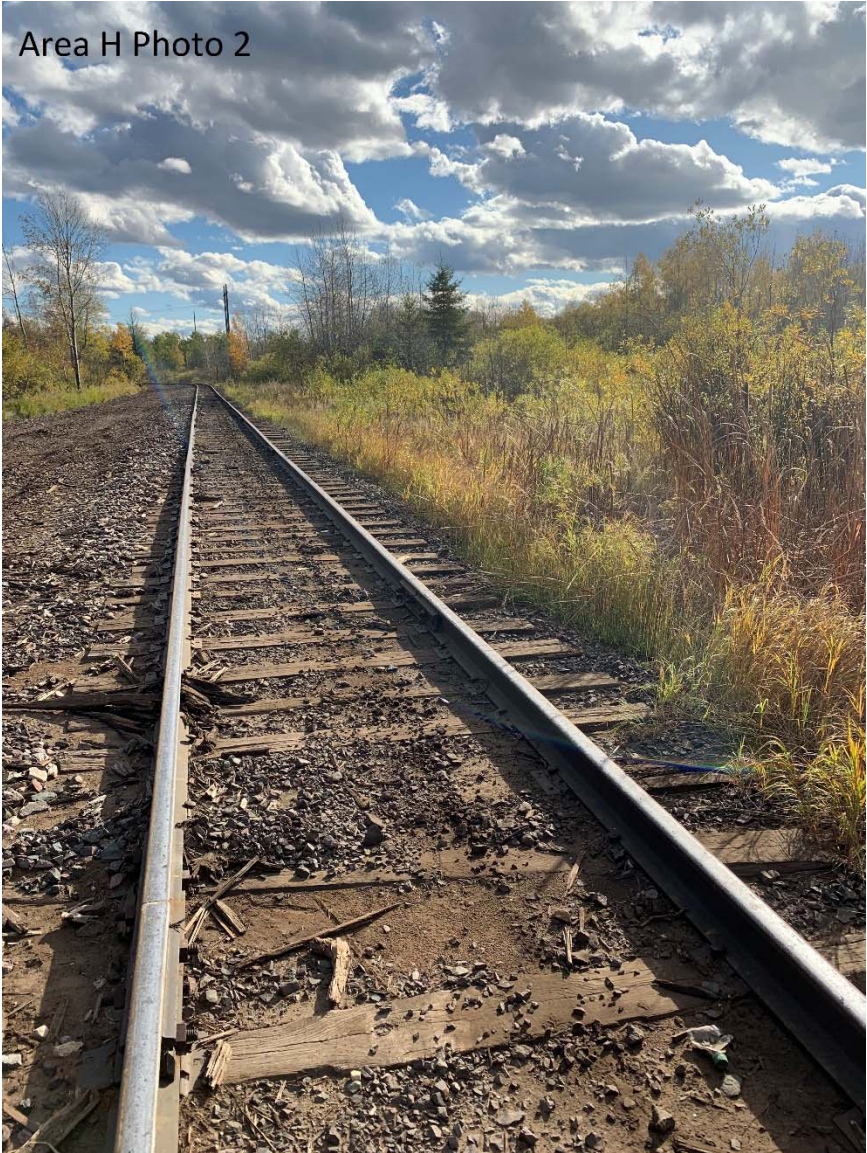
Area H Photo 1, (East side of RR tracks) looking Southwest from Eastern side:

Area H Photo 2, (West side of RR tracks) looking Southwest from western side:

Photographs: Photo: 1 ; Looking SW from Eastern side
 Photo: 2 ; Looking SW from Western side
 Photo: _____ ; _____
 Photo: _____ ; _____
 Photo: _____ ; _____

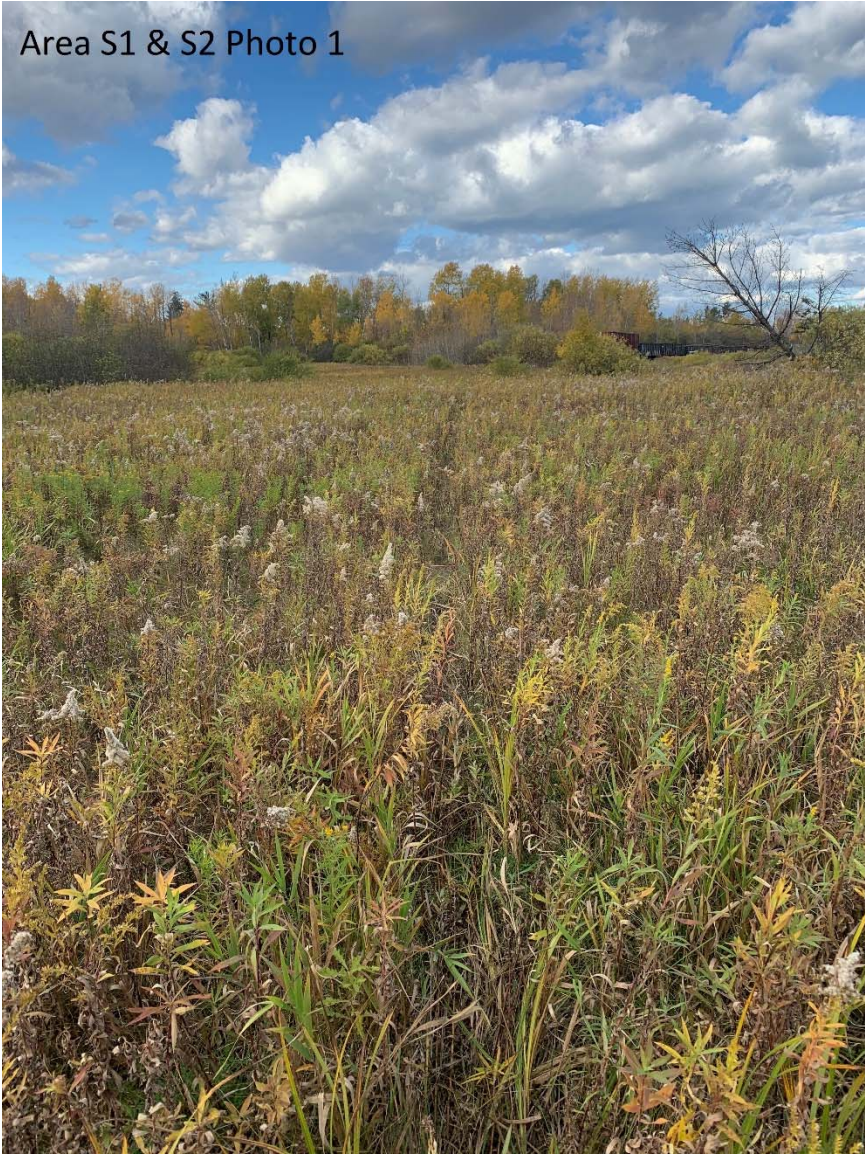
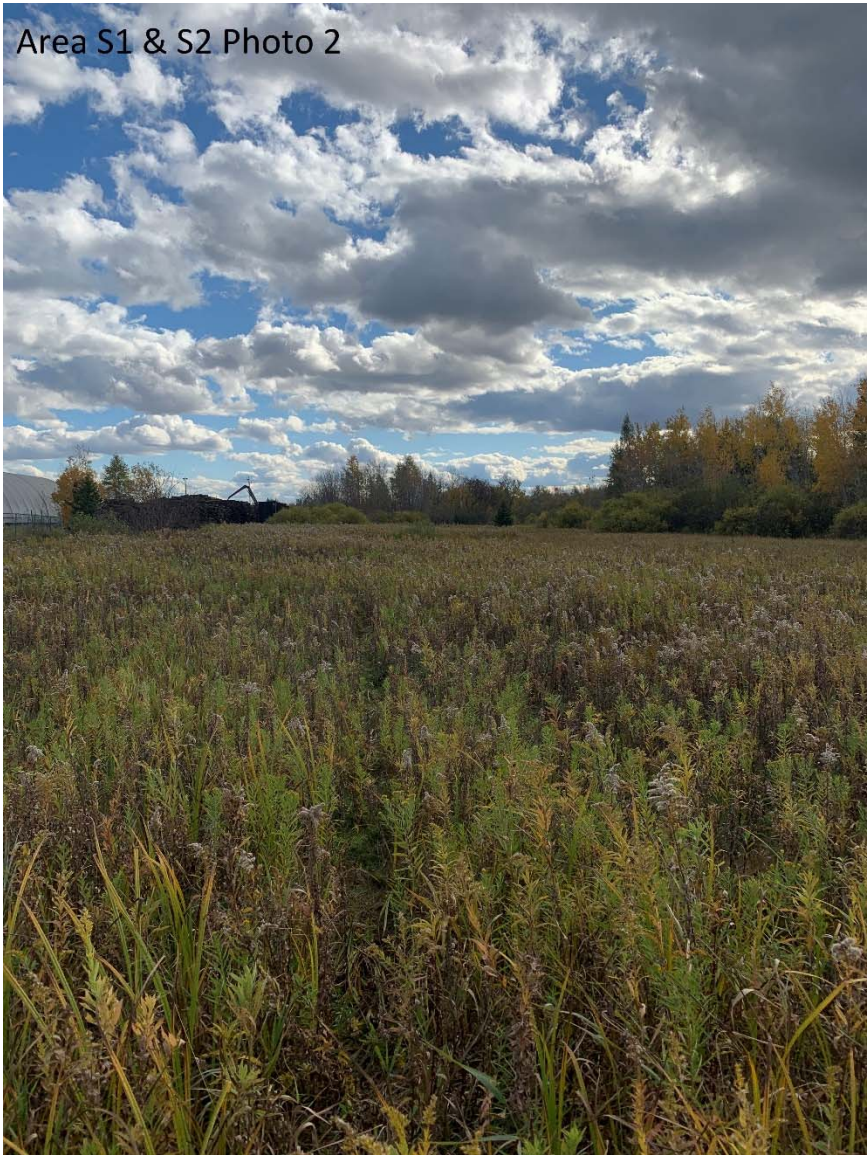
Area S Photo 1, looking North from center of area:

Area S Photo 2, looking South from center of area:

Photographs: Photo: 1 ; Looking N from center of area
 Photo: 2 ; Looking S from center of area
 Photo: _____ ; _____
 Photo: _____ ; _____
 Photo: _____ ; _____

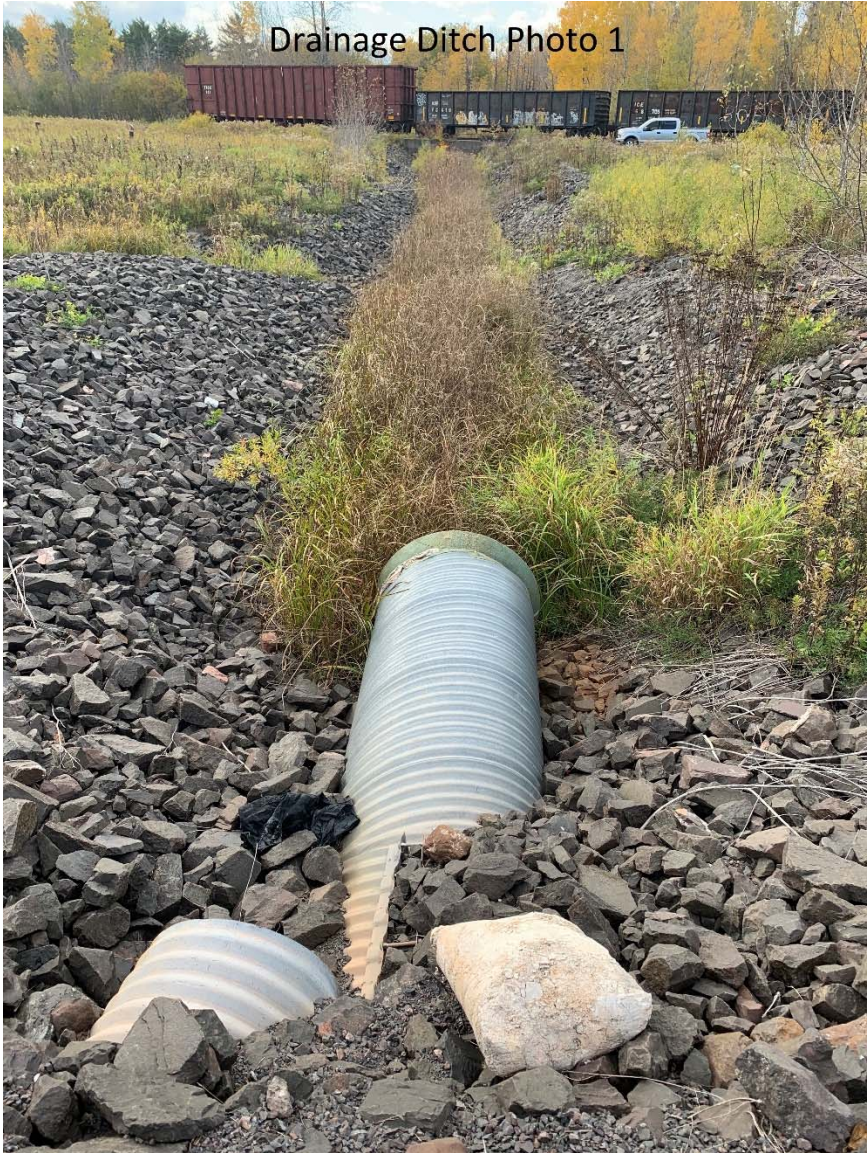
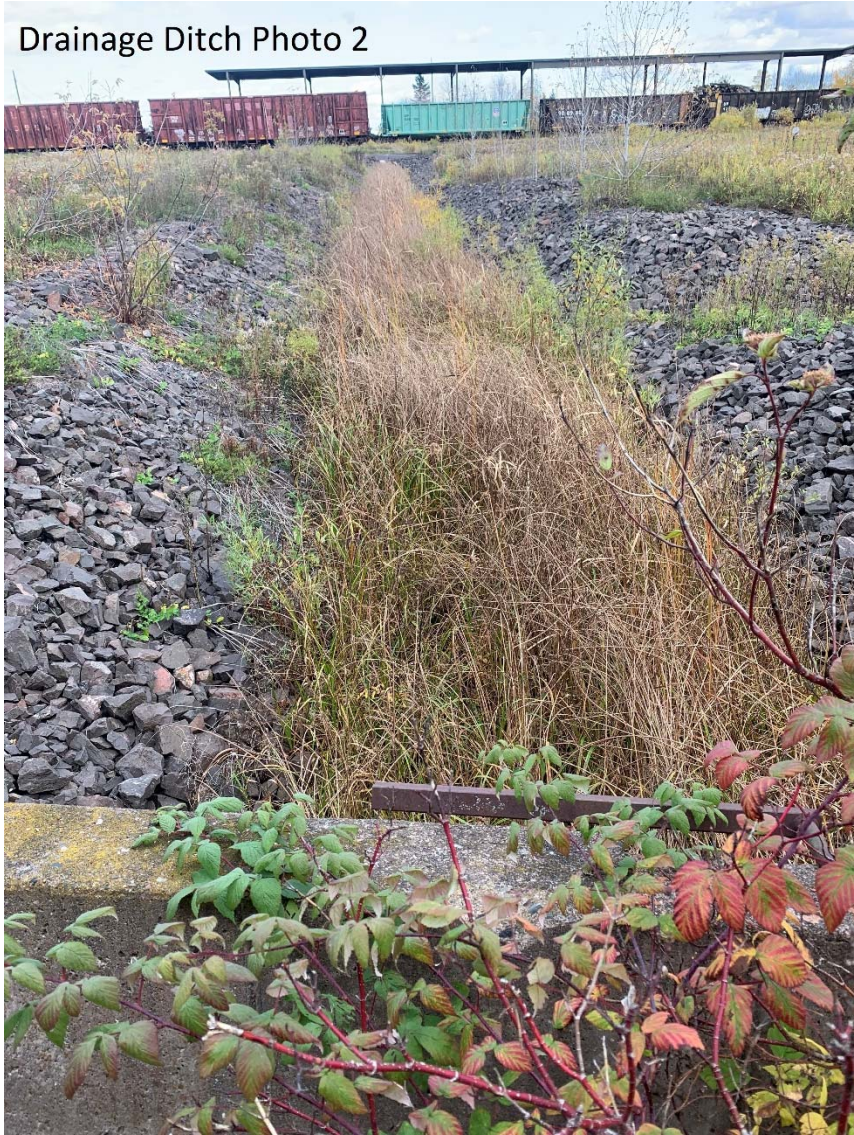
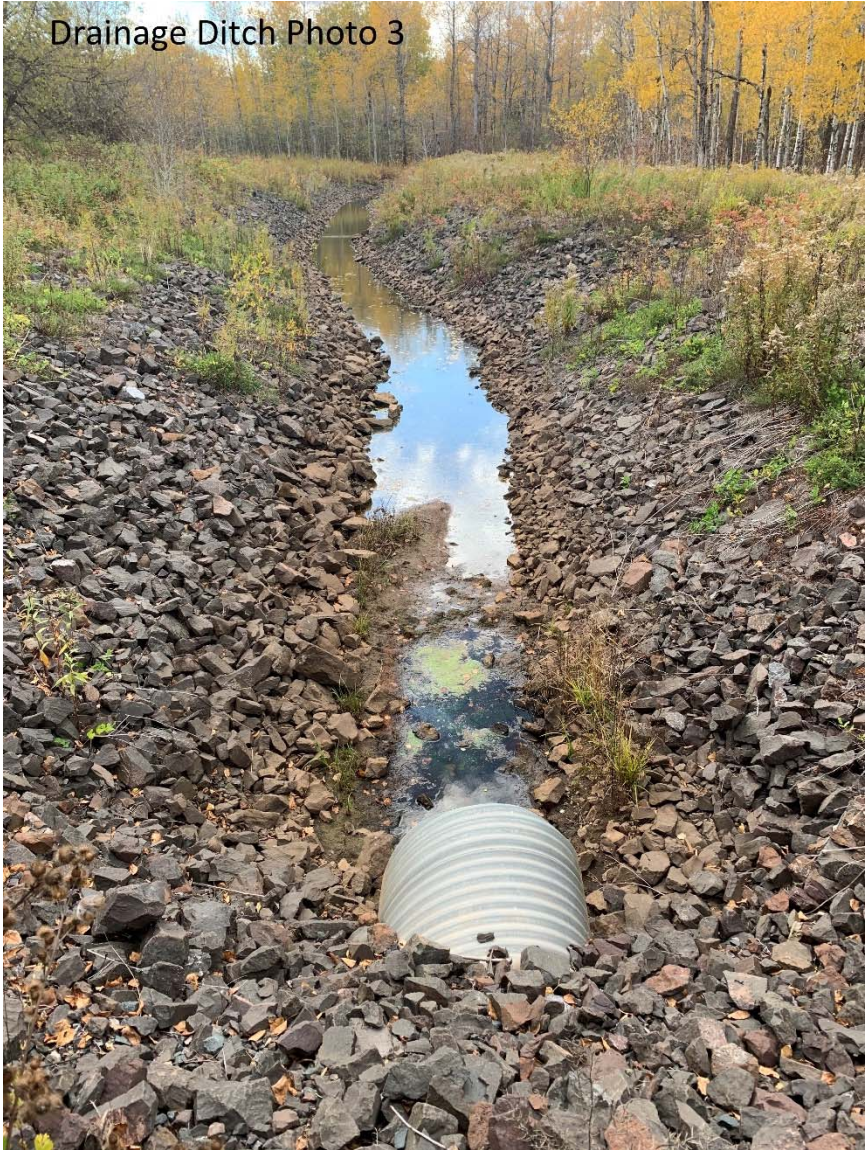
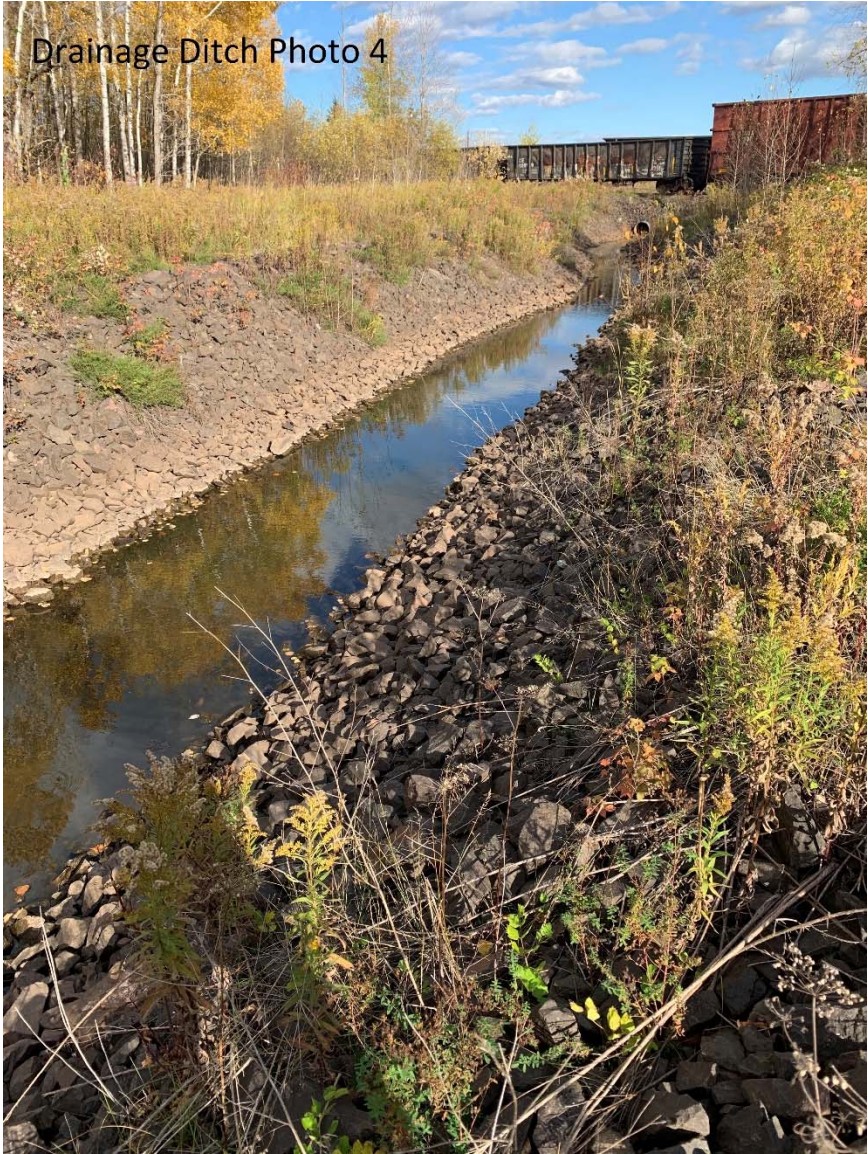
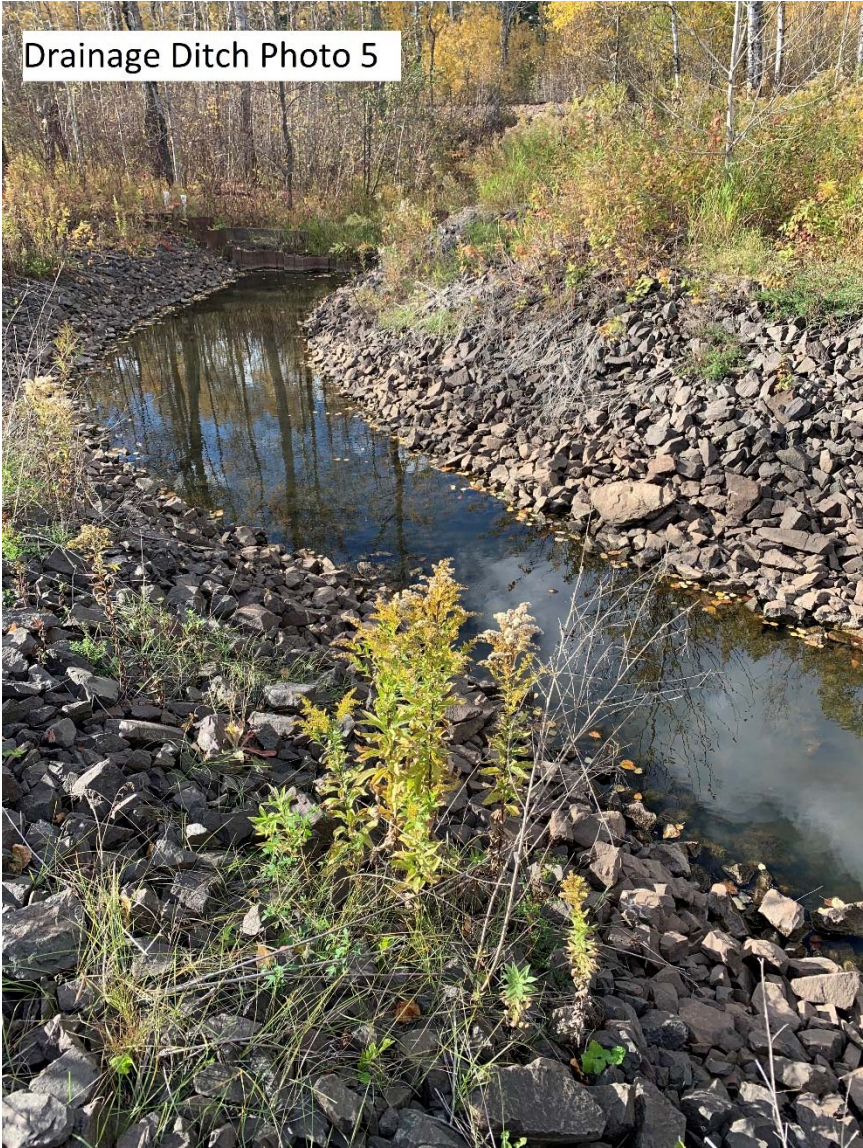
Outfall 001 Drainage Ditch Photo 1, looking West from Eastern edge:

Outfall 001 Drainage Ditch Photo 2, looking West from center area:

Outfall 001 Drainage Ditch Photo 3, looking West from center area:

Outfall 001 Drainage Ditch Photo 4, looking East from Western edge:

Outfall 001 Drainage Ditch Photo 5, looking North from Southern edge of ditch:

Photographs: Photo: 1 ; Looking W from Eastern edge
 Photo: 2 ; Looking E from center of area
 Photo: 3 ; Looking W from center of area
 Photo: 4 ; Looking E from western edge
 Photo: 5 ; Looking N from southern edge of ditch
