**RE: Former Koppers Inc. Facility, Superior Wisconsin  
WDNR DNR BRRTs No: 0216000484  
WDNR Facility ID: 816009810**

**Subject: 2022 On-Property Corrective Measures Monitoring & Maintenance Report**

Site Inspection – 10/04/22

# Former Koppers Inc. Facility – Superior, WI

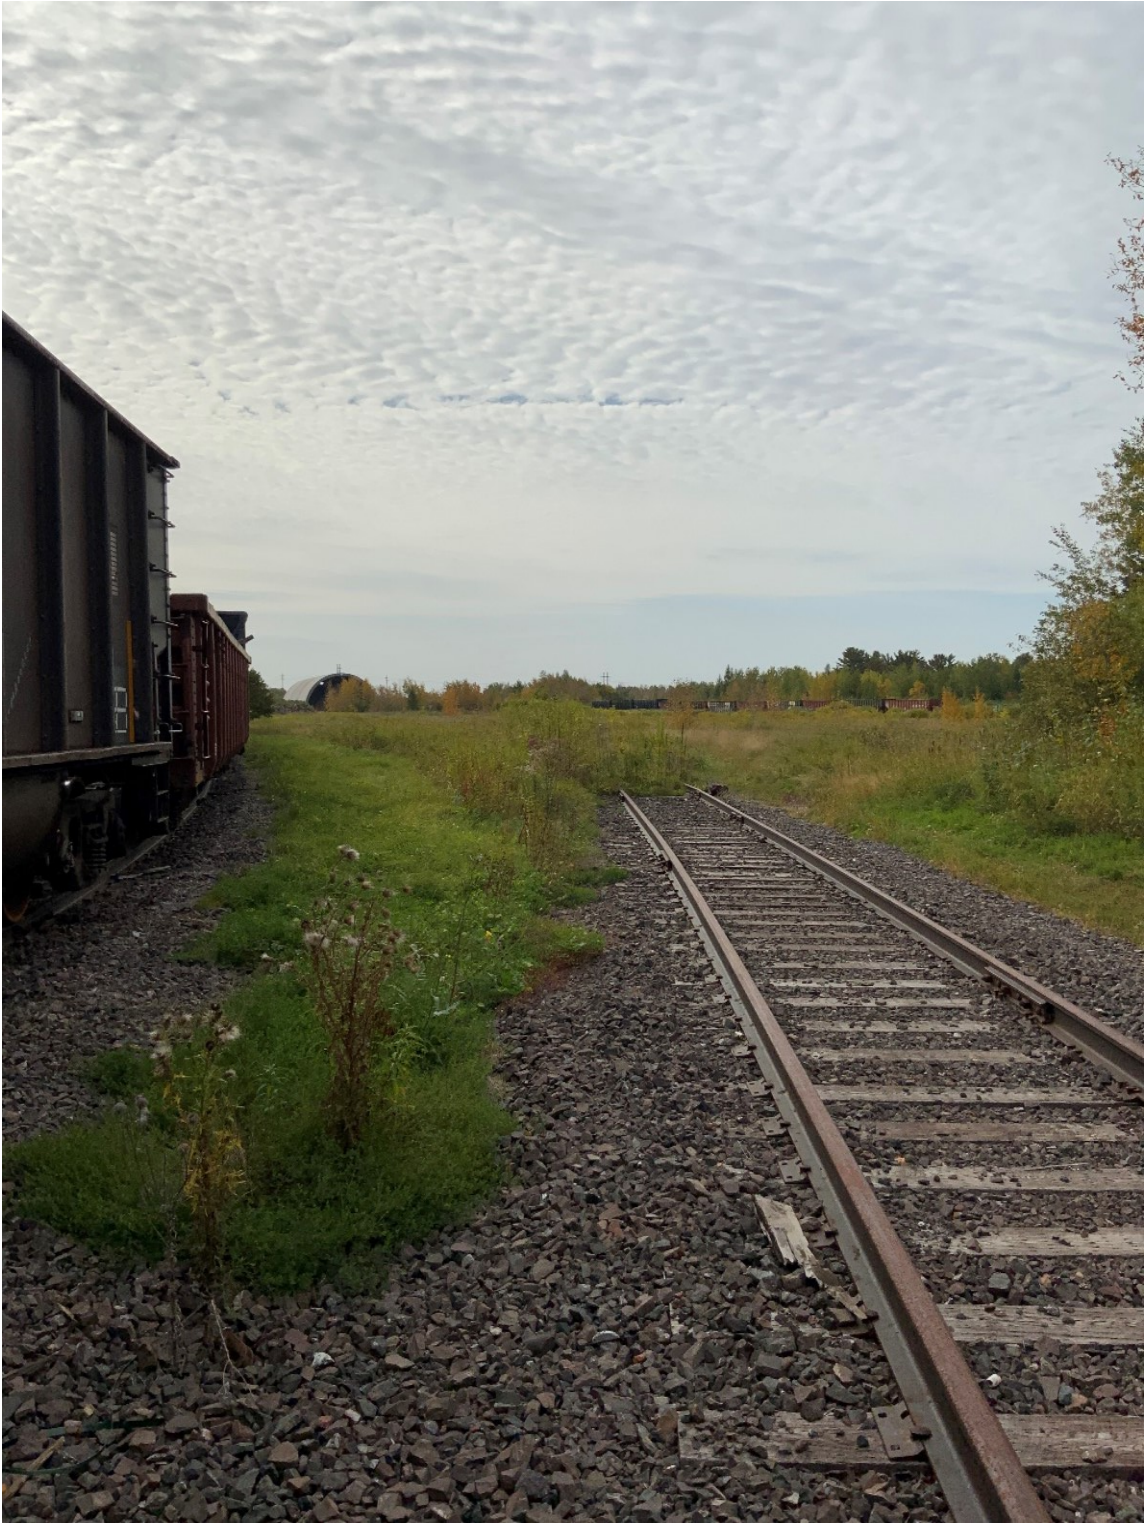
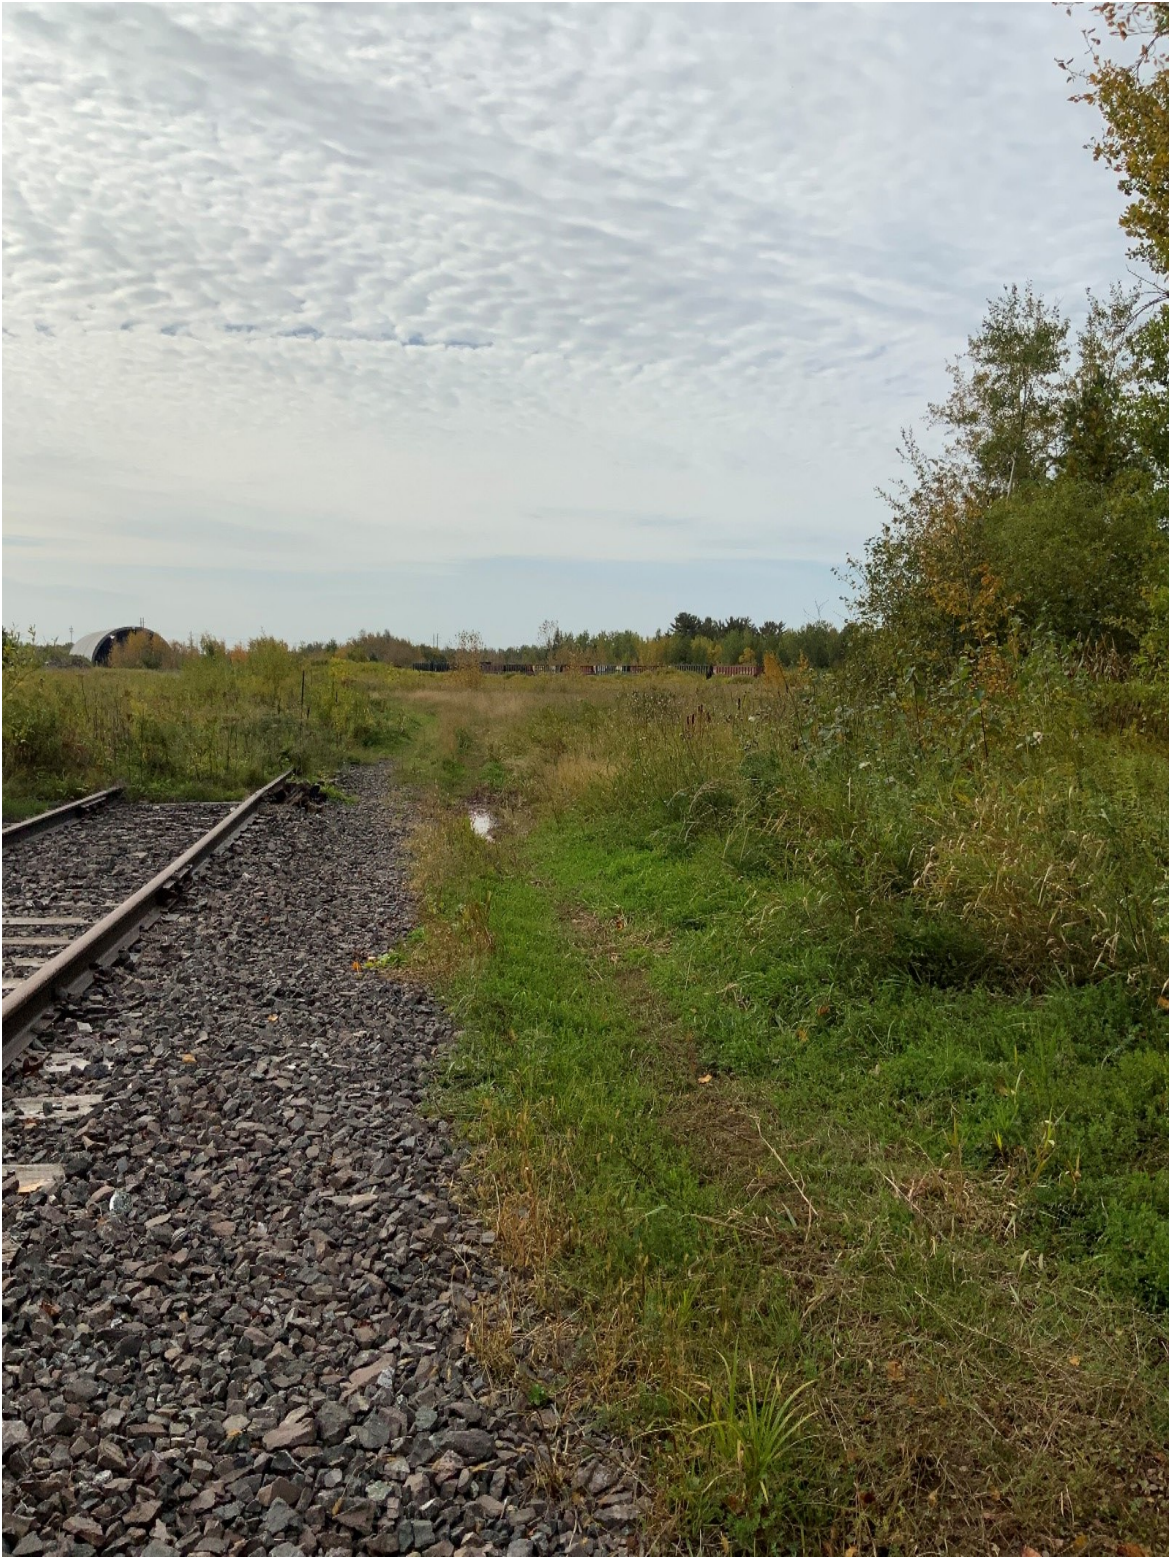
(check one)	No	Yes	If yes, provide description and take photos
Excessive erosion	X		<u>Depression</u>
Evidence of excessive settling or ponding	X	<del>X</del>	<u>Ditch filled with water, photos <u>5</u> + <u>6</u></u> MF 11-14-22 MF 11-14-22
Areas lacking well-established vegetation	X	<del>X</del>

Action Items: NA
