**Remediation & Redevelopment
 Continuing Obligation Review**

BRRTS ID No. 02-61-000488

Review Date: 04/22/2024

Site Name: Doberstein Lumber & Fence, Inc.

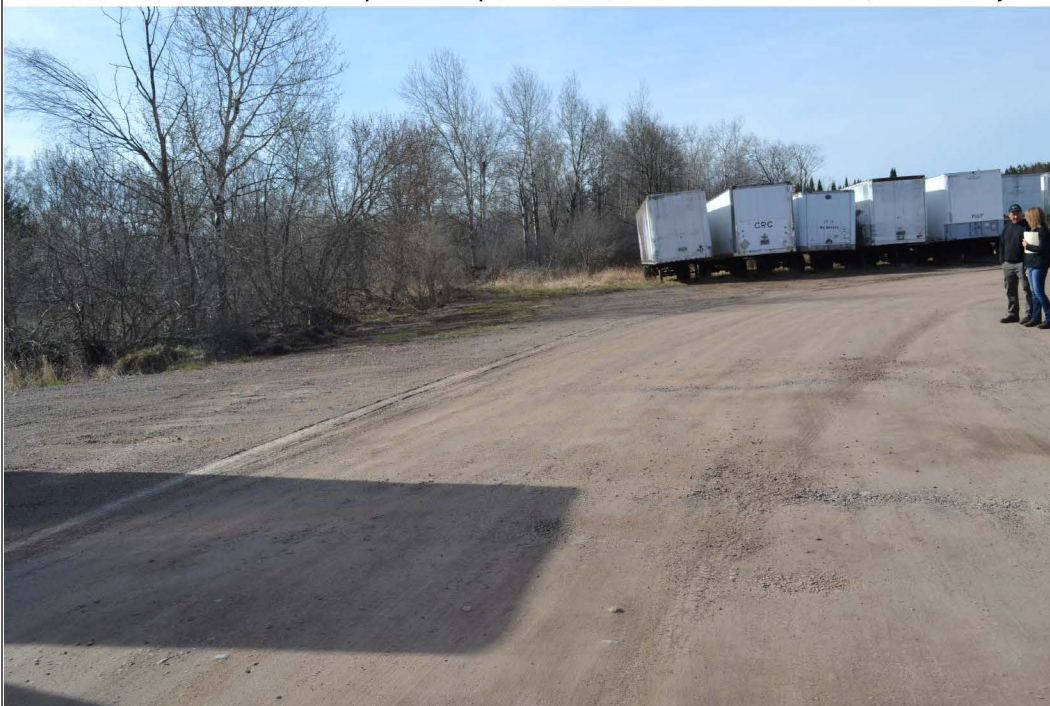
Title: Doberstein looking southeast at gravel cap

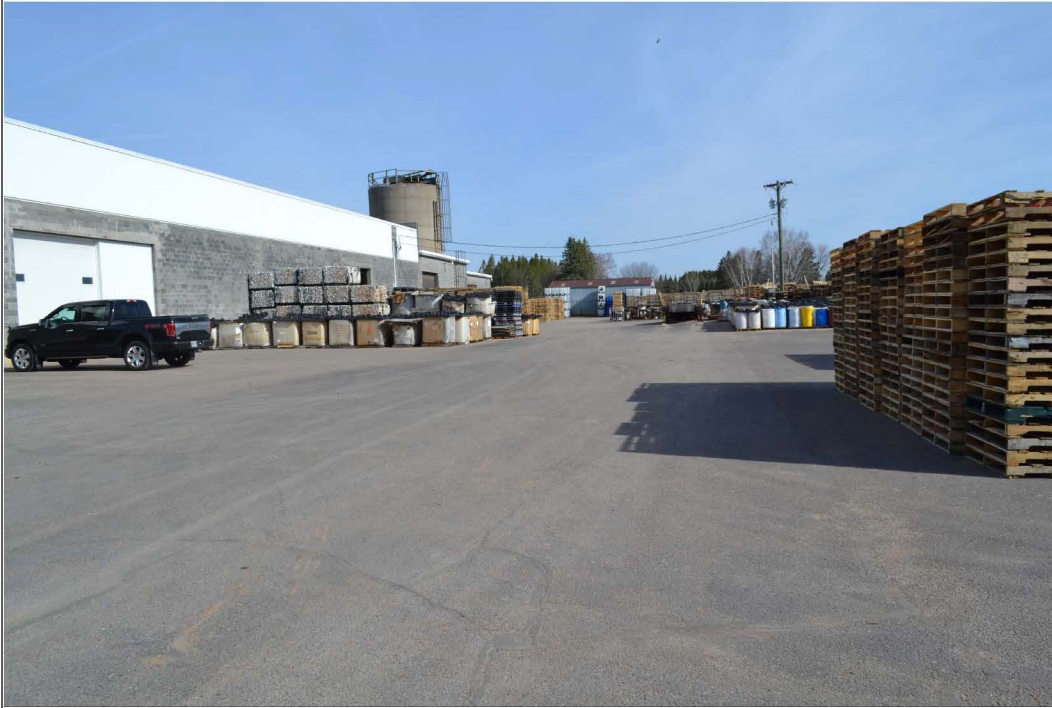
Title: Doberstein looking north at asphalt cap

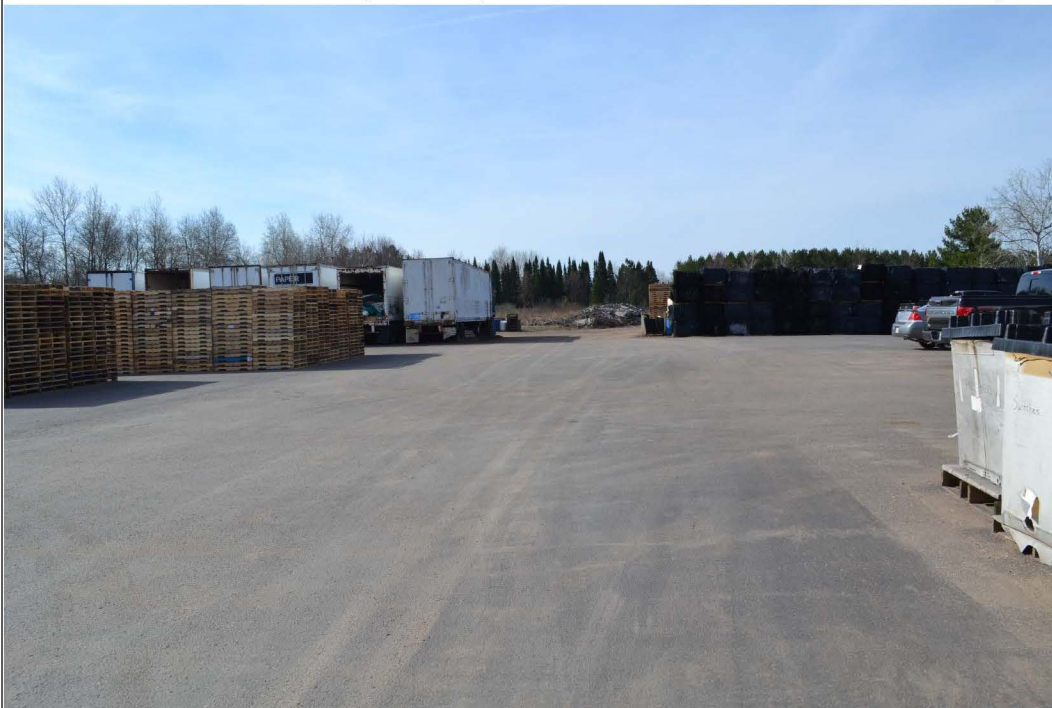
Title: Doberstein looking south at asphalt cap

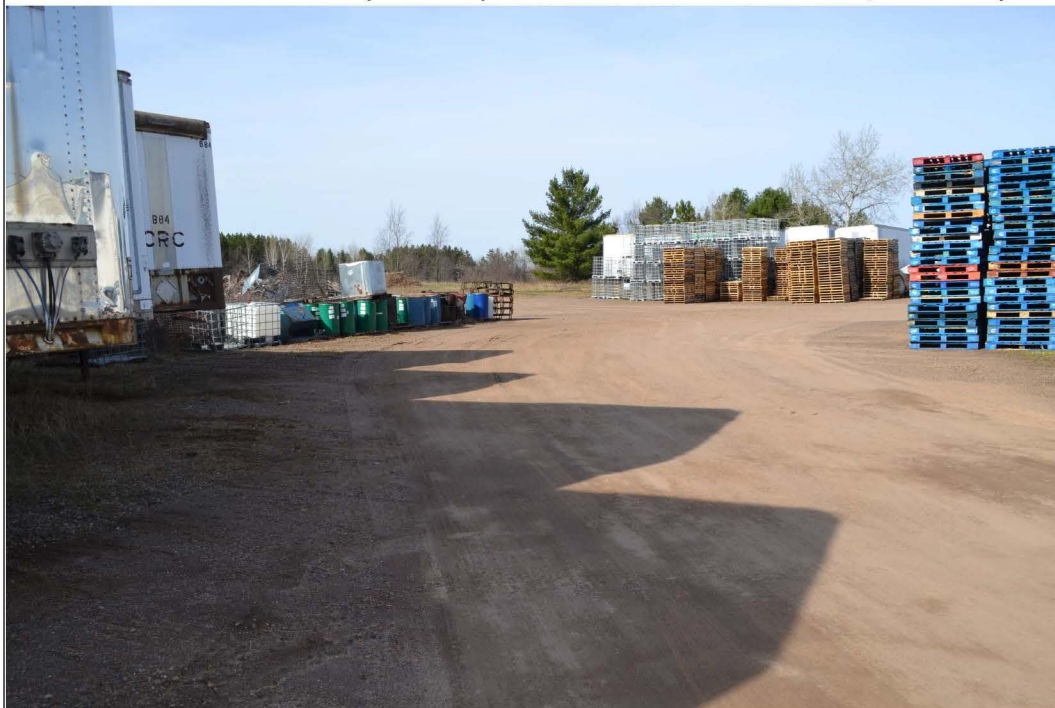
Title: Doberstein looking southwest at gravel cap

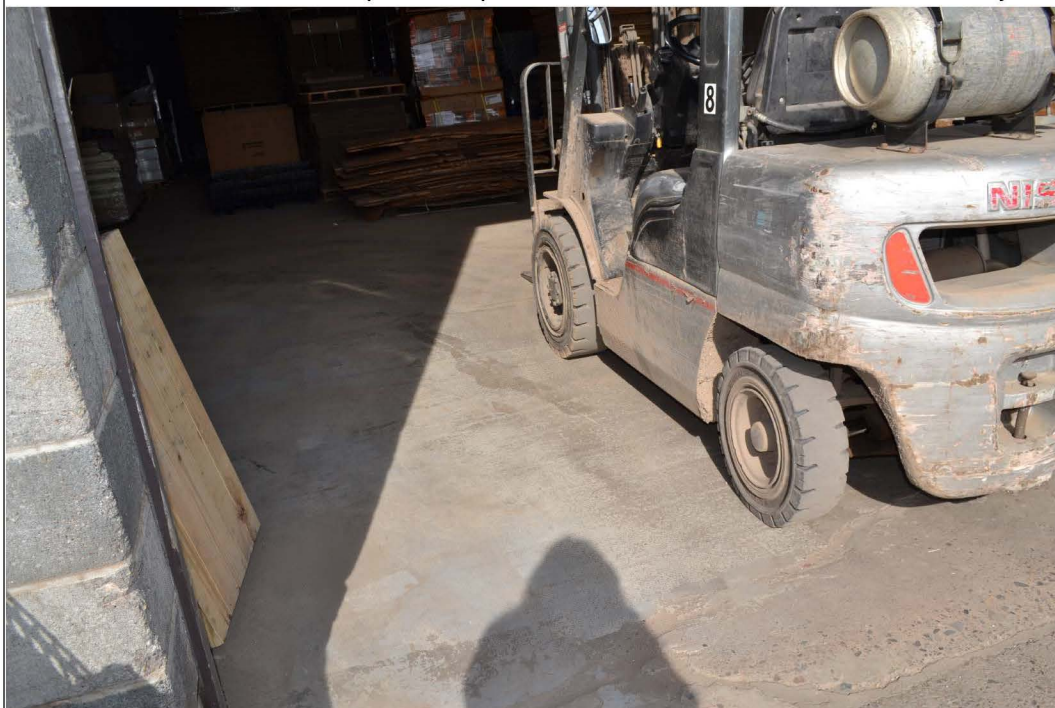
- Yes
- No – Describe what's not in compliance and the reasons for noncompliance:
Process Building Floor: Protective sealant needs to be reapplied. Next to the Process Building: Concrete cap needs cracks greater than 1/4" repaired/sealed.

Title: Doberstein looking west into the building at the floor sealant that needs repairs

- No
- Yes – Summarize the actions needed to return the site to compliance and identify who is responsible:
Process Building Floor: Protective sealant needs to be reapplied. Next to the Process Building: Concrete cap needs cracks greater than 1/4" repaired/sealed.

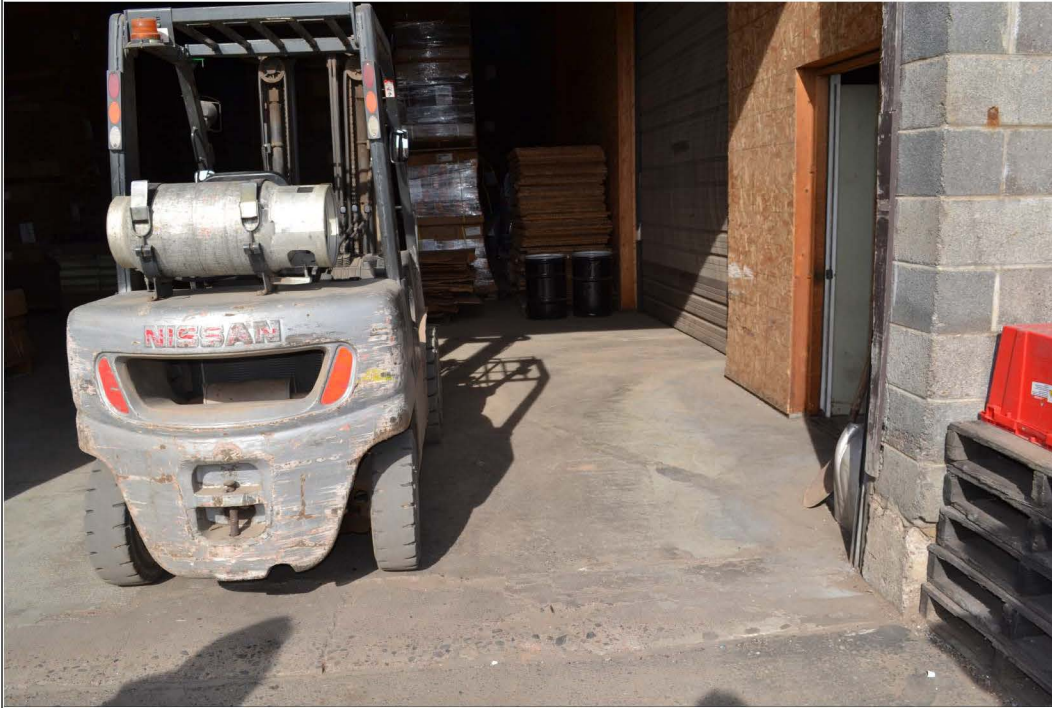
Title: Doberstein looking west into the building at the floor sealant that needs repairs

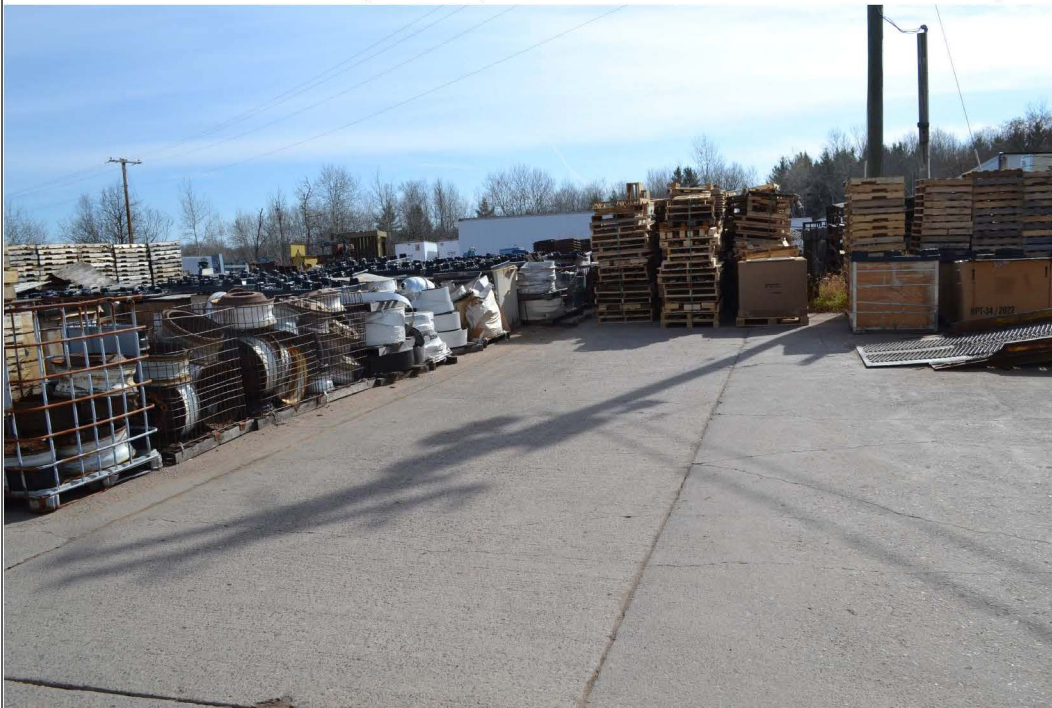
Title: Doberstein looking east at asphalt cap

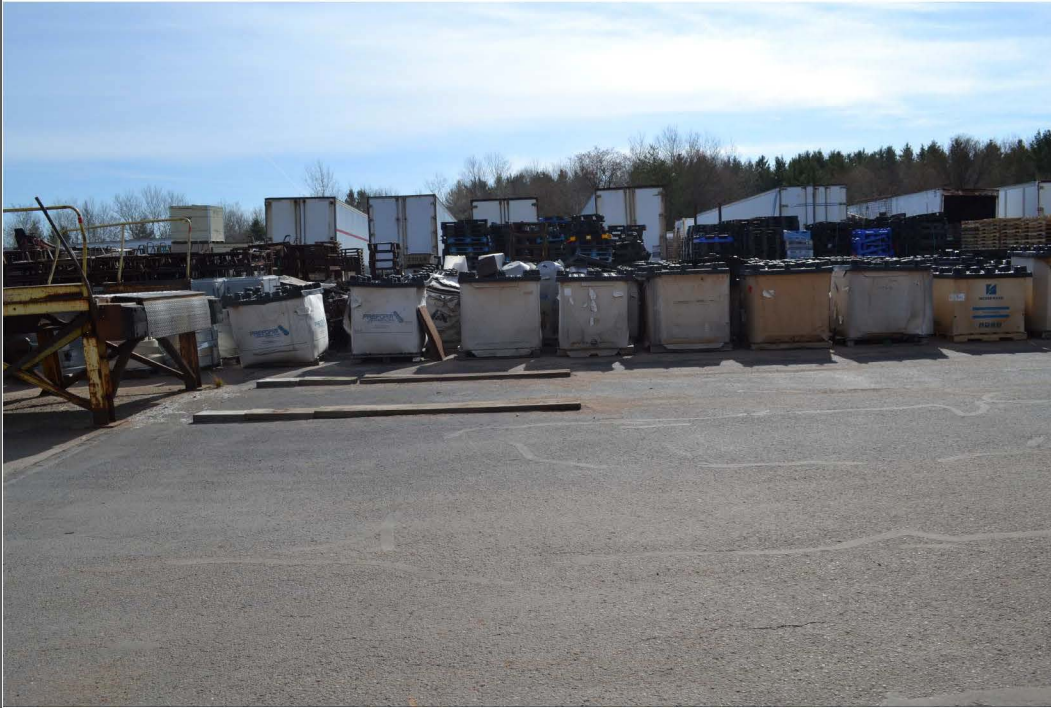
Title: Doberstein looking east at asphalt cap
