State of Wisconsin \ DEPARTMENT OF NATURAL RESOURCES

Site Name/BRRTS: Kewaunee Marsh Arsenic Spill (02-31-000508)

Re: Field Activities Report for June 15, 2016

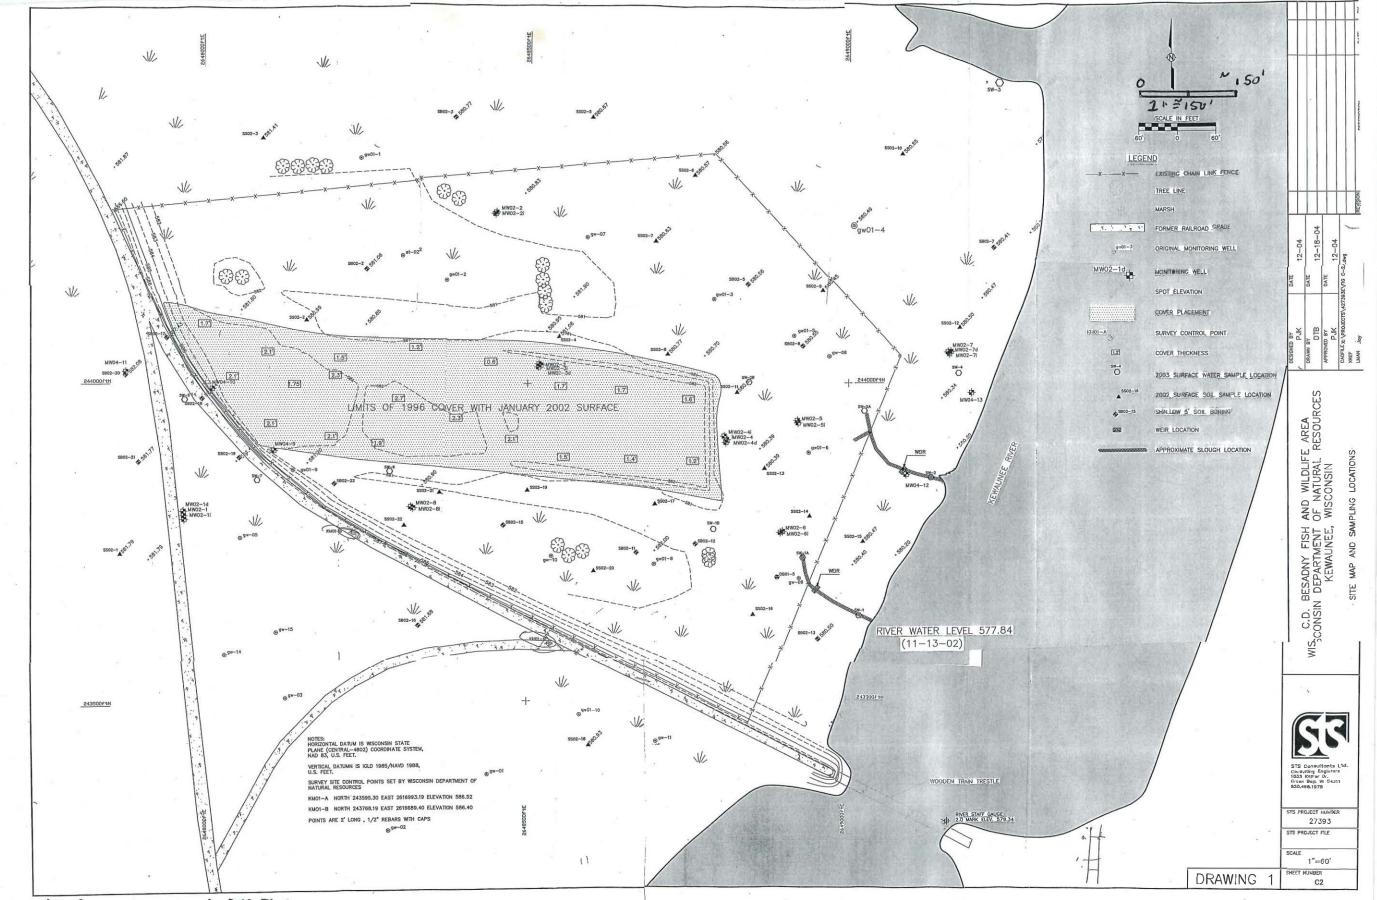
August 29, 2016 Annadnat to Field Notes: Photo of river staff gage, Kewaunee Marsh, June 15, 2016.

Depth to water observed from bridge and reported in field notes: 3.79'.

Depth to water based on closer examination of above photo: 3.70'
