State of Wisconsin \ DEPARTMENT OF NATURAL RESOURCES

To: File
From: Liz Victor *LV*
Date: December 29, 2016
Site Name/BRRTS: Kewaunee Marsh Arsenic Spill (02-31-000508)
Re: Field Activities Report for Dec 12, 2016

DRAFT CAP VEGETATIVE COVER EVALUATION
Kewaunee Marsh Arsenic Spill, 02-31-000508
December 2016

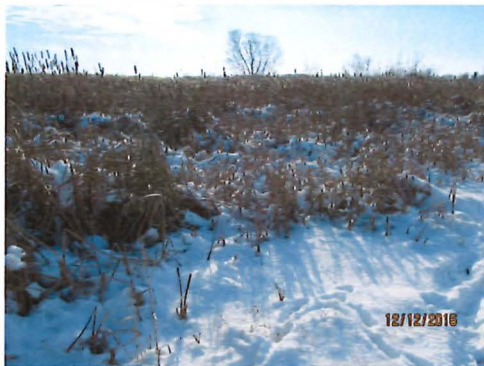
Stressed vegetation and tracks

Stressed Vegetation – The areas of stressed vegetation observed during the summer are still evident. The impacted reed canary grass, cattails and phragmites appeared to be smaller than in other areas both on and off the cap. The smaller RCG was identified by the papery sheath where the leaf attaches to the stem.

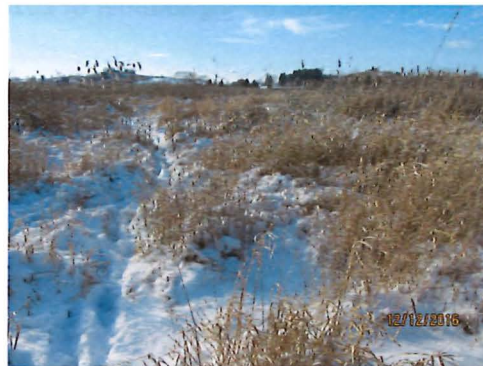
Stressed vegetation

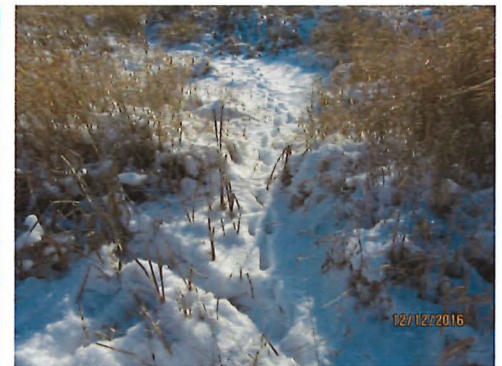
Deer Trails – Deer trails were numerous throughout the marsh. Many of the trails appeared to be from immature deer. During our walk along the perimeter of the fence we did not notice any tracks that looked like a deer had jumped the 6 ft fence. The rail trail is elevated above the marsh ~4-6 ft and is heavily vegetated making the southern fence line difficult to jump over from the inside. There are thick cattails along the eastern, northeastern and the easternmost portion of the north fence lines – these areas were observed to under water this past summer. The easiest, most open place to jump over the fence is along the western half of the north fence line.

Immature deer tracks on top of cap

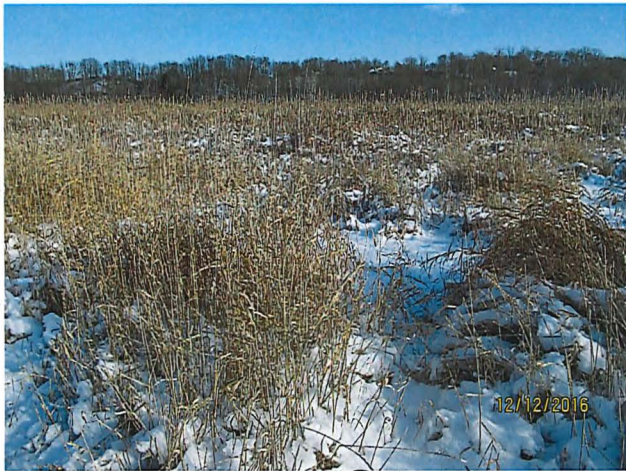
Stressed vegetation Area (Facing E.)

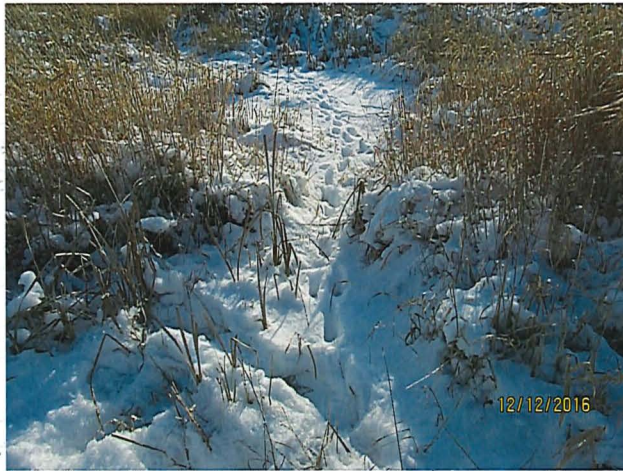
Immature Deer tracks Trapped in Fenced Area (Facing E.)

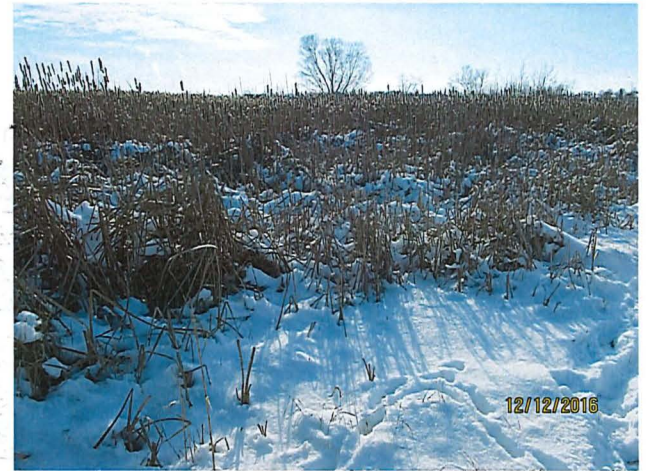
Stressed vegetation Area Cattail Growth Impacts (Facing S.)

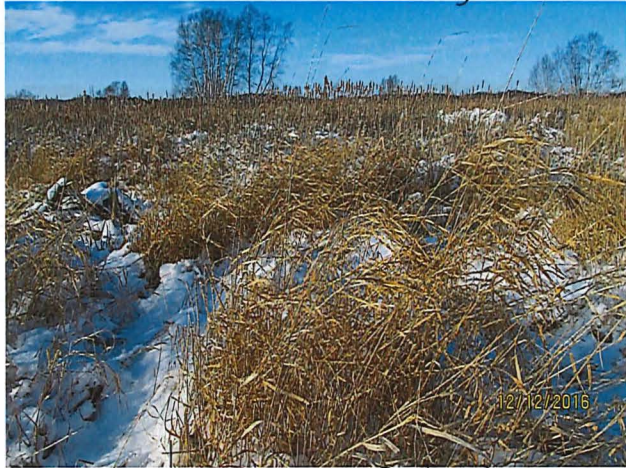
Stressed vegetation Area (Facing N)

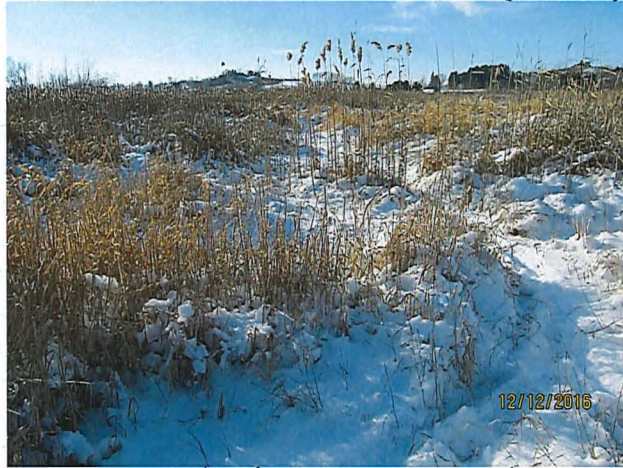
Stressed vegetation Area Stunted Plants (Facing W)

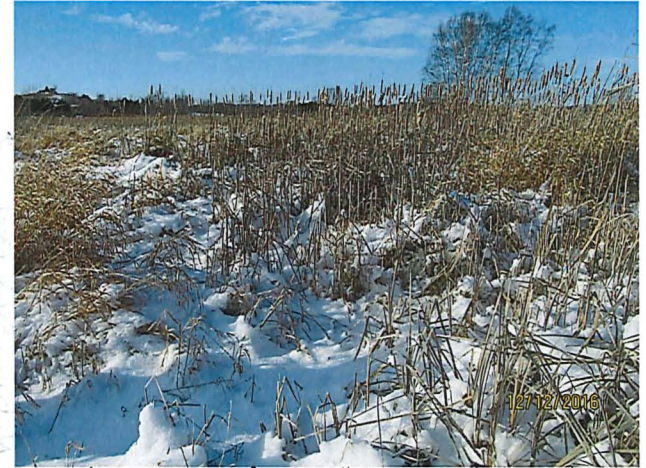
Stressed vegetation Area Cattail growth impacts (Facing NW)

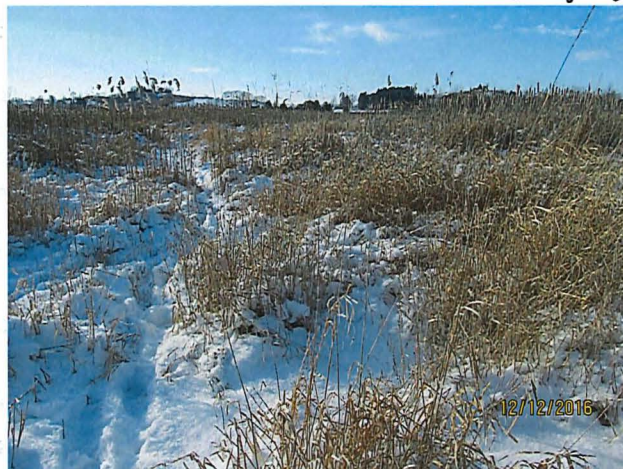
Stressed vegetation Area Stunted Phragmites - Cattails (Facing W.)

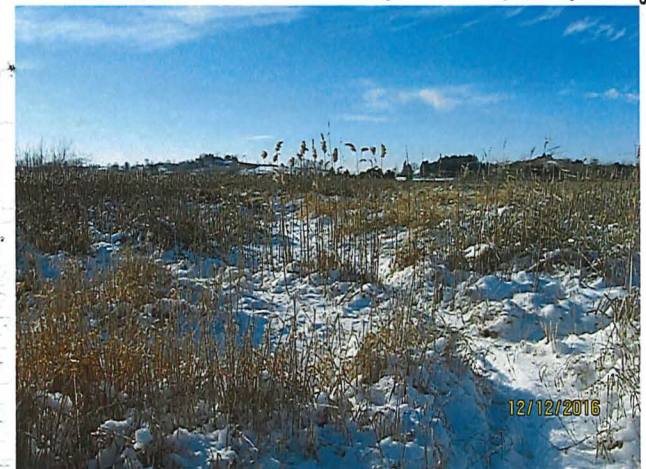
Stressed vegetation Area (Facing W.)

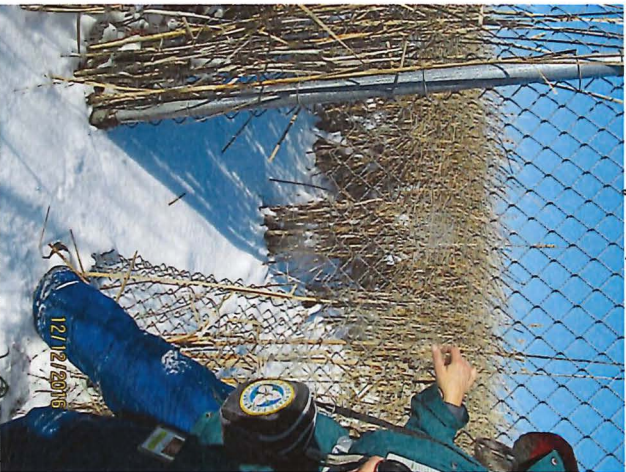
N. Fence hole Photo 2 (Facing N)

Fence - Two cut holes were observed in the fence. The GPS coordinates are attached and the locations of the cut holes are provided in the attached aerial showing GPS tracks. Both holes were cut flush to a fence post and the opening was frozen and could be walked on. The bottom of the fence appears to be flush with ground surface, however; they may be snowed/iced in. The dimensions of the holes are as follows:

| | Width | Height |
|---|---|---|
| Hole at WP #64 (photos titled: N. Fence Hole Photo (facing N) N. Fence Hole Photo #2 (facing N) | 2' 2" | 2' 10.5" |

- Repair the two known gaps in the fence and make other repairs, as necessary.
- Convert one of the gaps into a gate for foot access.
- Provide documentation of the repairs.

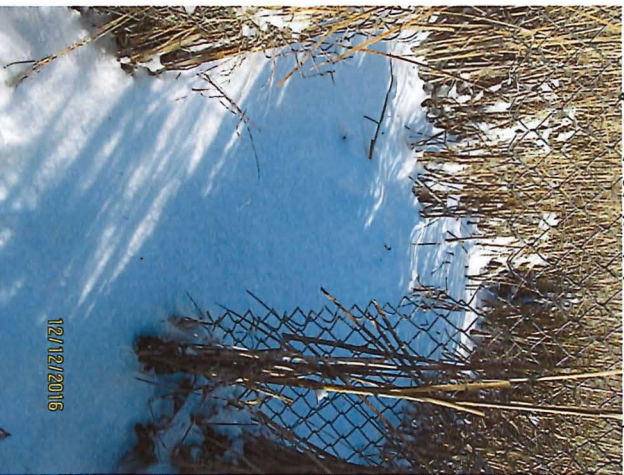
N. Angle Fence Hole (Facing NE)
(1:07pm)

| | Width | Height |
|---|---|---|
| Hole at WP #63 (photo titled: N.-Angle Fence hole (facing NE) N.-Angle Fence hole Photo 2(facing NE) | 2' 7" | 3' 3" |

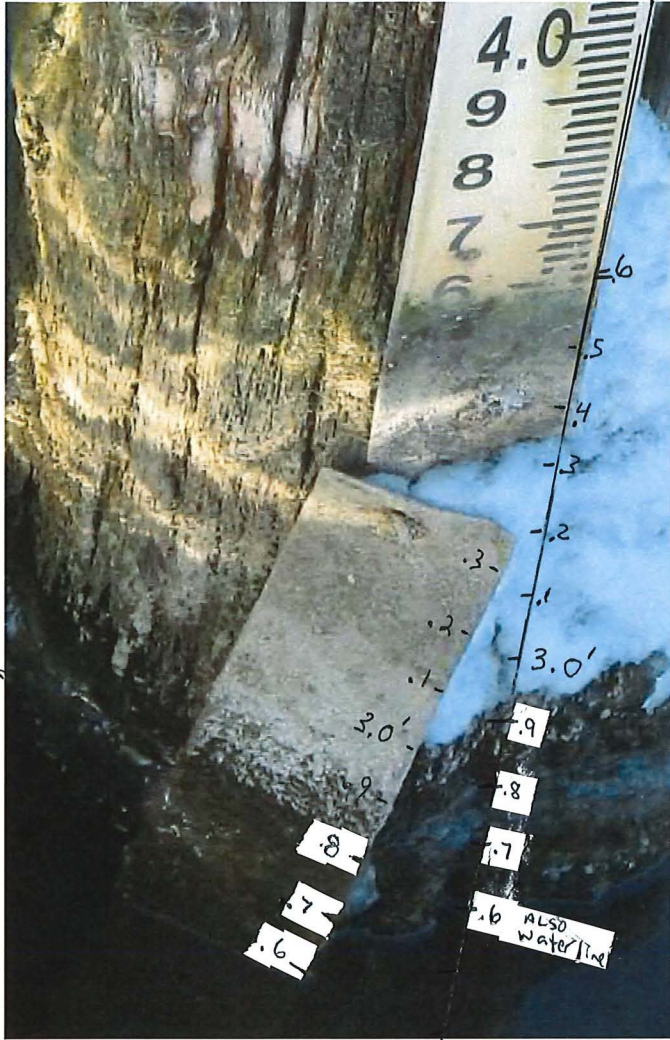
- The river was covered with ice along the edges of the river (open water in the center).
- Many of the PVC well markers could be observed from the bridge.
- Staff gage reading was estimated to be 2.6 ft (see attached photo of staff gage).
- The water was low enough to note that the gage is broken and the lower portion is unreadable. This may explain the absence of staff gage readings in past field notes and reports.

Faint white/grey line is water level

Estimated Reading: 2.6'

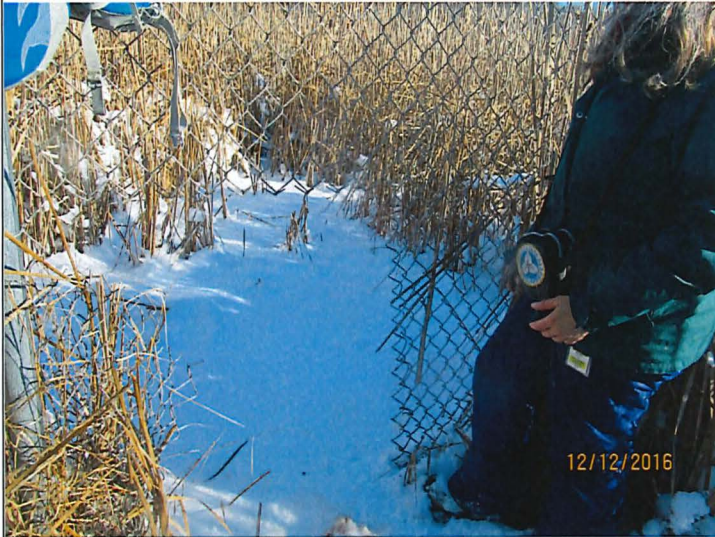
Title: One of the cut holes in the fence.

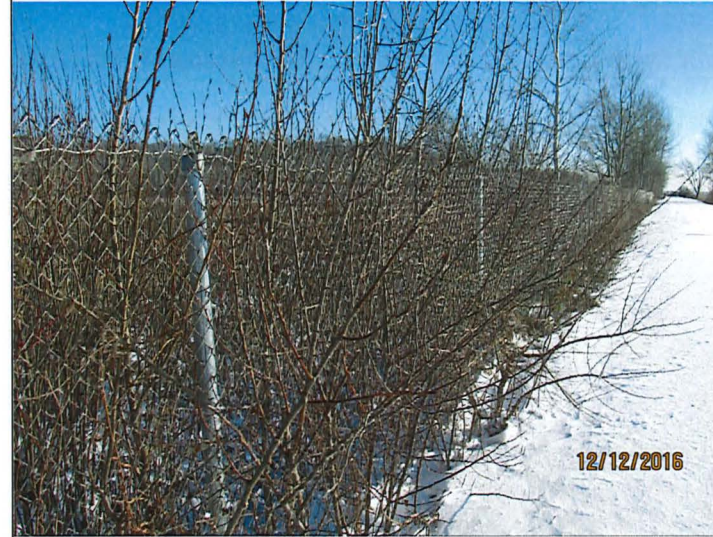
The fence poles have sunk several inches into the sediment at the mouth of the Southern Slough. The area adjacent to the southern fence is overgrown with bushes, young trees, and vines. The young trees and bushes have grown into the fence and vines cover other portions.

Title: Southern fence with small trees growing through fence.

- In the field, the edge of the cap is hard to differentiate from the adjacent vegetation and sediment. Any work on the cap will need GPS guidance.
- The holes in the fence will need repair and the entire fence should be cleared of vegetation (Task E of the attached Draft Cap Vegetative Cover Evaluation). The gates should be cleared of vegetation as well.
- The staff gage should be repaired unless it is determined this data is not needed.
- Mowing/cutting of paths through the marsh will aid navigation and future field work.
- The rail/trail is maintained as a snowmobile trail limiting access to the Marsh during the winter months to times when the snow cover is poor.
- Deer removal should be coordinated with the repair of the holes in the fence.
- The cap will require investigation and repair as described in Tasks A, B, and C in the attached Draft Cap Vegetative Cover Evaluation.

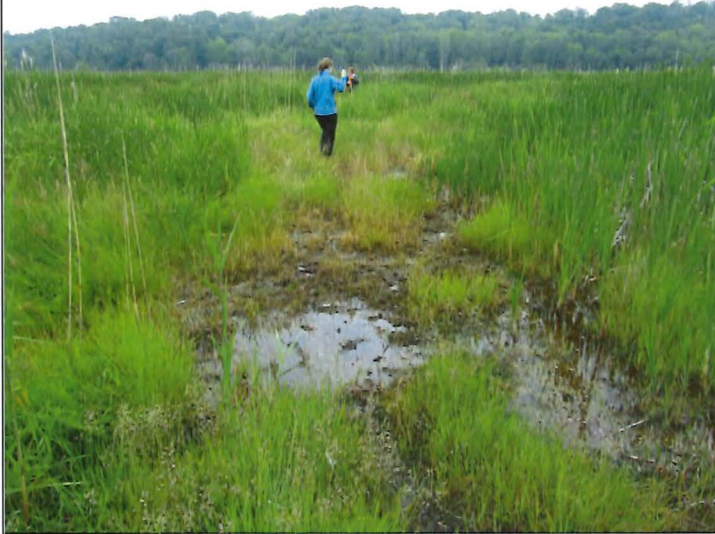
Title: 6/15/2016 (to E/NE): stressed vegetation eastern end of cap

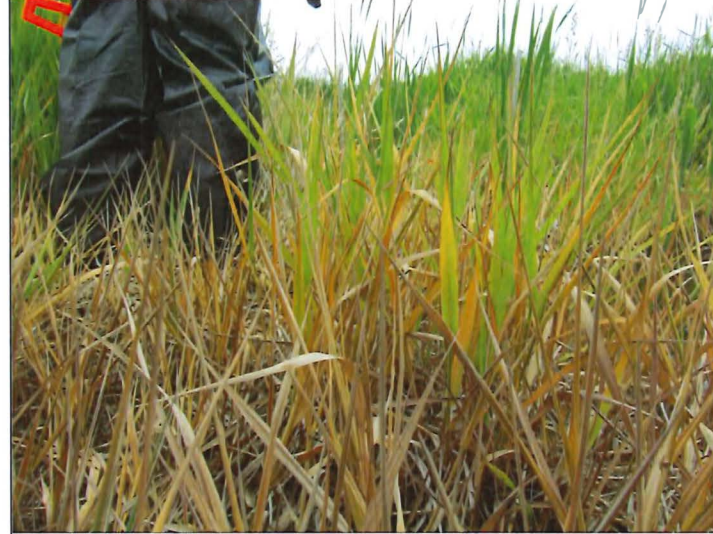
Title: 6/15/2016: closed up of stressed vegetation

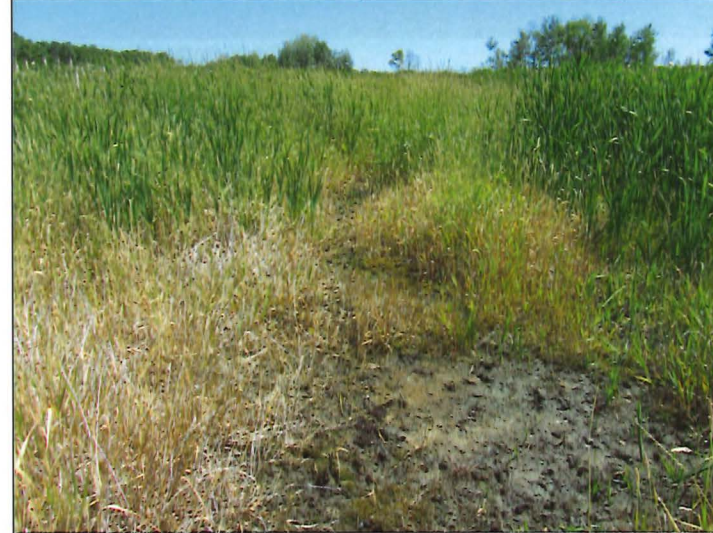
Title: 6/29/2016 to : stressed vegetation eastern end of cap

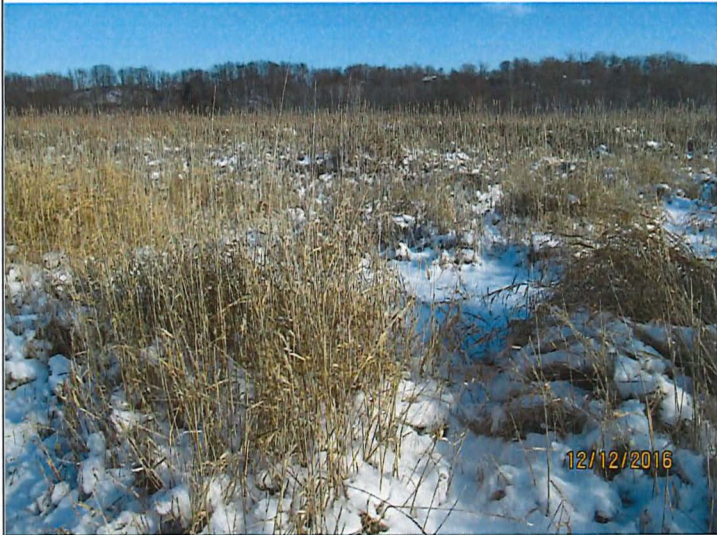
Title: 12/12/2016 (to E/NE) stressed vegetation eastern end of cap

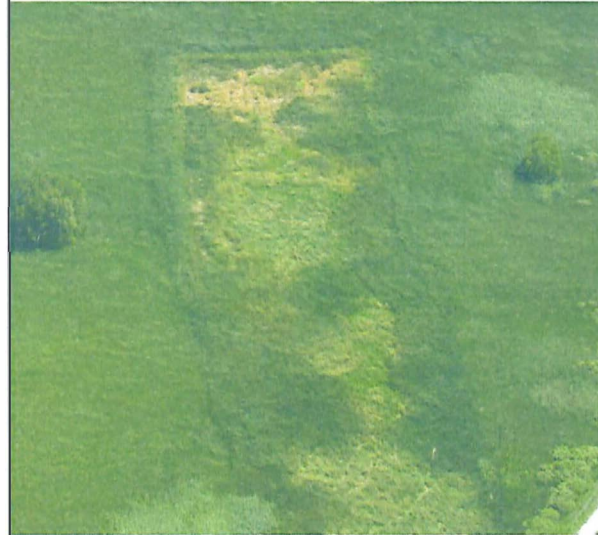
Conditions of Cap during summer 2016: Figure: "Aerial Photo taken by DNR on 7-13-2016" Cattails and (very minor) phragmites were observed encroaching onto cap. Original seeding was not evident (this was temporary). The remaining cap was reed canary grass. Toward the east side of the cap, standing water and distressed or dead reed canary grass was observed. Aerial photos of the capped area were taken and show the area of distressed vegetation. River water was between 580.7 and 581.04 so much of the eastern cap was submerged. Additional observations: Two holes in the fence surrounding the site were observed. Deer and other animal tracks were observed inside of the fence.

Title: 7/13/2016 Aerial Photograph of cap showing distressed vegetation

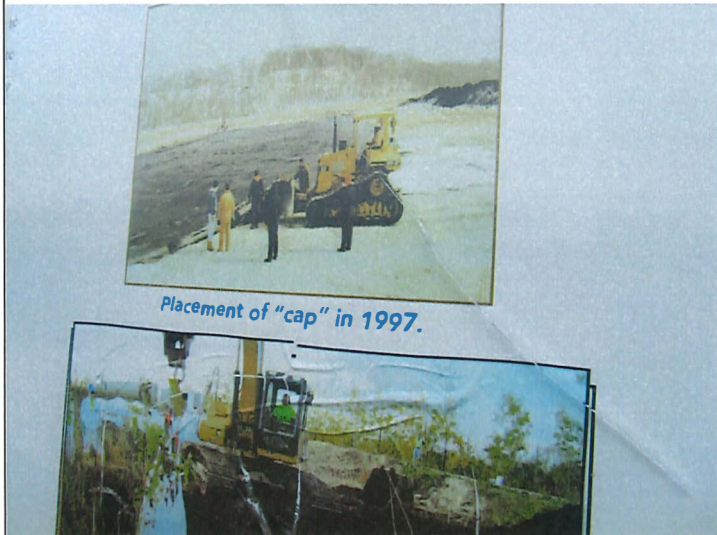
Title: 6/15/2016 Informational kiosk - cracks in Plexiglas
