December 7, 2022
File No. 25222269.00

Subject: Inspection of Vapor Mitigation System
Golden Flame Restaurant (Former WI DOT Susie's Restaurant - LGU-SL)
WDNR BRRTS No. 02-36-000516
2604 Custer St, Manitowoc, WI 54220

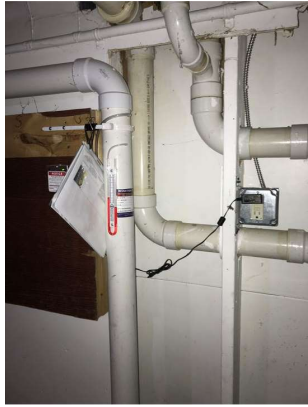
NOTES: (Record the reading on the gauge. Identify specific building and location description:) <input type="checkbox"/> Not Applicable Pickup Point No. 1 with liquid manometer and alarm. Manometer reads 1.0 inch water vacuum. Tested the alarm by temporarily shutting off the radon fan. Both the alarm light and the audible alert are working properly.

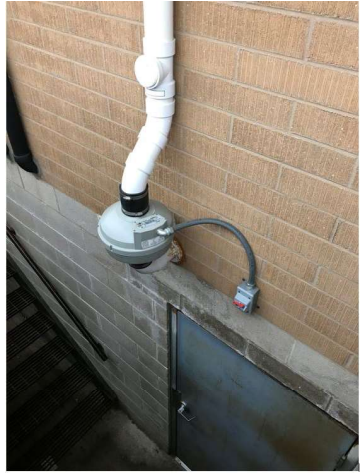
<p>NOTES: (Identify specific building and location description:)</p> <p><input type="checkbox"/> Not Applicable</p> <p>Fan is operating as intended. No damage or excessive motor noise observed.</p>
---	--

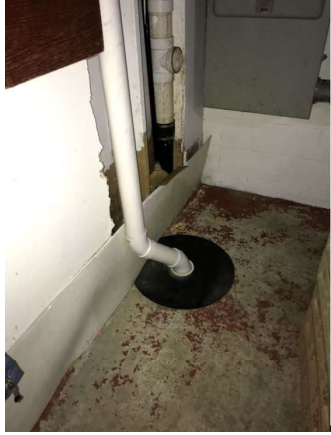
SYSTEM COMPONENT		Date of Inspection: 11/29/2022		
NAME	WHAT DOES IT DO?	WHAT DO I CHECK?	WHAT SHOULD I SEE?	WHAT TO FIX?
Suction Drop Point w/ Vent Pipe	<p>Suction Point : Soil gases are collected in a void space below the foundation, and tight seal prevents soil gas from getting inside the home.</p> <p>Vent Pipe: Pipe conveys the vacuum from the fan, and collects soil gases for discharge to the atmosphere.</p>	<p>Suction Point Seal</p> <p>Vent Pipe Condition</p>	<p>Seal is air tight around pipe penetration.</p> <p>Vent pipe is connected to fan, has not cracked.</p>	<p>Suction point seal or vent pipe may need to be sealed or replaced if cracks or leaks appear.</p> <p>If any piping or sealing of the system is altered or replaced, the system should be evaluated by a mitigation professional to verify effectiveness, which includes pressure readings.</p>
PHOTO		<p>NOTES: (Identify specific building and location description:)</p> <p><input type="checkbox"/> Not Applicable</p> <p>Pickup Point No. 1. Vent piping is secure and connected to the fan. No damage to piping observed. Used smoke pen to test pickup point floor seal and found no leakage.</p>

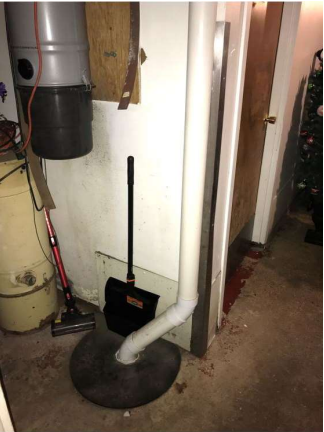
Pickup Point No. 2. Vent piping is secure and connected to the fan. No damage to piping observed. Used smoke pen to test pickup point floor seal and found no leakage.

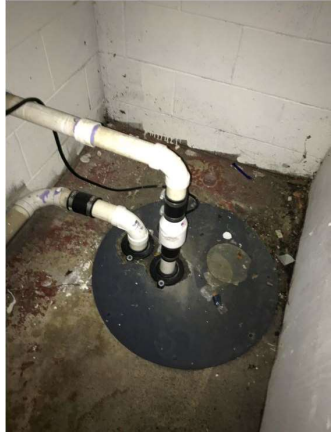
SYSTEM COMPONENT		Date of Inspection: 11/29/2022		
NAME	WHAT DOES IT DO?	WHAT DO I CHECK?	WHAT SHOULD I SEE?	WHAT TO FIX?
Sealed Sump w/Vent Pipe	<p>Sump Cover: Soil gases are collected in sump and the cover prevents soil gas from getting inside home.</p> <p>Vent Pipe: Pipe transports the soil gas from the sump for discharge to the atmosphere.</p>	Suction Point Seal	Seal is airtight to floor.	<p>Sump cover or vent pipe may need to be sealed or replaced if cracks or leaks appear.</p> <p>If any piping or sealing of the system is altered or replaced, the system should be evaluated by a plumber or a mitigation professional to verify effectiveness, which includes pressure readings.</p>
		Vent Pipe Seal Condition	Vent pipe is connected to the sump cover and is not cracked.	
PHOTO			<p>NOTES: (Identify specific building and location description:)</p> <p><input type="checkbox"/> Not Applicable</p> <p>Used smoke pen to test sump lid fittings and floor seal and found no leakage. No damage to piping observed. Sump pump did not appear to cycle while present, but restaurant owner indicated it was operating properly.</p>

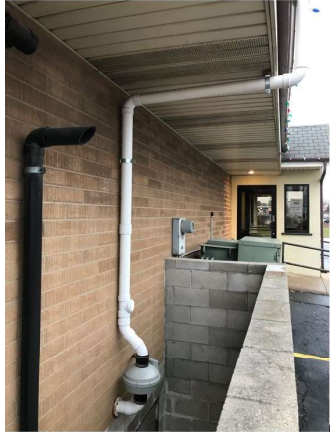
Vent pipe appears solid and connected to fan, no damage observed. Checked exhaust end for obstructions. No obstructions observed. The exhaust appears to be more than 15 feet from windows or air intakes.

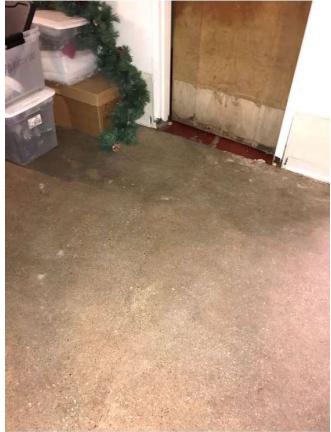
SYSTEM COMPONENT				Date of Inspection:	11/29/2022
NAME	WHAT DOES IT DO?	WHAT DO I CHECK?	WHAT SHOULD I SEE?	WHAT TO FIX?	
Foundation Floor	Foundation is a barrier that minimizes soil gas entry into building, and helps fan to work efficiently.	Foundation Condition	No penetrating cracks or holes in foundation.	Seal cracks or other penetrations as you would to prevent water from entering.	
		Foundation Footprint	Check if there have been alterations or additions to building or footprint.	If building floor plan has changed, notify DNR and contact a mitigation professional to evaluate if modifications to the vapor mitigation system are necessary.	
PHOTO			NOTES: (Identify specific building and location description:) <input type="checkbox"/> Not Applicable Some minor cracks observed in floor at southwest corner of basement near bathroom. The cracks are less than approximately 1/8" diameter and are east-west trending for several feet. No leakage observed. The cracks appear to be old and were likely present when the vapor mitigation system was installed. There do not appear to be any alterations to the building that would influence the vapor mitigation system.

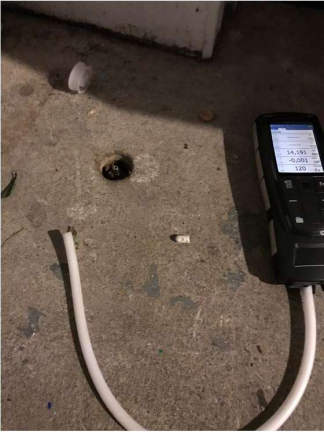
SYSTEM COMPONENT				Date of Inspection:	11/29/2022
NAME	WHAT DOES IT DO?	WHAT DO I CHECK?	WHAT SHOULD I SEE?	WHAT TO FIX?	
Sub Slab Vapor Port	This is a sample port to measure vacuum or take sample of soil gas if needed. It needs to remain sealed when not in use to prevent soil gas entry into the home.	Port Seal/Cap	If able to measure the vacuum with a micromanometer, the pressure differential should be at least 0.004 inches of H ₂ O or at least one Pascal.	Repair or replace the seal and cover as needed.	
		Port Condition	Port is sealed and capped when not in use.	Permanently seal hole if sample port is ever removed.	
PHOTO			<p>NOTES: (If taken, record the pressure differential reading. Identify specific building and location description:)</p> <p><input type="checkbox"/> Not Applicable</p> <p>Sub-slab Vacuum Observation Point 1 was missing plastic cover, but port cap was still in place. Installed new cover and measured vacuum using digital manometer at 0.278 inches water. No damage to port observed.</p>

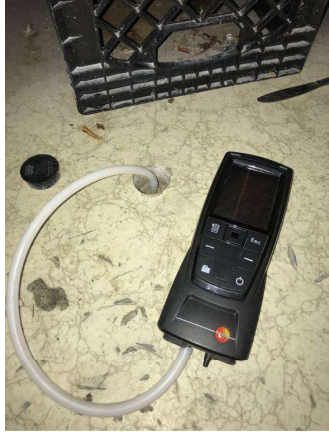
<p>Sub-slab Vacuum Observation Point 2 vacuum measured using digital manometer at 0.279 inches water. No missing components or damage to point observed.</p>

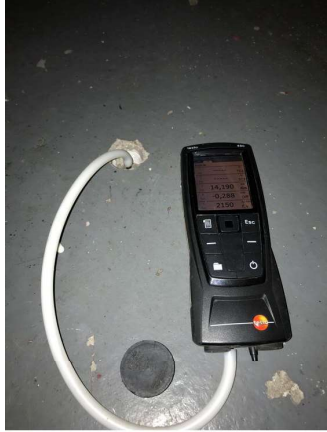
<p>Sub-slab Vacuum Observation Point 3 vacuum measured using digital manometer at 0.281 inches water. No missing components or damage to point observed.</p>
