January 18, 2023
File No. 25222269.00

Subject: Inspection of Vapor Mitigation System
Golden Flame Restaurant (Former WI DOT Susie's Restaurant – LGU-SL)
WDNR BRRTS No. 02-36-000516
2604 Custer St, Manitowoc, WI 54220

VMS Inspection Log, Form 4400-321

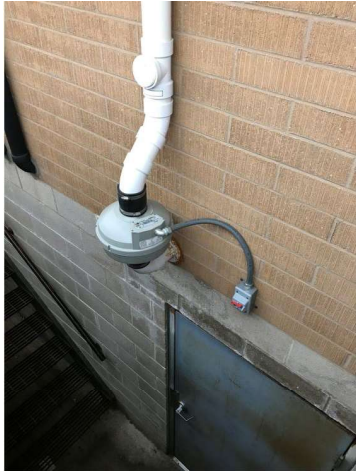
Fan is operating as intended. No damage or excessive motor noise observed.

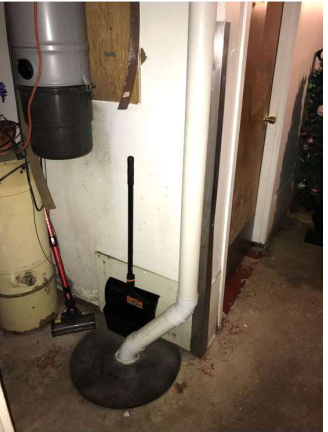
Pickup Point No. 2. Vent piping is secure and connected to the fan. No damage to piping observed. Used smoke pen to test pickup point floor seal and found no leakage.
