Second Five-Year Review Report
for
Penta Wood Products Superfund Site

Town of Daniels
Burnett County, Wisconsin

January 2010

United States Environmental Protection Agency
Region 5
Chicago, Illinois

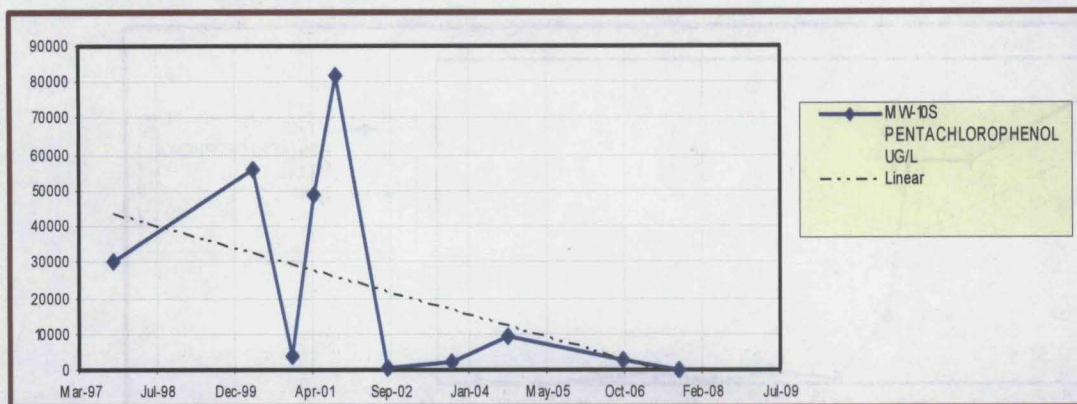
FIGURE 1
MW-10S PCP Concentration

Monitoring well MW-10S has shown wide fluctuations in PCP during groundwater collection periods, as shown in Figure 5. Since 2002, the presence of LNAPL (sheen or measurable product) has been inconsistent at MW-10S. The intermittent presence of LNAPL and change in sampling methods results in a wide range of PCP concentrations with concentrations significantly decreased since the use of a dedicated sampling pump. LNAPL was measured in MW-10S in May 2008 at a thickness of 0.40 feet and a thickness of 0.14 feet in October 2008. The presence of free product is likely the result of extraction well EW-03 pulling product towards it while actively pumping. Overall, PCP has declined from 56.100 µg/L prior to the start of groundwater extraction in 2004, to less than the detection limit in 2005 (less than 0.11 µg/L). In September 2007, it was detected at 24 µg/L in MW-10S. The well went dry during sampling in October 2008 and was unable to be sampled for PCP.

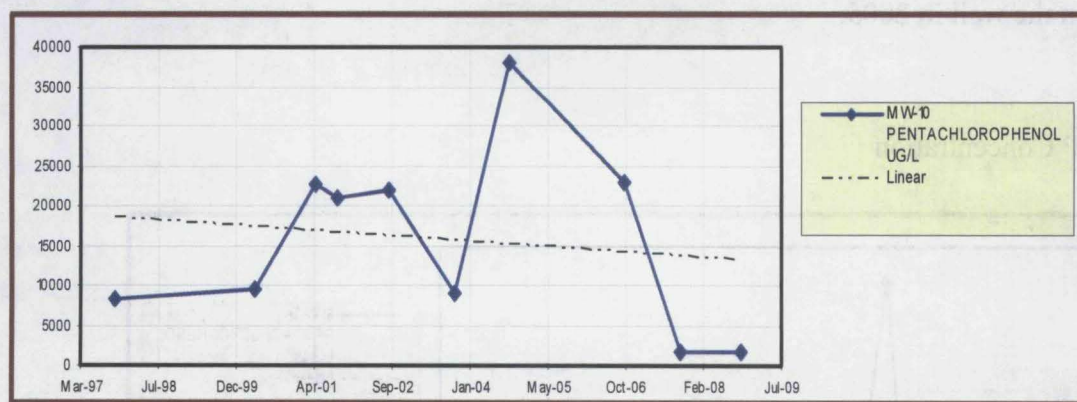
FIGURE 2
MW-10 PCP Concentration

PCP in monitoring well MW-10 increased from 9,530 $\mu\text{g/L}$ shortly before the startup of the treatment system, to 22,000 $\mu\text{g/L}$ in August 2002 (see Figure 2). Concentrations in the well did not drop immediately, but by September 2003, concentrations had fallen to 9,000 $\mu\text{g/L}$. In September 2004, PCP concentrations at MW-10 increased to 38,000 $\mu\text{g/L}$. This is likely a result of the extraction system restart in February 2004. MW-10 is located very close to extraction well EW-03, which pulls product toward it while actively pumping. In September 2006, a concentration of 23,000 $\mu\text{g/L}$ was reported, but by October 2008, PCP concentrations at MW-10 decreased to 1,630 $\mu\text{g/L}$ and were consistent with concentrations observed in 2007.

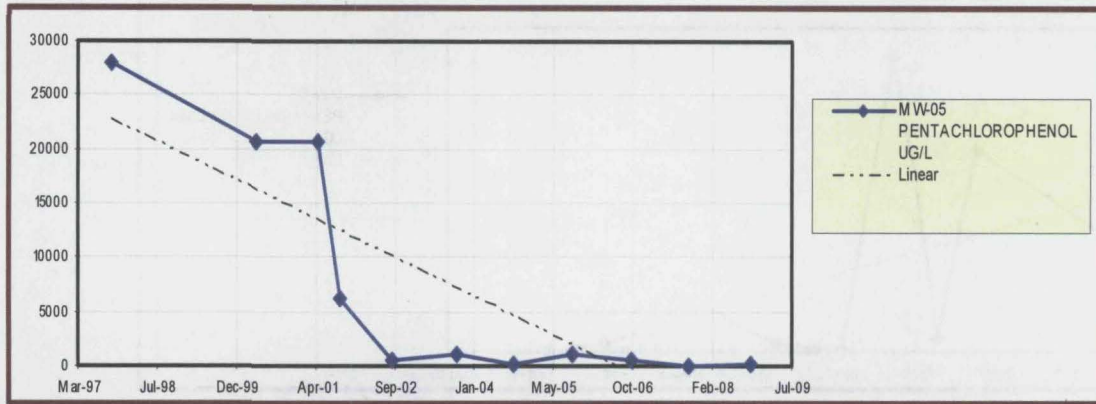
FIGURE 3
MW-05 PCP Concentration

PCP in monitoring well MW-05 has dropped sharply from 20,600 $\mu\text{g/L}$, prior to the start of operation of the groundwater treatment system, to 206 $\mu\text{g/L}$ in the most recent sample in October 2008 (see Figure 3). PCP concentrations remain low in this area because nearby uncontaminated

groundwater is being drawn radially toward EW-02 and EW-05 since their activation in February 2004, thereby purging the aquifer of PCP. Free product has never been observed in this well.

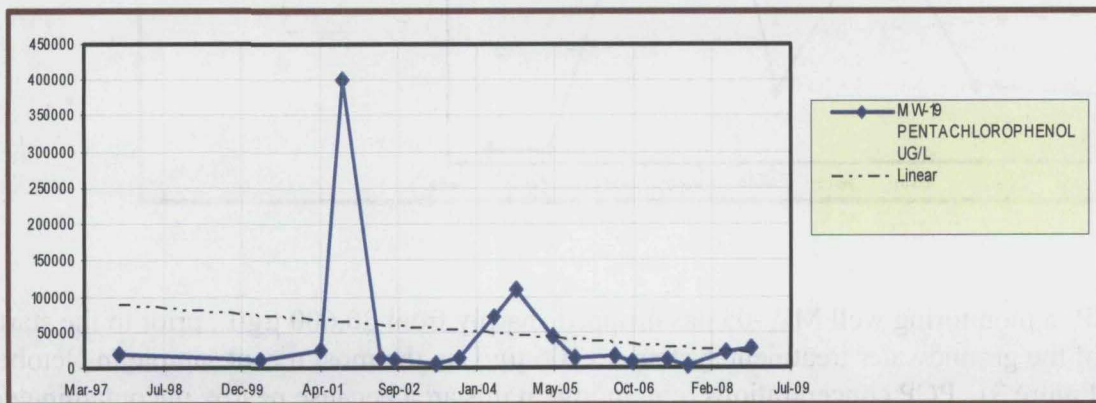
FIGURE 4
MW-19 PCP Concentration

LNAPL has been present in MW-19 since monitoring began, and any entrainment of LNAPL droplets in the sample will have notable effects on PCP concentrations, impacting the evaluation of PCP trends. The LNAPL has resulted in large variations in PCP concentrations (see Figure 4) that are not believed to be indicative of the dissolved phase groundwater concentrations. LNAPL continues to be observed in MW-19 (0.90 feet in May 2008 and product detected but thickness not measured due to an obstruction in the well in October 2008). The PCP concentrations were measured at 23,000 $\mu\text{g/L}$ in May 2008 and 27,900 $\mu\text{g/L}$ in October 2008, which is slightly higher than the PCP concentration reported in 2006 and 2007. Although variability of PCP concentrations in samples collected from wells with LNAPL is expected, the variability of PCP concentrations in this well appears to have decreased since the installation of dedicated sampling equipment in the well in 2005.

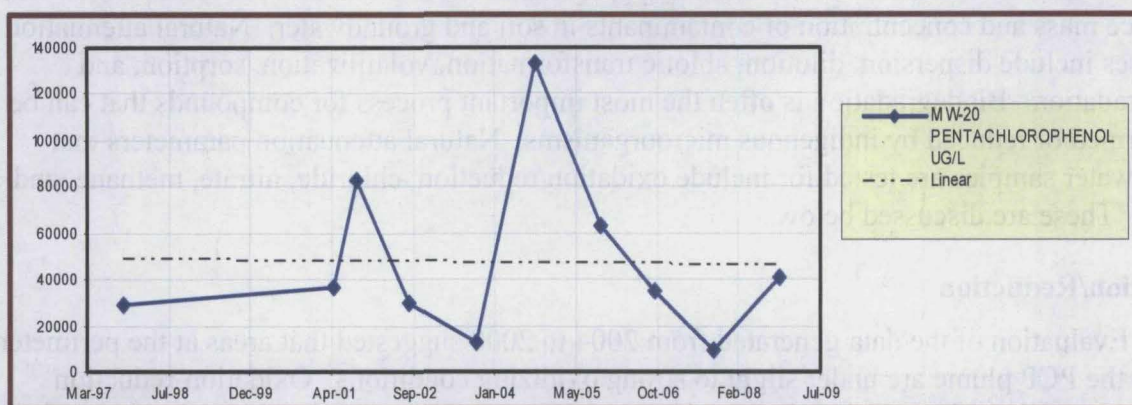
FIGURE 5
MW-20 PCP Concentration

LNAPL has also been present in MW-20 since monitoring began, with the exception of May 2006, when the well was dry. As with MW-19, the LNAPL has resulted in large variations in PCP (see Figure 5) that are not believed to be indicative of dissolved phase groundwater concentrations. After eliminating bailer sampling methods with the use of dedicated Grundfos Redi-Flo 2 MP1 pumps starting in 2005, the entrapment of LNAPL in groundwater samples from this well should be minimized. LNAPL was detected in MW-20 in May 2008 at a thickness of 1.71 feet. The LNAPL thickness was not calculated in October 2008 due to an obstruction in the well. PCP concentrations have declined since the installation and use of the dedicated sampling pumps, and in October 2008, PCP at MW-20 was detected at 41,000 $\mu\text{g/L}$.

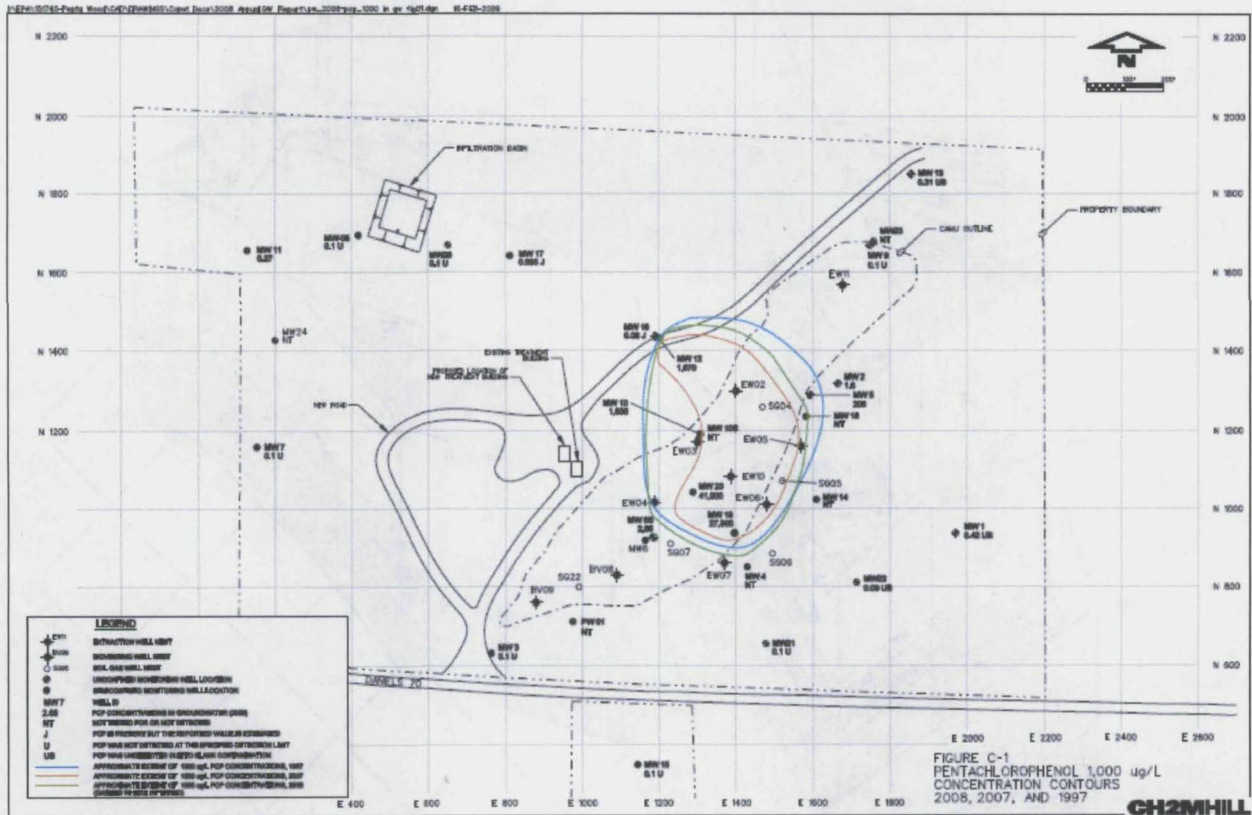
Figure 10 – PCP 1000 µg/L Concentration Contours

To observe PCP trends over time, PCP concentration contours that exceed 1,000 µg/L are presented in Figure 10. PCP concentration contours that exceed the PAL of 1 µg/L are presented in Figure 11. The 1997 contour represents baseline conditions prior to the operation of the groundwater extraction and treatment system.

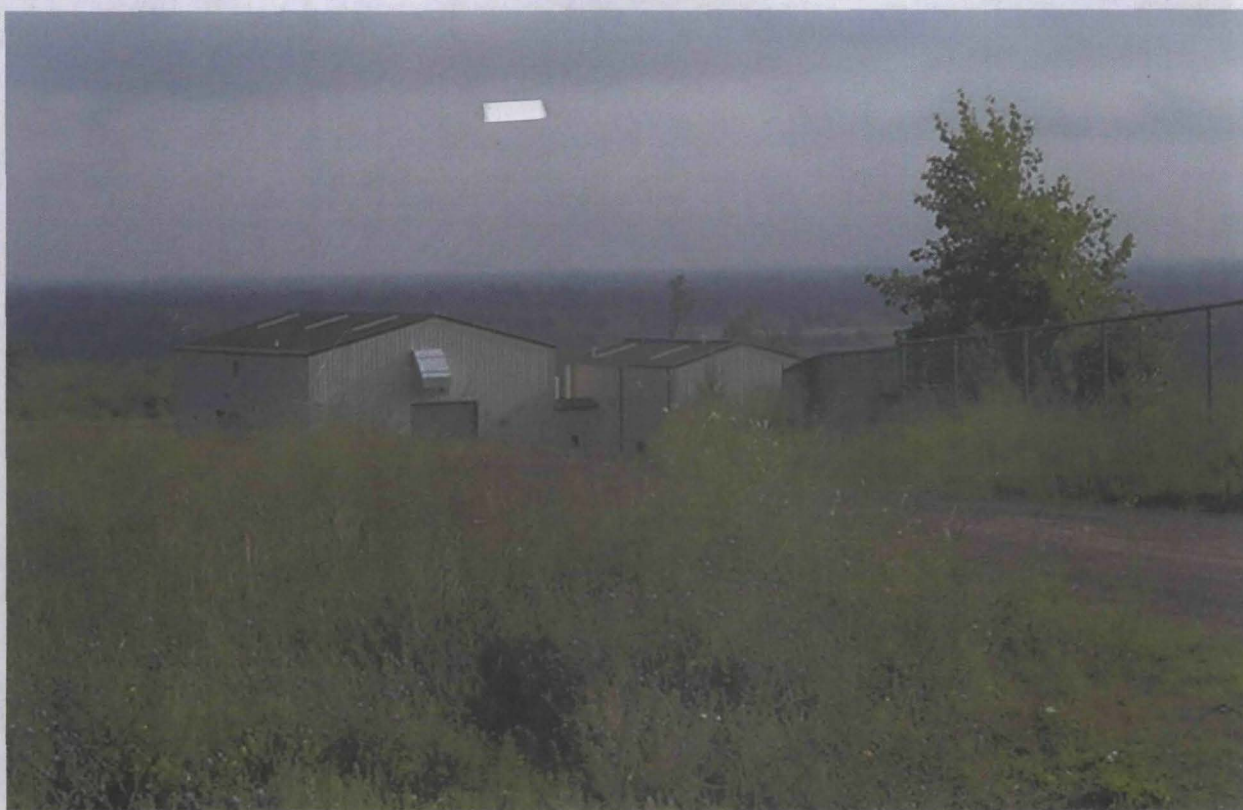
NONE. THE TREATMENT PLANT DOES SIT ON A HIGH ELEVATION RELATIVE TO THE REST OF THE SITE + WAS HIT BY LIGHTNING WHICH CAUSED SIGNIFICANT DAMAGE TO THE ELECTRICAL COMPONENTS OF THE PLANT. THE PLANT WAS SUBSEQUENTLY UPGRADED TO MINIMIZE ANY FUTURE DAMAGE TO THE PLANT

Penta Wood Treatment Plant Looking NE

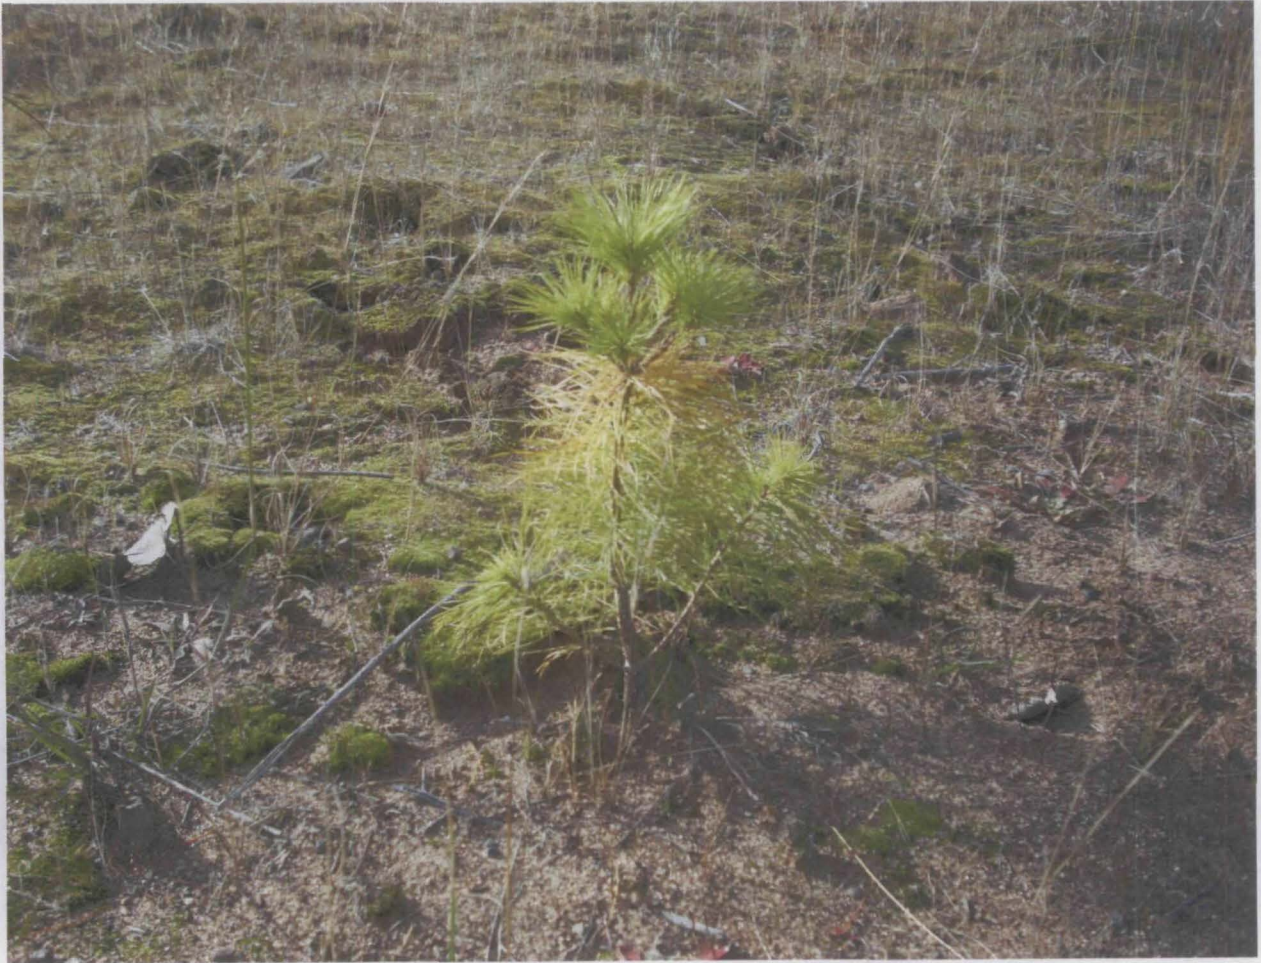
To address the recommendation for promoting revegetation and maintaining erosion control measures on site, 1,000 red and white pine trees were planted in an 18 acre area where grass had not grown in the spring of 2009. Seventy-five percent of the saplings were thriving as of October 2009. Grass never took hold because the soil is largely comprised of sand.

Pine Tree Planted Spring 2009

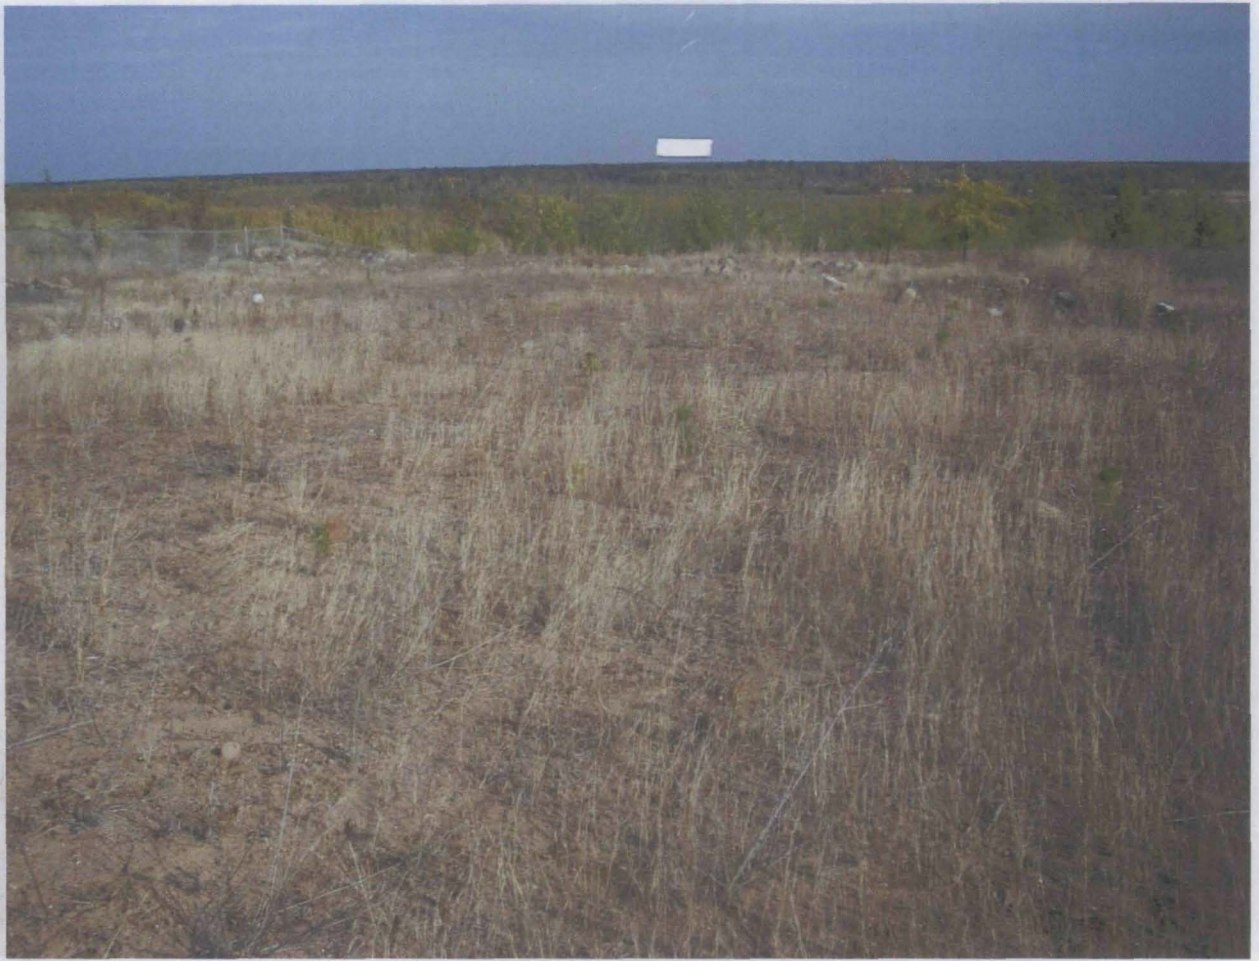
Group of Pine Trees Planted, Spring 2009 With CAMU in the Top Left on the Other Side of the Fence
