RCRA PRELIMINARY ASSESSMENT
NARRATIVE SUMMARY

SITE NAME: Freeman Chemical Company

EPA ID. NO.: WID 980615439

LOCATION: Railroad Street
Saukville, Ozaukee County, Wisconsin

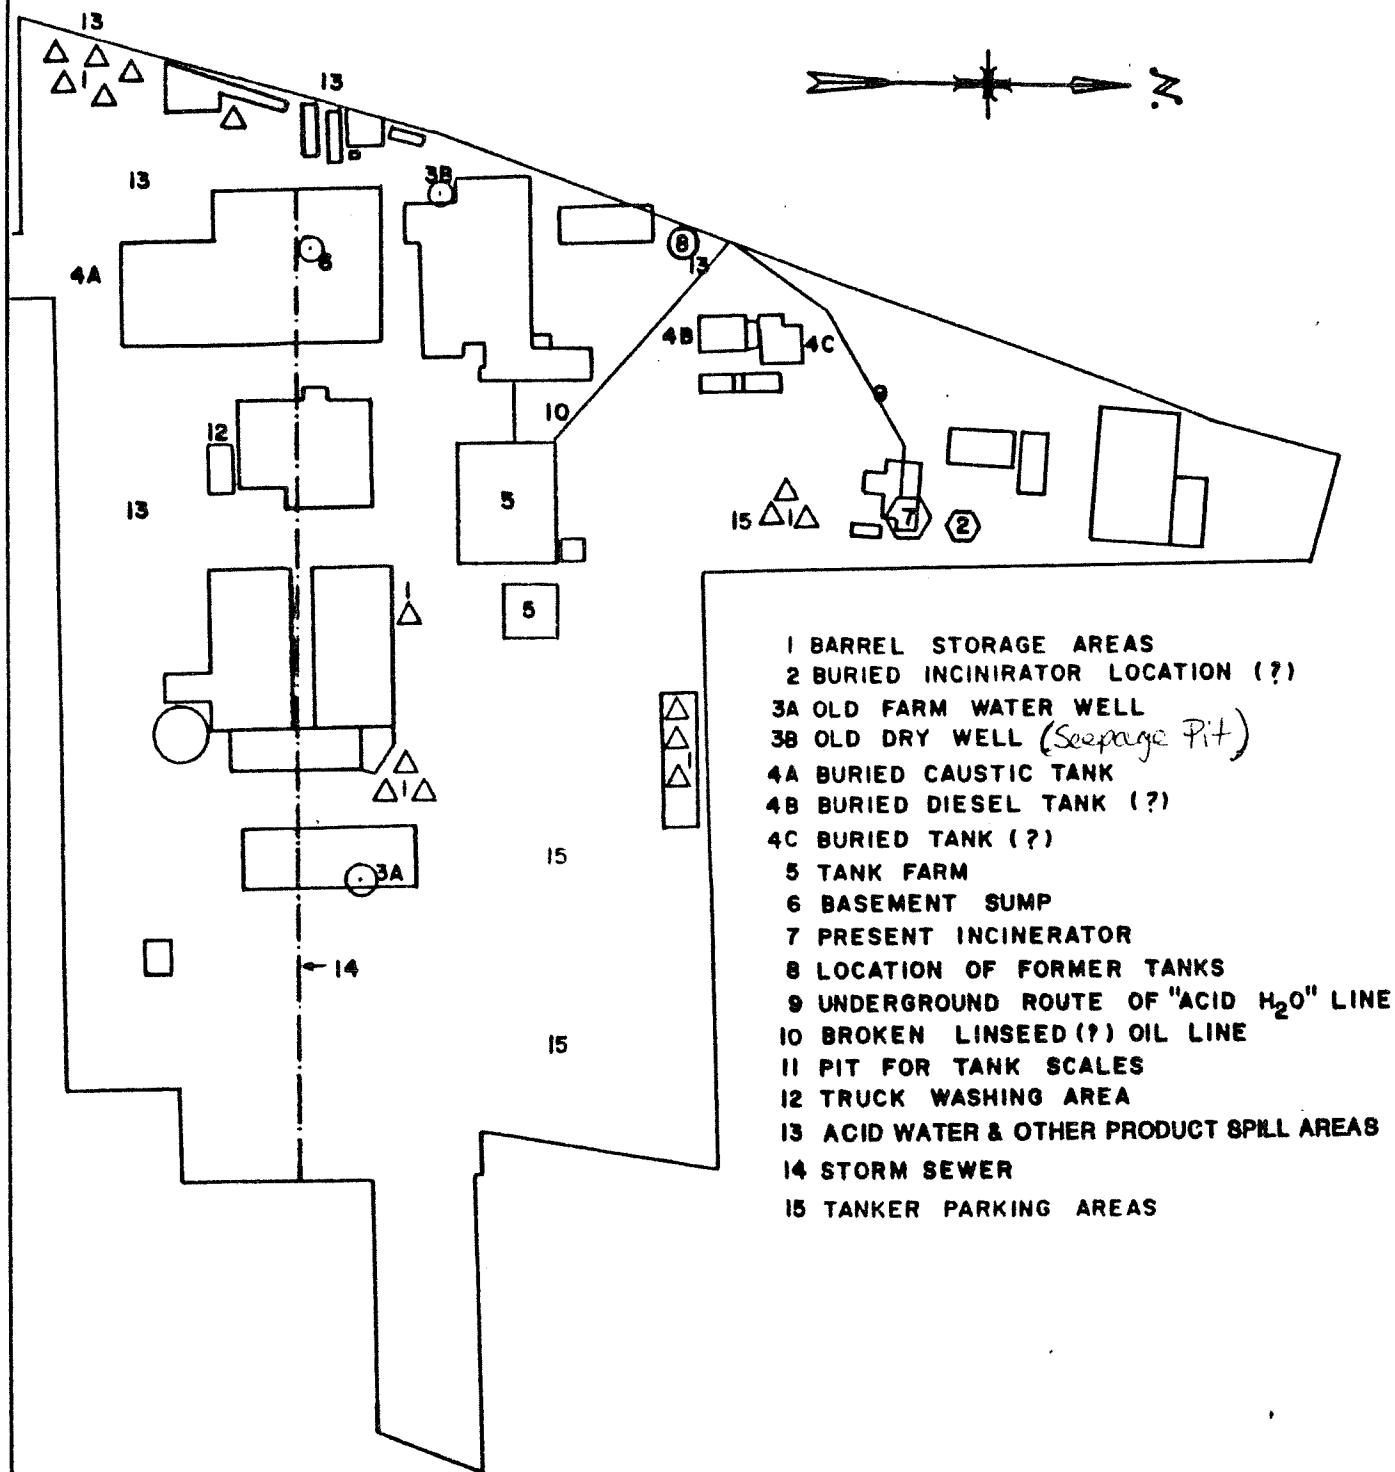
prior to incineration. The tanks are above ground and are located inside a building. Three underground tanks have been used for storage of gasoline, diesel fuel, and caustics (see attached^{ment} 2 for location of tanks). The

Seepage Pit: From 1948 to 1952, waste reaction water was charged directly to the Milwaukee River. Beginning in 1952, and continuing until 1965, reaction water was discharged to a seepage pit located on the west end of the facility (see attachment 2). The exact location of this pit has not been determined and the site is presently covered by asphalt. The pit may have extended down to the top of the dolomite, which is about 15 feet ^{below the surface} thick in this area.

KNOWN OR SUSPECTED RELEASES: ^P Accidental spillage of waste streams, resins, and raw materials have occurred at Freeman Chemical throughout the life of the facility. Attachment 2 shows the facility layout and the potential sources of groundwater contamination.

The seepage pit that operated from 1952-65 is a source of known releases of reaction water. This pit may have provided a direct conduit for hazardous constituents to reach the dolomite. Other known releases include spills of reaction water at the incinerator site, at least one underground pipeline leak, ^{and} product and raw materials ^{spills} at the railroad siding. It is suspected that releases have occurred in numerous barrel storage areas and at the tank sites. The Interim Remedial Investigation Report by Hatcher Incorporated notes that at least one of the buildings has a sump that is constructed at or close to the top of the dolomite, which could provide a pathway for contamination. In addition, at least two tanker spills have occurred at the tanker parking areas. These spills resulted in overland flow of Freeman property and onto a school yard to the north. Freeman responded by removing sod and excavating soil.

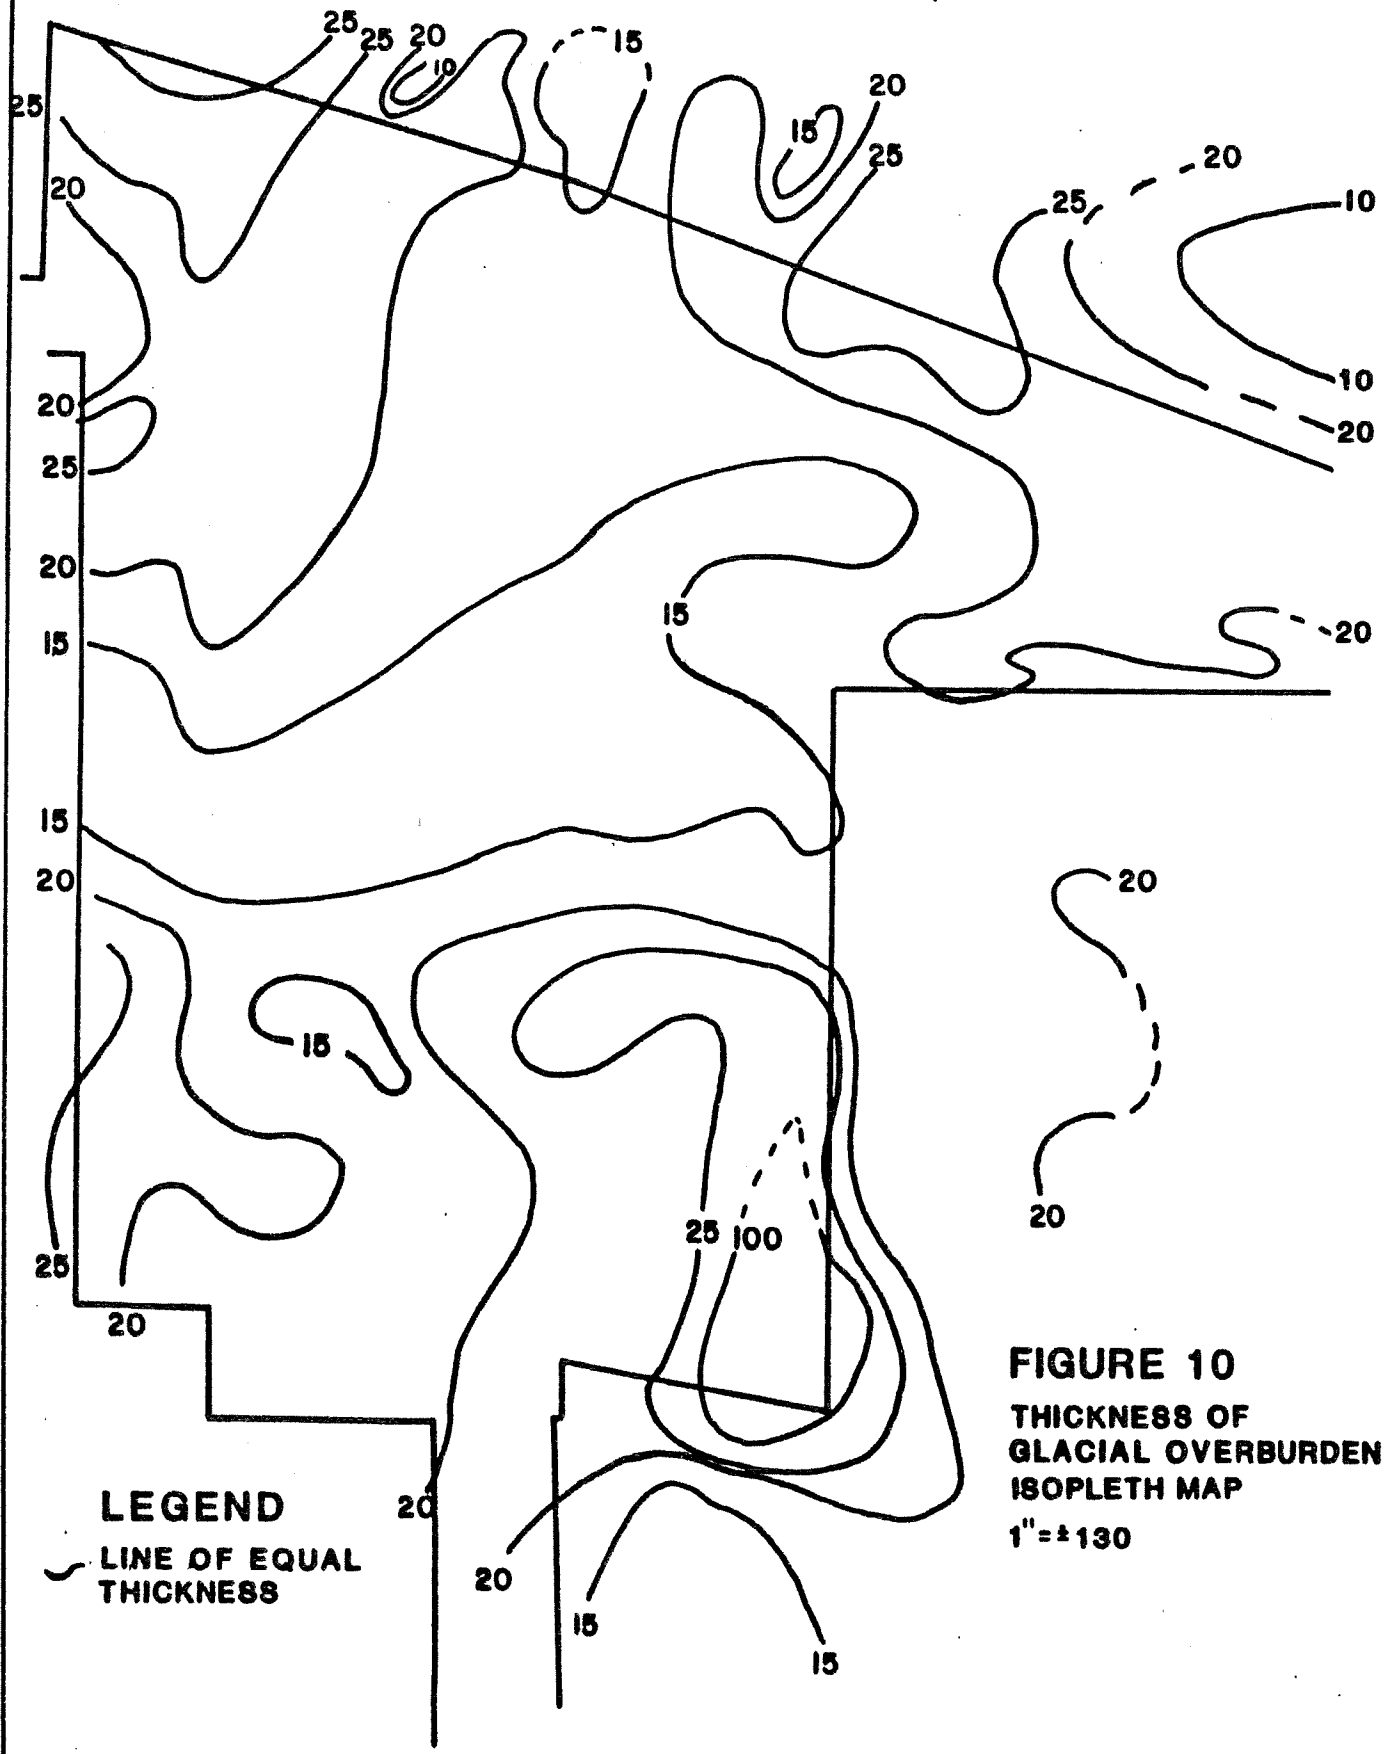
Attachment 3

POLLUTANT DISPERSAL: The primary pollutant dispersal pathway is via movement of water in the subsurface through the unsaturated zone and below the water table. Detailed information on hydrogeology ^{is} presented in the February 1986 Hatcher report. Bedrock at the site consists of the Niagara dolomite, which also serves as a local aquifer. Surficial glacial deposits covering the dolomite average about 15 feet thick (see attachment 3) and consists of soil or ~~fill~~, silty sand, dense clay, and glacial till.

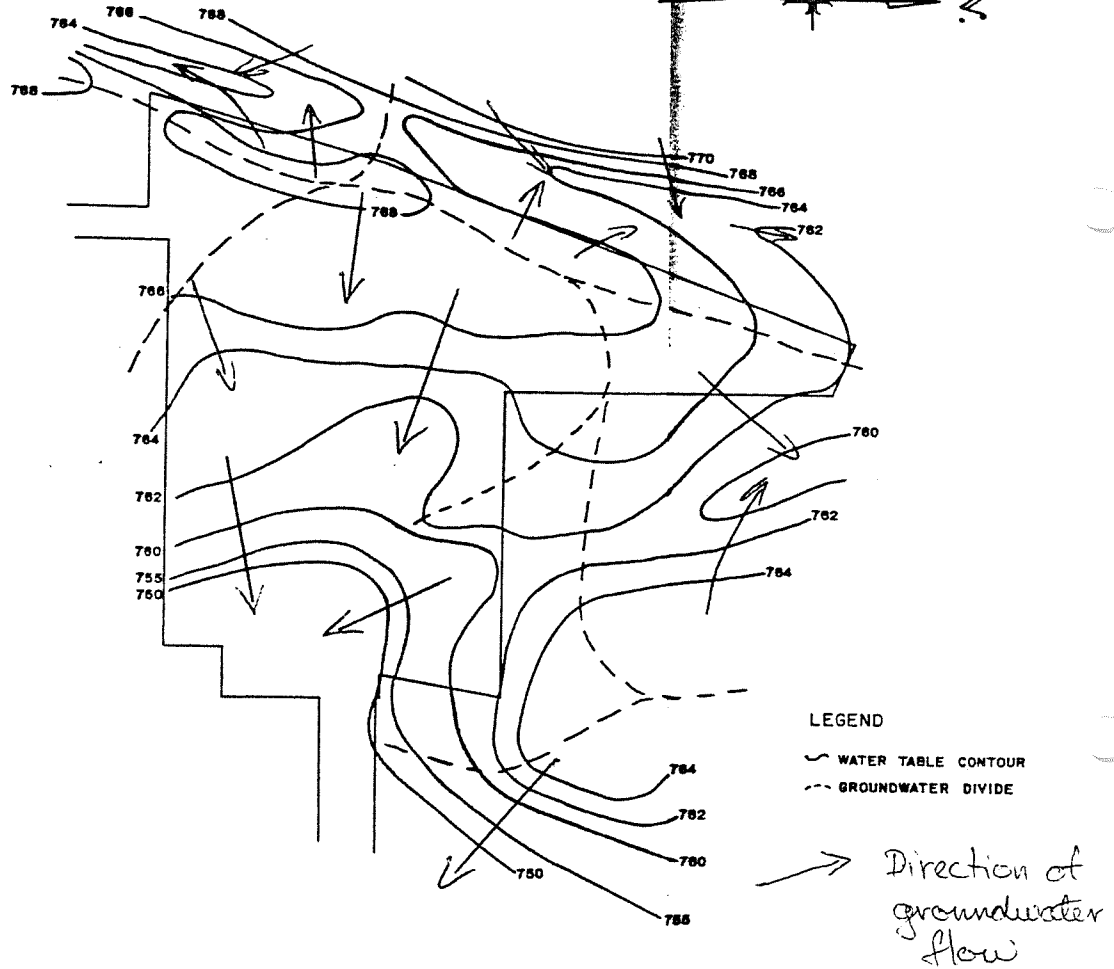
Attachment 4 shows a water table map for summer 1985. Groundwater flow was

generally to the south ^{toward the Milwaukee River}. However, along the west property boundary ^x groundwater flow was westward. Attachment 5 is a map showing groundwater head values within the dolomite aquifer. A local groundwater high is present ~~at~~ ^{below} the facility ^{in the dolomite, with} causing radial groundwater flow away from ^{the high} this facility. Attachment 6 shows a difference in head between the water table and the dolomite aquifer. The difference is smallest in the area of the groundwater mound. However, at all locations the head in the dolomite is less than in the glacial deposits, indicated that downward movement of groundwater is occurring and that the area serves as a recharge zone.

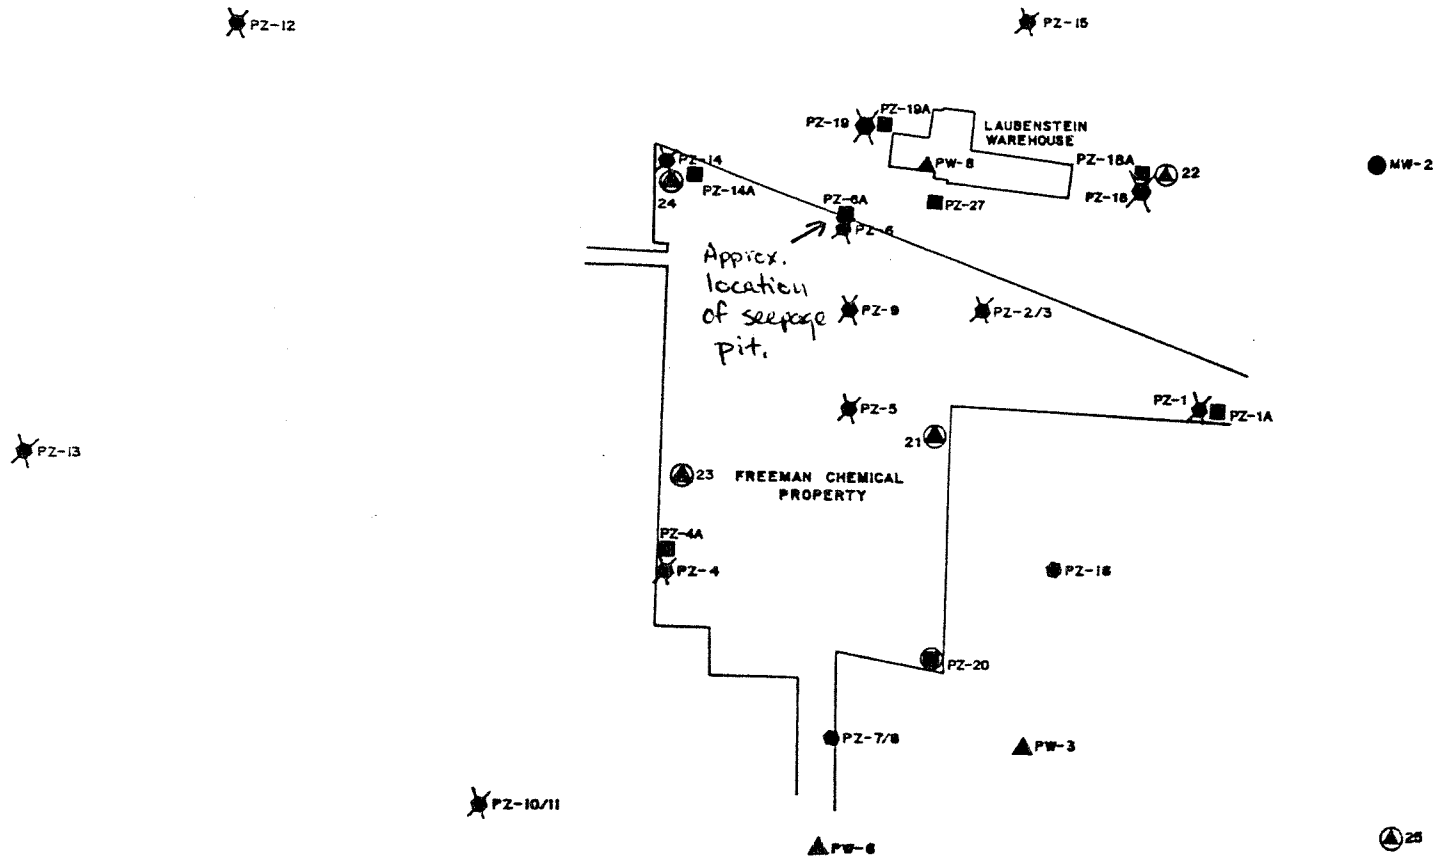
Groundwater contamination has been well documented at the Freeman Chemical site. Attachment 7 shows the location of monitoring wells at the facility.

Contamination is present in all the upper dolomite piezometers, except Well 22. the highest level of contamination is found in Well 21, which showed high levels of benzene, toluene, and ethyl benzene, and private Well 8, which has a very high level of trichloroethylene (2000 ug/l) and lesser amounts of other volatile organics.

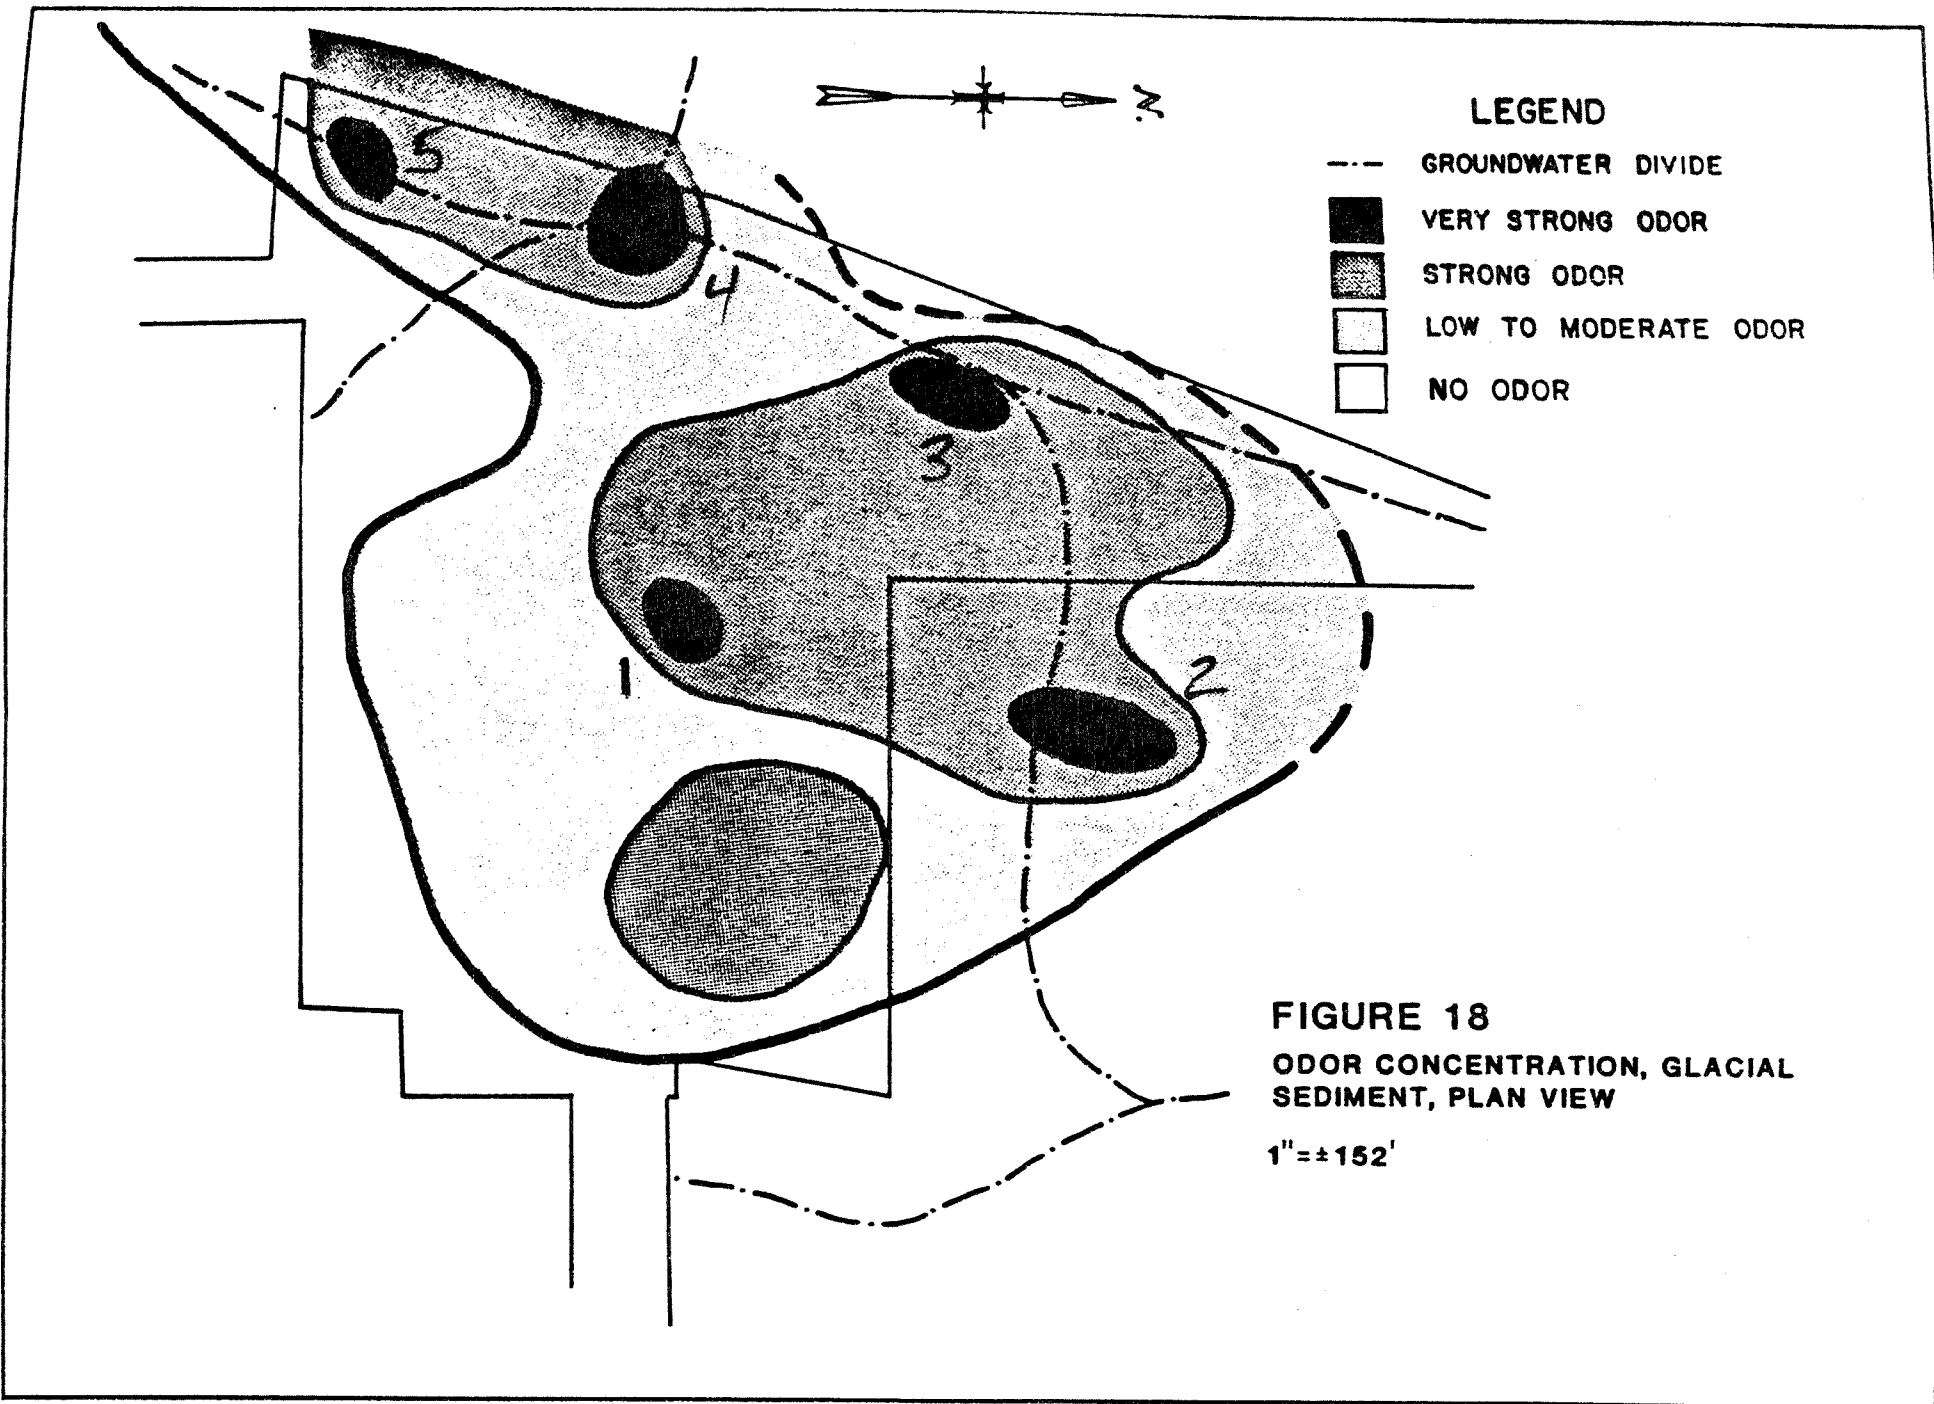
FIGURE 18
ODOR CONCENTRATION, GLACIAL
SEDIMENT, PLAN VIEW

An odor survey of the glacial deposits performed during augering and coring yielded the results displayed in Attachment 8. The five areas of strongest odor are located near the (1) tank farm; (2) off site in school yard area ^(associated with tanker spills); (3) near several buried tanks; (4) at the site of the seepage pit; (5) and in the extreme southwest corner of the property, near the train tracks and ~~in~~ ^a container storage area.
