TS-AMD-86710-34
June 1986

AERIAL PHOTOGRAPHIC ANALYSIS OF TWO
HAZARDOUS WASTE DISPOSAL AREAS

Saukville and Stoughton, Wisconsin

*Freeman Chemical
Corp.*

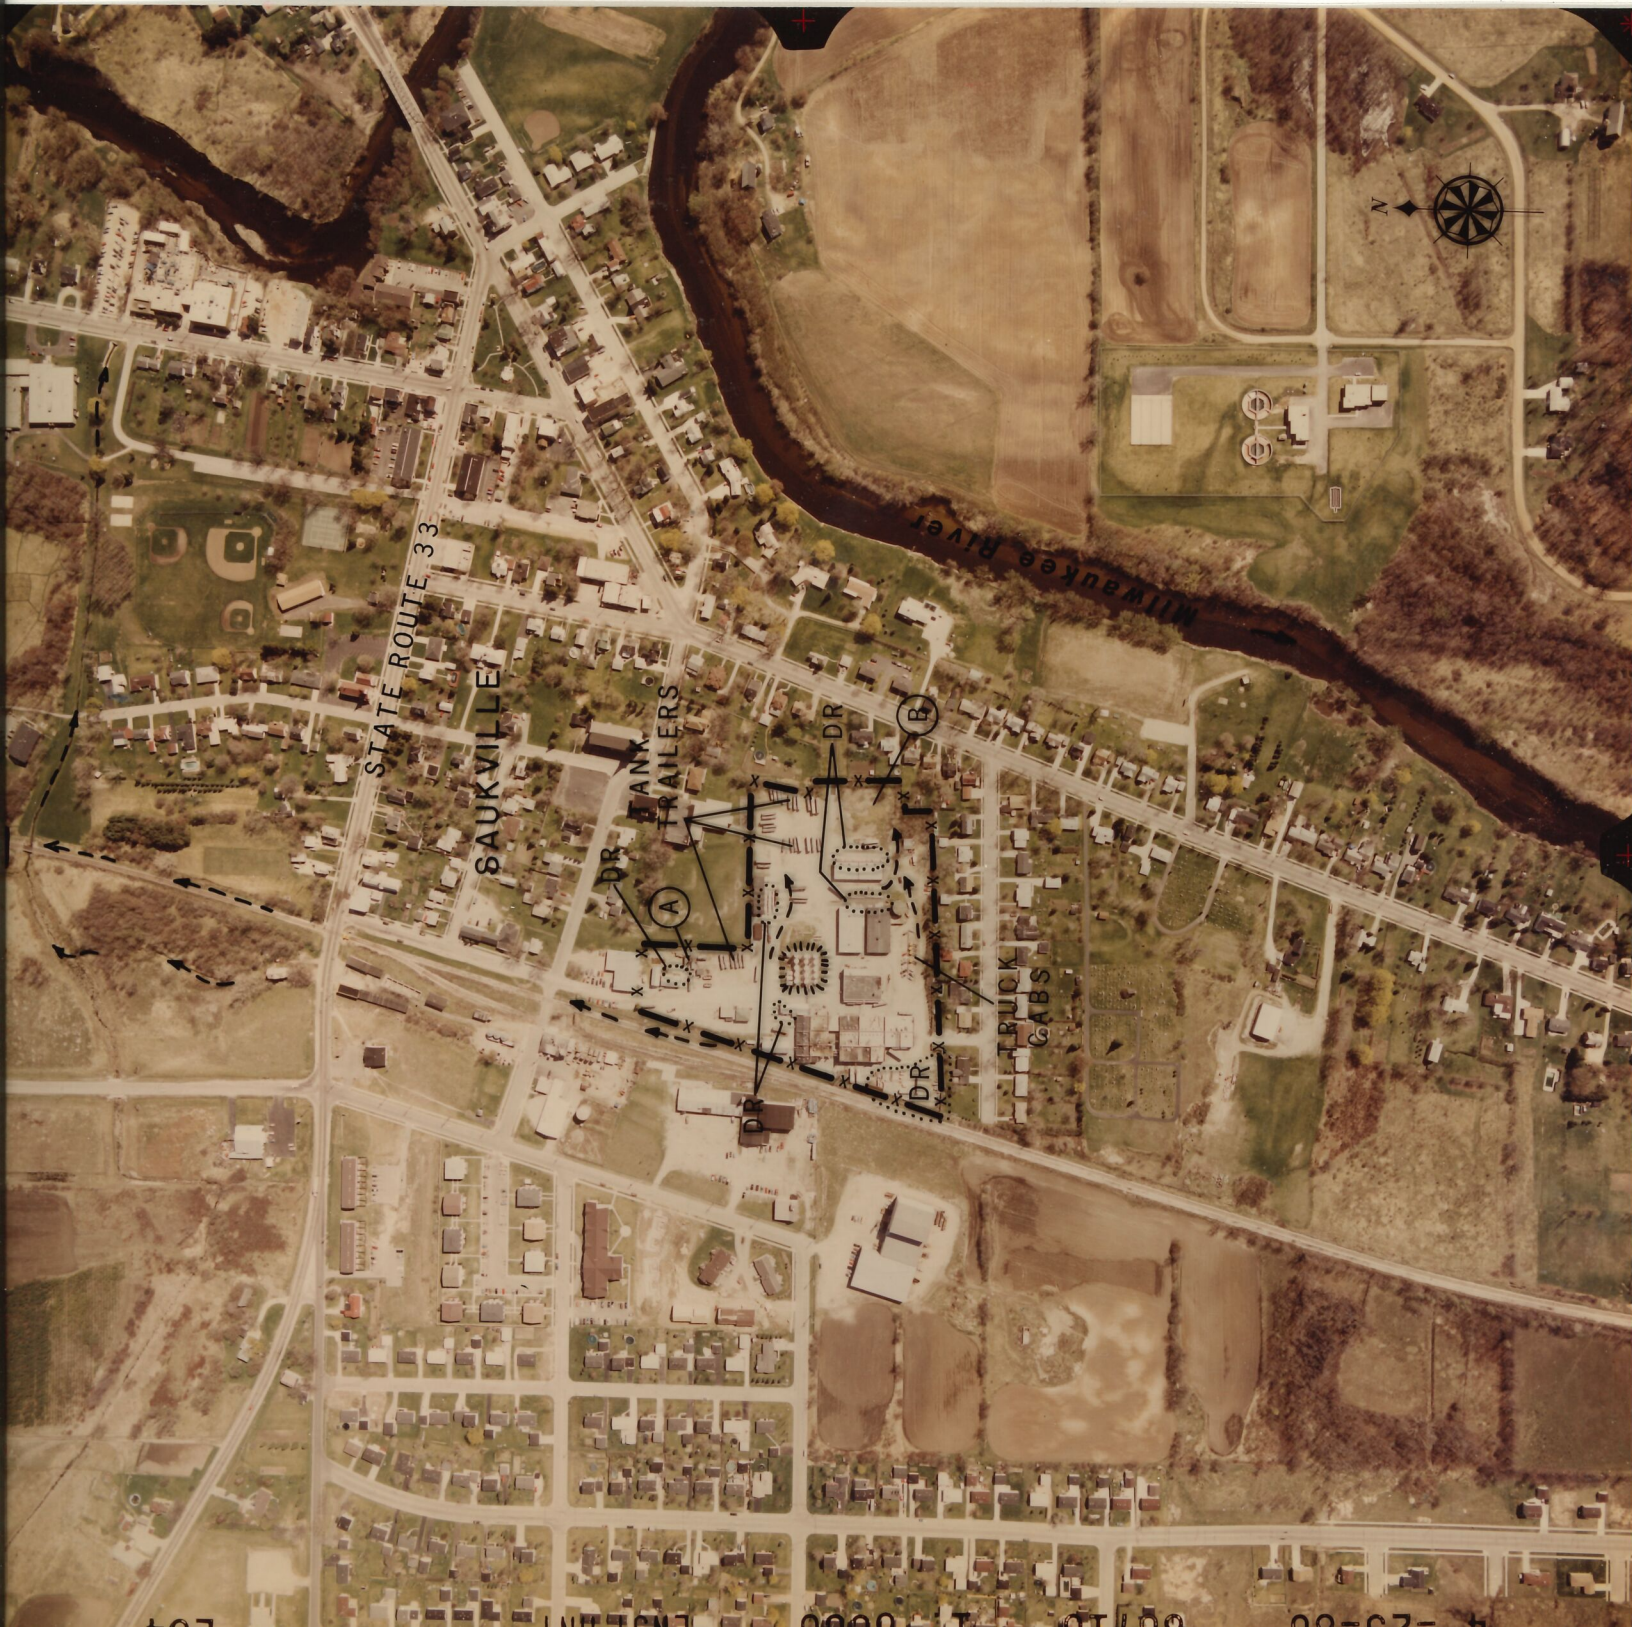
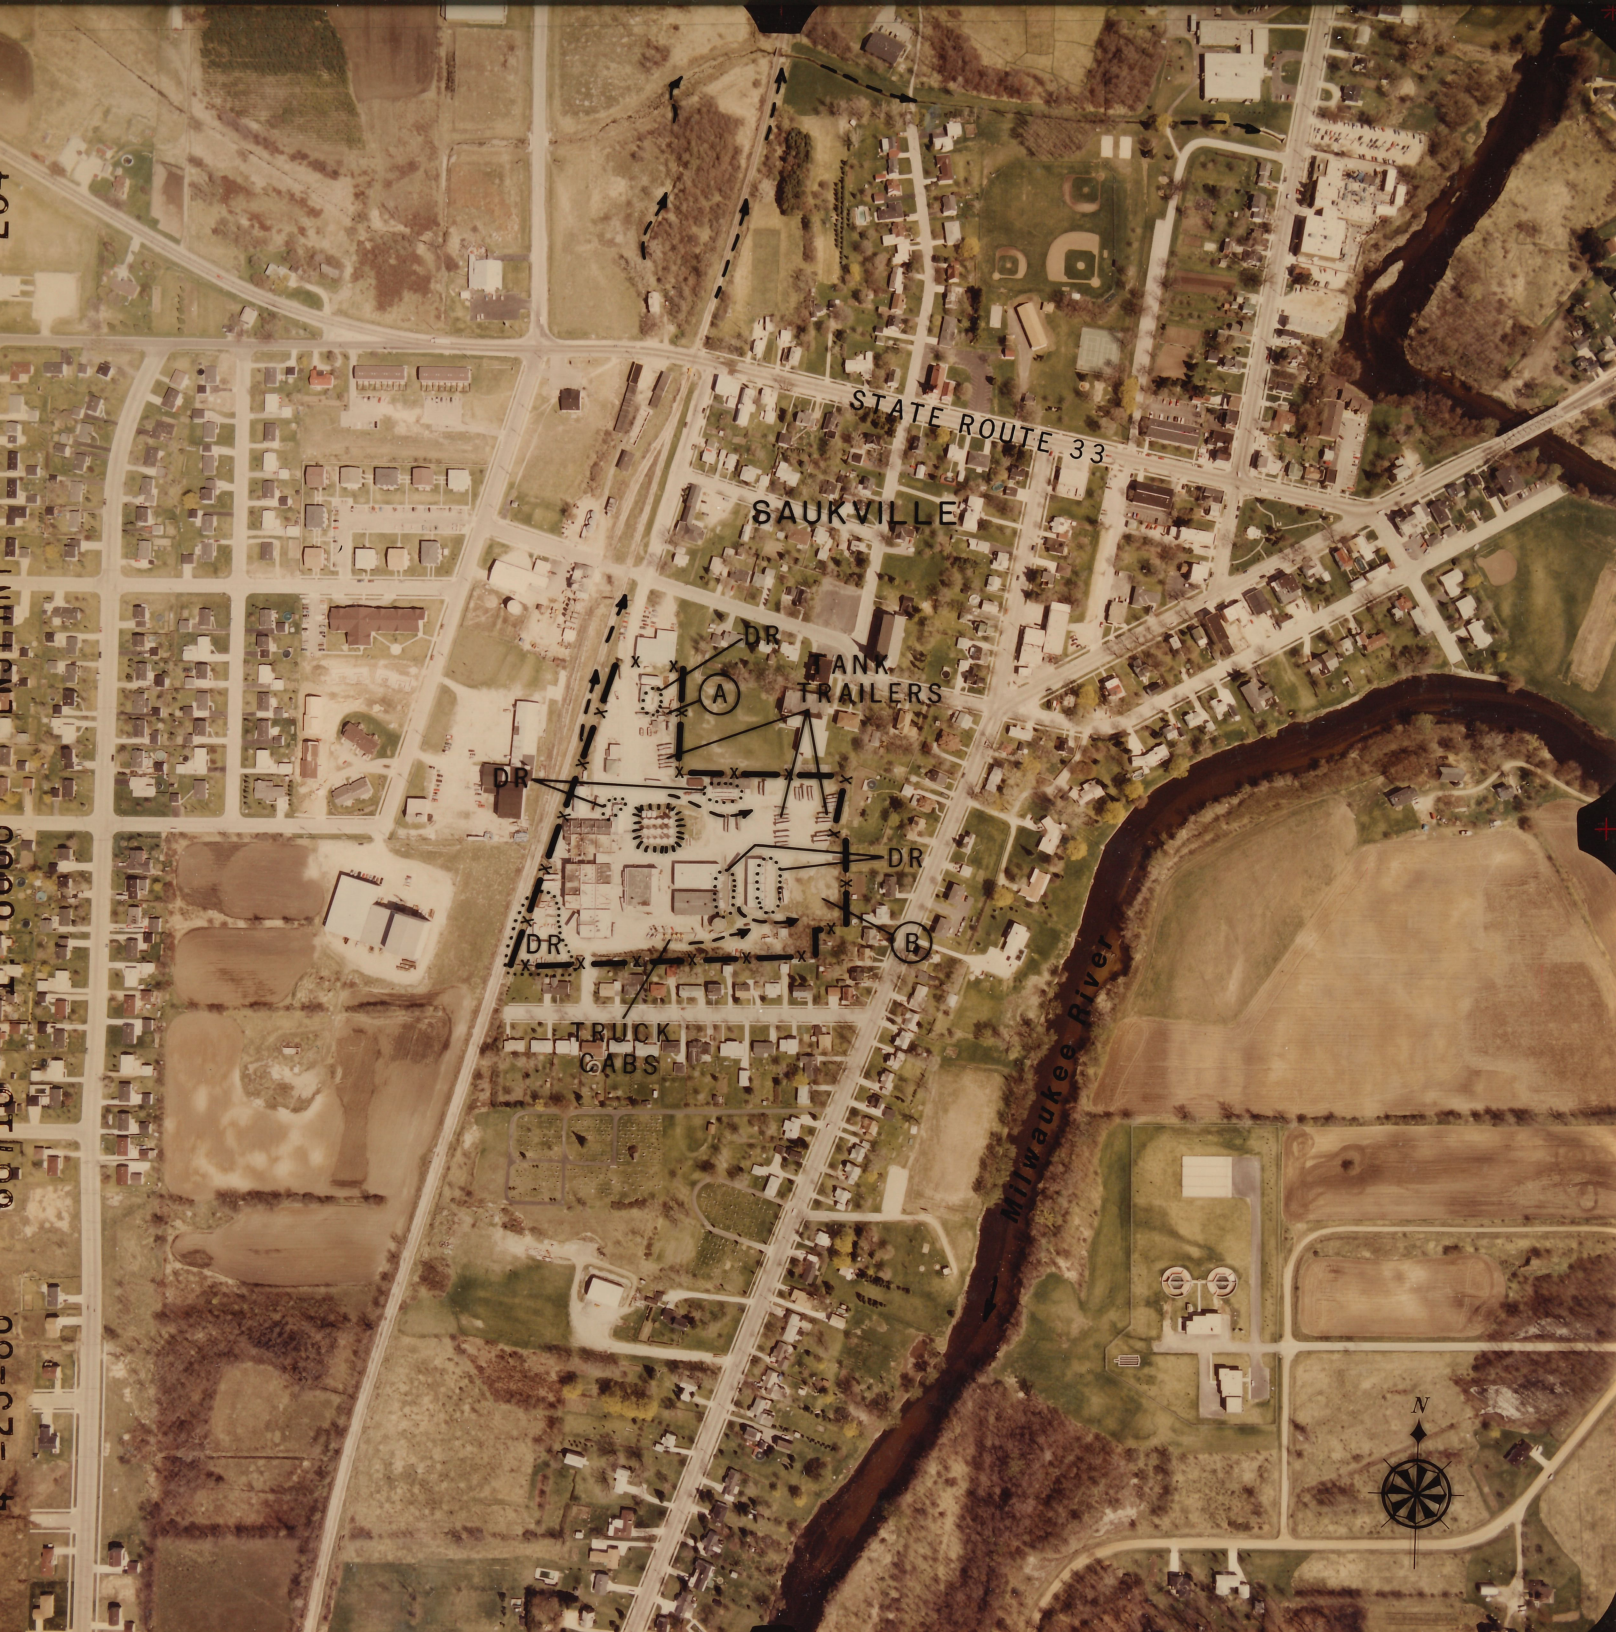
The 1986 photographs (Figures 3 and 4) shows the Freeman Chemical Company is operational. It has 16 vertical and 3 horizontal storage tanks within a containment dike at the center of the facility. There are three large uncontained storage tanks next to the railroad on the west side of the site and one large vertical tank, probably for water storage, at the south end of the site that also lacks secondary containment. Parking for tank trailers is in the northeastern portion of the facility, although there are 30 of these trailers parked throughout the site. Numerous 55-gallon drums are in use at several loading and handling areas, although none of these open areas has secondary containment.

Waste disposal activities are in the northern portion of the site where there is a large incinerator (annotation A) and two dumpsters. No evidence of liquid waste lagoons is noted and there are no visible signs of spillage or leakage problems.

Surface runoff within the facility migrates to a terrain depression (annotation B) on the east side of the site. An earthen berm runs along the east parameter of the depression and prevents runoff from escaping into an adjacent residential area of Saukville. This low area does not appear to be lined so contaminated surface runoff or spillage could pose a threat to the ground water.
