Freeman Chemical Corporation  
Saukville, Wisconsin

Corrective Measure Activities

Site Construction Documentation Report

Hatcher Incorporated  
Richmond, Virginia  
Job No. 0001-003

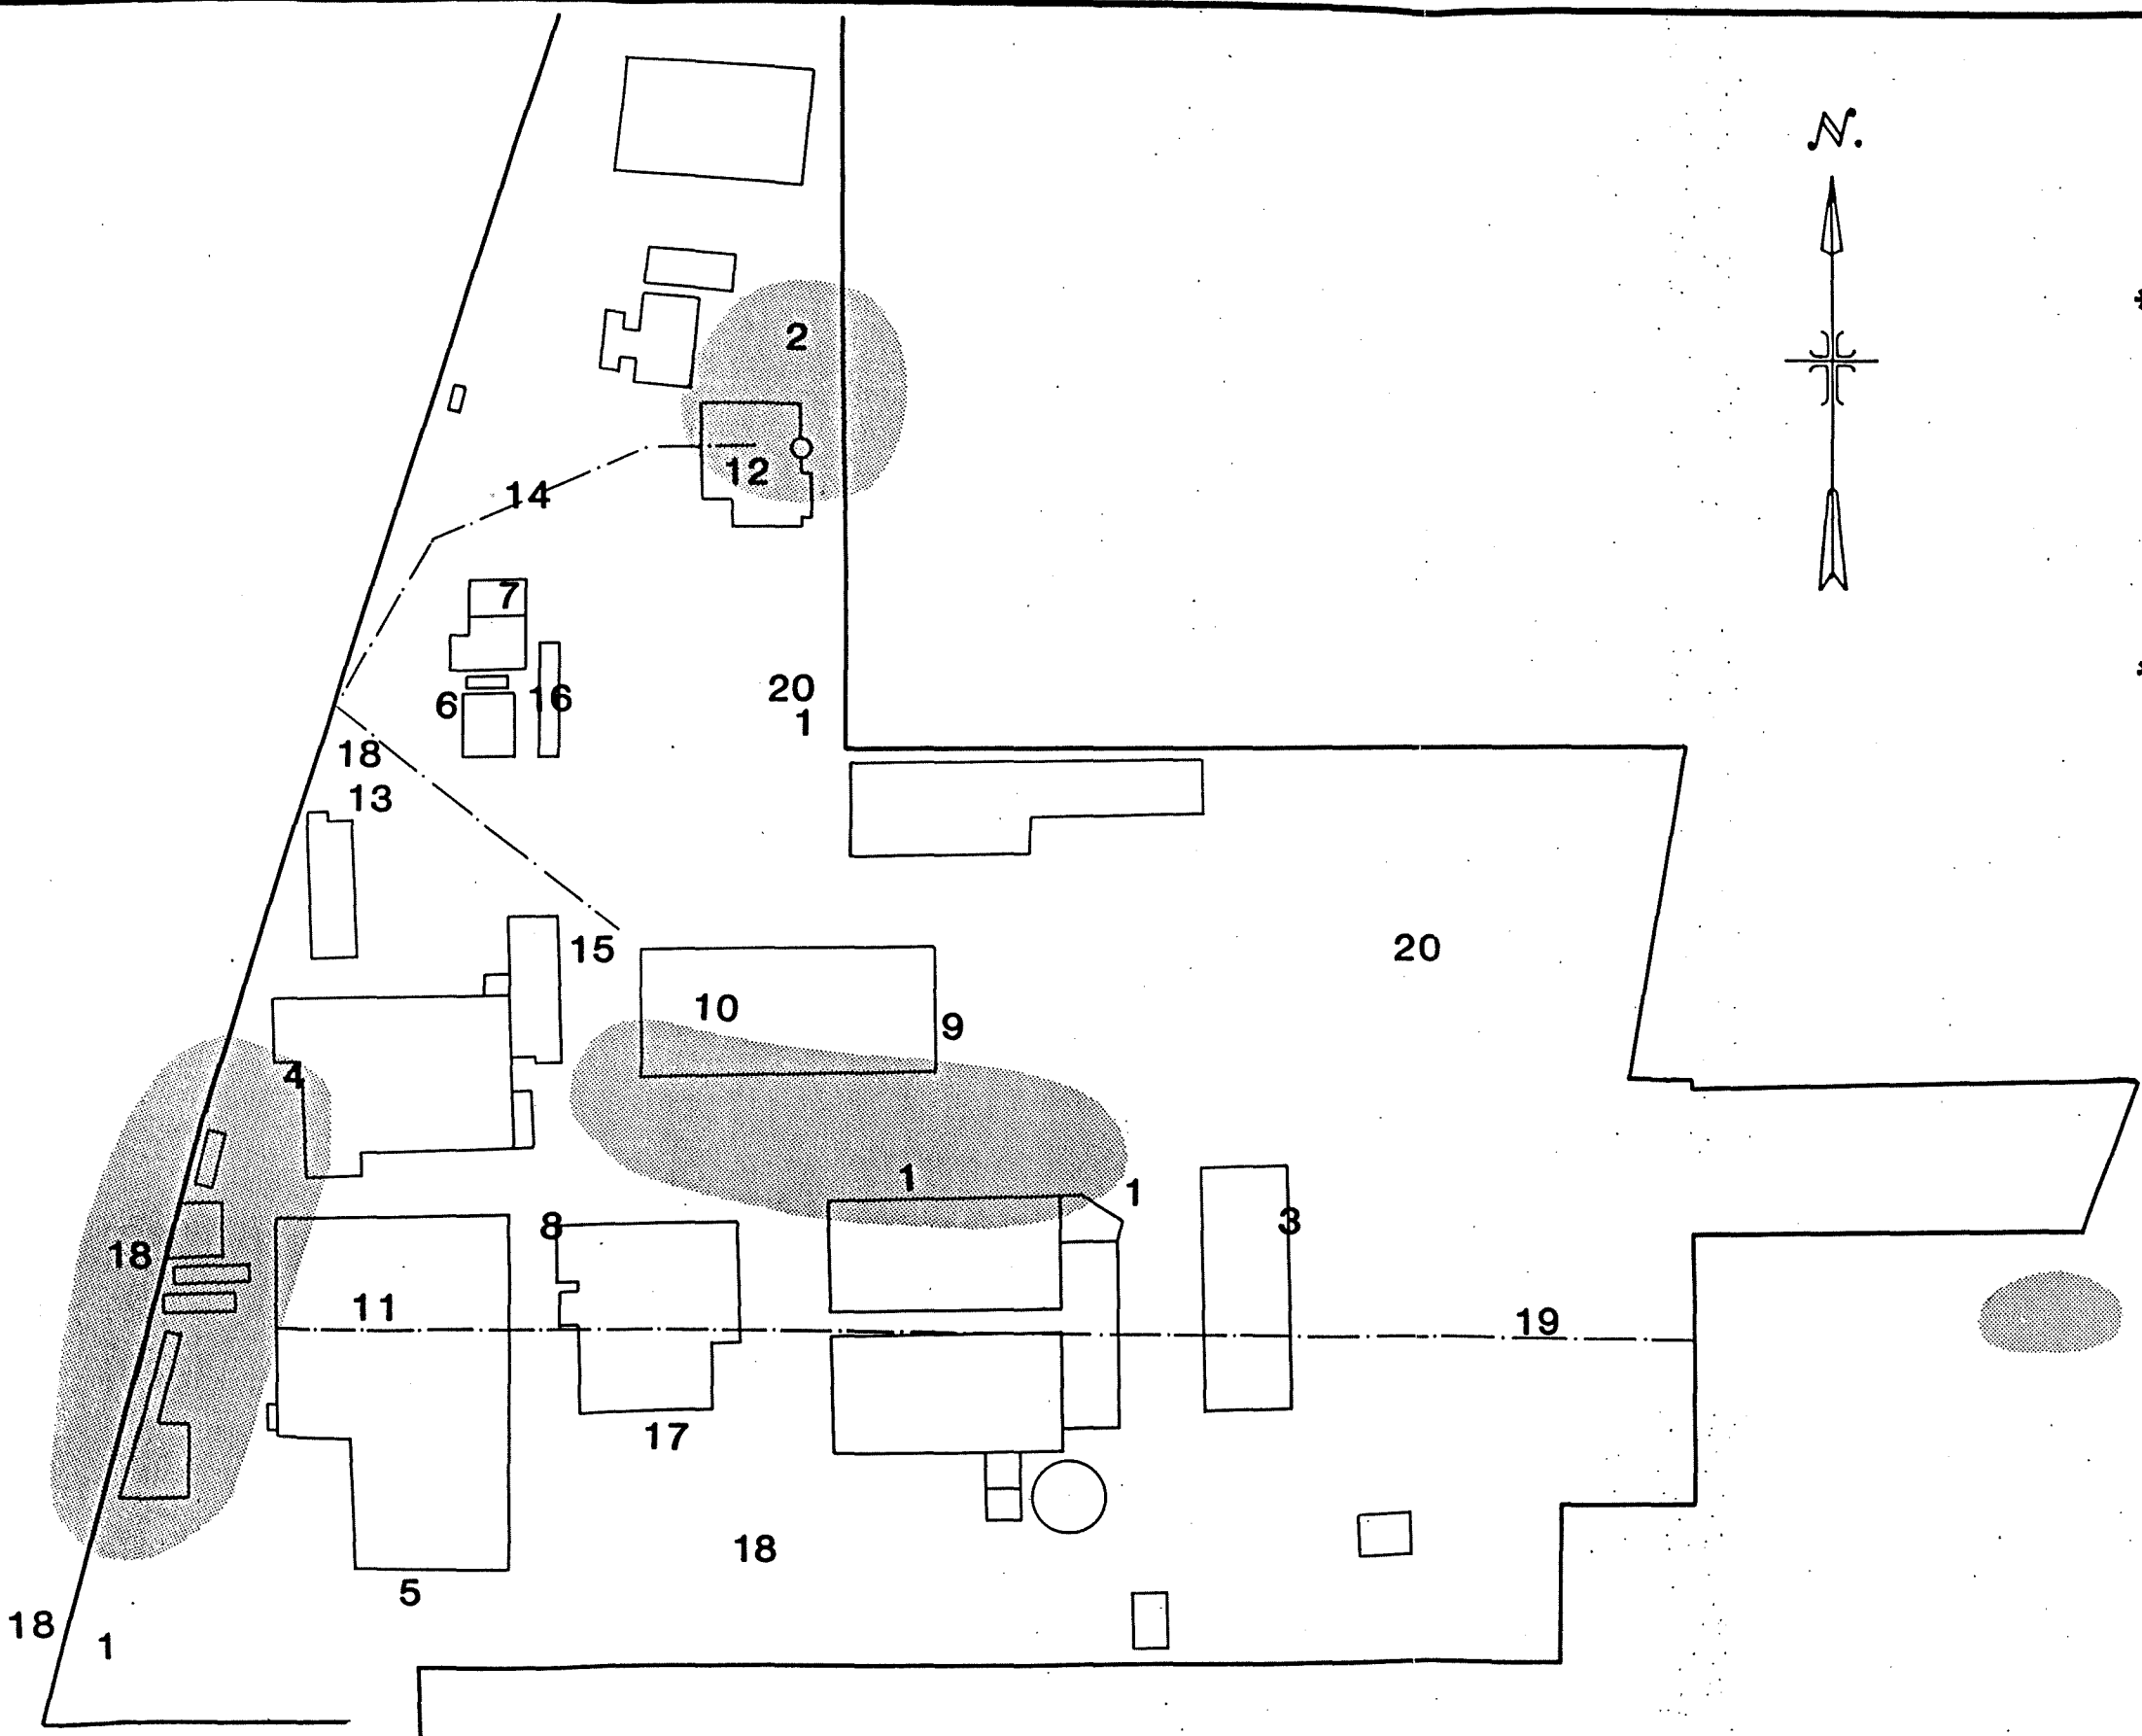
The location of potential sources of groundwater pollution existing prior to 1986 are shown in Figure 2-1. The figure also indicates areas in which the highest levels of groundwater contamination were found. These data indicate that contamination probably resulted from discharge of the acid reaction water to the "old dry well" in addition to leaks and spills of chemicals and wastes from handling and storage areas, including the former tank farm and incinerator areas.

Approximate Locations of Highest Groundwater Contamination Within the Glacial Sediments
