▲ **ENGINEERING & CONSTRUCTION CORPORATION** ▲

Re: Operation and Maintenance
Summary - January 1994
Landfill Gas and Leachate
Extraction System
Refuse Hideaway Landfill -
Middleton, Wisconsin
Terra Job # 468

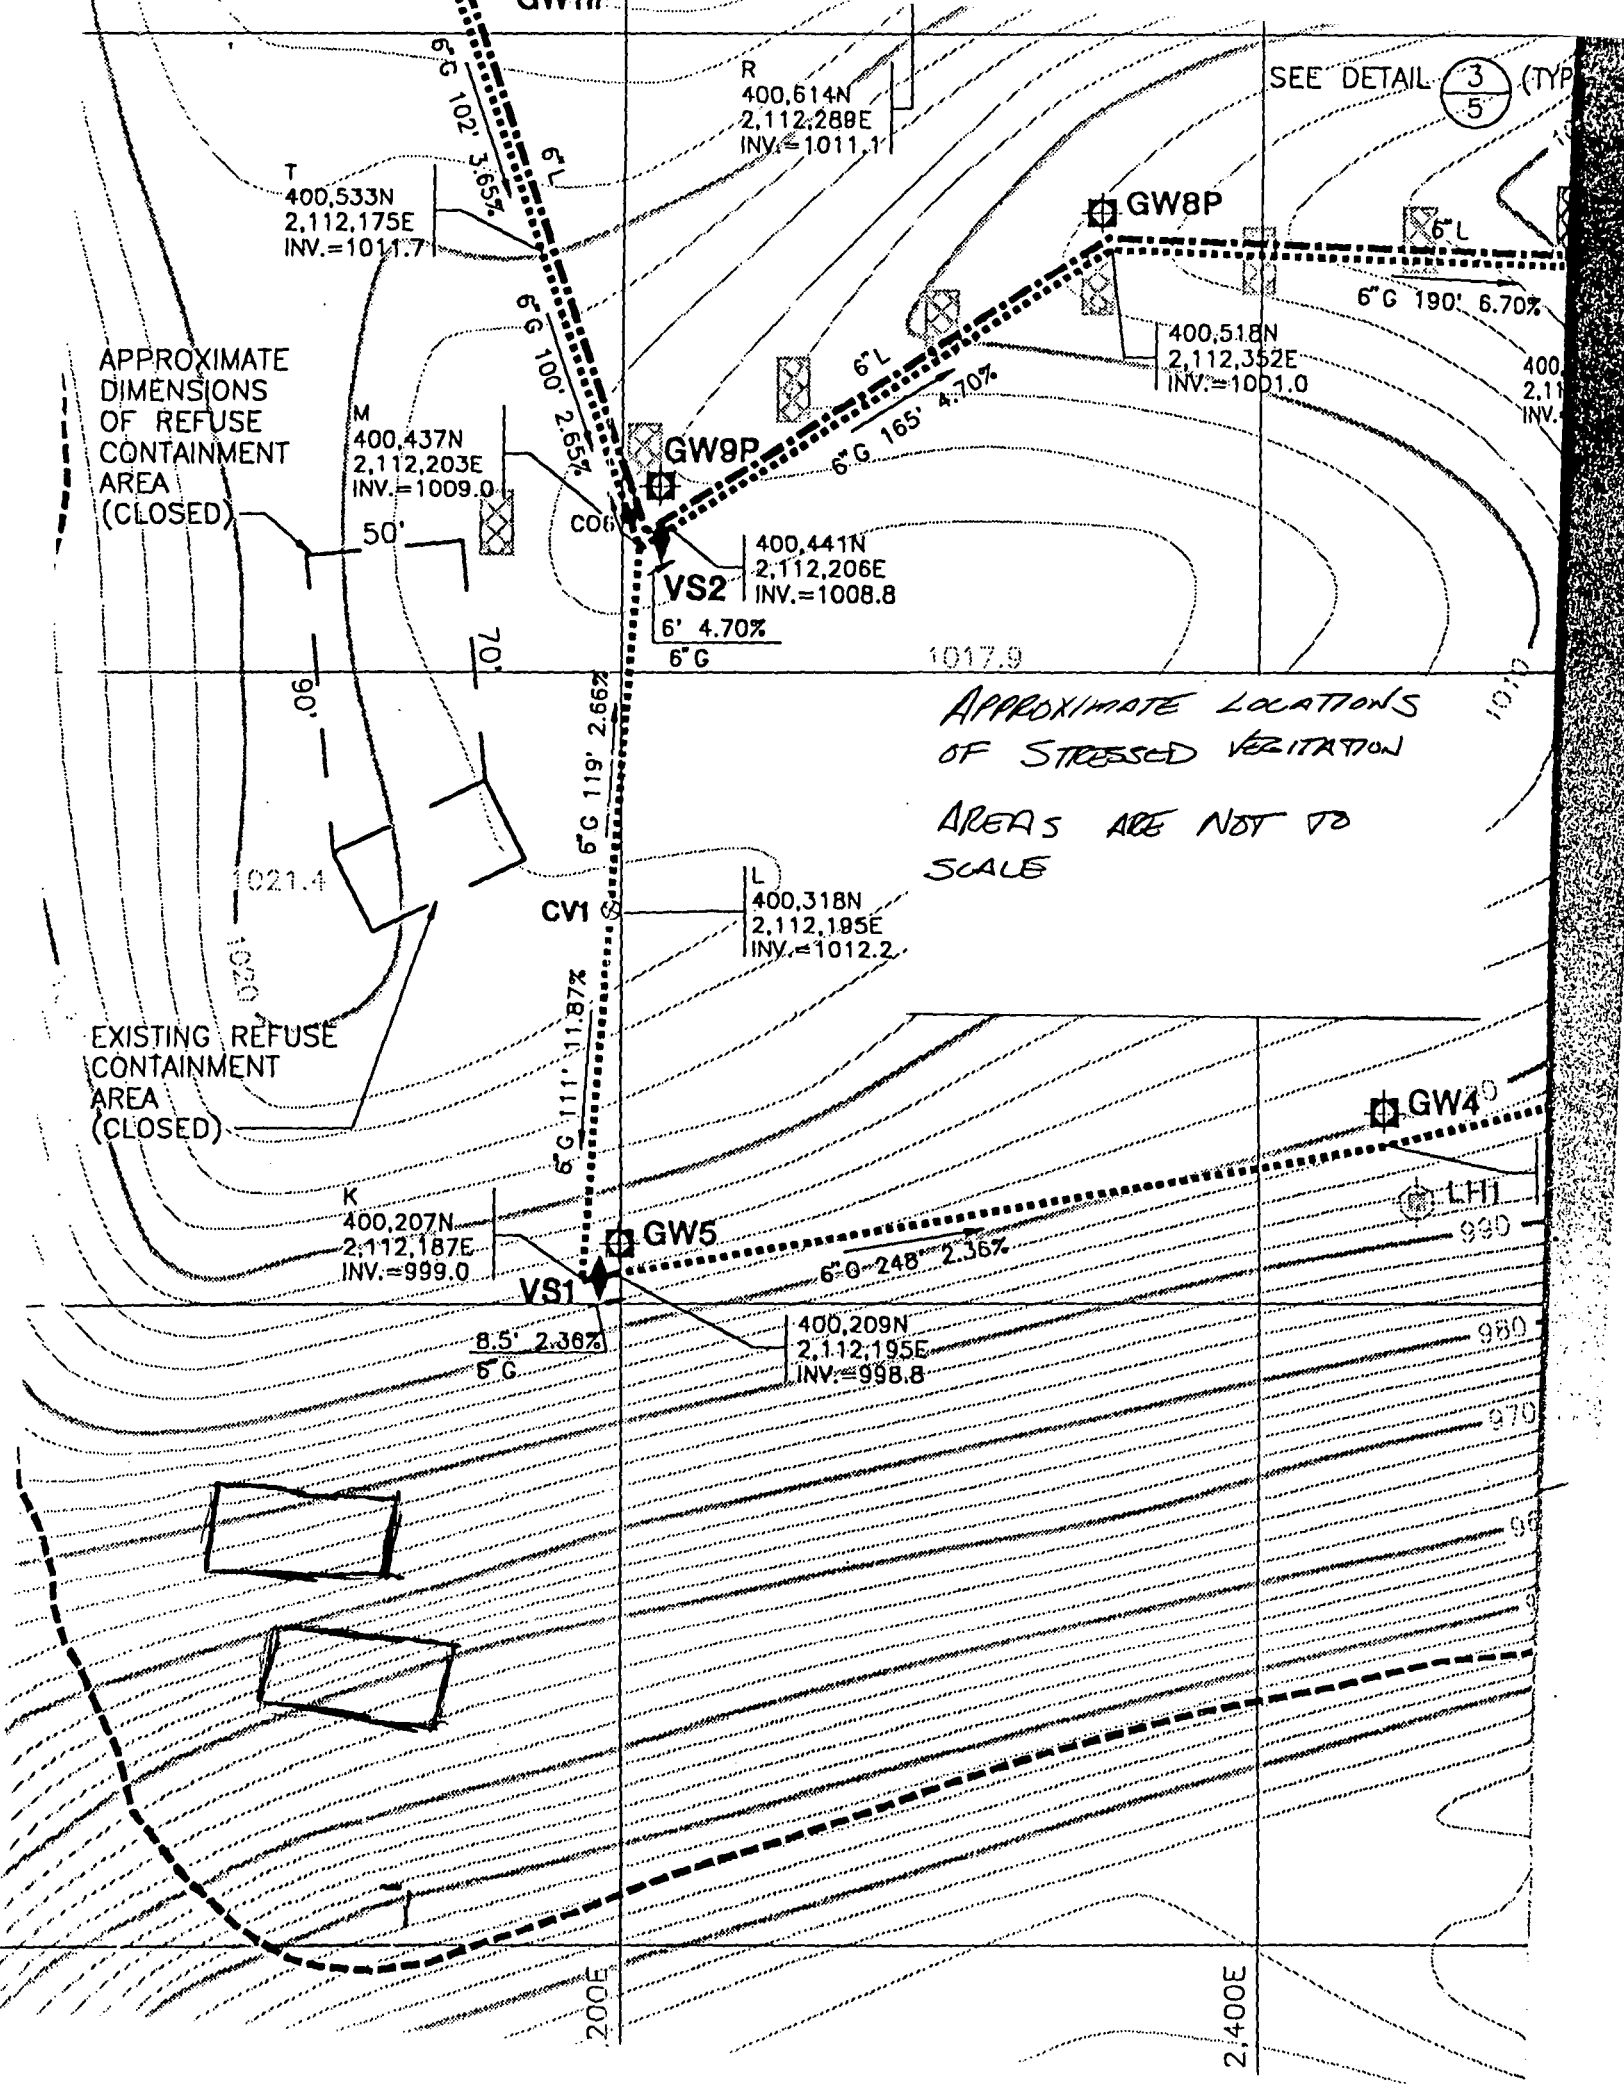
EXISTING REFUSE
CONTAINMENT
AREA
(CLOSED)

APPROXIMATE LOCATIONS
OF STRESSED VEGETATION
AREAS ARE NOT TO
SCALE
