**CONSTRUCTION COMPLETION REPORT-
LANDFILL GAS SYSTEM MODIFICATIONS**

**REFUSE HIDEAWAY LANDFILL
BRRTS NO. 02-13-000849
CONSTRUCTION PROJECT NO. RRSP
7562 U.S. HIGHWAY 14
MIDDLETON, WISCONSIN 53562**

May 2015

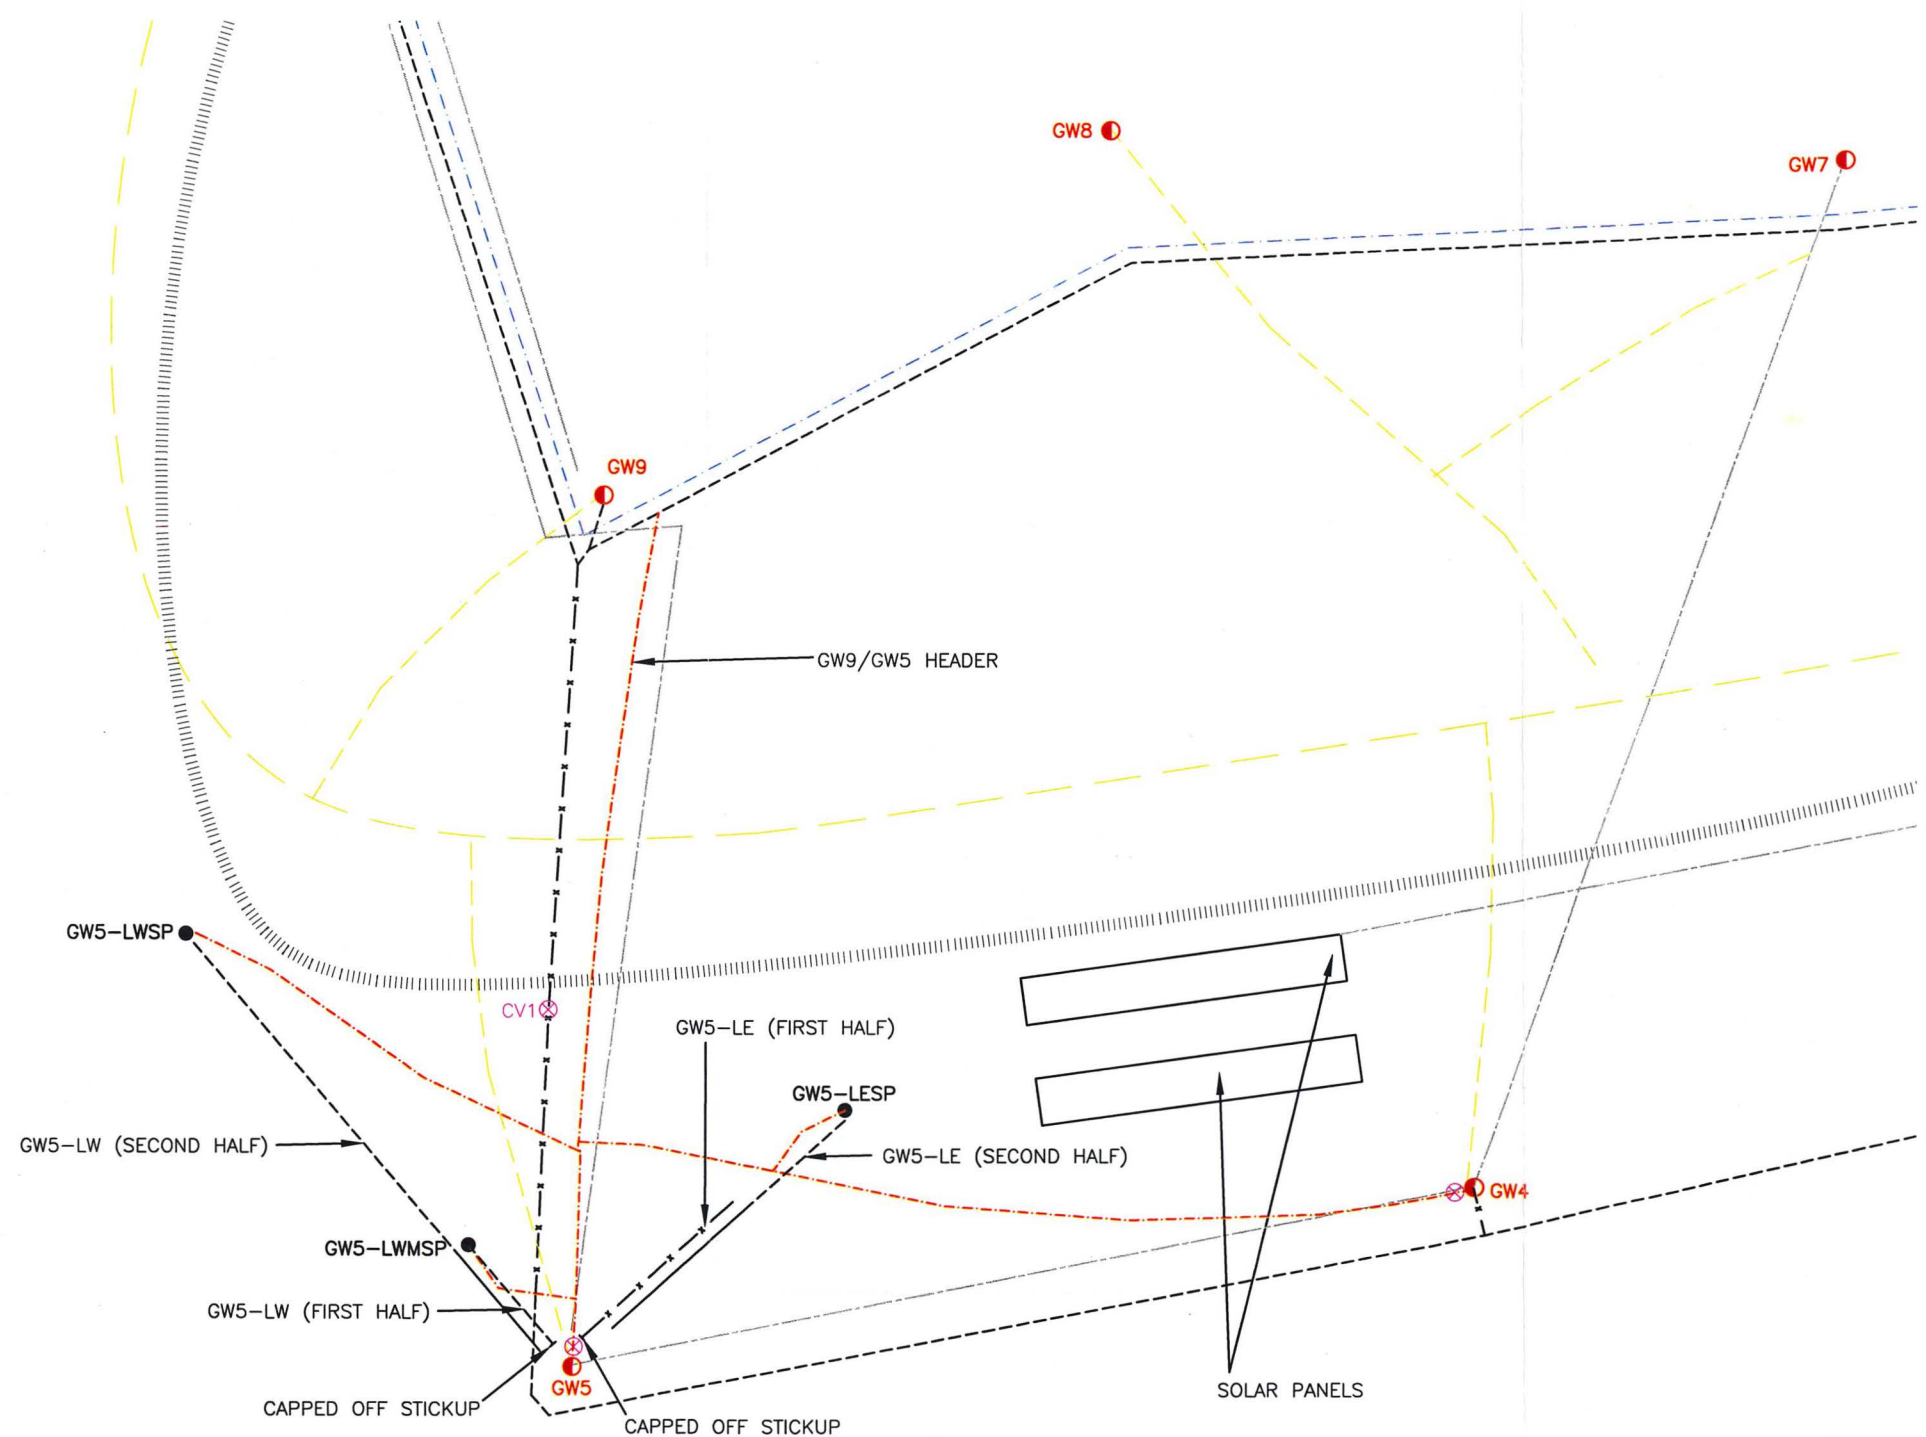
A trench was excavated perpendicular to the new GW9/GW5 header toward the GW5-LWSP stickup location (**Figure 4**). Refuse was removed in the vicinity of GW5-LWSP in order to access

During the afternoon, Terra personnel began excavating along the perforated lateral GW5LE (first half). The area close to GW5 remained saturated. The first half segment of the GW5EL was not connected to the system because the lateral was under water and the GW5 well screen should be able to provide a sufficient radius of influence in the immediate vicinity of GW5. The initial excavation along the GW5LE lateral pipe was backfilled. The location of the connection to the GW5-LE (second half) was moved to the northeast end of the GW5LE lateral pipe (see GW5-LESP location on **Figure 4**).

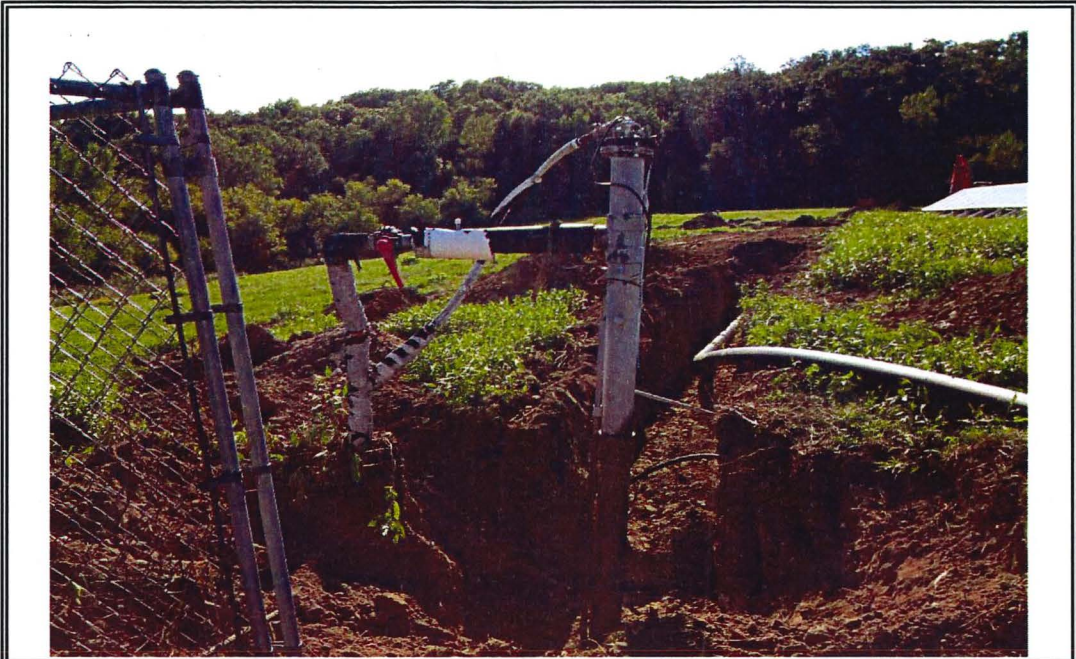
PHOTO:	DATE:	SUBJECT:
1	9/3/2014	GW-4 During Construction (Looking Northwest)

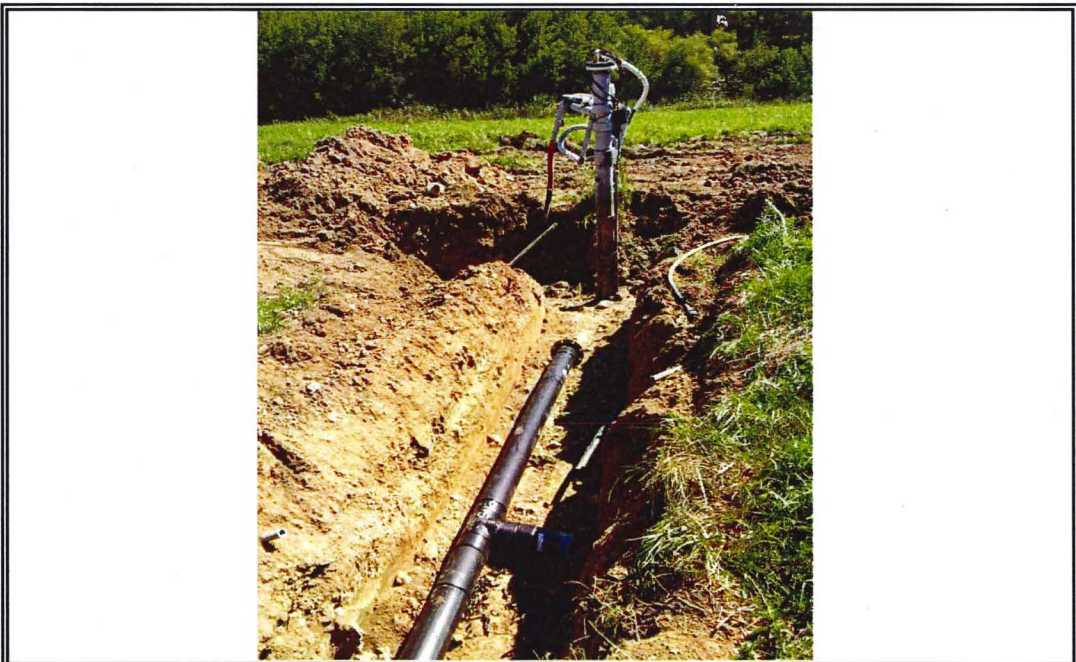
Excavation activities continued in the GW5 area and west toward the lateral well GW5LW. While excavating in the vicinity of GW5 to unearth the connection to the first half of the GW5LW, refuse was encountered and extracted. Saturated conditions were evident at a depth of approximately 10 feet below grade where the horizontal laterals terminated near GW5 and water was apparently draining into the excavation. The crushed stone surrounding the laterals did not drain the water to the underlying refuse as anticipated. Due to the saturated conditions and the greater than expected depth of the GW5 lateral well connections, the design was modified. Field Order #1 was issued for the relocation of the GW5 lateral well connections. The design modification eliminated the need for prolonged dewatering of the excavation in the GW5 area. The design modification may also reduce the severity of future water blockages at the lateral well connections.

PHOTO:	DATE:	SUBJECT:
2	9/3/2014	GW-5 During Construction (Looking South)

Instead of tying into the GW5LW (first half) at the saturated GW5 wellhead area, plans were revised and the proposed tie in location was shifted upslope and northwest along the GW5LW (first half) perforated pipe. The proposed tie-in location for the GW5LW (second half) was also shifted from the southeastern end of the perforated pipe to the northwest end of the perforated pipe (the tie in location and sample port are identified as GW5-LWSP on **Figures 3 and 4**).

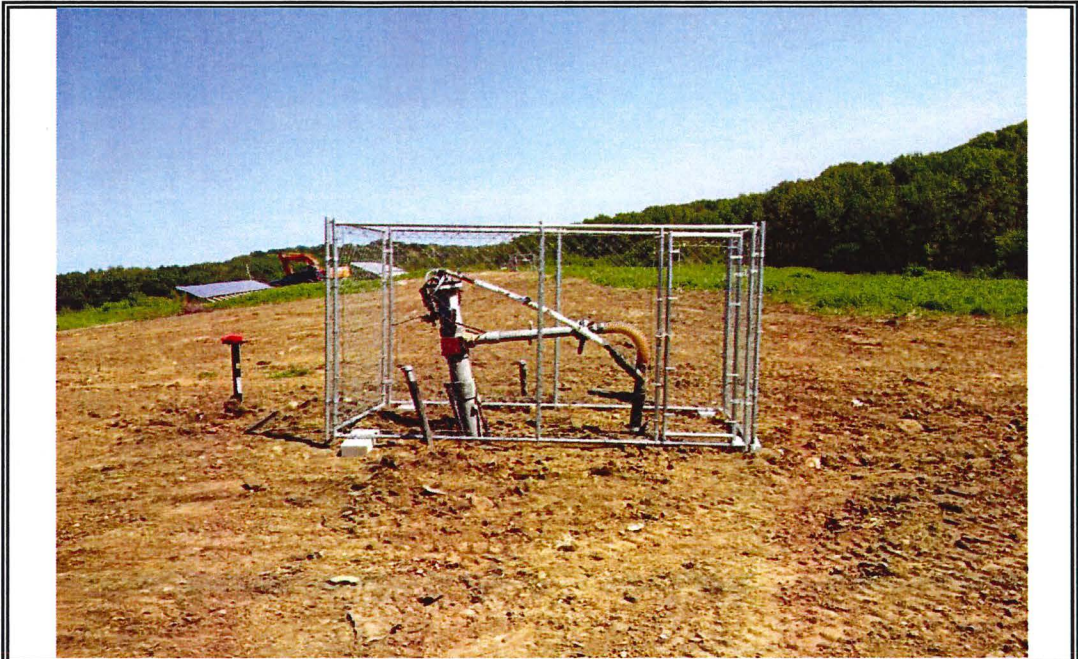
PHOTO:	DATE:	SUBJECT:
3	9/9/2014	GW-5 Post-Construction (Looking East)

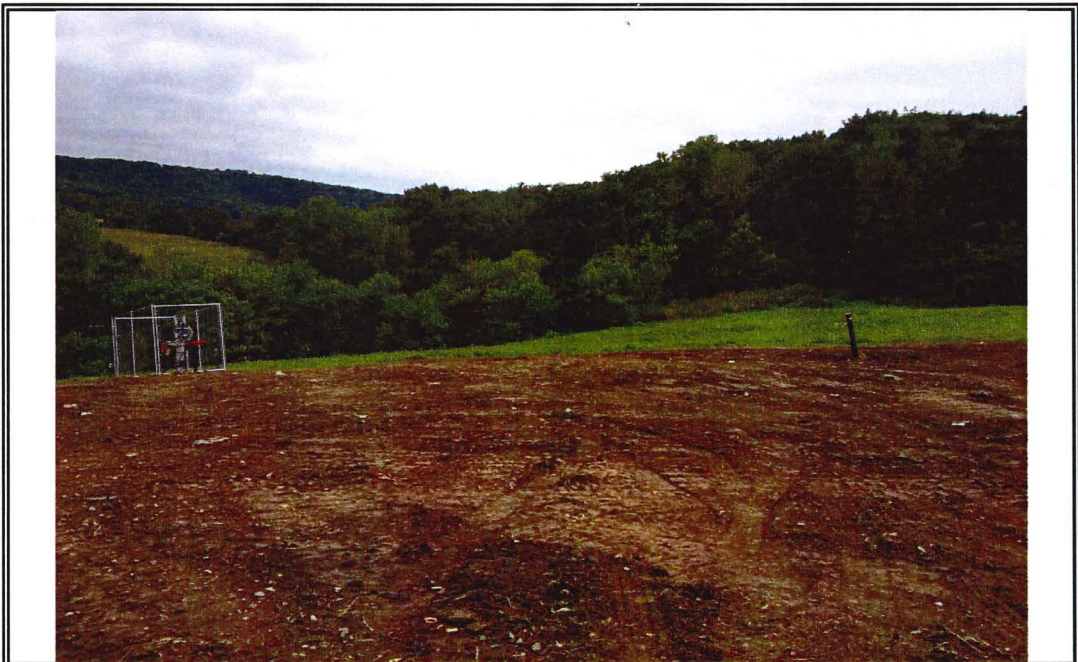
PHOTO:	DATE:	SUBJECT:
4	9/11/2014	GW-5 and GW-5 Lateral West Middle Stickup Area Post Construction (Looking Southwest)
