Current Conditions Evaluation

**Refuse Hideaway Landfill
Town of Middleton, Dane County, WI**

Revision 0
December 2019

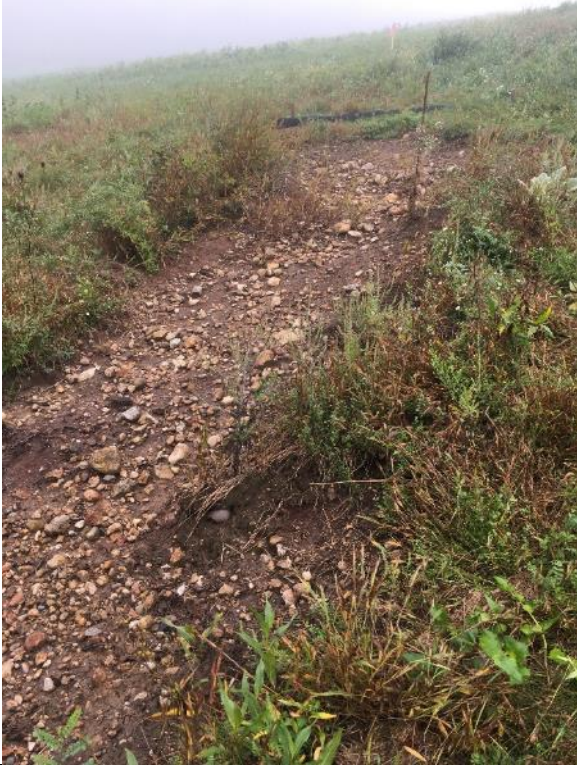
Client Name: Wisconsin Department of Natural Resources		Site Location: Refuse Hideaway Landfill Town of Middleton, Dane County, Wisconsin	Project No.: 335719.0001.0000, Phase 1
Photo No. 1	Date 09-16-2019

Rills from stormwater erosion were only observed at one location on the southern slope of the final cover. At this location, two sets of erosion control wattles were installed upstream in August by TRC per the WDNR's request to minimize additional erosion until the areas can be repaired. Bare ground and stressed vegetation existed at the location where the erosion rills were forming on the final cover. Several other small areas of the final cover exhibited bare soil and stressed vegetation. Refer to Figure 1, noting the areas where bare ground and stressed vegetation was identified using a handheld GPS. The cause of the bare ground and stressed vegetation could be from LFG penetrating the final cover, leachate exposure, sterile soil, shade from trees or other causes. Seed could be placed on these bare areas, but if the bare areas are caused by LFG, leachate, sterile soil, or shade from trees, the seeding likely will not establish.

Description Area with erosion, bare ground and stressed vegetation with wattle installed.

- **MONITOR:** Repair areas of stormwater erosion to the final cap.

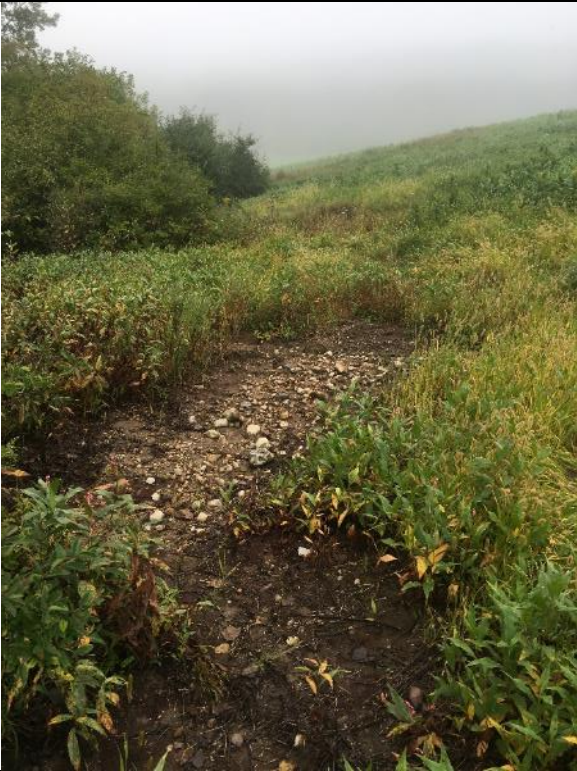
Client Name: Wisconsin Department of Natural Resources		Site Location: Refuse Hideaway Landfill Town of Middleton, Dane County, Wisconsin	Project No.: 335719.0001.0000, Phase 1
Photo No. 7	Date 09-16-2019

Description Area with bare ground and stressed vegetation.

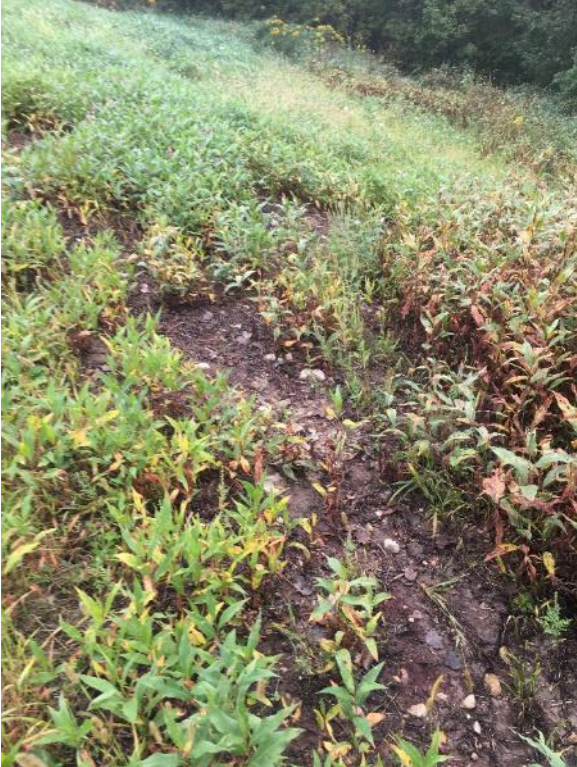
Photo No. 8	Date 09-16-2019

Description Area with bare ground and stressed vegetation.

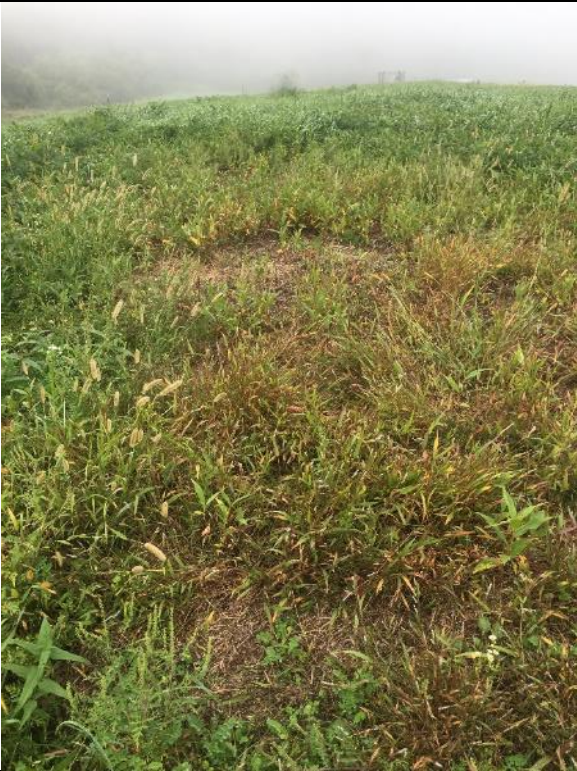
Client Name: Wisconsin Department of Natural Resources		Site Location: Refuse Hideaway Landfill Town of Middleton, Dane County, Wisconsin	Project No.: 335719.0001.0000, Phase 1
Photo No. 9	Date 09-16-2019

Description Area with bare ground and stressed vegetation.

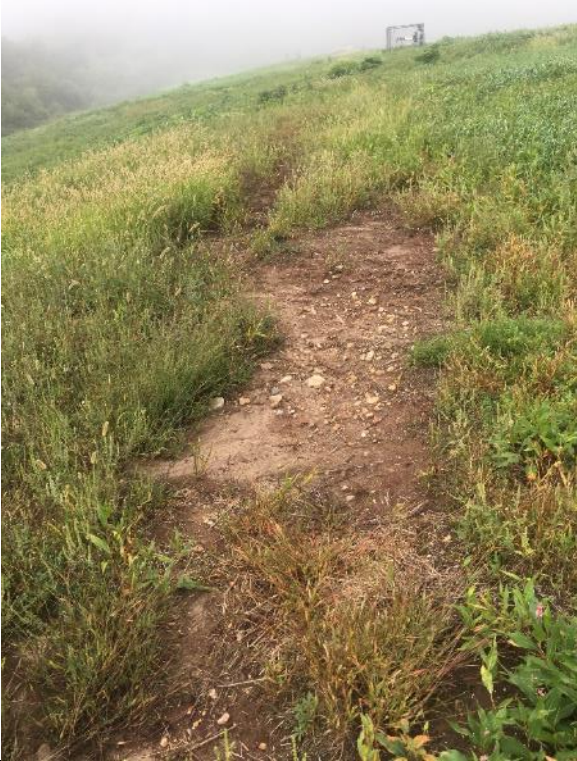
Client Name: Wisconsin Department of Natural Resources		Site Location: Refuse Hideaway Landfill Town of Middleton, Dane County, Wisconsin	Project No.: 335719.0001.0000, Phase 1
Photo No. 11	Date 09-16-2019

Description Area with bare ground and stressed vegetation.

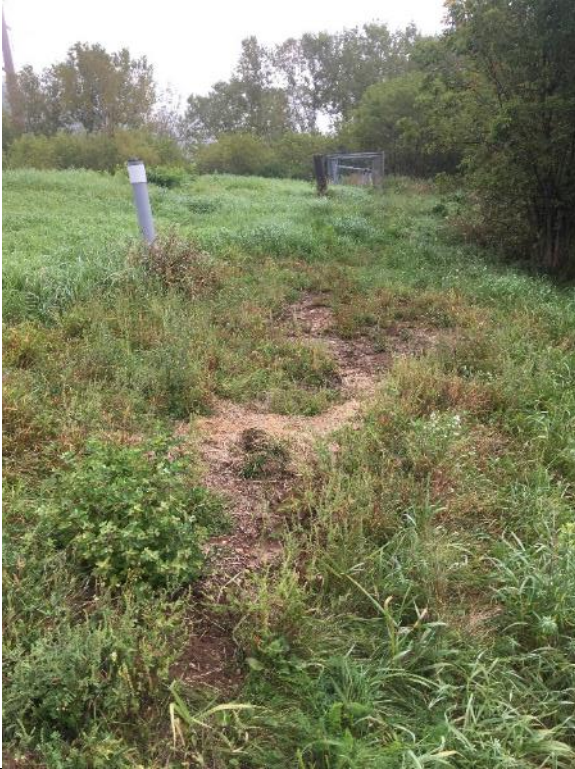
Client Name: Wisconsin Department of Natural Resources		Site Location: Refuse Hideaway Landfill Town of Middleton, Dane County, Wisconsin	Project No.: 335719.0001.0000, Phase 1
Photo No. 13	Date 09-16-2019

Description Area with bare ground and stressed vegetation.

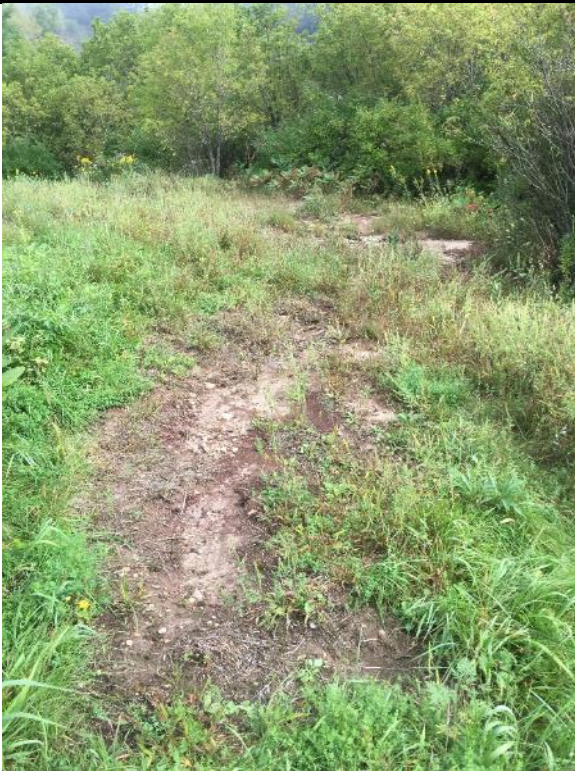
Photo No. 14	Date 09-16-2019

Description Area with bare ground and stressed vegetation.

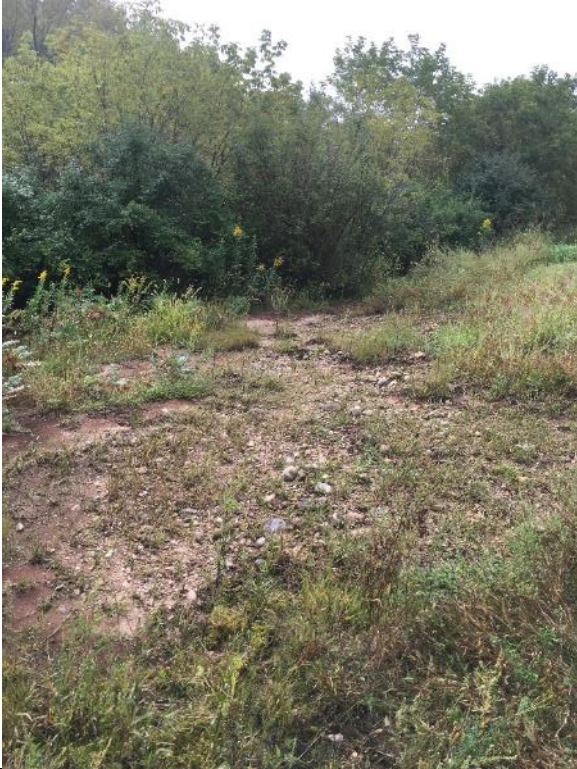
Client Name: Wisconsin Department of Natural Resources		Site Location: Refuse Hideaway Landfill Town of Middleton, Dane County, Wisconsin		Project No.: 335719.0001.0000, Phase 1	
Photo No. 15	Date 09-16-2019

Description Area with bare ground and stressed vegetation.

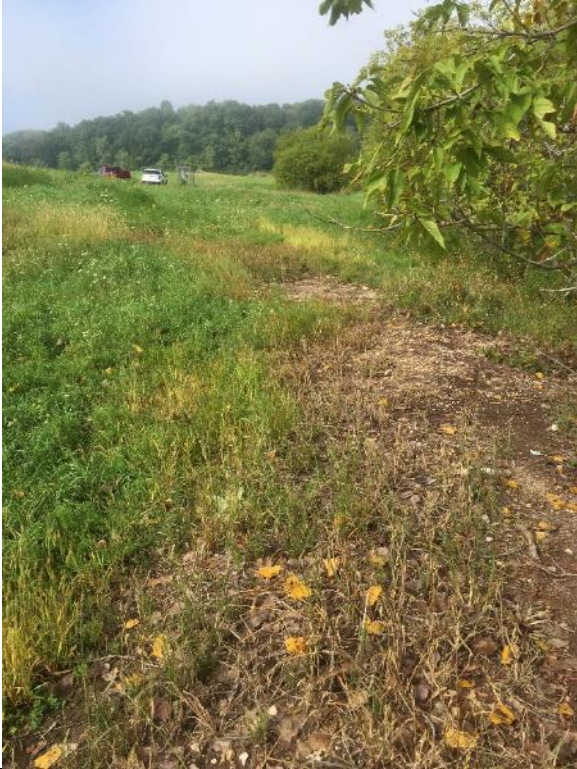
Client Name: Wisconsin Department of Natural Resources		Site Location: Refuse Hideaway Landfill Town of Middleton, Dane County, Wisconsin		Project No.: 335719.0001.0000, Phase 1	
Photo No. 17	Date 09-16-2019

Description Area with bare ground and stressed vegetation.

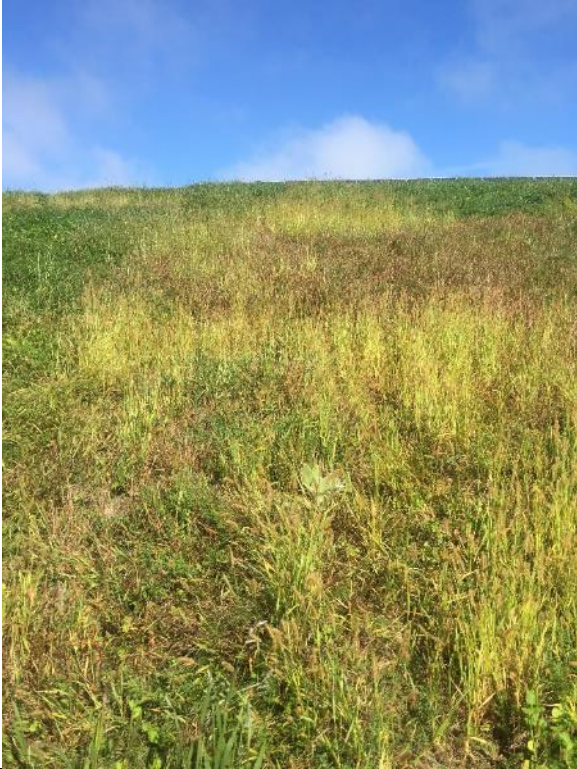
Client Name: Wisconsin Department of Natural Resources		Site Location: Refuse Hideaway Landfill Town of Middleton, Dane County, Wisconsin		Project No.: 335719.0001.0000, Phase 1	
Photo No. 19	Date 09-16-2019

Description Area with bare ground and stressed vegetation.

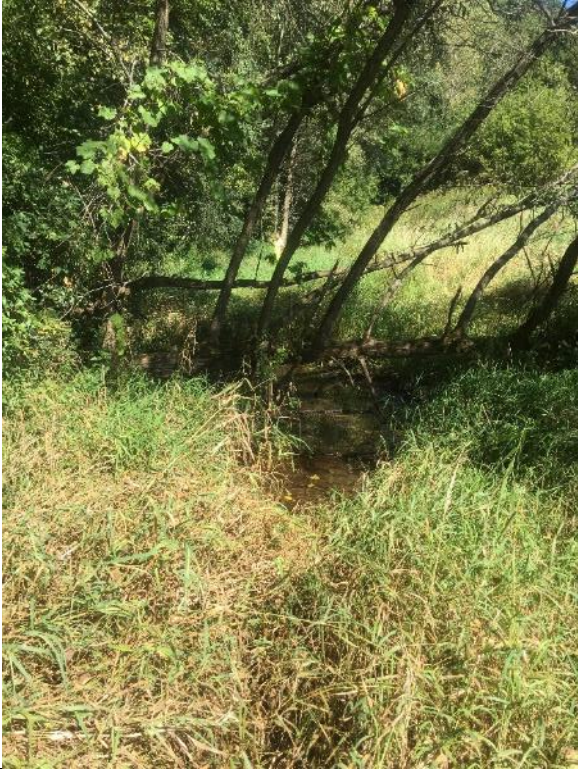
Client Name: Wisconsin Department of Natural Resources		Site Location: Refuse Hideaway Landfill Town of Middleton, Dane County, Wisconsin		Project No.: 335719.0001.0000, Phase 1	
Photo No. 21	Date 09-16-2019

Differential settlement has occurred at the landfill resulting in the formations of some depressions in the final cover. These depressions were identifiable by ponding water from the recent rain events and visual vehicle tire ruts indicating saturated soil areas in the final cover. In general, the depressions appeared to be shallow and have not significantly affected the final cover vegetation growth. The depressions in the final cover should continue to be monitored and if these areas continue to hold water over dry periods during the seasons, the WDNR should consider repairing the depressions. Repair would include the addition of topsoil to the specific areas. No regrading or other final cover repairs would be needed. The worst depressions exist west of gas well GW-6, in the northern portion of the landfill and in the northern portion of the western drainage ditch. Table 1 contains an engineer's opinion of probable cost (OPC) for repairing the depressions by adding topsoil. The OPC assumes the repair of 0.5 acres of depressions at an average depth of 1-foot.

Description Low area with standing water.

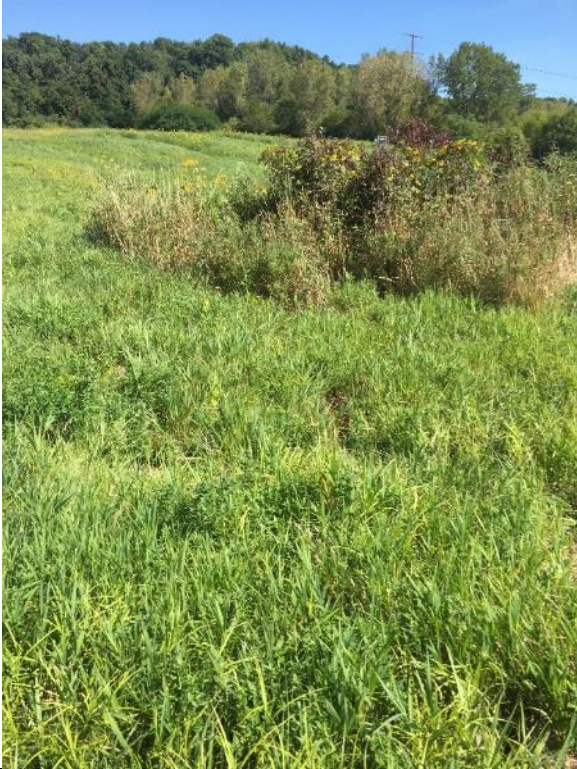
Client Name: Wisconsin Department of Natural Resources		Site Location: Refuse Hideaway Landfill Town of Middleton, Dane County, Wisconsin		Project No.: 335719.0001.0000, Phase 1	
Photo No. 23	Date 09-16-2019

Description Low area with standing water.

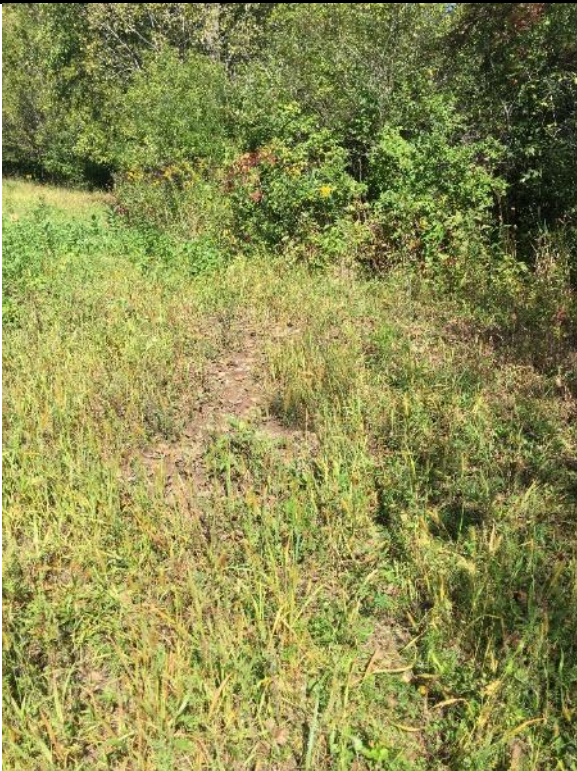
Photo No. 24	Date 09-16-2019

Description Area with bare ground and stressed vegetation.

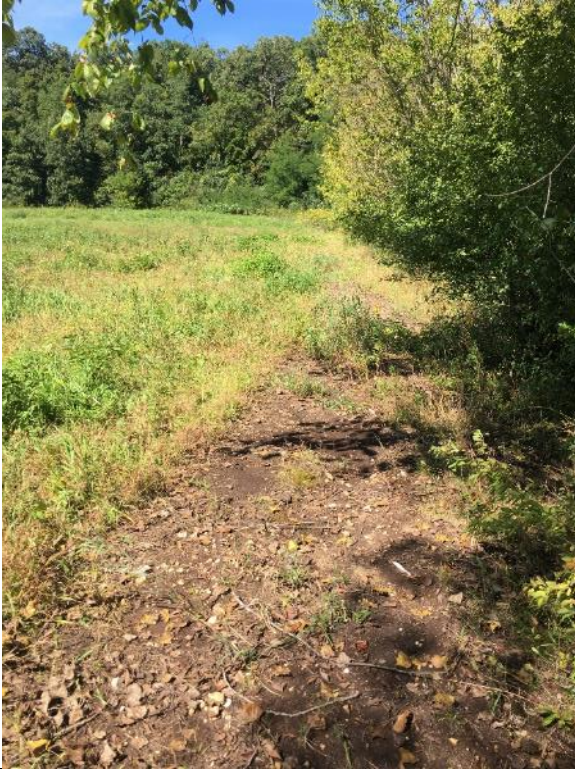
Client Name: Wisconsin Department of Natural Resources		Site Location: Refuse Hideaway Landfill Town of Middleton, Dane County, Wisconsin	Project No.: 335719.0001.0000, Phase 1
Photo No. 25	Date 09-16-2019

Description Area with bare ground and stressed vegetation.

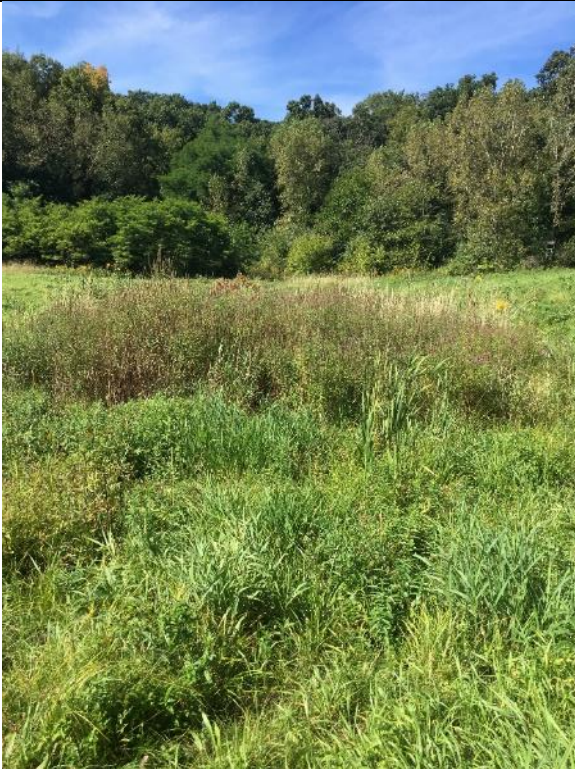
Photo No. 26	Date 09-16-2019

Description Low area with standing water.

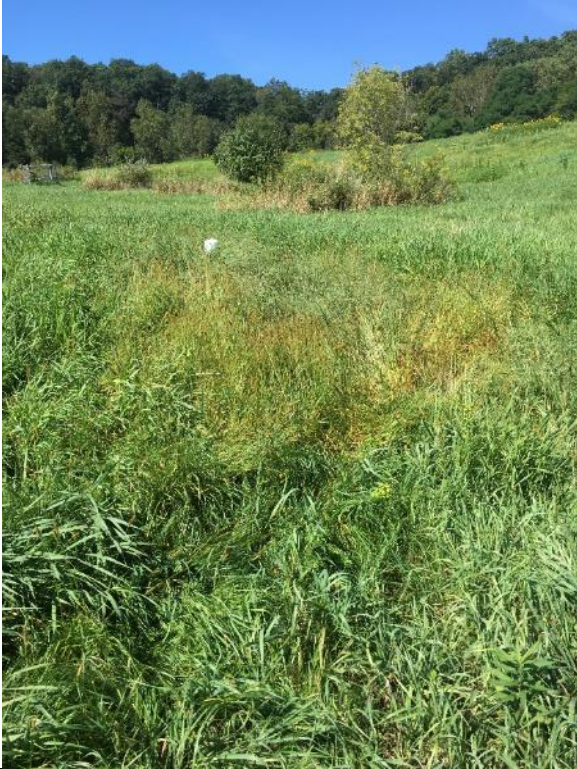
Client Name: Wisconsin Department of Natural Resources		Site Location: Refuse Hideaway Landfill Town of Middleton, Dane County, Wisconsin		Project No.: 335719.0001.0000, Phase 1	
Photo No. 27	Date 09-16-2019

Description Low area with standing water.

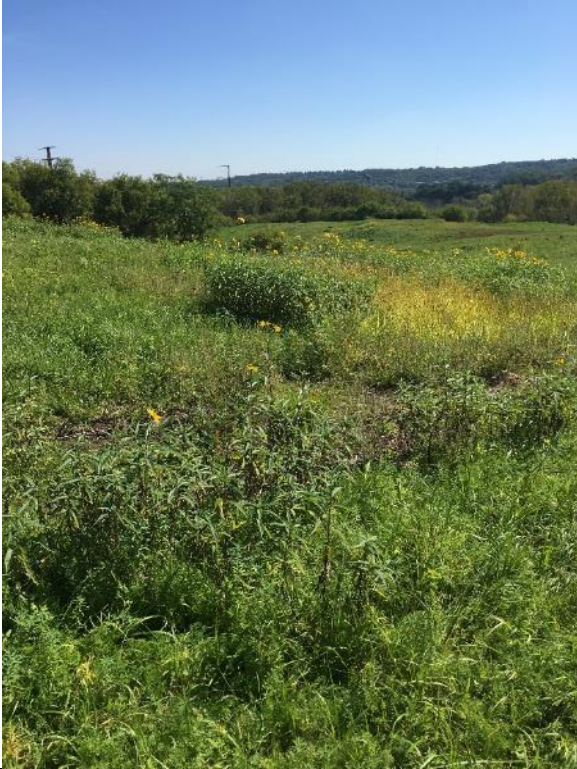
Client Name: Wisconsin Department of Natural Resources		Site Location: Refuse Hideaway Landfill Town of Middleton, Dane County, Wisconsin		Project No.: 335719.0001.0000, Phase 1
Photo No. 29	Date 09-16-2019

Description Area with bare ground and stressed vegetation.

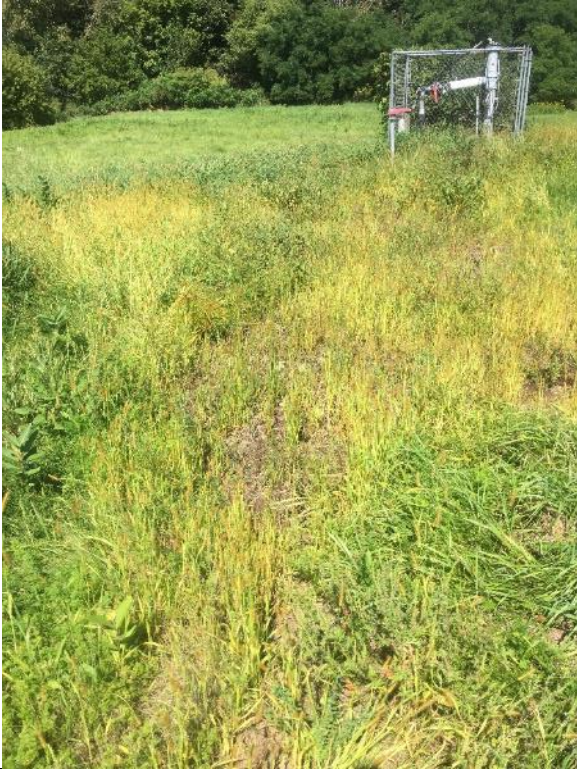
Client Name: Wisconsin Department of Natural Resources		Site Location: Refuse Hideaway Landfill Town of Middleton, Dane County, Wisconsin		Project No.: 335719.0001.0000, Phase 1	
Photo No. 31	Date 09-16-2019

Description Area with bare ground and stressed vegetation.

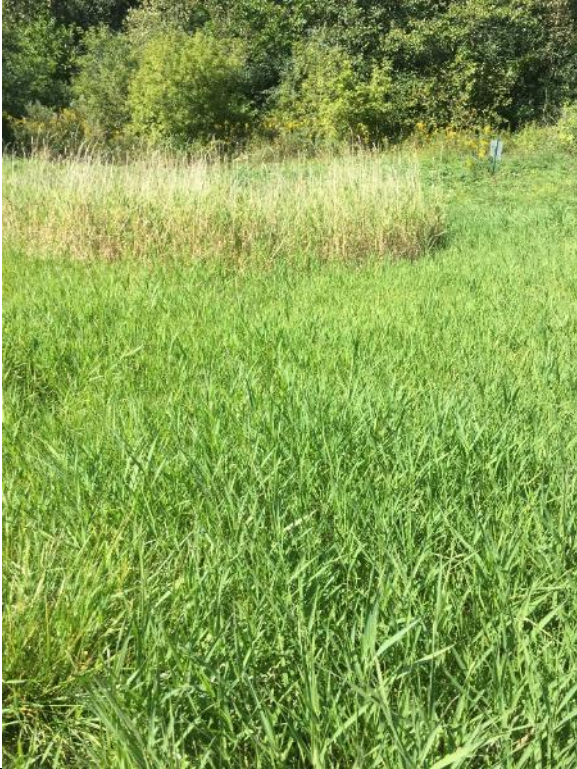
Client Name: Wisconsin Department of Natural Resources		Site Location: Refuse Hideaway Landfill Town of Middleton, Dane County, Wisconsin		Project No.: 335719.0001.0000, Phase 1	
Photo No. 33	Date 09-16-2019

Description Low area with standing water.

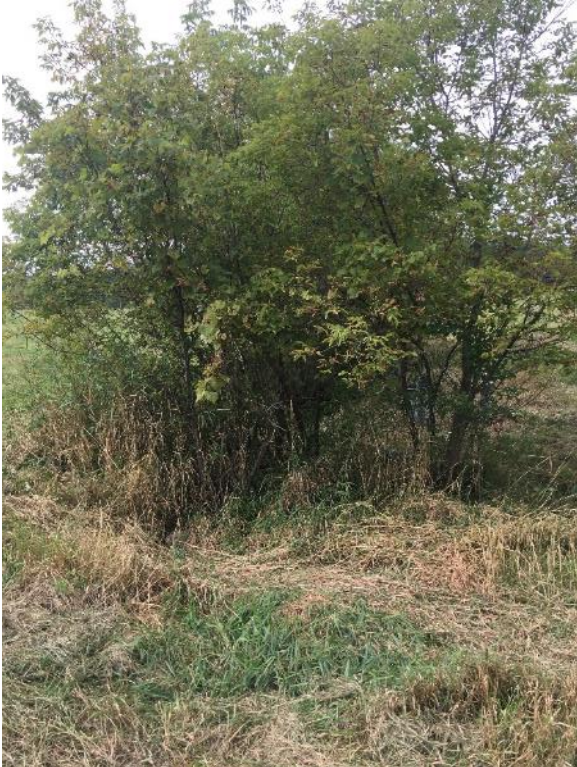
Client Name: Wisconsin Department of Natural Resources		Site Location: Refuse Hideaway Landfill Town of Middleton, Dane County, Wisconsin	Project No.: 335719.0001.0000, Phase 1
Photo No. 35	Date 09-23-2019

Riprap in the western drainage ditch, southwest of the landfill, has eroded and exposed geotextile at a couple of locations in the ditch. The riprap portion of the western drainage ditch is also overgrown with trees and vegetation which has helped stabilize the riprap and ditch. To repair the ditch at the locations where the geotextile is exposed, trees will need to be removed to access the ditch and repair the riprap. The WDNR should consider repairing the location in the western drainage ditch where the geotextile is exposed by placing additional geotextile and riprap. Table 3 contains an OPC for repairing the riprap in the western drainage ditch.

Description Riprap drainage ditch with overgrown trees.

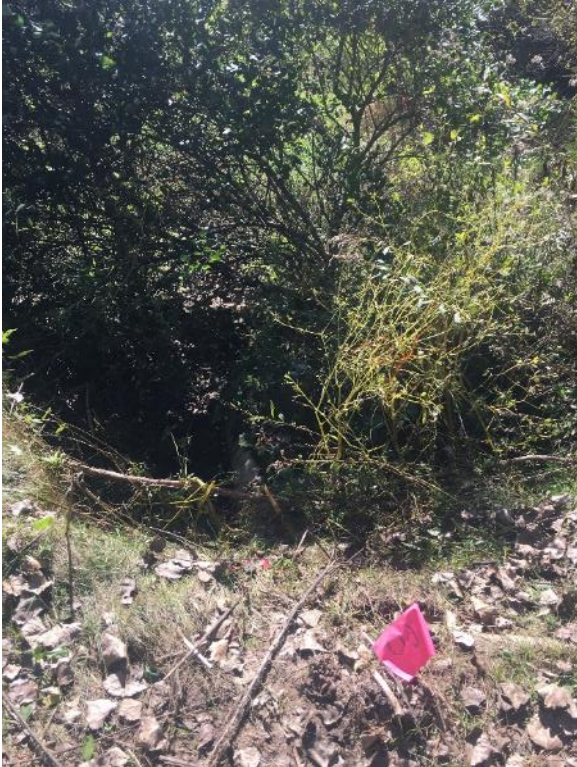
Client Name: Wisconsin Department of Natural Resources		Site Location: Refuse Hideaway Landfill Town of Middleton, Dane County, Wisconsin		Project No.: 335719.0001.0000, Phase 1	
Photo No. 39	Date 10-09-2019

Description Washout on the backside of the sedimentation basin berm exposing the back-half of the discharge pipe.

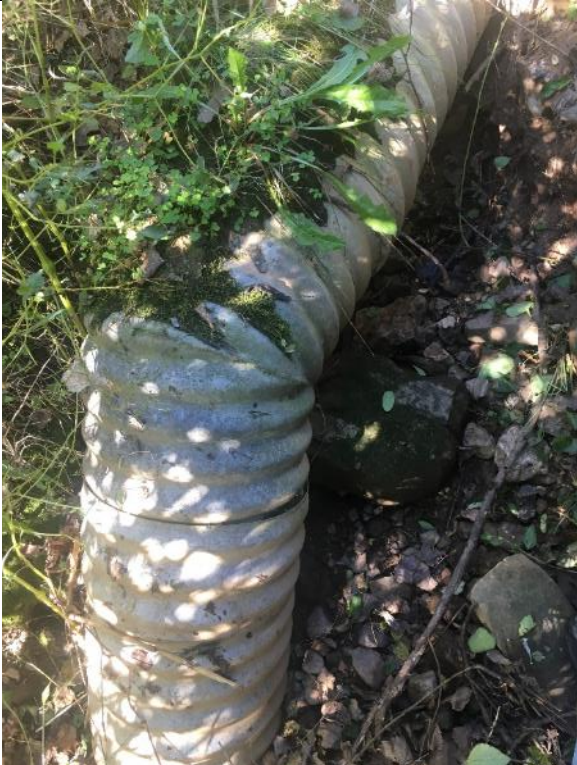
Photo No. 40	Date 10-09-2019

Description Washout on the backside of the sedimentation basin berm exposing the back-half of the discharge pipe.

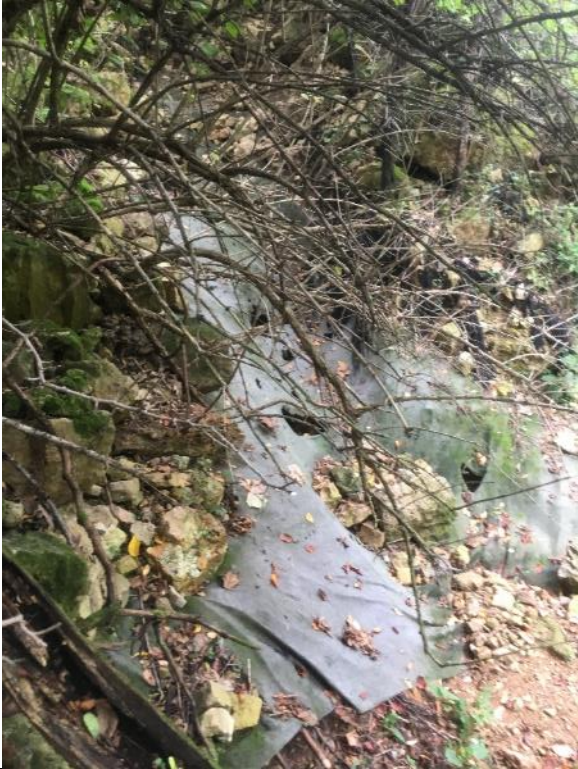
Client Name: Wisconsin Department of Natural Resources		Site Location: Refuse Hideaway Landfill Town of Middleton, Dane County, Wisconsin	Project No.: 335719.0001.0000, Phase 1
Photo No. 41	Date 09-23-2019

Description Exposed geotextile and washout on the southern portion of the western drainage ditch.

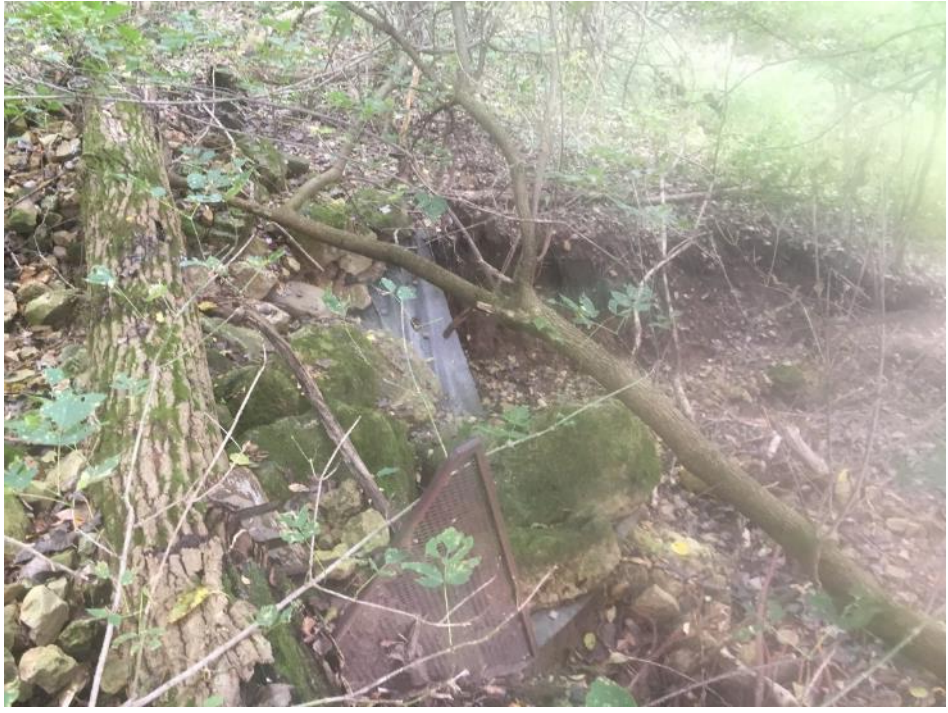
Client Name: Wisconsin Department of Natural Resources		Site Location: Refuse Hideaway Landfill Town of Middleton, Dane County, Wisconsin	Project No.: 335719.0001.0000, Phase 1
Photo No. 43	Date 09-23-2019

Description Exposed geotextile and washout near the southern discharge on the western drainage ditch.

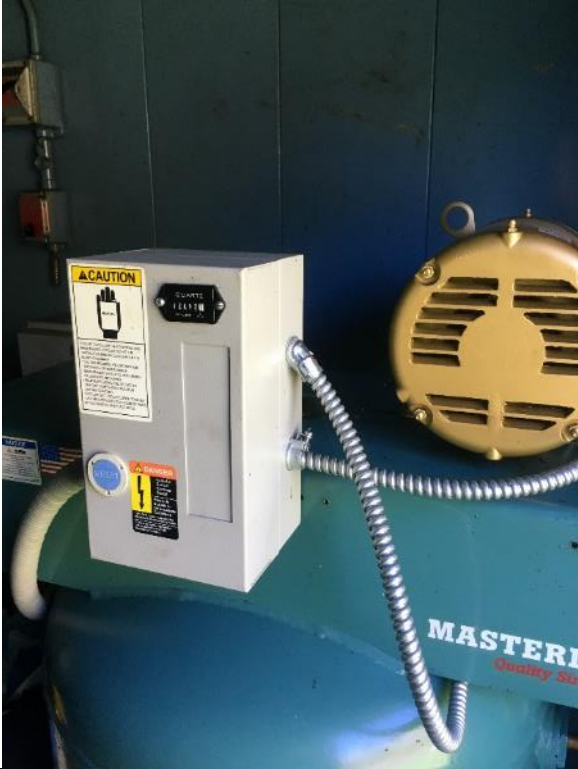
Client Name: Wisconsin Department of Natural Resources		Site Location: Refuse Hideaway Landfill Town of Middleton, Dane County, Wisconsin	Project No.: 335719.0001.0000, Phase 1
Photo No. 45	Date 09-16-2019

From historical site documents, on August 29, 2017 the compressor failed, and the leachate extraction system has remained non-operational since. Upon failure of the compressor, the compressor manufacturer's service vendor was contacted. On September 6, 2017 a representative from Energetics (Division of EMS Industrial, Inc.) was on-site to inspect and troubleshoot the compressor. Energetics indicated that several internal components of the compressor's motor were damaged or had failed. Energetics provided information about repair and replacement options as well as information with regard to the installation of a temporary compressor and flow meter to more accurately determine the leachate collection system air demands.

Description Electric motor and electrical on the existing compressor tank.

- Repair or replace the compressor,
- Install piping between the compressor and the dryer,
- Replace desiccant and filters in the dryer,
- Jet the leachate pipes, and
- Repair or replace the existing pumps and components in gas wells GW-4, GW-5, GW-8, GW-9, GW-10, GW-11 and GW-12.

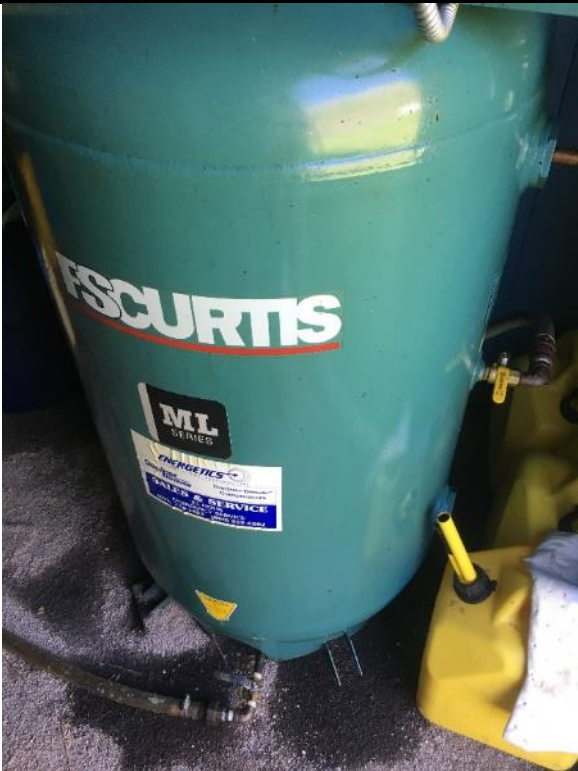
Photo No. 46	Date 09-16-2019

Description Existing compressor tank.
