June 23, 2022

Subject: Refuse Hideaway Landfill  
May 2022 Operation Monitoring and Maintenance Activities

<b>Client Name:</b> Wisconsin Department of Natural Resources (WDNR)	<b>Site Location:</b> Refuse Hideaway Landfill Middleton, WI	<b>Project No.:</b> TRC #457573
---	--	------------------------------------

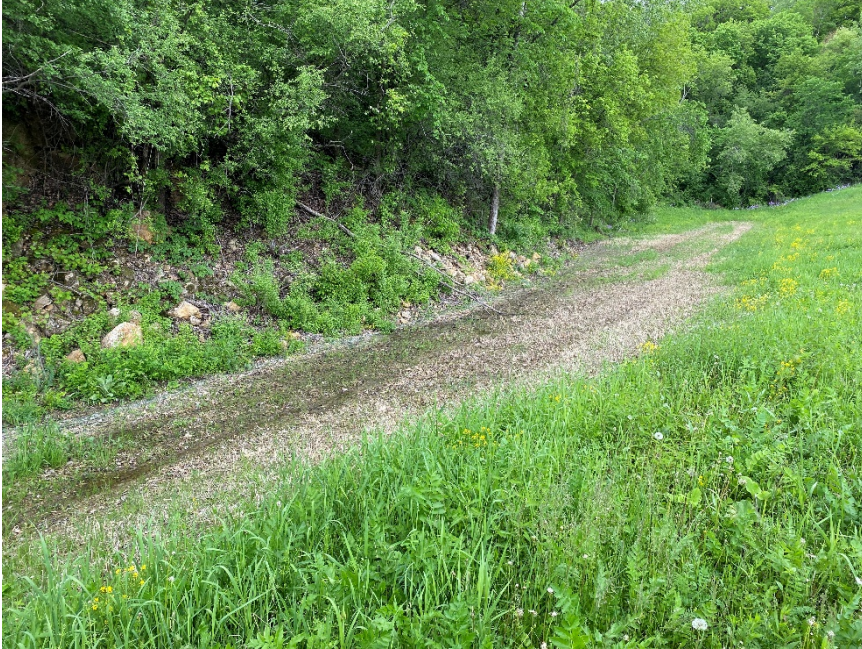
<b>Photo No.</b> 1	<b>Date</b> 5/26/2022

<b>Vegetation die-off:</b>			
<i>West Drainage Ditch</i> - The north portion shows signs of ponding or slow drainage, see Photo 1. No standing water in this area during the inspection but vegetation regrowth was sparing indicating water may be ponding at times.			
<i>East Drainage Ditch</i> - Some vegetation die-off and light erosion was observed along a north portion of the drainage ditch, see Photo 3. TRC will continue to monitor.			
<b>Maintain surface water conveyances and the sedimentation basin by completing the following:</b>			
<b>Inspect drainage ditches for erosion, blockages, and vegetation, describe and note any issues:</b>			
<i>East Drainage Ditch</i> - Some light erosion to the north end of the north-to-south portion observed, see Photo 3. Some riprap has fallen from the west embankment of the northern culvert, see Photo 2. Riprap was removed from the drainage way and placed back on the embankment. TRC will continue to monitor this location to determine if riprap is unstable.

<b>Description</b> <u>Western Drainage Ditch:</u> North portion contained vegetation die-off and wet soil conditions which may indicate that the area contains standing water at times. No standing water was observed at the time of the inspection.

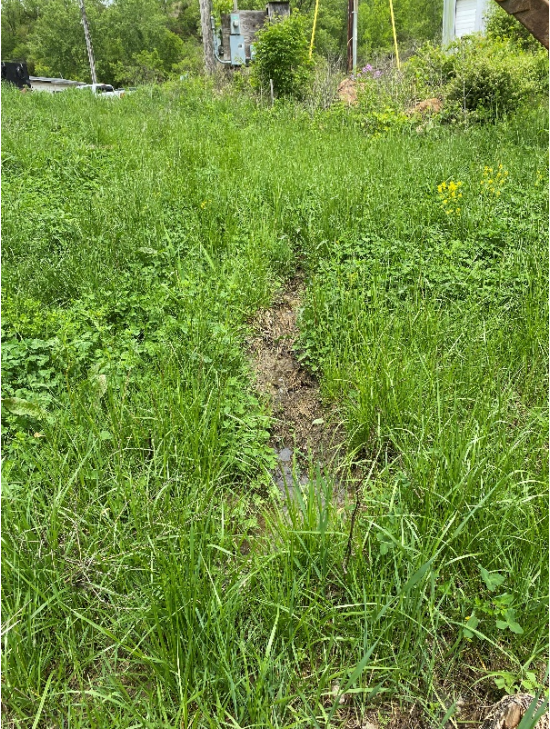
<b>Description</b> <u>Eastern Drainage Ditch:</u> Some vegetation die-off and light erosion observed along the drainage pathway at the north portion of the drainage ditch.
