July 22, 2022

Subject: Refuse Hideaway Landfill
June 2022 Operation Monitoring and Maintenance Activities

TRC completed the following operation, monitoring, and maintenance activities at the Refuse Hideaway Landfill in Middleton, WI in June 2022.

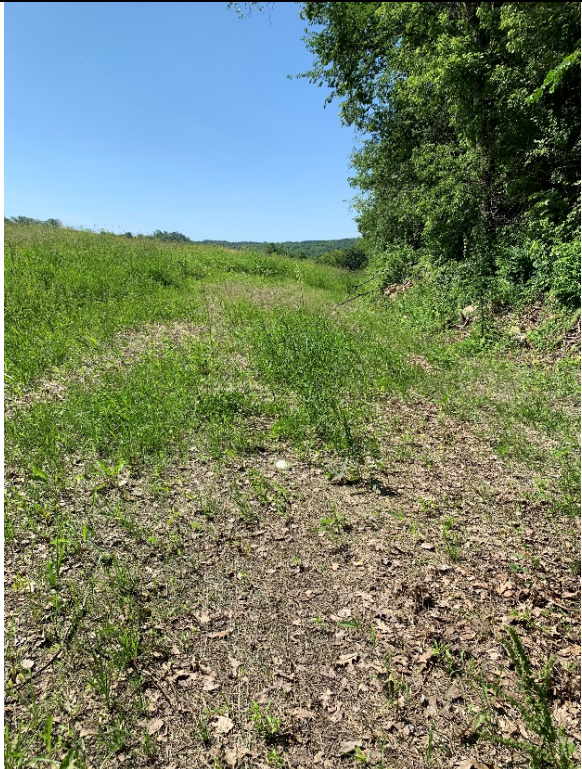
Client Name: Wisconsin Department of Natural Resources (WDNR)		Site Location: Refuse Hideaway Landfill Middleton, WI	Project No.: TRC # 457573
Photo No. 1	Date 6/20/2022

Description <u>Western Drainage Ditch:</u> North portion contained vegetation die-off and wet soil conditions which may indicate that the area contains standing water at times. No standing water was observed at the time of the inspection.

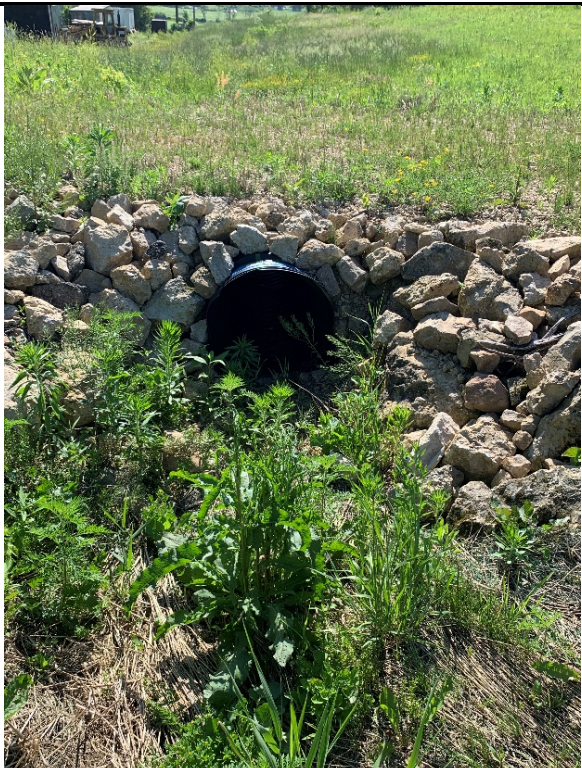
Photo No. 2	Date 6/20/2022

Description <u>Eastern Drainage Ditch:</u> Riprap has remained in place at the west side of the western culvert. In May of 2022, TRC had observed a small amount of riprap that had fallen from the embankment and collected in the drainage pathway. TRC had placed the fallen riprap back to the embankment.

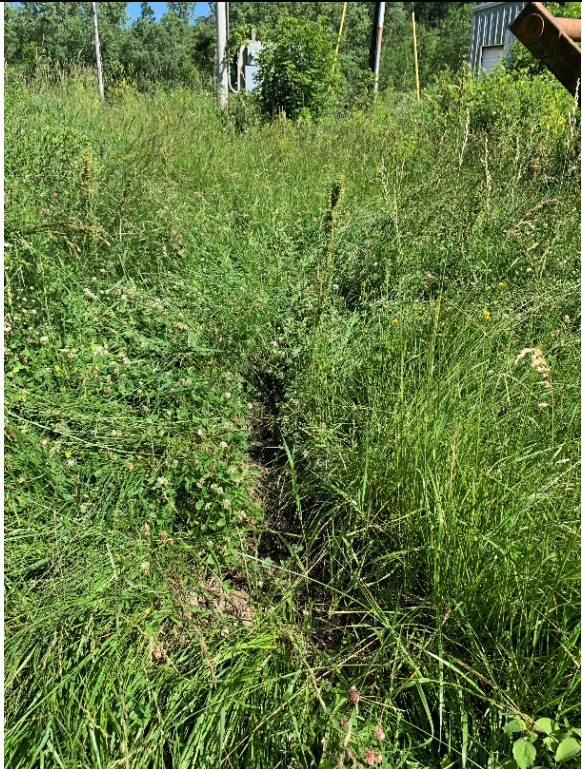
Client Name: Wisconsin Department of Natural Resources (WDNR)		Site Location: Refuse Hideaway Landfill Middleton, WI	Project No.: TRC # 457573
Photo No. 3	Date 6/20/2022

Inspect drainage ditches for erosion, blockages, and vegetation, describe and note any issues: <i>East Drainage Ditch</i> - Some light erosion to the north end of the north-to-south portion observed, see Photo 3.			
Inspect sedimentation basin banks and outfalls for erosion, describe and note any issues: No erosion or other issues at sedimentation basin banks and outfalls.			
Measure the distance between the invert of the sedimentation basin outlet and the top of the sediments accumulated in the basin (June Only): No sediment accumulation.

Description <u>Eastern Drainage Ditch:</u> Some vegetation die-off and light erosion observed along the drainage pathway at the north portion of the drainage ditch.

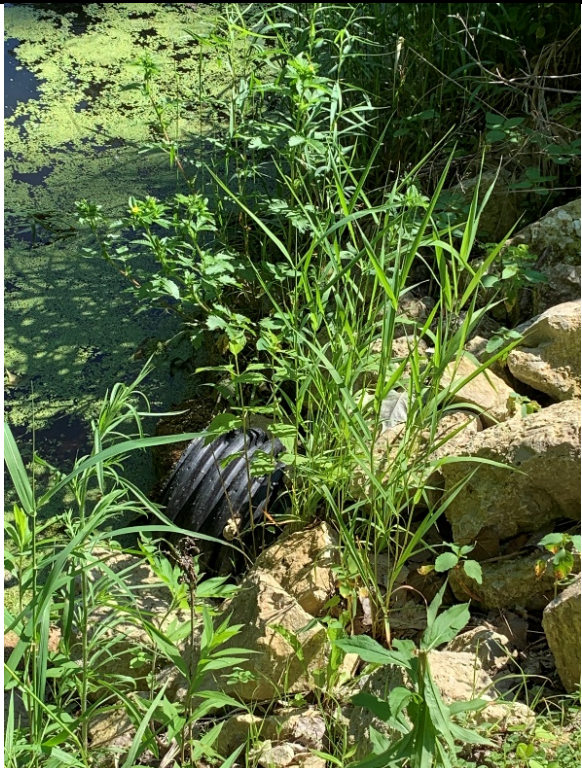
Photo No. 4	Date 6/20/2022

Description <u>Sediment Basin:</u> No sediment accumulation at outfall.
