Subject: Refuse Hideaway Landfill  
July 2022 Operation Monitoring and Maintenance Activities

TRC conducted a monthly inspection of the landfill cap and stormwater conveyance features on July 18, 2022. An inspection form and photo log are attached with further details.

## Photographic Log

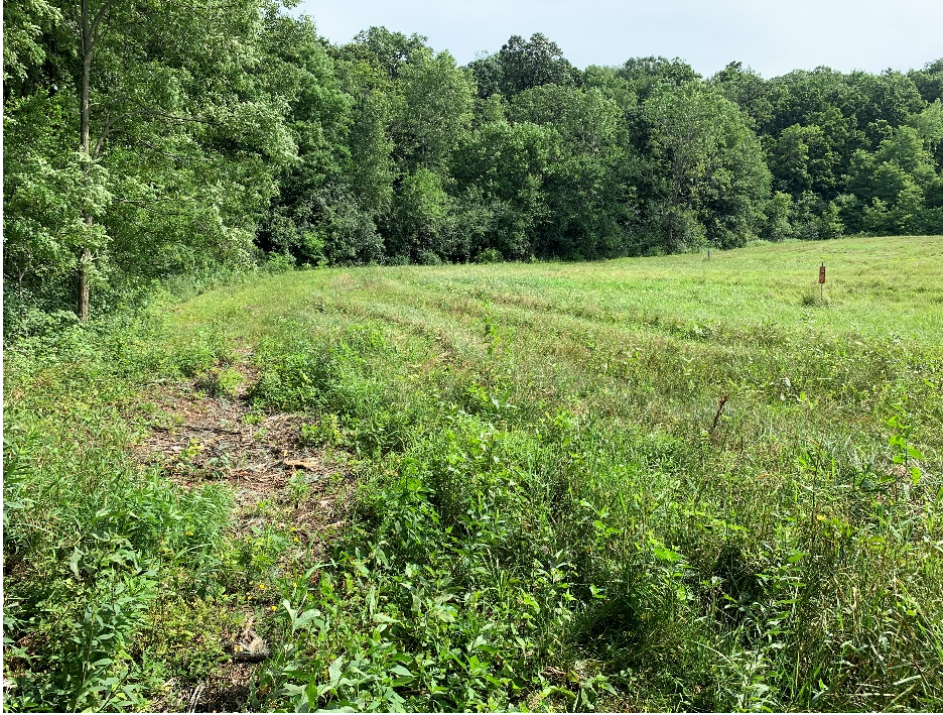
<b>Client Name:</b> Wisconsin Department of Natural Resources (WDNR)		<b>Site Location:</b> Refuse Hideaway Landfill Middleton, WI	<b>Project No.:</b> TRC # 457573
<b>Photo No.</b> 1	<b>Date</b> 7/19/2022

<b>Description</b> <u>Western Drainage Ditch:</u> North portion contained vegetation die-off and wet soil conditions which may indicate that the area contains standing water at times. No standing water was observed at the time of the inspection.

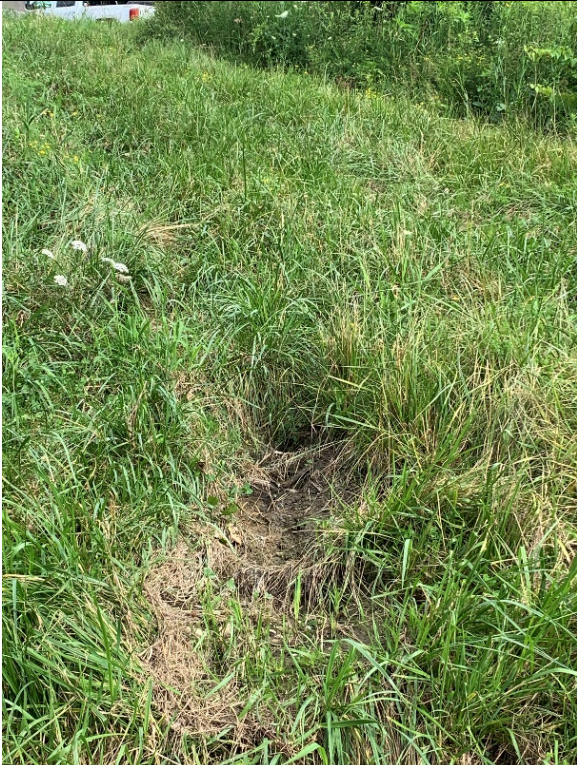
<b>Photo No.</b> 2	<b>Date</b> 7/19/2022

<b>Description</b> <u>Eastern Drainage Ditch:</u> Some vegetation die-off and light erosion observed along the drainage pathway at the north portion of the drainage ditch.

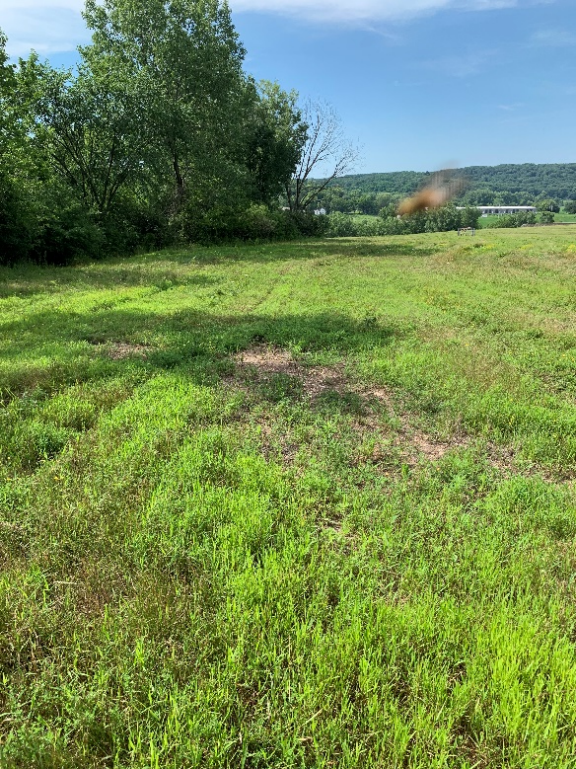
<b>Photo No.</b> 3	<b>Date</b> 7/19/2022

<b>Extent of vegetation cover:</b> The cap has been mowed since the previous inspection. Vegetation cover is acceptable over the majority of the Site. Some areas that were seeded post-construction in 2021 are not showing signs of growth as shown in Photos 1, 3 and 4. No erosion is evident however, re-seeding may be required at various locations throughout the Site, TRC will continue to monitor.			
<b>Significant erosion:</b> No evidence of significant erosion at the Site observed.			
<b>Repeated erosion:</b> No evidence repeated erosion at the Site observed.			
<b>Vegetation die-off:</b> <i>West Drainage Ditch</i> - The north portion shows signs of ponding or slow drainage, see Photo 1. No standing water in this area during the inspection but vegetation regrowth was sparing indicating water may be ponding at times.  <i>East Drainage Ditch</i> - Some vegetation die-off and light erosion was observed along a north portion of the drainage ditch, see Photo 2. TRC will continue to monitor.

<b>Description</b> <u>Northeastern Landfill</u> Extents: Following mowing, it was apparent that select areas that were seeded following the 2021 construction event contained bare soil. Additional seeding may be needed in Fall 2022.

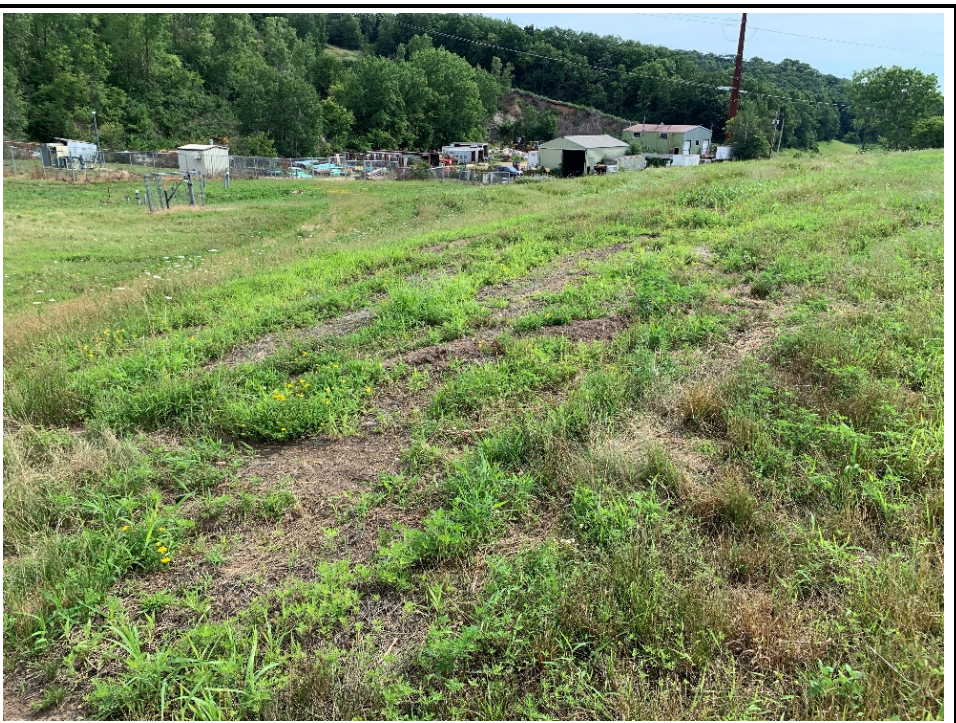
<b>Photo No.</b> 4	<b>Date</b> 7/19/2022

<b>Description</b> <u>Central Landfill Extents:</u> Following mowing, it was apparent that select areas that were seeded following the 2021 construction event contained bare soil. Additional seeding may be needed in Fall 2022.
