Subject: Refuse Hideaway Landfill
August 2022 Operation Monitoring and Maintenance Activities

Photographic Log

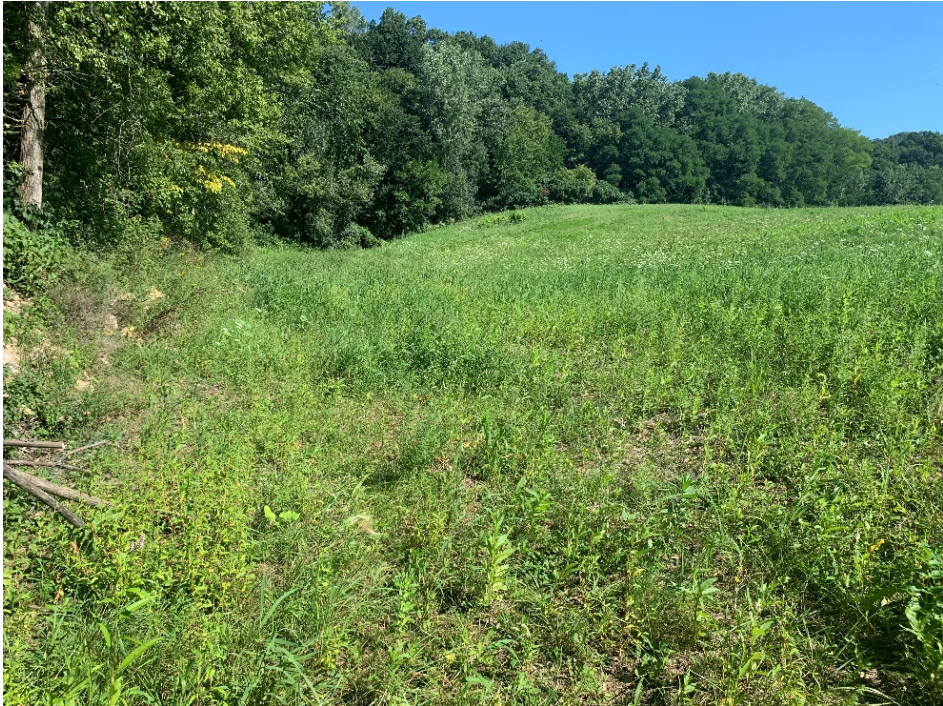
Client Name: Wisconsin Department of Natural Resources (WDNR)		Site Location: Refuse Hideaway Landfill Middleton, WI	Project No.: TRC # 457573
Photo No. 1	Date 8/22/2022

Description <u>Western Drainage Ditch:</u> North portion shows signs of increased vegetation regrowth compared to previous months. No standing water was observed at the time of the inspection.

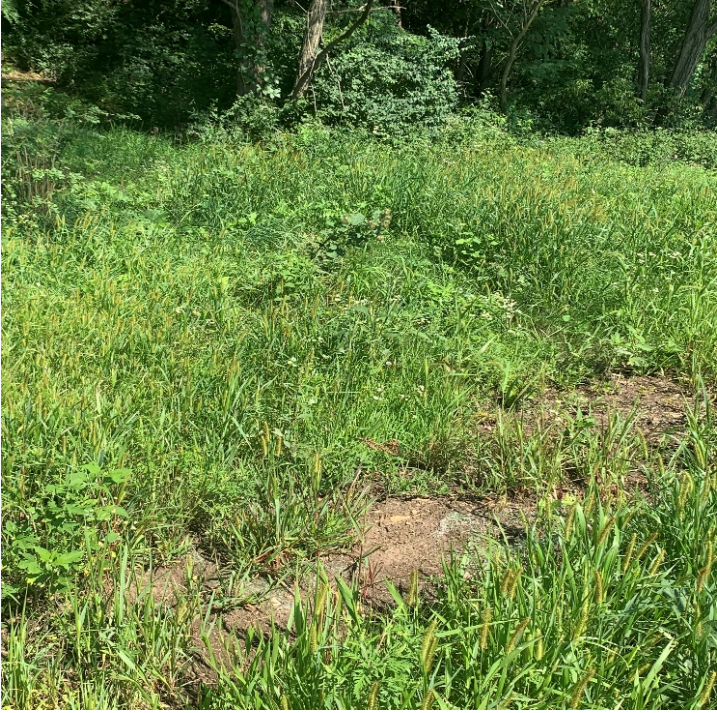
Client Name: Wisconsin Department of Natural Resources (WDNR)		Site Location: Refuse Hideaway Landfill Middleton, WI	Project No.: TRC # 457573
Photo No. 3	Date 8/22/2022

Description <u>Northwestern Landfill Extents</u> Select areas that were seeded following the 2021 construction event contained bare soil. Additional seeding may be needed in Fall 2022.			
Photo No. 4	Date 8/22/2022

TRC conducted a monthly inspection of the landfill cap and stormwater conveyance features on August 22, 2022. TRC personnel observed areas of bare soil throughout the landfill cap that were previously seeded in 2021. To address this, TRC recommends reseeding these areas in the Fall of 2022. An inspection form and photo log are attached with further details.

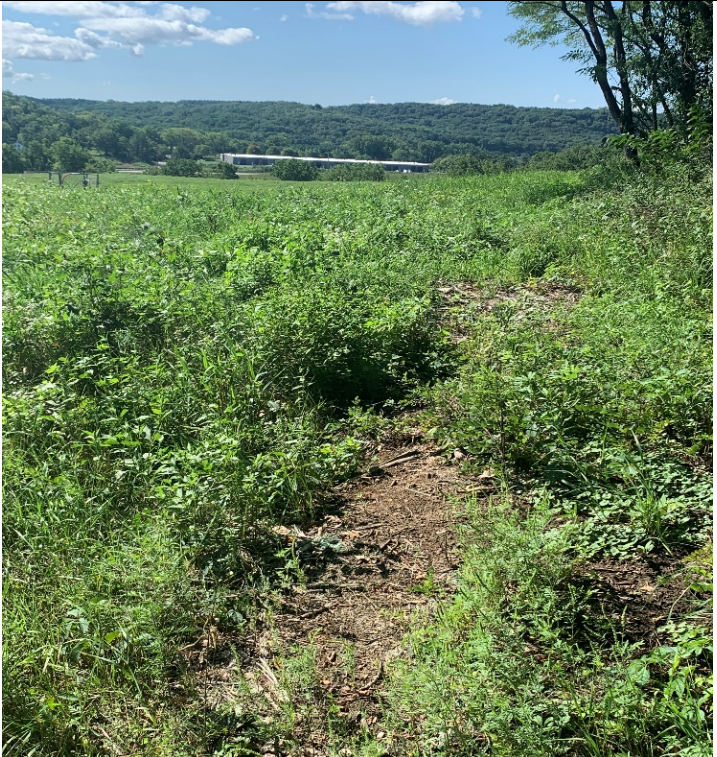
Description <u>Northern Landfill Extents</u> Select areas that were seeded following the 2021 construction event contained bare soil. Additional seeding may be needed in Fall 2022.

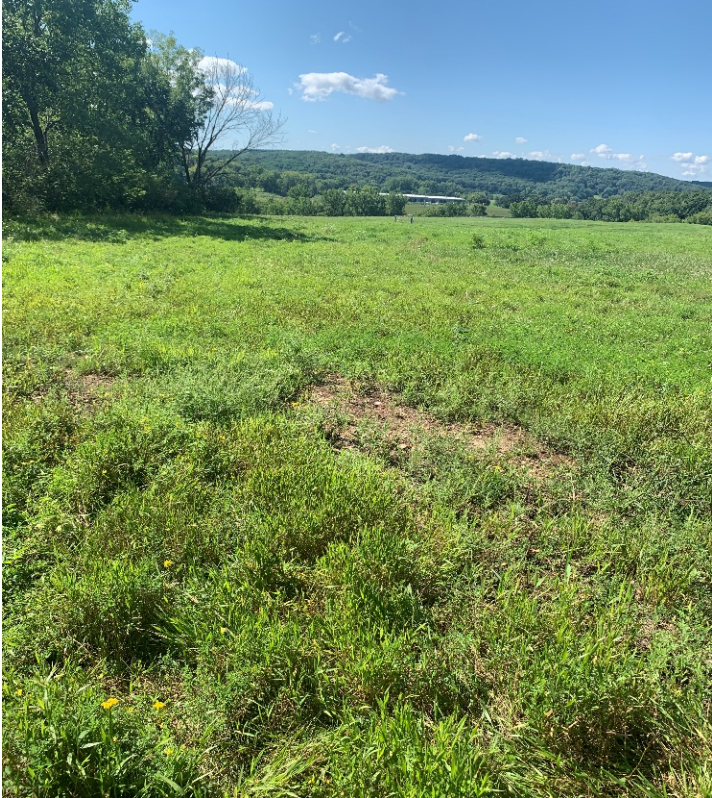
Client Name: Wisconsin Department of Natural Resources (WDNR)		Site Location: Refuse Hideaway Landfill Middleton, WI	Project No.: TRC # 457573
Photo No. 5	Date 8/22/2022

Description <u>Northeastern Landfill Extents</u> Select areas that were seeded following the 2021 construction event contained bare soil. Additional seeding may be needed in Fall 2022.

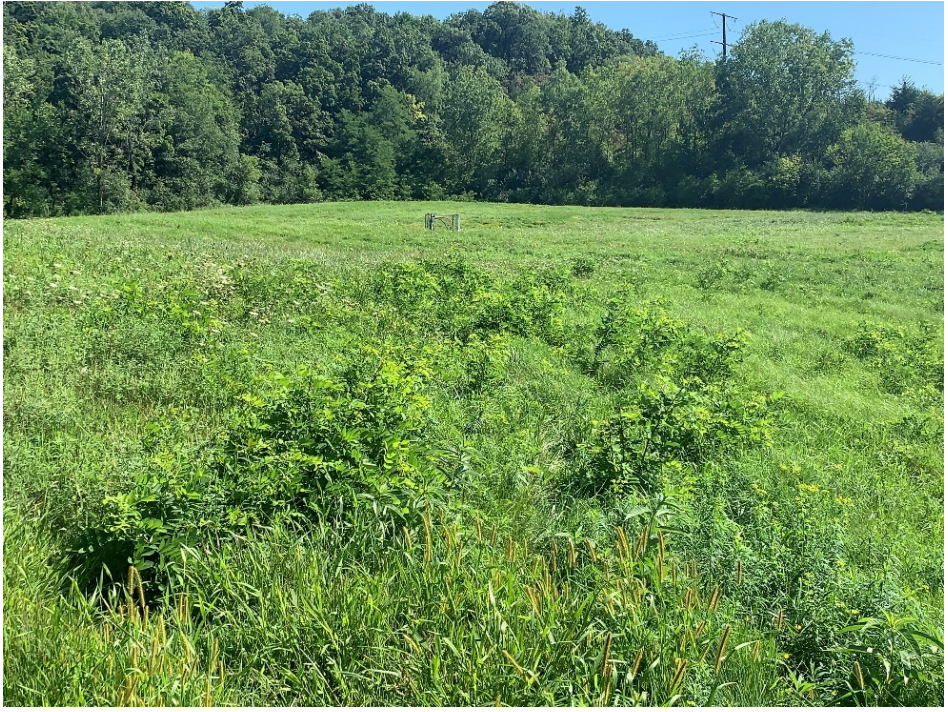
Client Name: Wisconsin Department of Natural Resources (WDNR)		Site Location: Refuse Hideaway Landfill Middleton, WI	Project No.: TRC # 457573
Photo No. 7	Date 8/22/2022

Description <u>Northwestern Landfill</u> Extents: Signs of emerging shrub growth were observed at the northwest portion of the landfill surface.			
Photo No. 8	Date 8/22/2022

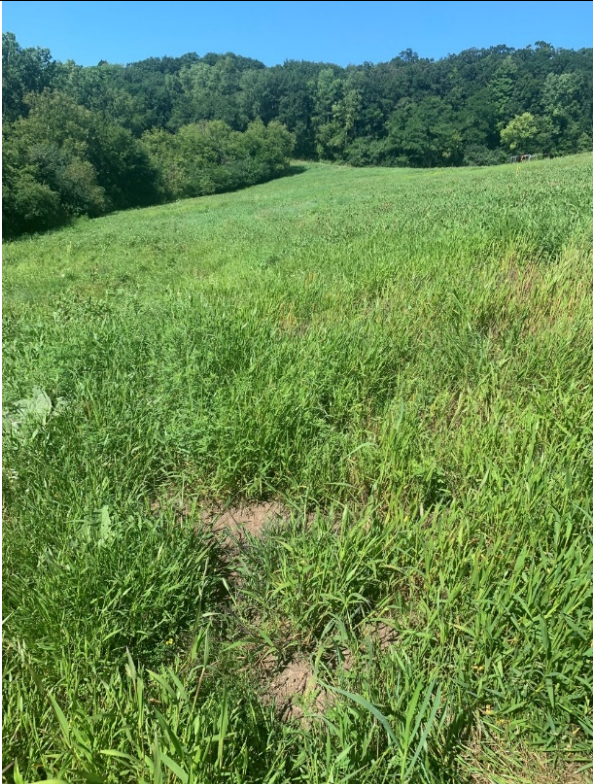
Description <u>Southern Landfill Extents</u> Areas of bare soil (potential turkey bedding) were observed at the southern portion of the landfill surface. Additional seeding may be needed in Fall 2022.
