Subject: Refuse Hideaway Landfill
September 2022 Operation Monitoring and Maintenance Activities

Client Name: Wisconsin Department of Natural Resources (WDNR)	Site Location: Refuse Hideaway Landfill Middleton, WI	Project No.: TRC # 457573
---	--	-------------------------------------

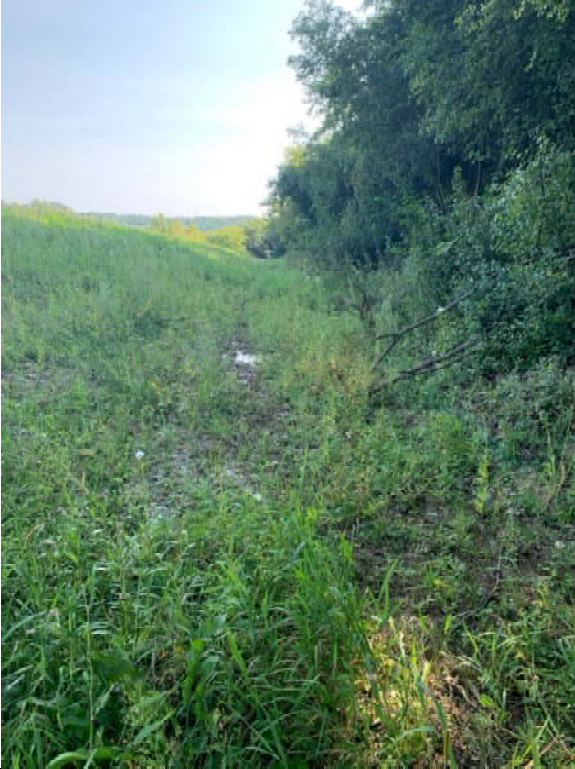
Photo No. 1	Date 9/13/2022		
Description <u>Western Drainage Ditch:</u> North portion shows signs of standing water at the time of the inspection. Surface water is flowing naturally towards the southern riprap. 3.15" of rain was recorded between September 10 and 12.

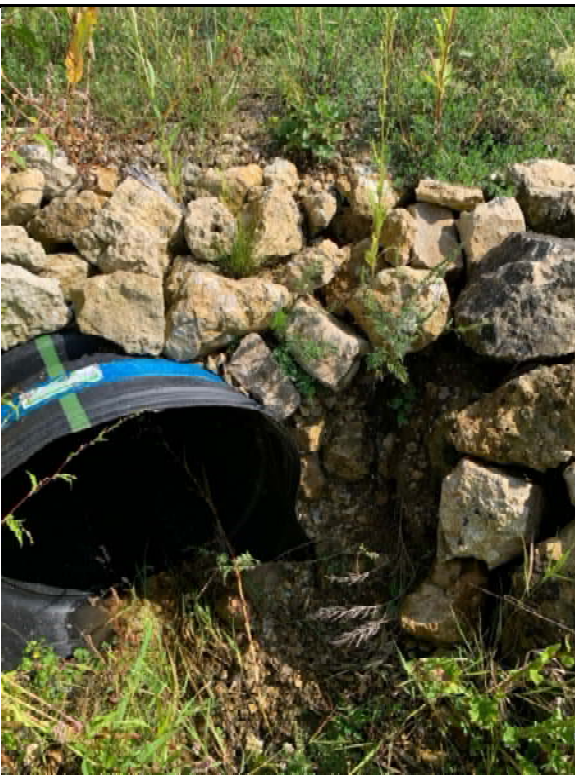
Photo No. 2	Date 9/13/2022		
Description <u>Eastern Drainage Ditch:</u> Some riprap has begun to washout from the west side of the western culvert. Gravel has begun to wash into the culvert, but the drainage way was not obstructed.

<i>East Drainage Ditch</i> - TRC has continued to monitor the riprap along west embankment of the northern culvert. Riprap appears to be eroding and beginning to fail. Some vegetation die-off and light erosion was observed along a north portion of the drainage ditch; see Photos 2 and 3.			
Beyond the above noted issues, drainage ways are acceptable, with minor changes from previous conditions.			
Extent of vegetation cover: Vegetation cover is acceptable over the majority of the Site, with vegetation growth between 16"-20". Mowing of the cap is expected to be completed in late September. Some areas that were seeded post-construction in 2021 are not showing signs of growth, as shown in Photos 4-6. No erosion is evident, though reseeding may be required at various locations throughout the Site. TRC plans to reseed select areas in October as approved by WDNR.			
Some tree regrowth has started to the northeast (photo 7) and east central (photo 8) portions of the landfill. These areas will be further inspected following the fall mowing event.

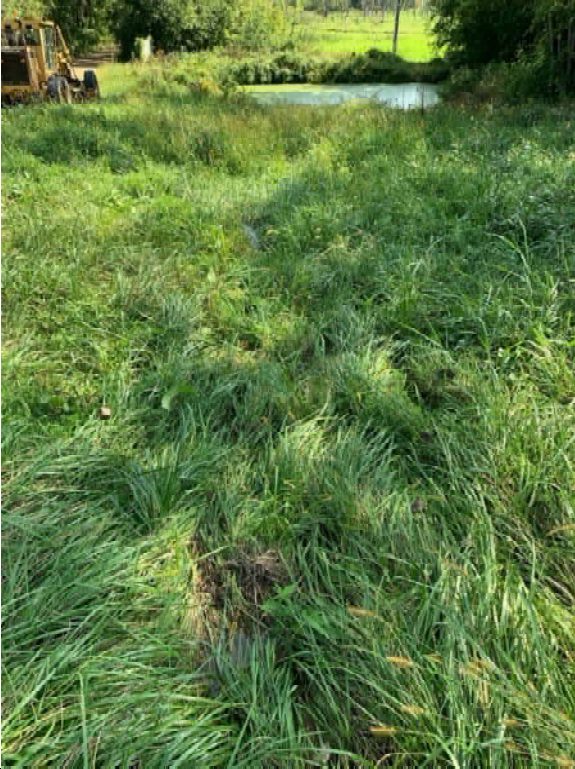
Description <u>Eastern Drainage Ditch:</u> The north portion of the drainage pathway shows natural flowage of surface water. 3.15" of rain was recorded between September 10 and 12. Light erosion is observed.

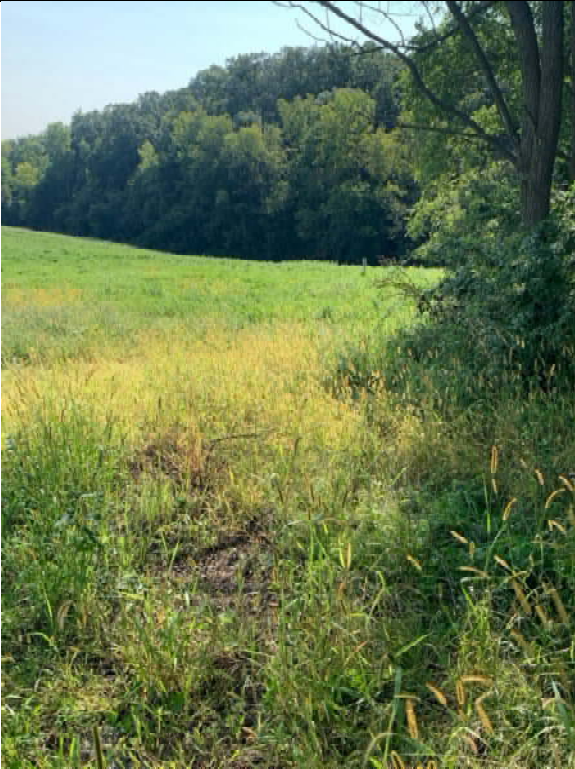
Photo No. 4	Date 9/13/2022

Description <u>Northwestern Landfill Extents:</u> Select areas that were seeded following the 2021 construction event contained bare soil. Reseeding is scheduled for October 2022.

TRC conducted a monthly inspection of the landfill cap and stormwater conveyance features on September 13, 2022. TRC personnel observed areas of bare soil throughout the landfill cap that were previously seeded in 2021. TRC plans to reseed these areas in October 2022 as approved by the WDNR. An inspection form and photo log are attached with further details.

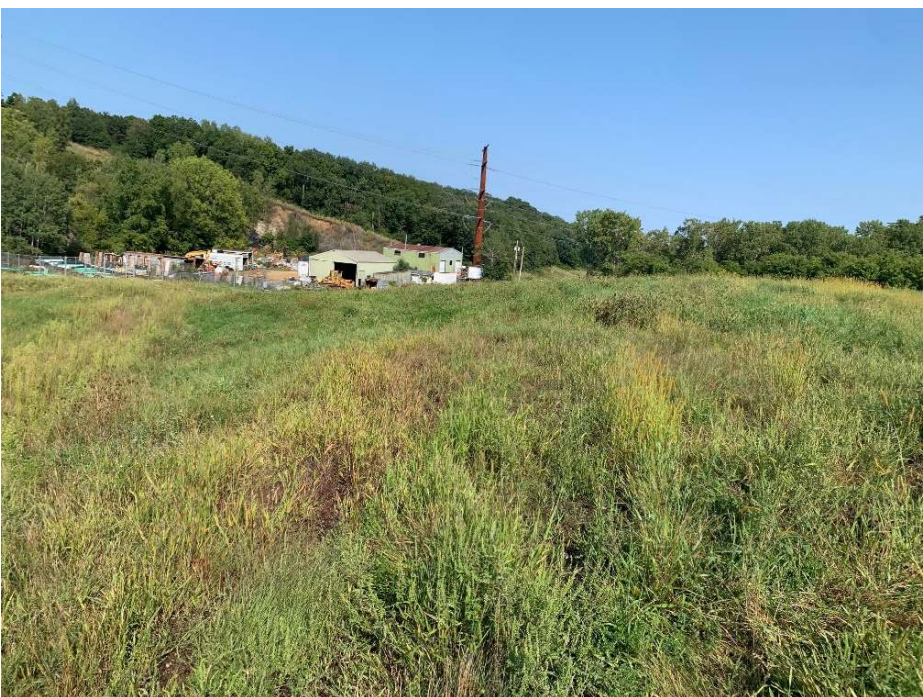
Photo No. 6	Date 9/13/2022

Description <u>Central Landfill Extents:</u> Select areas that were seeded following the 2021 construction event contained bare soil. Reseeding is scheduled for October 2022.

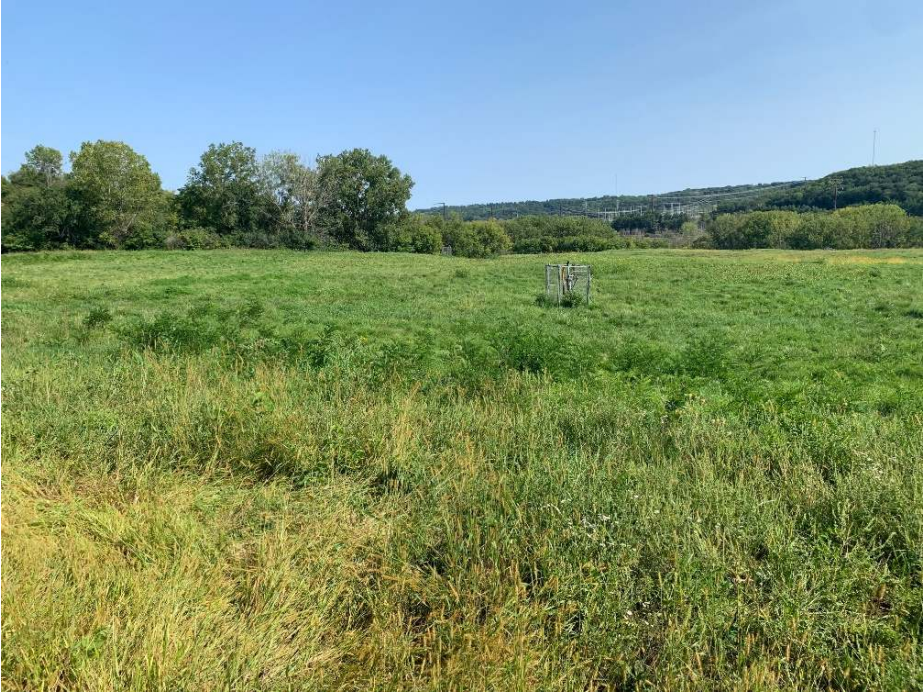
Description <u>Northwest Landfill Extents:</u> Signs of emerging shrub growth were observed at the northwest portion of the landfill surface.

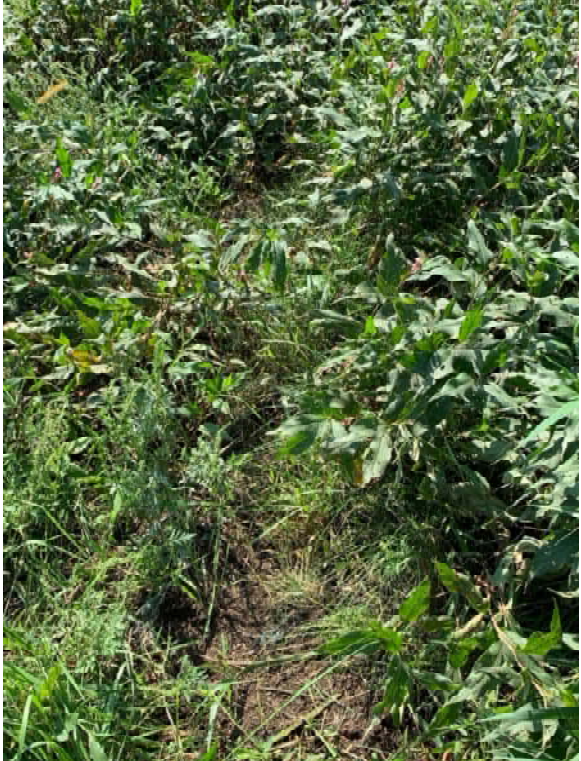
Photo No. 8	Date 9/13/2022

Description <u>East Central Landfill Extents:</u> Signs of emerging shrub growth were observed along the east central portion of the landfill surface.
