Subject: Refuse Hideaway Landfill
October 2022 Operation Monitoring and Maintenance Activities

TRC completed the following operation, monitoring, and maintenance activities and system troubleshooting at the Refuse Hideaway Landfill in Middleton, WI in October 2022.

Photographic Log

Gas Vent GV-4 Repair Field Notes

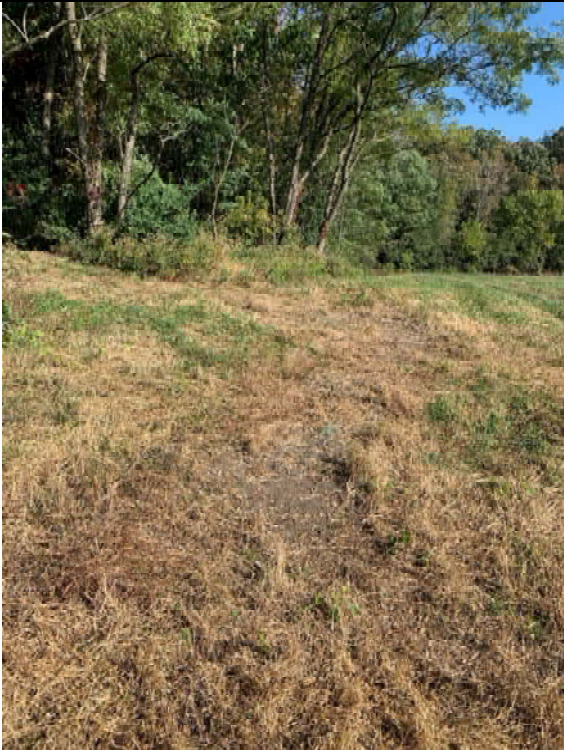
Description <u>Western Drainage Ditch:</u> North portion shows signs vegetation die off at the time of the inspection. During September's inspection standing water was observed. Surface water is flowing naturally towards the southernly riprap. TRC reseeded the area on October 20, 2022.			
Photo No. 2	Date 10/11/2022

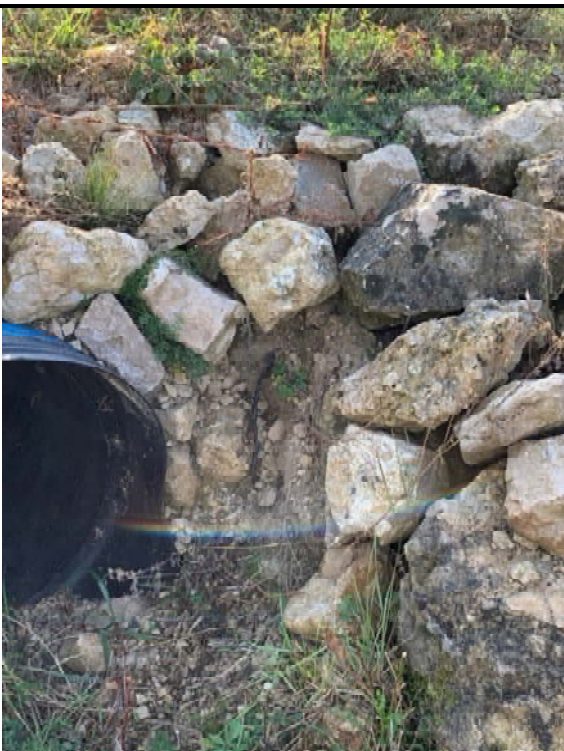
Description <u>Eastern Drainage Ditch:</u> Riprap has begun to deteriorate at the west side of the western culvert. Drainage is flowing and is not being obstructed.

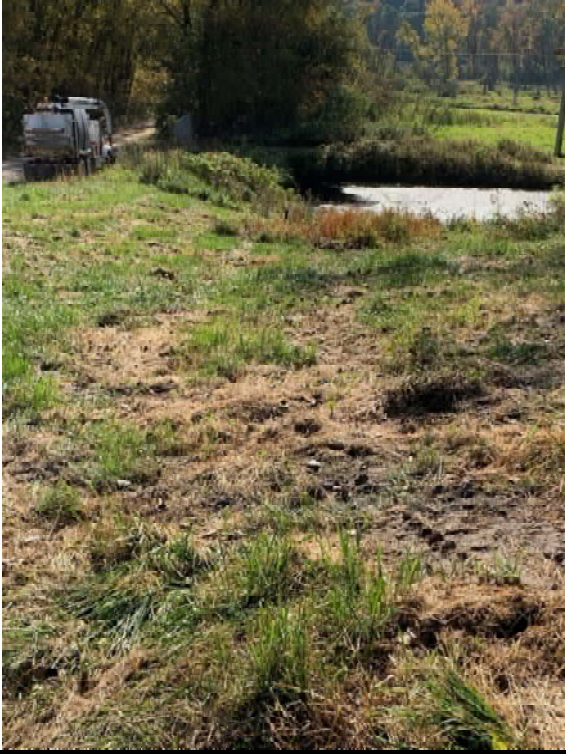
3	10/11/2022		
Description <u>Eastern Drainage Ditch:</u> After mowing operations bare soil was observed at the north portion of the drainage ditch. Drainage shows natural flowage of surface water into the sediment pond. TRC reseeded the area on October 20, 2022.			
Photo No.	Date

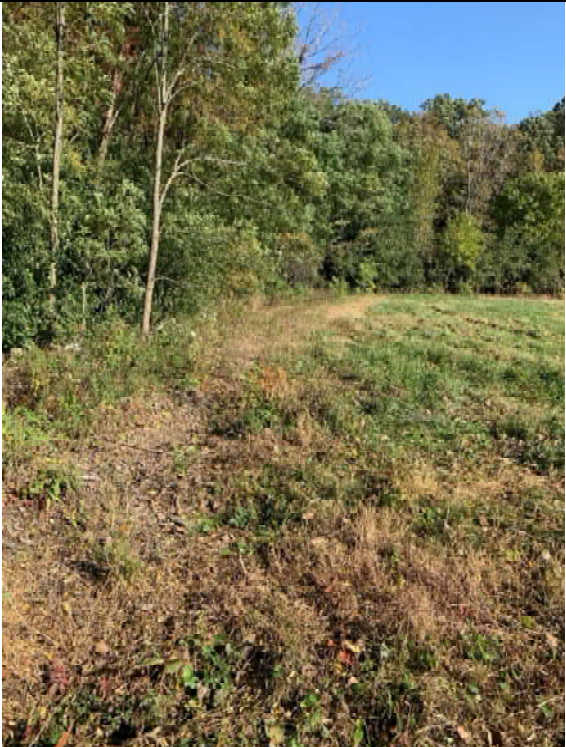
Extent of vegetation cover: Vegetation cover is acceptable over the majority of the Site. Some areas that were seeded post-construction in 2021 are not showing signs of growth, as shown in photos 4-6. Re-seeding was conducted by TRC on October 20, 2022 in select areas to re-establish vegetation. The areas will be monitored for regrowth in Spring of 2023. Burrowing was observed at gas extraction wells GW-2, GW-4, and GW-12, see photos 7-9. Larger holes were filled in with top soi during the October 20, 2022 reseeded event.			
Significant erosion: No evidence of significant erosion at the Site observed.			
Repeated erosion: No evidence repeated erosion at the Site observed.			
Vegetation die-off: <i>West Drainage Ditch</i> - The north portion shows signs of vegetation die off, see Photo 1. No standing water in this area during the inspection but vegetation regrowth was sparing indicating water may be ponding at times. <i>East Drainage Ditch</i> - Following the mowing event light erosion was observed along a north portion of the drainage ditch, see Photo 3. TRC will continue will reseed in the fall. TRC reseeded select areas in both drainage ditches on October 20, 2022 to re-establish vegetation. The areas will be monitored for regrowth in Spring of 2023.

4	10/11/2022		
Description <u>Northwestern Landfill Extents</u> Select areas that were seeded following the 2021 construction event contained bare soil. TRC reseeded the areas on October 20, 2022.

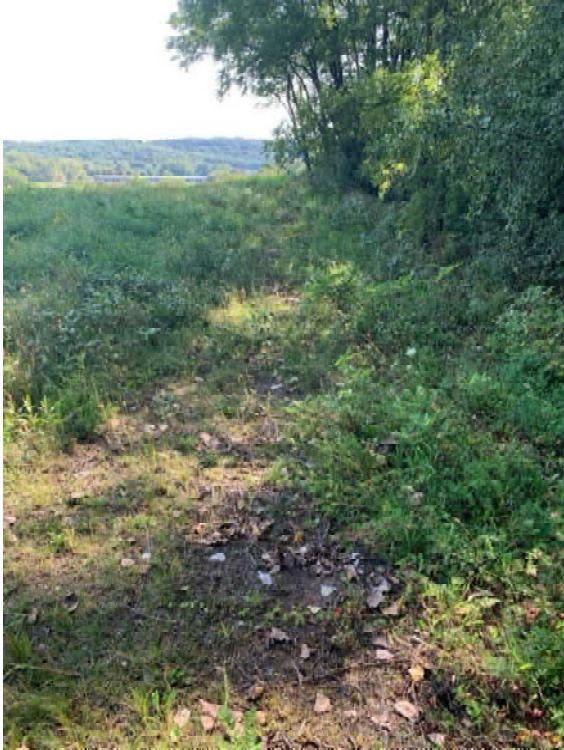
Client Name: Wisconsin Department of Natural Resources (WDNR)		Site Location: Refuse Hideaway Landfill Middleton, WI	Project No.: TRC # 457573
Photo No. 5	Date 10/11/2022

Description <u>Northern Landfill Extents</u> Select areas that were seeded following the 2021 construction event contained bare soil. TRC reseeded the areas on October 20, 2022.			
Photo No. 6	Date 10/11/2022

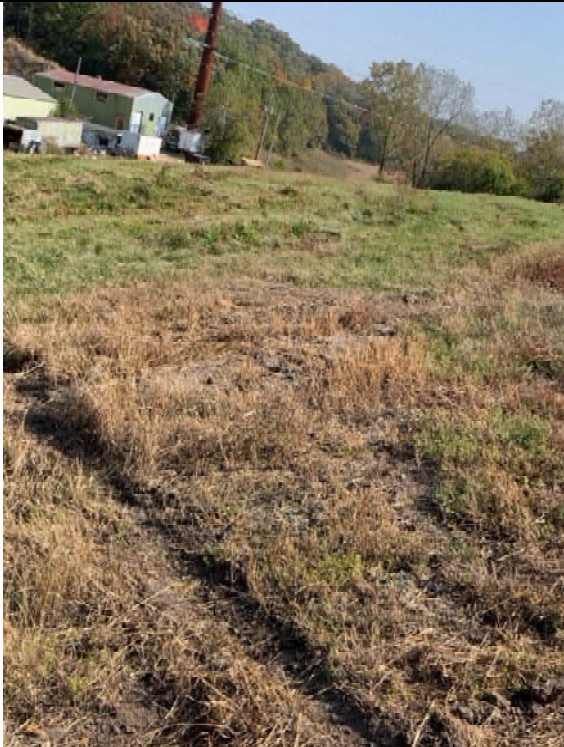
Description <u>Central Landfill Extents</u> Select areas that were seeded following the 2021 construction event contained bare soil. TRC reseeded the areas on October 20, 2022.

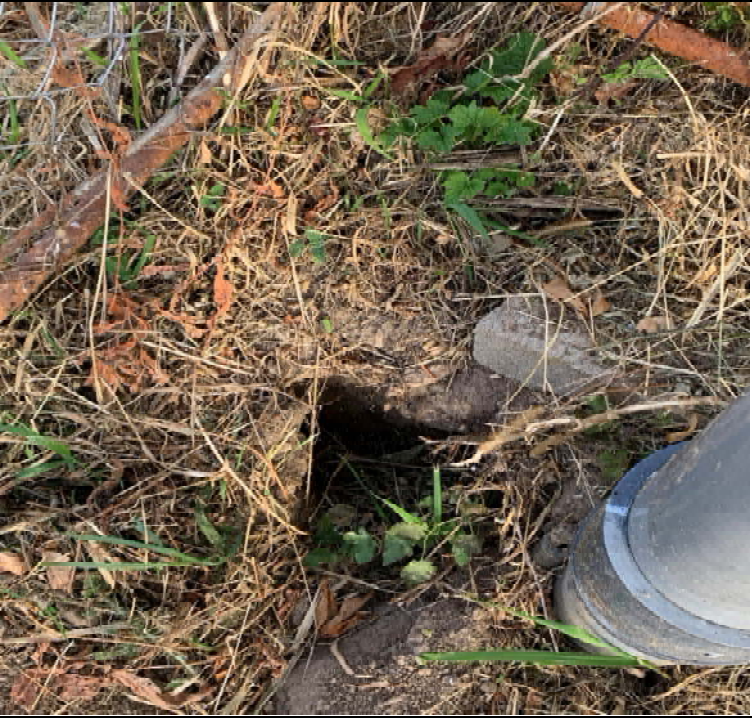
Photo No. 7	Date 10/11/2022

<p>Description <u>Southern Landfill Extents:</u> Signs of burrowing at GW-2. No damage to the header pipe.</p> <p>Holes were filled in during the October 20, 2022 reseeding event.</p>

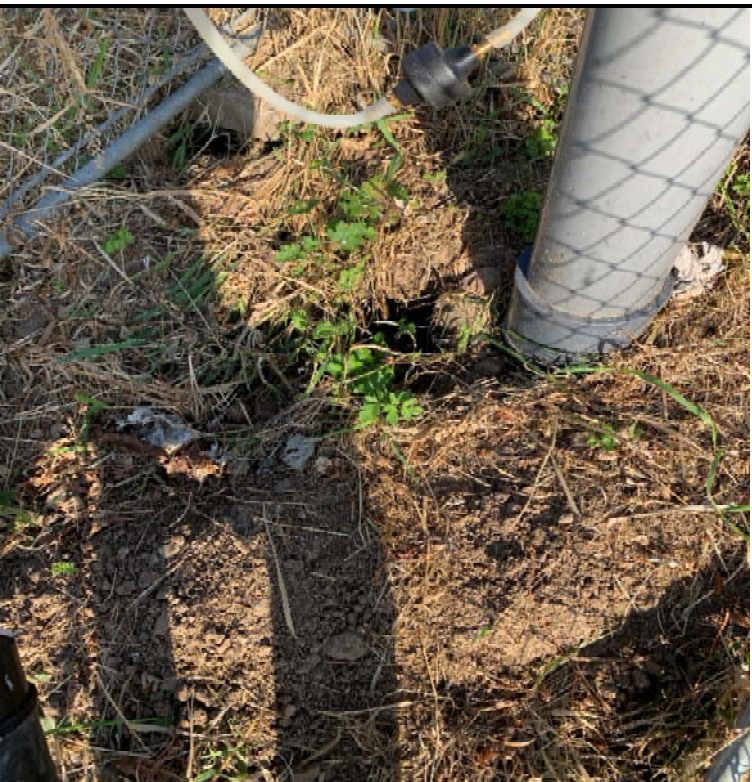
Photo No. 8	Date 10/11/2022

<p>Description <u>Southern Landfill Extents:</u> Signs of burrowing at GW-4. No damage to the header pipe.</p> <p>Holes were filled in during the October 20, 2022 reseeding event.</p>

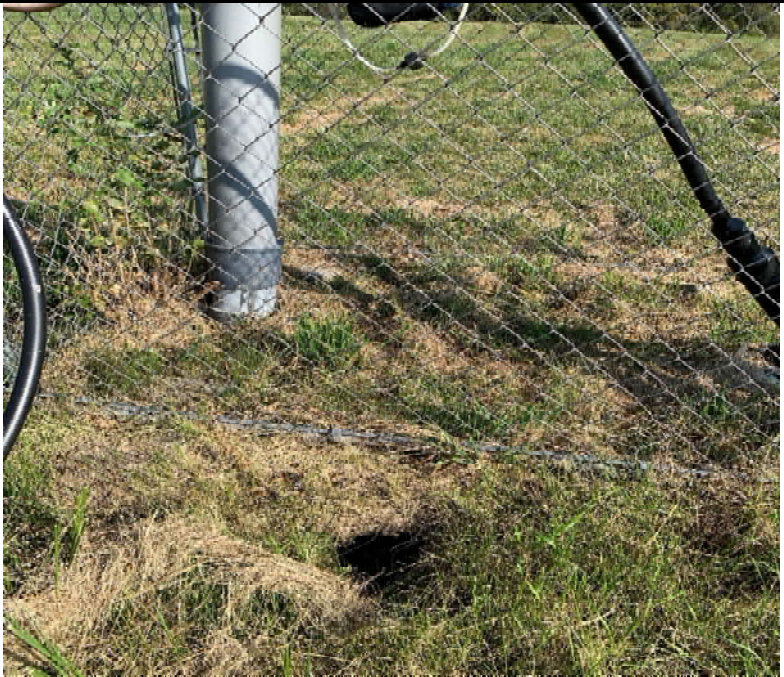
Client Name: Wisconsin Department of Natural Resources (WDNR)		Site Location: Refuse Hideaway Landfill Middleton, WI	Project No.: TRC # 457573
Photo No. 9	Date 10/11/2022

Description <u>Northern Landfill Extents:</u> Signs of burrowing at GW-12. No damage to the header pipe. Holes were filled in during the October 20, 2022 reseeding event.

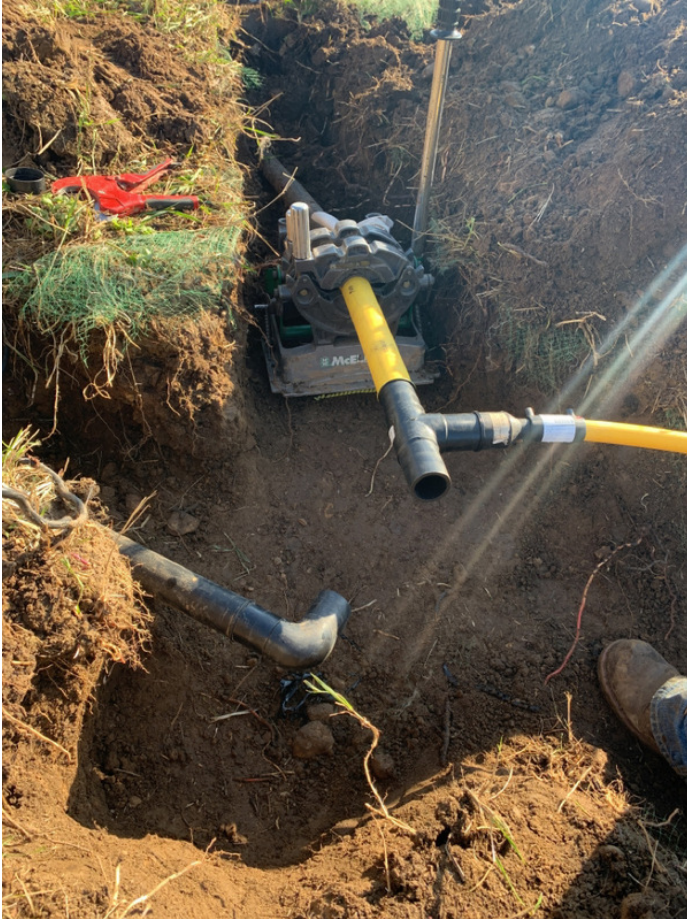
Photo Info - 1. 09:29, JR repairing the air line at GV-4

During the October 6, 2022, site visit, TRC observed that the air line for gas vent GV-4 was damaged during the September mowing event. TRC coordinated the repairs of the air line with J&R Underground (J&R) and the line was repaired between October 21 and 28, 2022. During the October 21 site visit, the air line was exposed, and it was found that the service line to GV-4 was broken off from a t-fitting installed on the main air supply line. J&R ordered a new t-fitting and installed the fitting along with a new service line to GV-4 on October 28, 2022. Photos of the repair are included in the attached October 28, 2022 field notes.

Photo Date	October 28, 2022
Photo Time	09:29
View Direction	
Description	JR repairing the air line at GV-4
Photographers Name	Andrew astehn

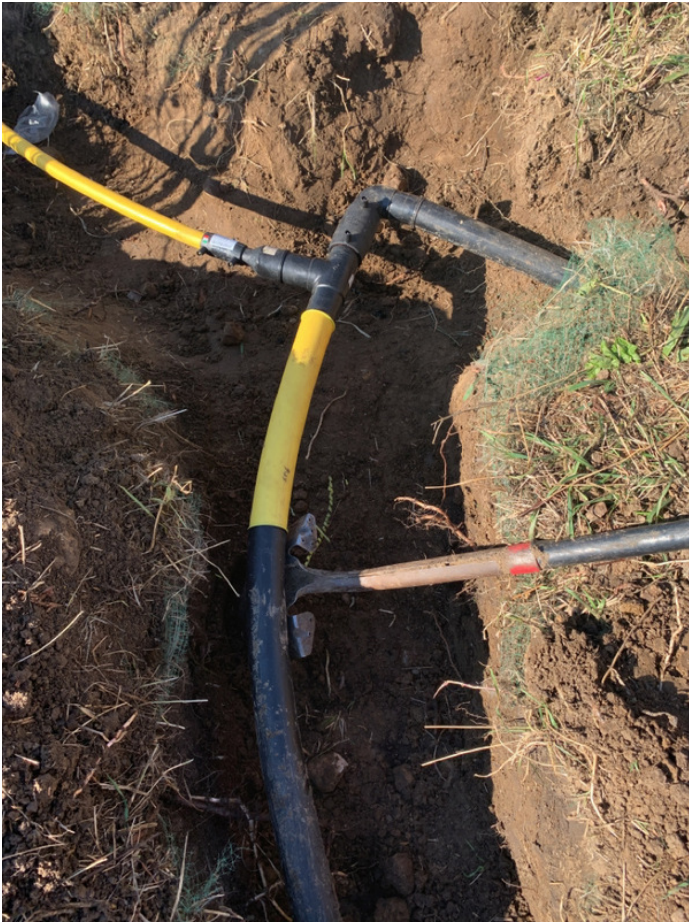
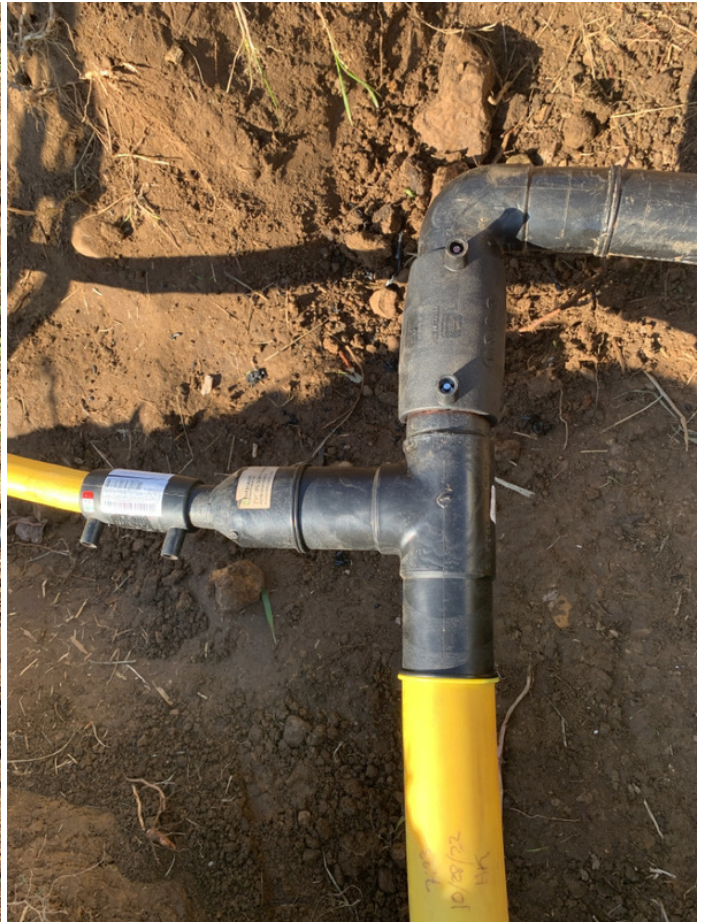
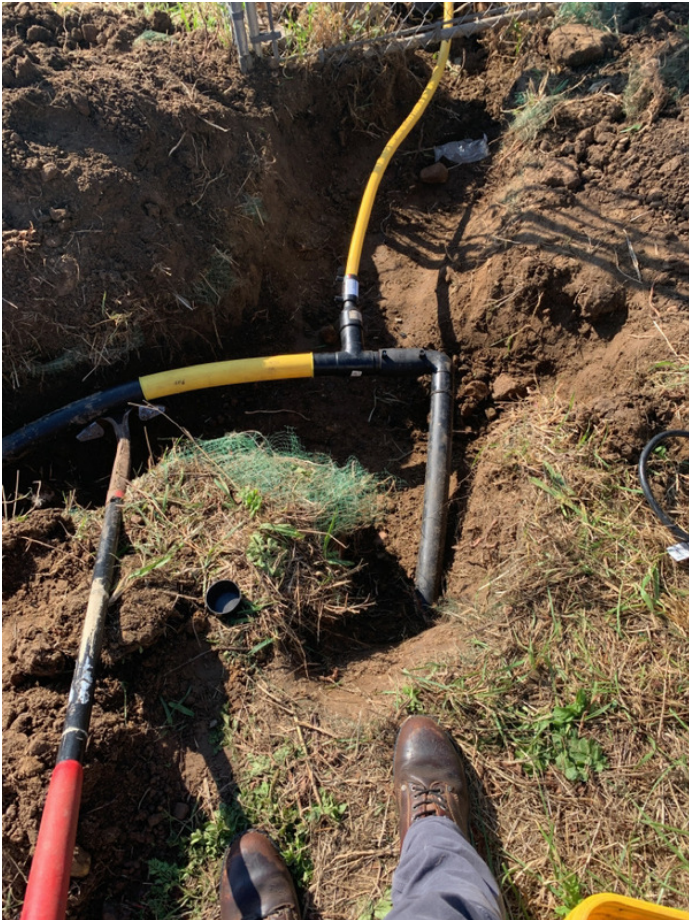
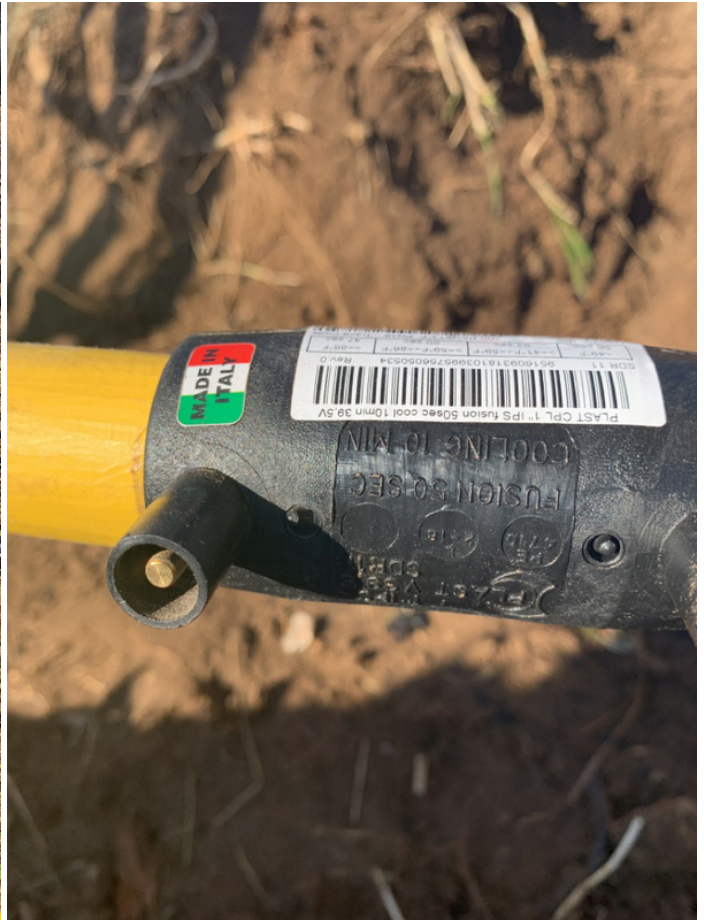
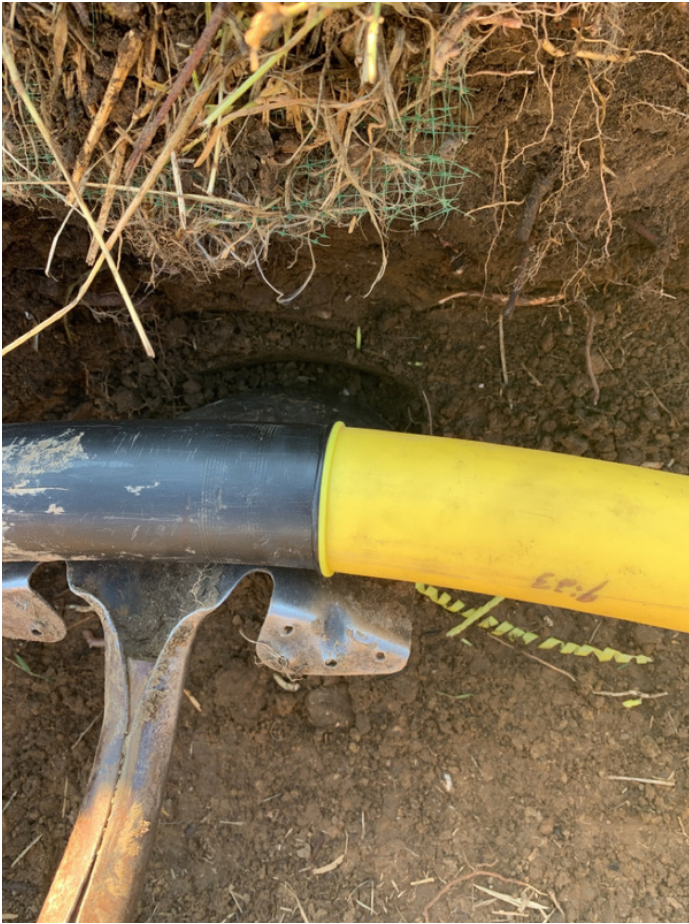
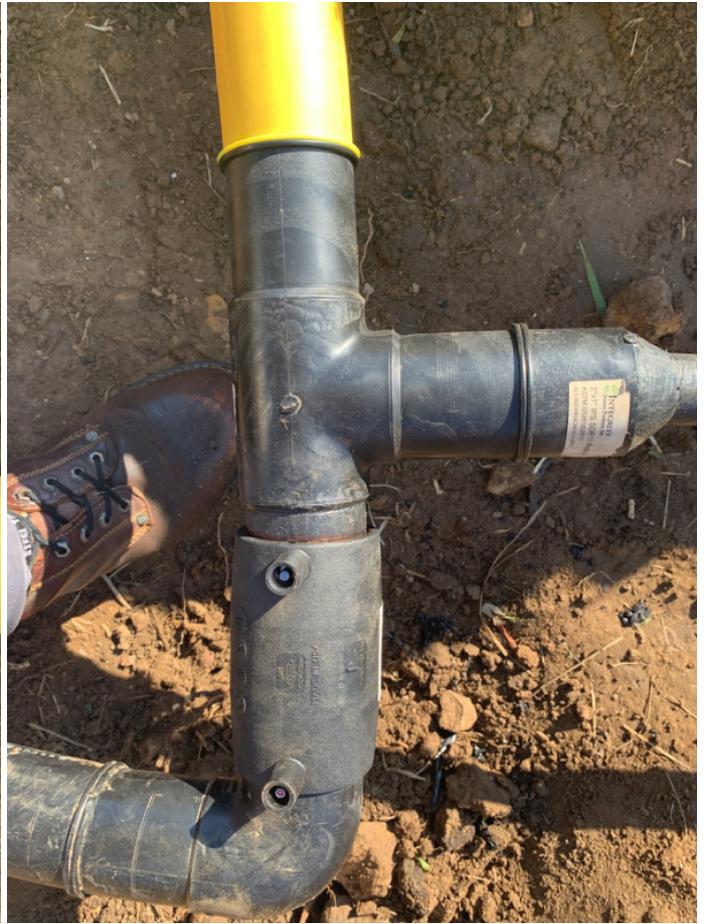
Photo Info - 2. 10:21, Supply line repairs complete.

Photo Date	October 28, 2022
Photo Time	10:21
View Direction	
Description	Supply line repairs complete.
Photographers Name	Andrew astehn

Time of Summary Entry	10:25
Description of Activities	<p>JR has installed two butt fusions. One to the existing supply line running east to west and one to the t fitting.</p> <p>Electro fuse joints were used to attached the supply line at the 90 degree bend and the two connections on the 1 inch service line.</p>
Initials	AS

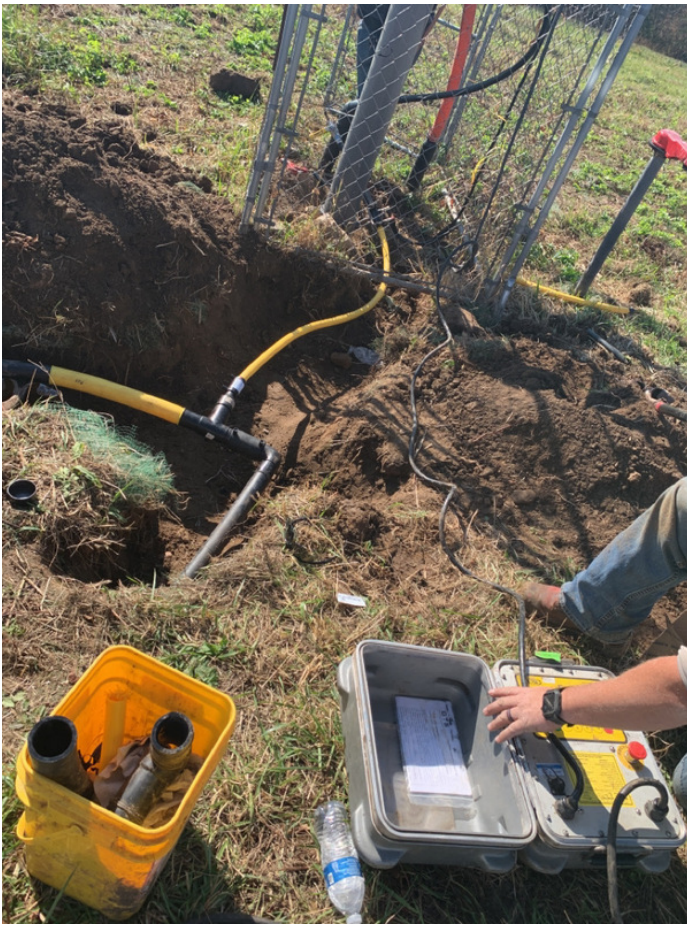
Photo Info - 3. 10:25, Electro fuse wells used for connecting the the 90 degree on the supply line and the two connections for the 1 inch line. See photo

Photo Date	October 28, 2022
Photo Time	10:25
View Direction	
Description	Electro fuse wells used for connecting the the 90 degree on the supply line and the two connections for the 1 inch line. See photo
Photographers Name	Andrew Stehn

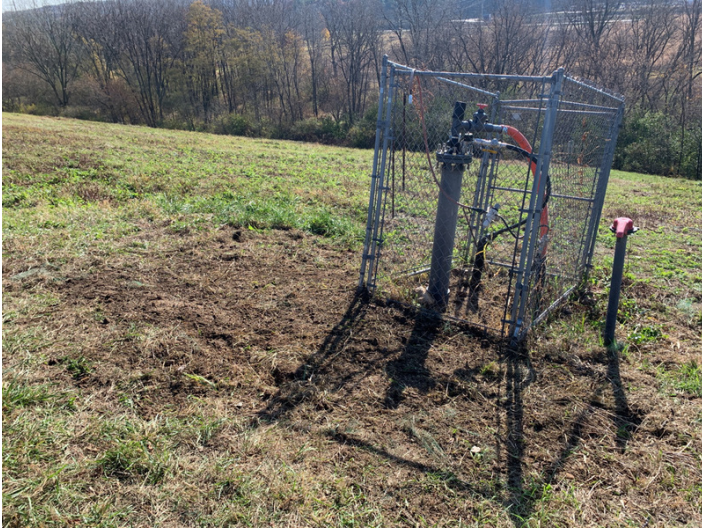
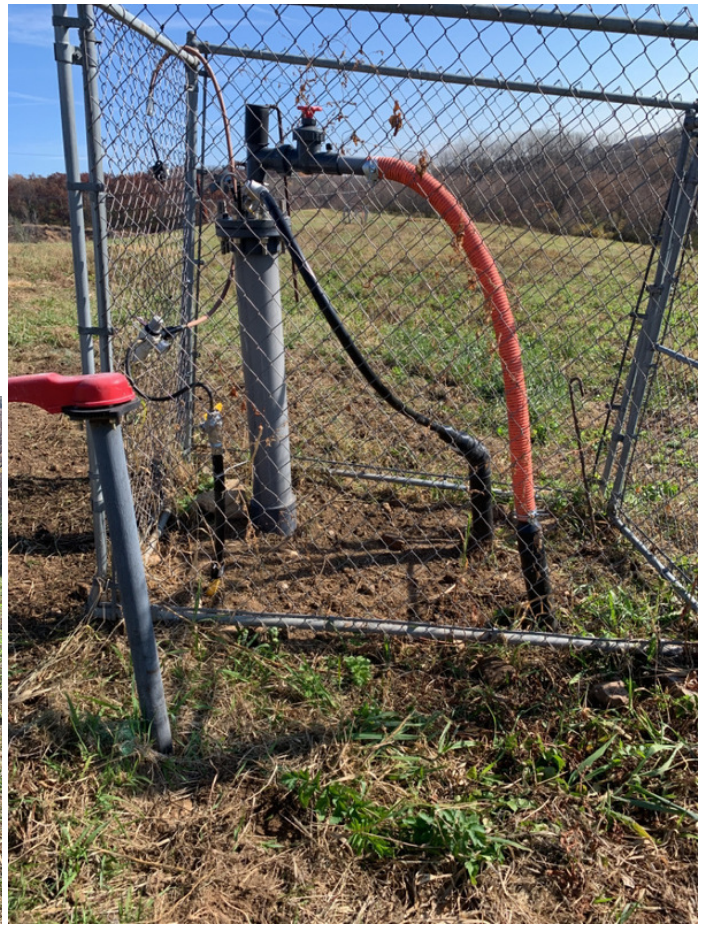
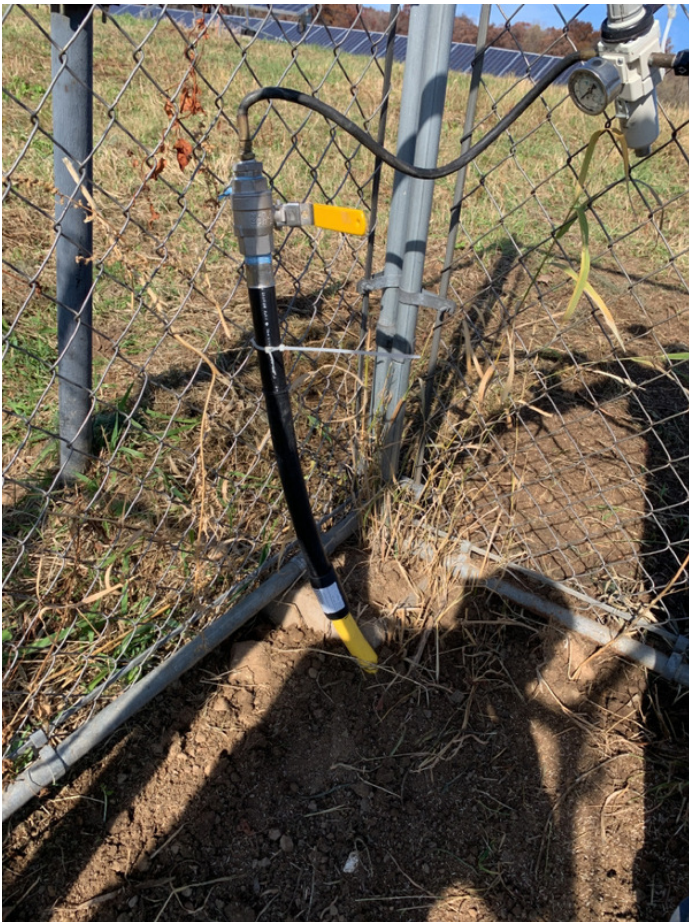
Photo Info - 4. 11:07, Air line repairs and backfilled. TRC placed grass seed down after backfilling was complete.

Photo Date	October 28, 2022
Photo Time	11:07
View Direction	
Description	Air line repairs and backfilled. TRC placed grass seed down after backfilling was complete.
Photographers Name	Andrew astehn

Time of Summary Entry	11:00
Description of Activities	<p>JR completed the air line repair and backfilling. See photos. TRC placed grass seed on disturbed area.</p> <p>JR offsite 1100</p> <p>Andy called Cindy and proved update to her that line was repaired.</p> <p>Andy restarted blower system and vac out to well field is 6 to 7 in wc. Flow around 148cfm</p>
Initials	AMS
