December 16, 2022

Subject: Refuse Hideaway Landfill
November 2022 Operation Monitoring and Maintenance Activities

Photographic Log

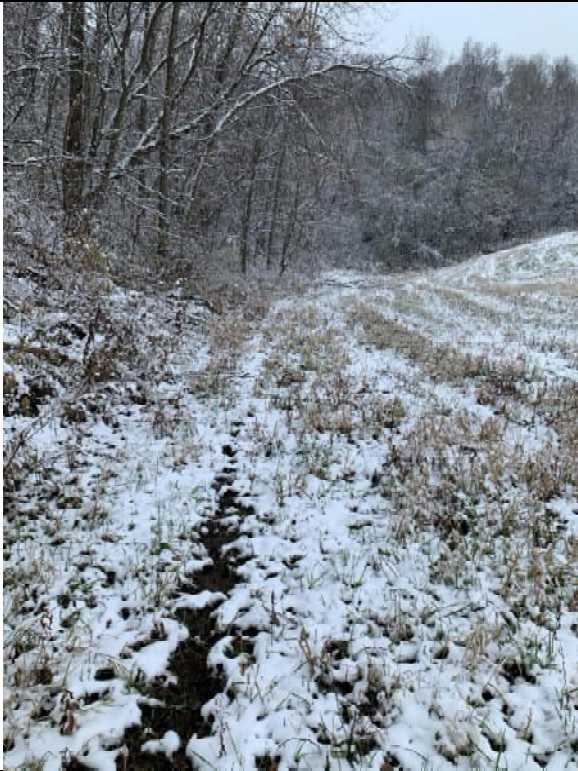
Client Name: Wisconsin Department of Natural Resources (WDNR)		Site Location: Refuse Hideaway Landfill Middleton, WI	Project No.: TRC # 457573
Photo No. 1	Date 11/15/2022

Description <u>Western Drainage Ditch:</u> North portion shows signs of vegetation die off as well as standing/slow to drain water at the surface at the time of the inspection. TRC reseeded the area in October 2022. The ground surface was partially obscured by light snow cover during inspection.			
Photo No. 2	Date 11/15/2022

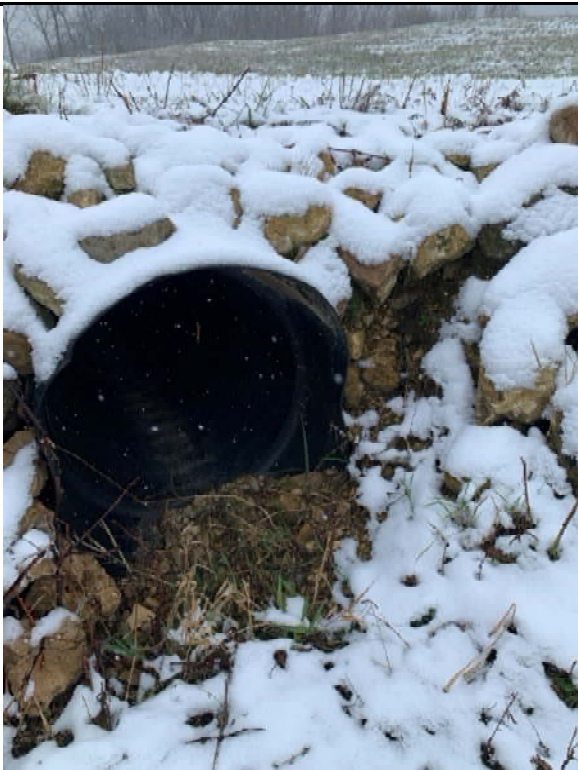
Description <u>Eastern Drainage Ditch:</u> Riprap has begun to deteriorate at the west side of the western culvert. Drainage is flowing and is not being obstructive.

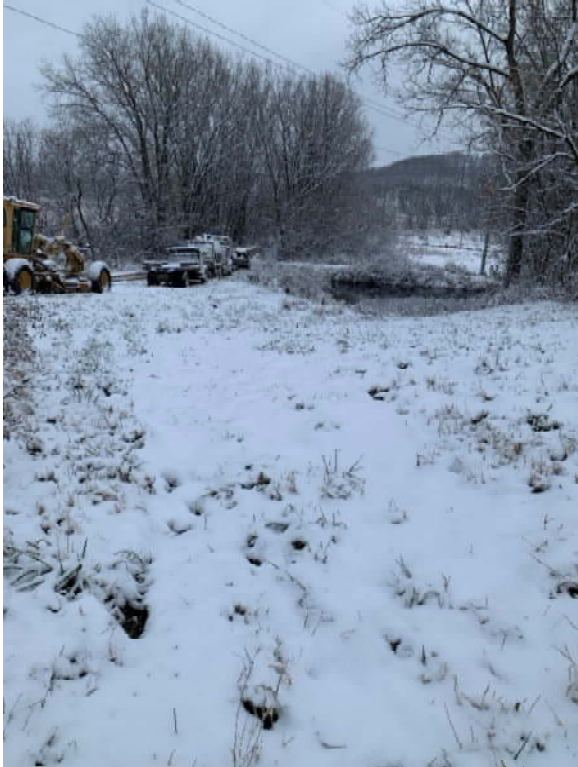
Client Name: Wisconsin Department of Natural Resources (WDNR)		Site Location: Refuse Hideaway Landfill Middleton, WI	Project No.: TRC # 457573
Photo No. 3	Date 11/15/2022

Description <u>Eastern Drainage Ditch:</u> Select areas that were seeded following the 2021 construction event contained bare soil. Reseeding and ground cover was applied by TRC in October 2022. Drainage shows natural flowage of surface water into the sediment pond. The ground surface was partially obscured by light snow cover during inspection.

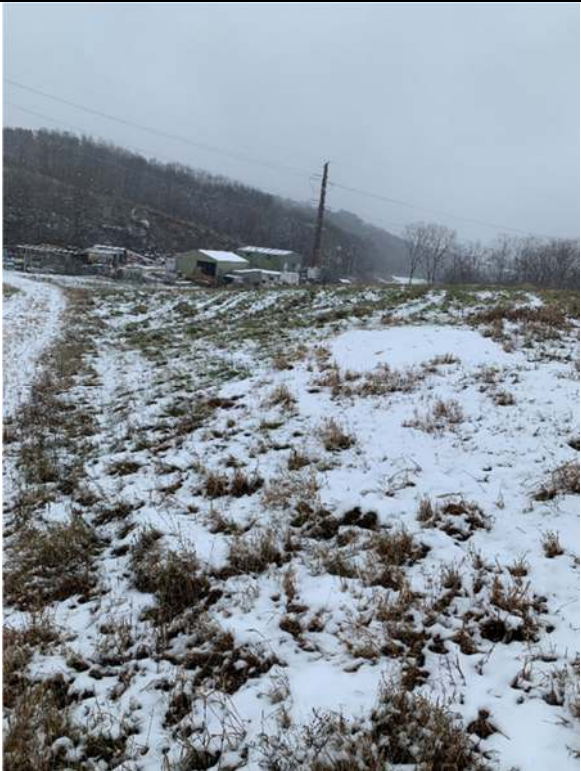
Client Name: Wisconsin Department of Natural Resources (WDNR)		Site Location: Refuse Hideaway Landfill Middleton, WI	Project No.: TRC # 457573
Photo No. 5	Date 11/15/2022

Description <u>Central Landfill:</u> Select areas that were seeded following the 2021 construction event contained bare soil. TRC reseeded the areas in October 2022. The ground surface was partially obscured by light snow cover during inspection.

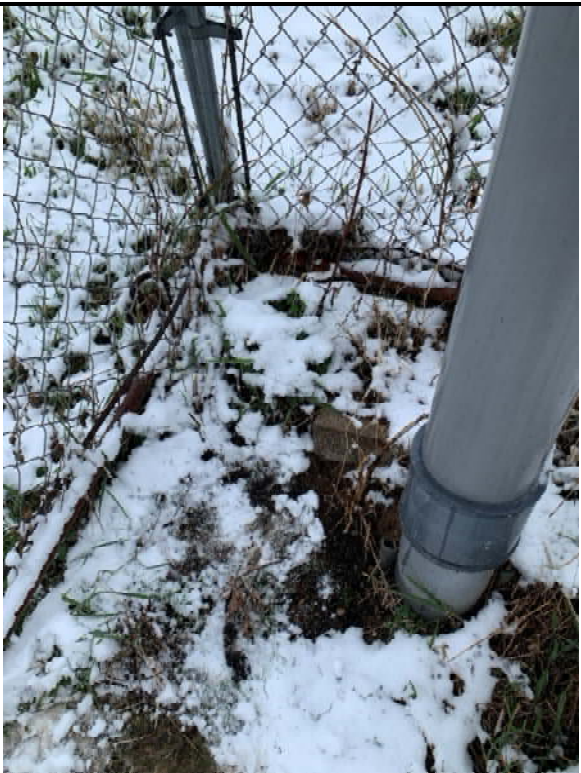
Photo No. 6	Date 11/15/2022

Description <u>Southern Landfill Extents:</u> Burrowing filled in with soil at GW-2. Ground partially obscured by light snow cover.

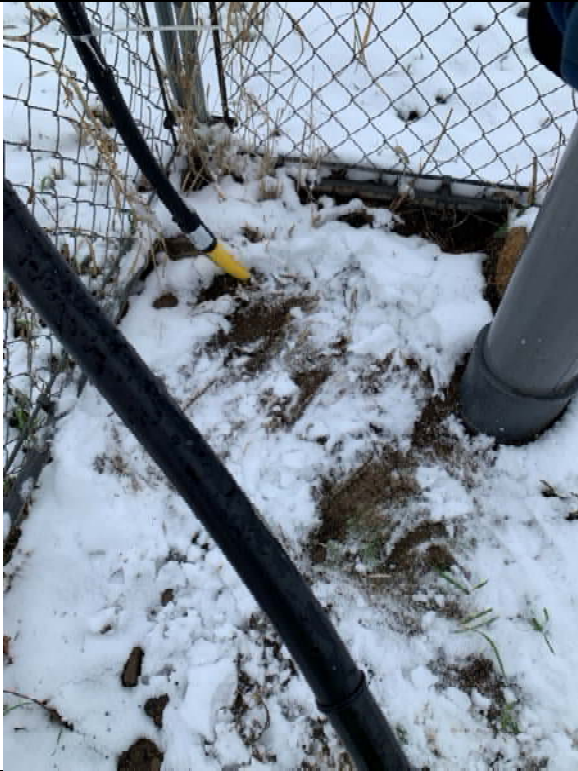
Client Name: Wisconsin Department of Natural Resources (WDNR)		Site Location: Refuse Hideaway Landfill Middleton, WI	Project No.: TRC # 457573
Photo No. 7	Date 11/15/2022

Description <u>Southern Landfill Extents:</u> Burrowing filled with soil at GW-4. Ground partially obscured by light snow cover.

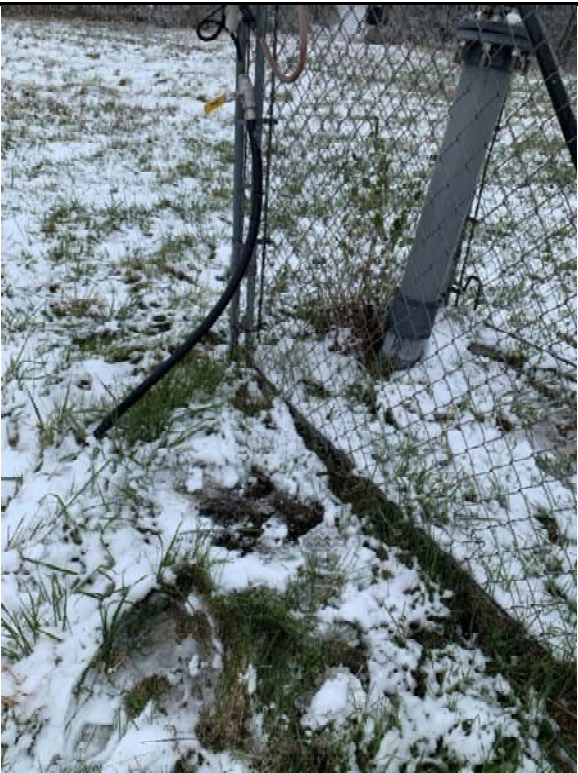
Photo No. 8	Date 11/15/2022

Description <u>Northern Landfill Extents:</u> Burrowing filled in with soil at GW-12. Ground partially obscured by light snow cover.
