Subject: Refuse Hideaway Landfill
April 2023 Operation Monitoring and Maintenance Activities

TRC completed the following operation, monitoring, and maintenance activities at the Refuse Hideaway Landfill (the Site) in Middleton, WI in April 2023.

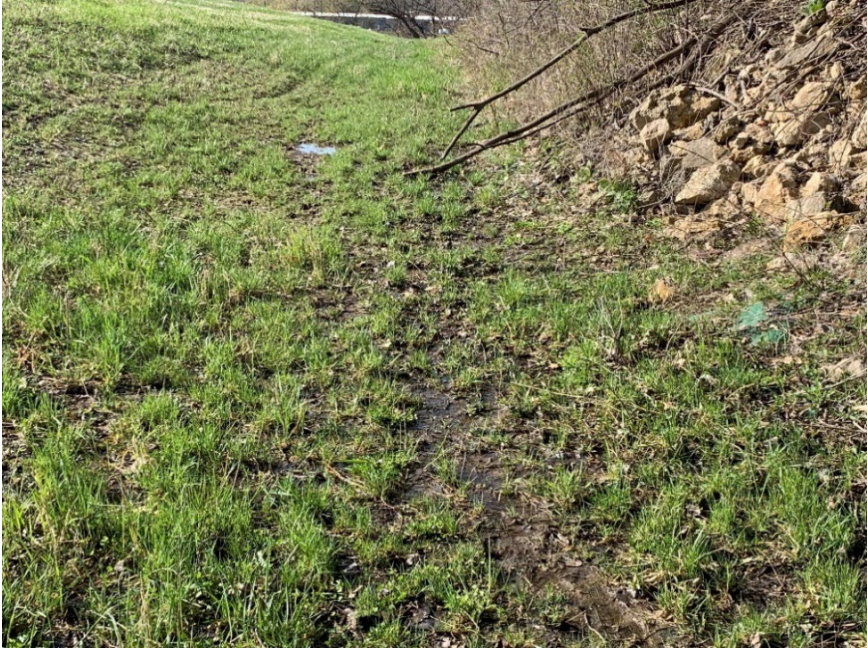
Client Name: Wisconsin Department of Natural Resources (WDNR)		Site Location: Refuse Hideaway Landfill Middleton, WI	Project No.: TRC # 457573
Photo No. 1	Date 4/24/2023

West Drainage Ditch - During the April inspection, standing /slow to drain water was observed at the surface to the north. See photo 1. This area was previously identified as having less positive slope than its surrounding and was regraded during 2020-2021 grading work at the site. The final post construction survey showed positive slope.

Description <u>Western Drainage Ditch:</u> Surface water was observed at the north portion of the drainage ditch. Surface water is flowing naturally towards the southernly riprap area.

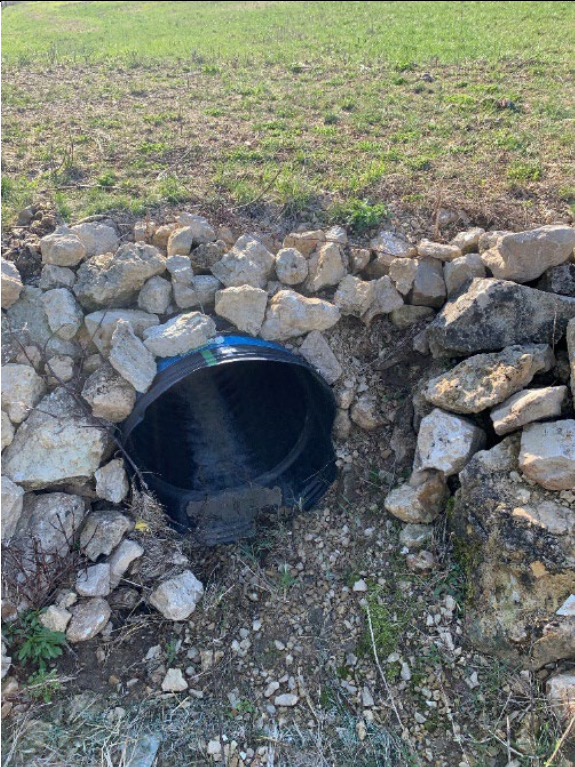
Photo No. 2	Date 4/24/2023

East Drainage Ditch - A small portion of the riprap at the west embankment of the northern culvert appears to have eroded. See photo 2.

Description <u>Eastern Drainage Ditch:</u> Some riprap has begun to deteriorate at the west side of the western culvert. Surface water is flowing and is not being obstructed.

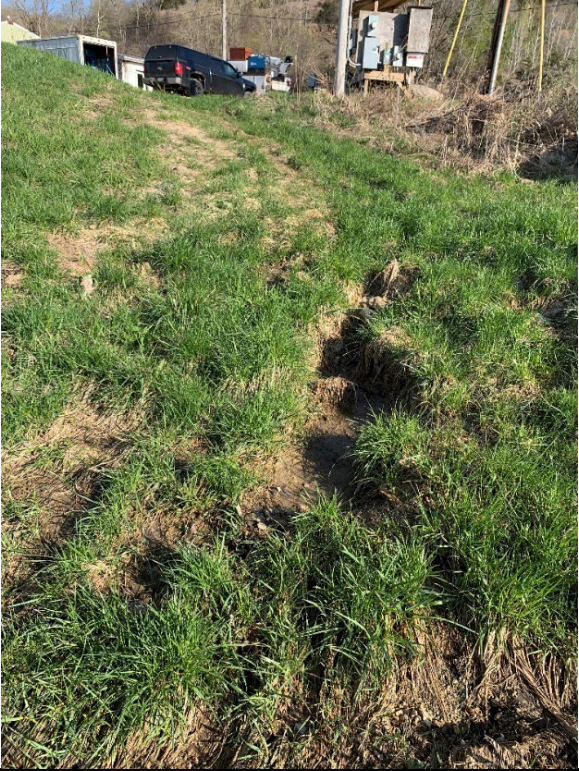
Client Name: Wisconsin Department of Natural Resources (WDNR)		Site Location: Refuse Hideaway Landfill Middleton, WI	Project No.: TRC # 457573
Photo No. 3	Date 4/24/2023

Vegetation cover is acceptable over the majority of the site. Various areas were reseeded and ground cover was applied in the fall of 2022 and remains in place. See photo #3.

Description <u>Eastern Drainage Ditch:</u> Areas were reseeded and erosion mat was applied in the fall of 2022. Grass is emerging from mat. Rill erosion is emerging and will be monitored.			
Photo No. 4	Date 4/24/2023

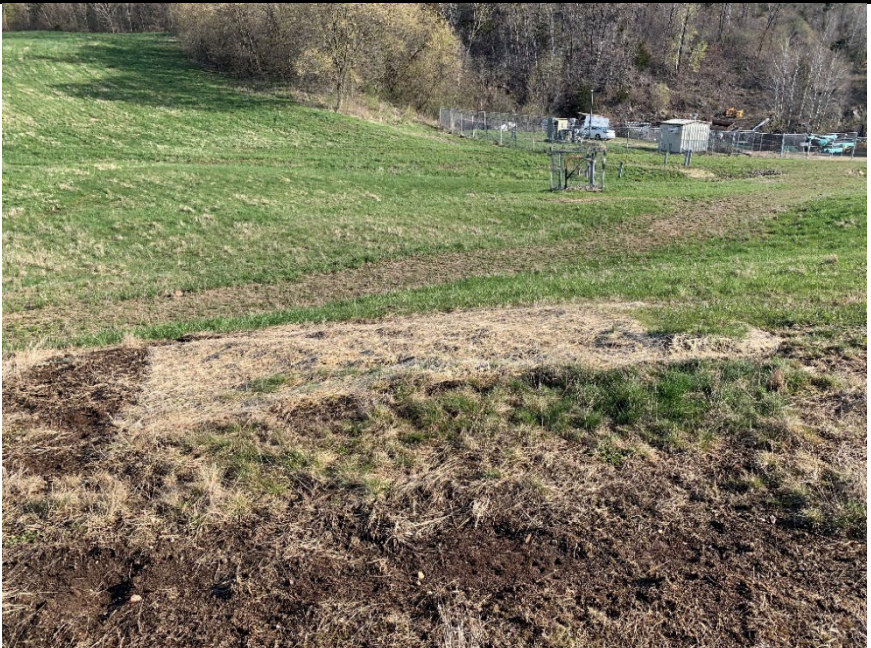
Areas at the west drainage ditch and east drainage ditch previously showed signs of vegetation die-off and were reseeded in the fall of 2022. Ground cover in these areas remains and TRC will continue to monitor regrowth in 2023. See photo 4.

Description <u>Eastern Landfill Extents:</u> Reseeding and ground cover was previously applied in the Fall of 2022 and remains in place. Grass is starting to emerge from mat.

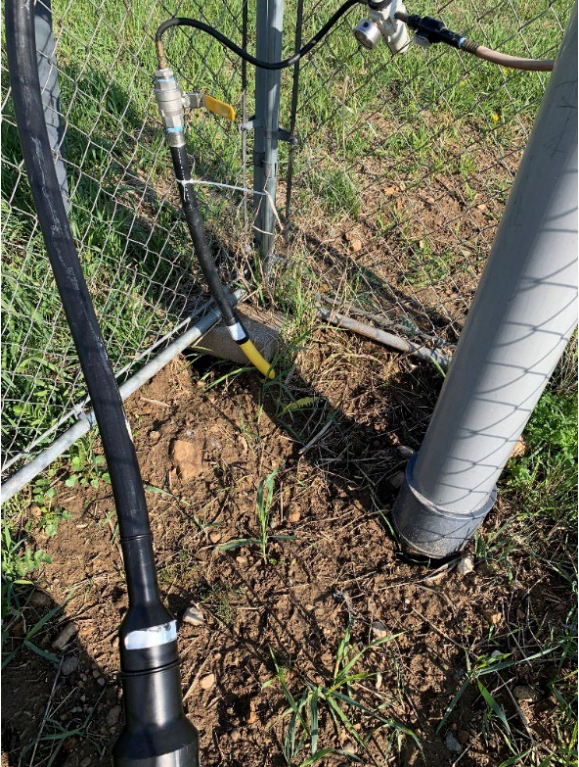
Client Name: Wisconsin Department of Natural Resources (WDNR)		Site Location: Refuse Hideaway Landfill Middleton, WI	Project No.: TRC # 457573
Photo No. 5	Date 4/24/2023

Burrowed areas were filled in with soil at gas extraction wells GW-2, GW-4, and GW-12. New burrowing was identified at GW-4. See photo 5.

Description <u>Southern Landfill Extents:</u> Evidence of burrowing around GW-4. GW-2, GW-4 and GW-12 areas were filled with soil in the Fall of 2022 and GW-2 and GW-12 remain in good condition.

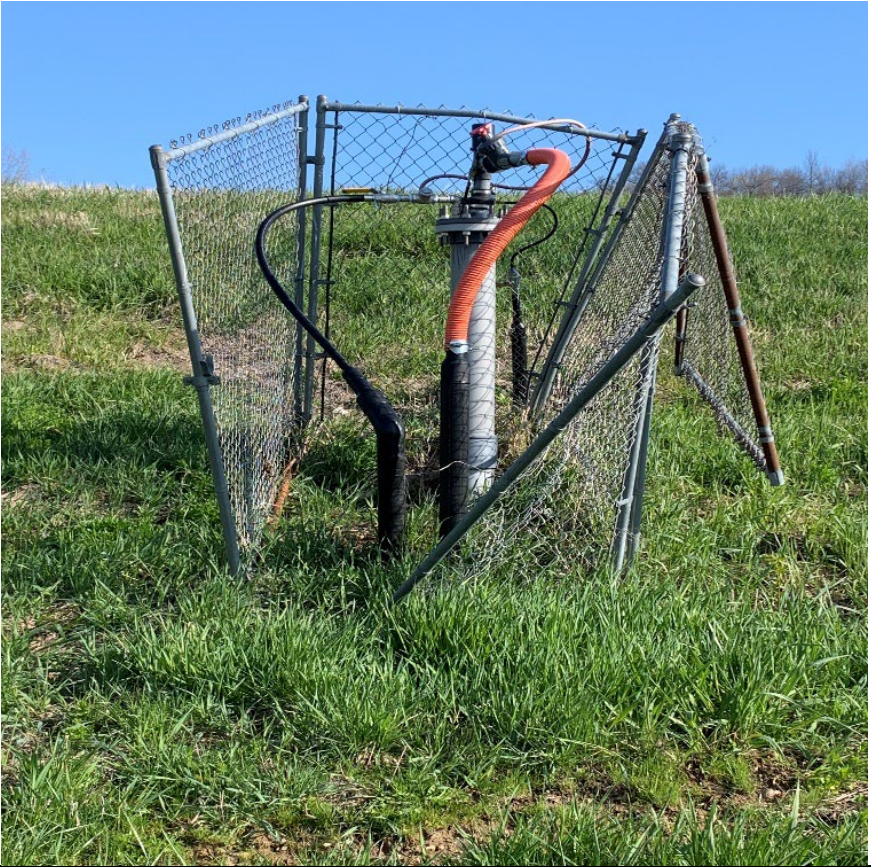
Client Name: Wisconsin Department of Natural Resources (WDNR)		Site Location: Refuse Hideaway Landfill Middleton, WI	Project No.: TRC # 457573
Photo No. 7	Date 4/24/2023

Fencing around GW-1 and GW-2 are damaged but still provide protection from lawn tractor. See photo 6 and photo 7.

Description <u>Southern Landfill Extents:</u> GW-2 protective fencing is in damaged. Fencing still provides protection from mowing operations.
