Subject: Refuse Hideaway Landfill
July 2023 Operation Monitoring and Maintenance Activities

TRC completed the following operation, monitoring, and maintenance activities at the Refuse Hideaway Landfill (the Site) in Middleton, WI in July 2023.

Attachment 2
Photographic Log

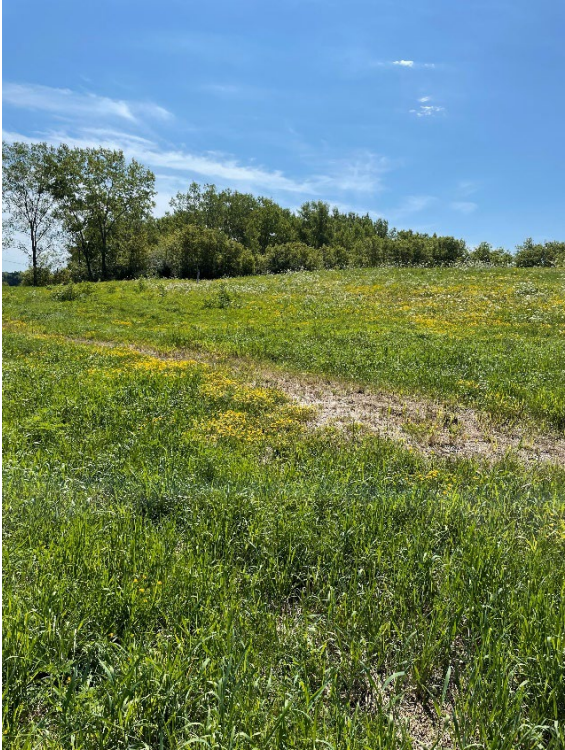
Areas at the west drainage ditch and east drainage ditch previously showed signs of vegetation die-off and were reseeded in the fall of 2022. Ground cover in these areas remains and TRC will continue to monitor regrowth in 2023. (see photo #1 and # 5).

Description <u>Eastern Drainage Ditch:</u> Significant vegetation is present throughout the drainage ditch. Bare spots are present to the north, above the drainage way and will likely require reseeding.					
Photo No. 2	Date 7/28/2023

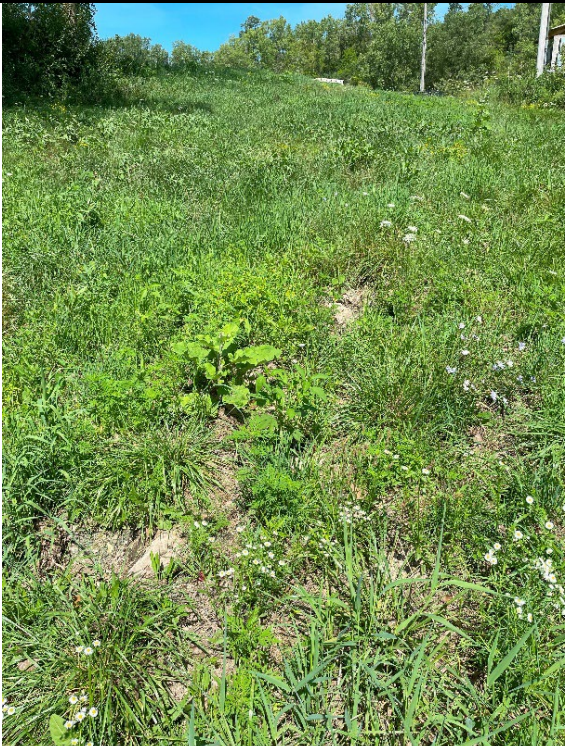
Evidence of erosion at the eastern drainage ditch above the sediment basin was observed. Vegetation is in place, but ruts are starting to form (See photo #2). TRC will continue to monitor the area.

Description <u>Eastern Drainage Ditch:</u> Evidence of erosion starting to occur was observed at the north portion of the eastern drainage ditch leading to the sediment basin. Vegetation is still intact but ruts are starting to form.

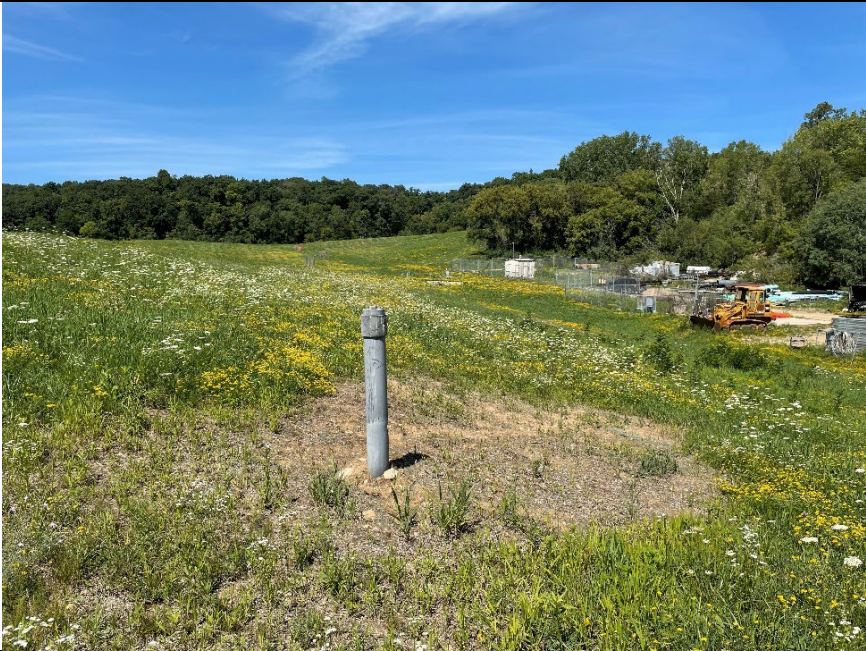
Vegetation cover is acceptable over the majority of the site. Various areas were reseeded and ground cover was applied in the fall of 2022. Various areas that were previously reseeded show evidence of little to no regrowth and may require additional reseeding. (see photo #3 and #4).

Description <u>Eastern Landfill Extents</u> Reseeding and ground cover was previously applied in the Fall of 2022. Some bare spots remain and will likely require reseeding.			
Photo No. 4	Date 7/28/2023

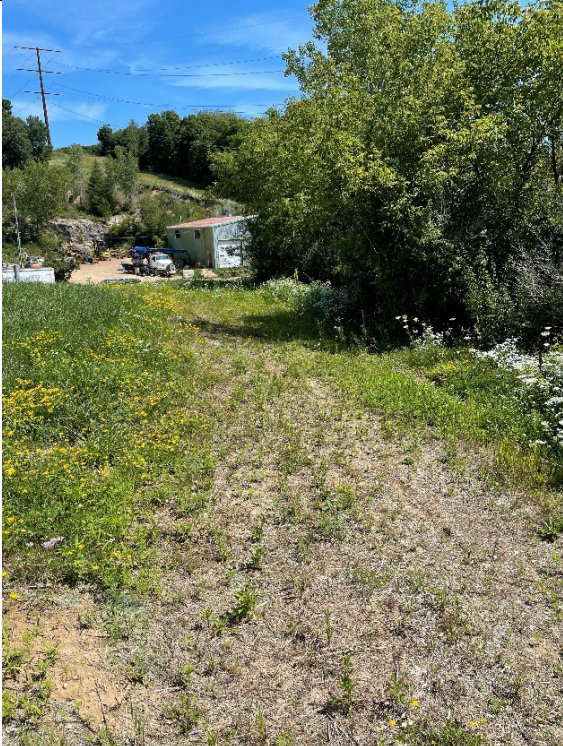
Description <u>Eastern Landfill Extents</u> Reseeding and ground cover was previously applied in the Fall of 2022. Some bare spots remain and will likely require reseeding.

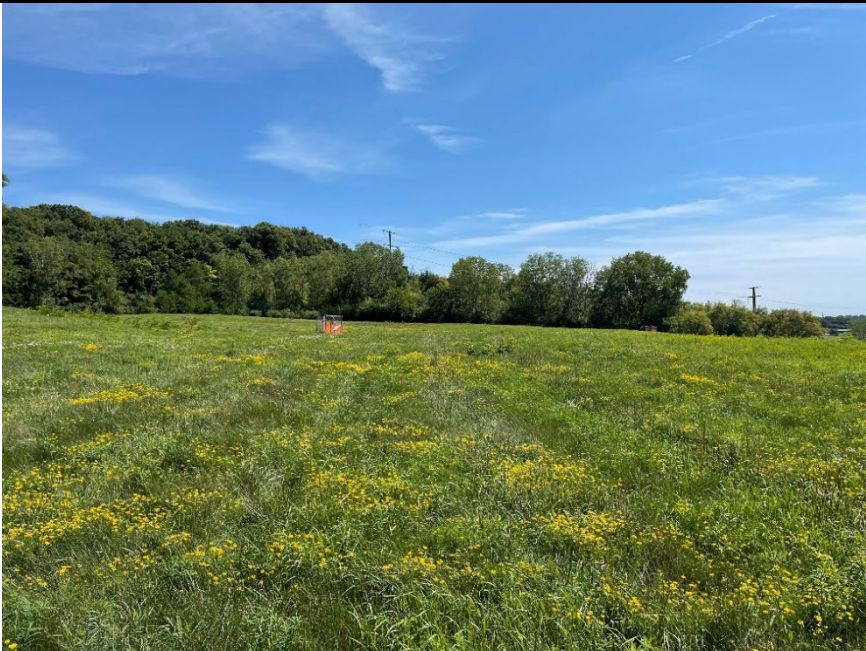
Description <u>Northern Landfill Extents:</u> Cap remains in good condition with full vegetation cover.
