September 21, 2023

Subject: Refuse Hideaway Landfill
August 2023 Operation Monitoring and Maintenance Activities

Attachment 3
Photographic Log

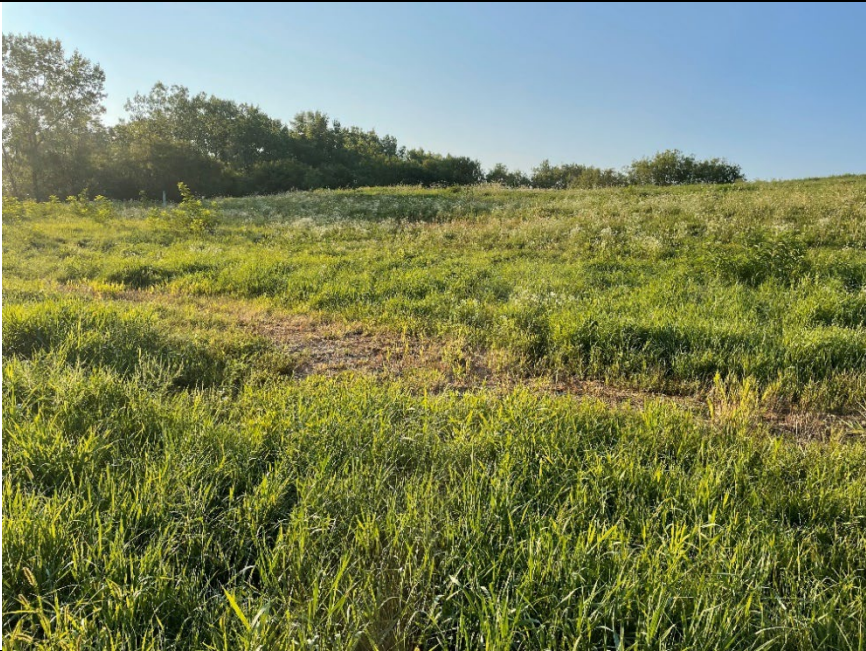
Client Name: Wisconsin Department of Natural Resources (WDNR)		Site Location: Refuse Hideaway Landfill Middleton, WI	Project No.: TRC # 457573
Photo No. 1	Date 8/22/2023

Description <u>Eastern Drainage Ditch:</u> Significant vegetation is present throughout the drainage ditch. Bare spots are present to the north, above the drainage way and will likely require reseeding.			
Photo No. 2	Date 8/22/2023

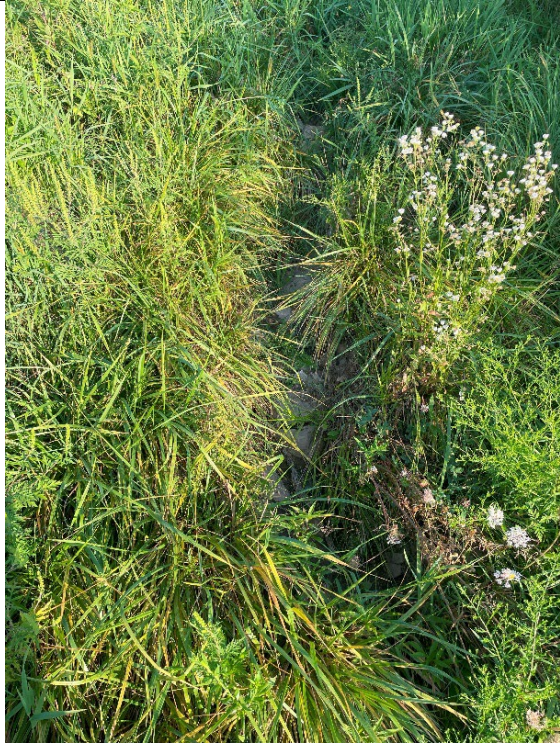
<p>Extent of vegetation cover:</p> <p>Vegetation cover is acceptable over the majority of the site. Various areas were reseeded and ground cover was applied in the fall of 2022 and remains in place (see photo #3 and #4).</p>
<p>Significant erosion:</p> <p>No evidence of significant erosion was observed at the site.</p>
<p>Repeated erosion:</p> <p>No evidence of significant erosion was observed at the site.</p>
<p>Vegetation die-off:</p> <p>Areas at the west drainage ditch and east drainage ditch previously showed signs of vegetation die-off and were reseeded in the fall of 2022. Ground cover in these areas remains and TRC will continue to monitor regrowth in 2023. (see photo #1 and # 5).</p>
<p>Maintain surface water conveyances and the sedimentation basin by completing the following:</p> <p>Inspect drainage ditches for erosion, blockages, and vegetation, describe and note any issues:</p> <p>Evidence of erosion at the eastern drainage ditch above the sediment basin was observed. Vegetation is in place, but ruts are starting to form (See photo #2). TRC will continue to monitor the area.</p>

Description <u>Eastern Drainage Ditch:</u> Evidence of erosion starting to occur was observed at the north portion of the eastern drainage ditch leading to the sediment basin. Vegetation is still intact but ruts are starting to form.

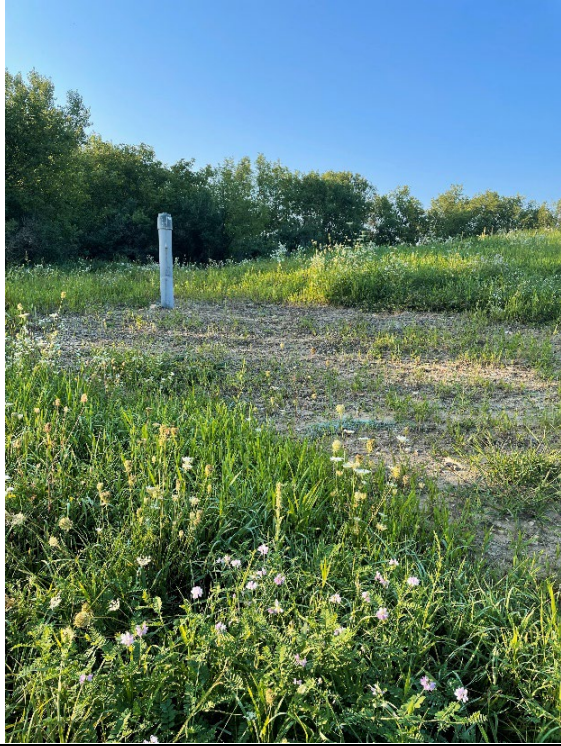
Client Name:		Site Location:		Project No.:	
Wisconsin Department of Natural Resources (WDNR)		Refuse Hideaway Landfill Middleton, WI		TRC # 457573	
Photo No.	Date				
3	8/22/2023

Description <u>Eastern Landfill Extents</u> Reseeding and ground cover was previously applied in the Fall of 2022. Some bare spots remain and will likely require reseeding.					
Photo No.	Date				
4	8/22/2023

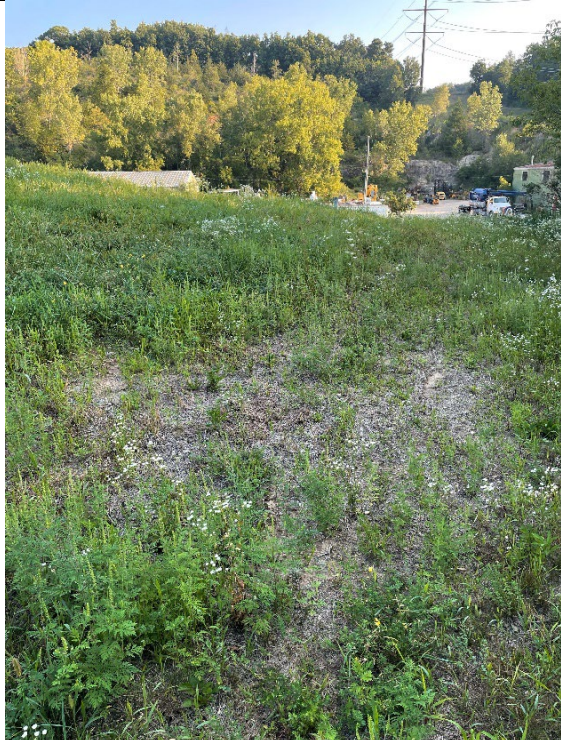
Description <u>Eastern Landfill Extents</u> Reseeding and ground cover was previously applied in the Fall of 2022. Some bare spots remain and will likely require reseeding.

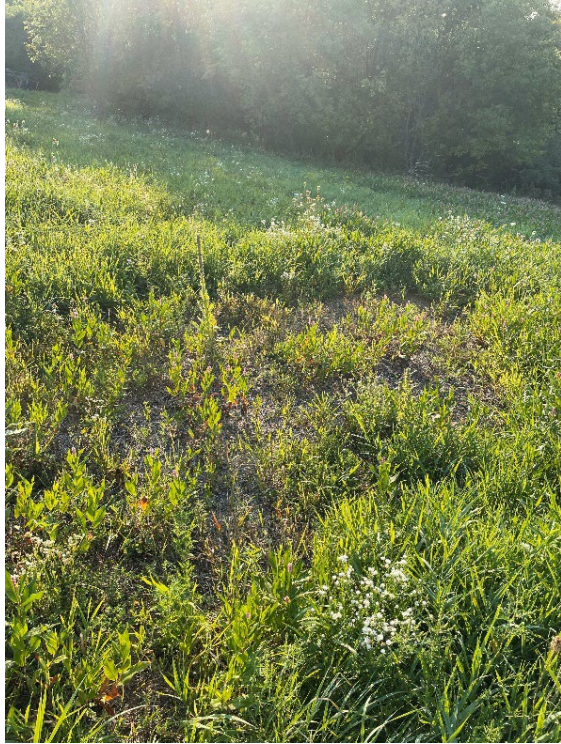
Client Name: Wisconsin Department of Natural Resources (WDNR)		Site Location: Refuse Hideaway Landfill Middleton, WI	Project No.: TRC # 457573
Photo No. 5	Date 8/22/2023

Description <u>Southern/Eastern Landfill Extents</u> Reseeding and ground cover was previously applied in the Fall of 2022. Some bare spots remain and will likely require reseeding.

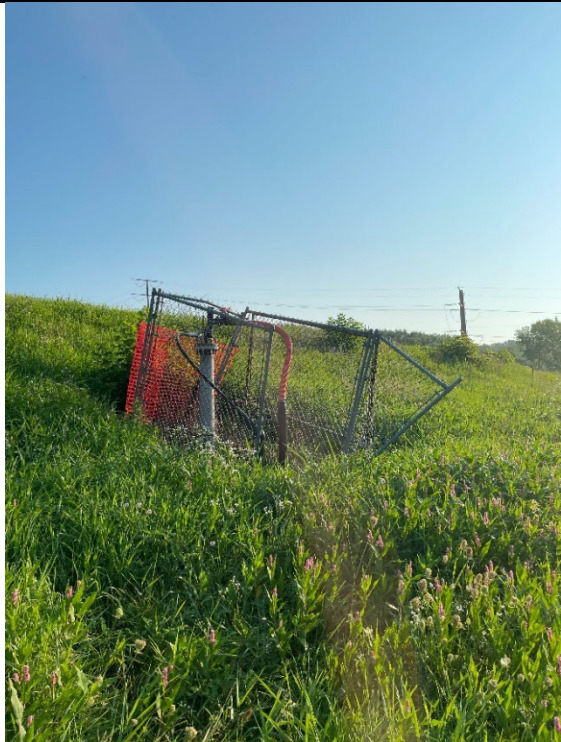
Photo No. 6	Date 8/22/2023

Description <u>Southern Landfill Extents:</u> GW-2 protective fencing is falling apart. Fencing still provides protection during mowing operations. GW-1 protective fencing is in the same condition as GW-2.

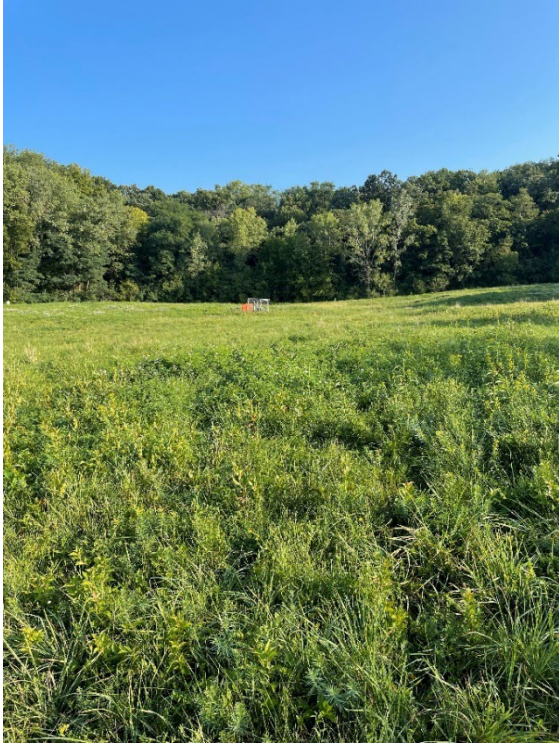
Client Name: Wisconsin Department of Natural Resources (WDNR)		Site Location: Refuse Hideaway Landfill Middleton, WI	Project No.: TRC # 457573
Photo No. 7	Date 8/22/2023

Description <u>Northern Landfill Extents:</u> Cap remains in good condition with full vegetation cover.
