Subject: Refuse Hideaway Landfill
October 2023 Operation Monitoring and Maintenance Activities

TRC completed the following operation, monitoring, and maintenance activities at the Refuse Hideaway Landfill (the Site) in Middleton, WI in October 2023.

Photographic Log

Client Name: Wisconsin Department of Natural Resources (WDNR)		Site Location: Refuse Hideaway Landfill Middleton, WI	Project No.: TRC # 457573
Photo No. 1	Date 10/31/2023

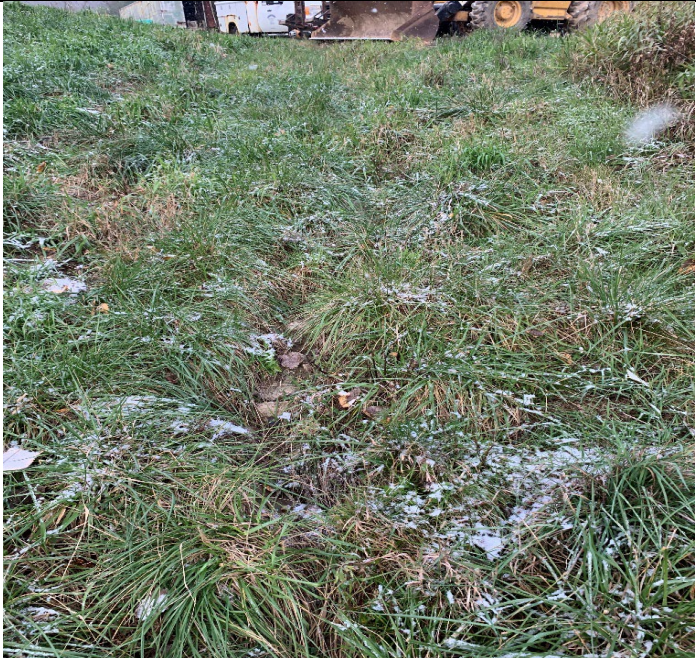
<p>Extent of vegetation cover:</p> <p>Vegetation cover is acceptable over the majority of the site. Various areas were reseeded and ground cover was applied in the fall of 2022. Some bare spots remain and will likely require reseeding in Spring of 2024 (see photo #3 and #4).</p>
<p>Significant erosion:</p> <p>No evidence if significant erosion was observed at the site.</p>
<p>Repeated erosion:</p> <p>No evidence if significant erosion was observed at the site.</p>
<p>Vegetation die-off:</p> <p>Areas at the west drainage ditch and east drainage ditch previously showed signs of vegetation die-off and were reseeded in the fall of 2022. Ground cover in these areas remains, however some areas may require reseeding in Spring of 2024 (see photo #1).</p>
<p>Maintain surface water conveyances and the sedimentation basin by completing the following:</p> <p>Inspect drainage ditches for erosion, blockages, and vegetation, describe and note any issues:</p> <p>Evidence of erosion at the eastern drainage ditch above the sediment basin was observed. Vegetation is in place, but ruts are starting to form (See photo #2). TRC will continue to monitor the area.</p>

Description <u>Eastern Drainage Ditch:</u> Evidence of erosion starting to occur was observed at the north portion of the eastern drainage ditch leading to the sediment basin. Vegetation is still intact but ruts are starting to form.

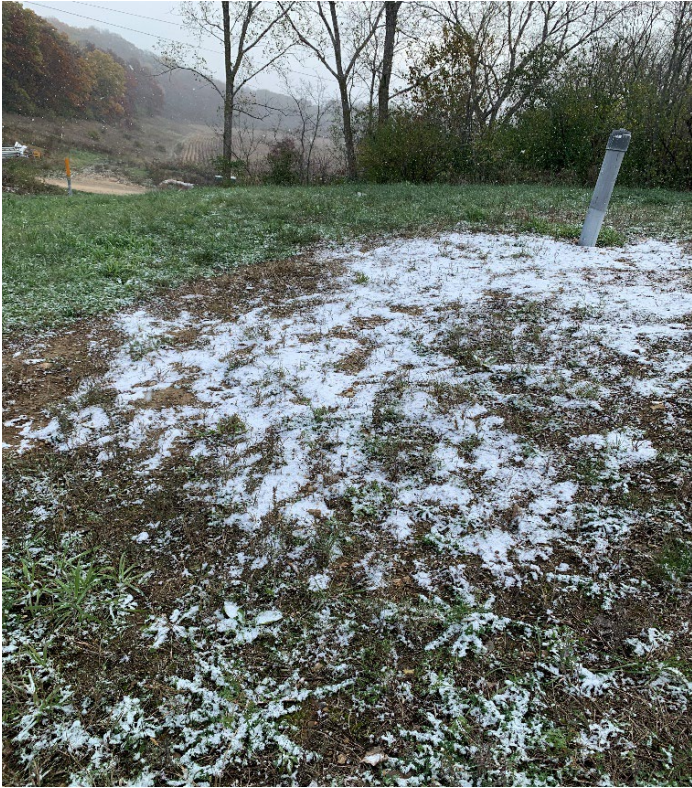
Client Name: Wisconsin Department of Natural Resources (WDNR)		Site Location: Refuse Hideaway Landfill Middleton, WI	Project No.: TRC # 457573
Photo No. 3	Date 10/31/2023

Description <u>Eastern Landfill Extents</u> Reseeding and ground cover was previously applied in the Fall of 2022. Some bare spots remain and will likely require reseeding in Spring of 2024.

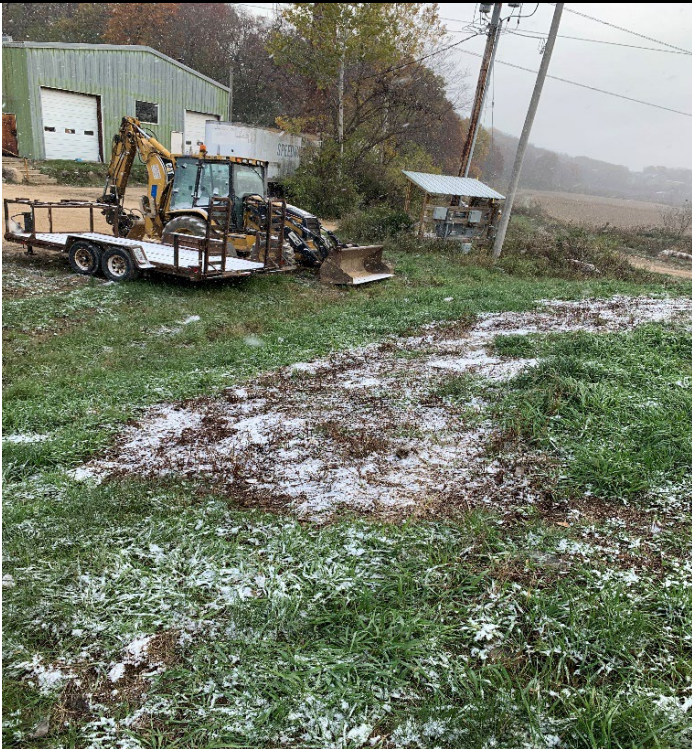
Photo No. 4	Date 10/31/2023

Description <u>Eastern Landfill Extents</u> Reseeding and ground cover was previously applied in the Fall of 2022. Some bare spots remain and will likely require reseeding in Spring of 2024.

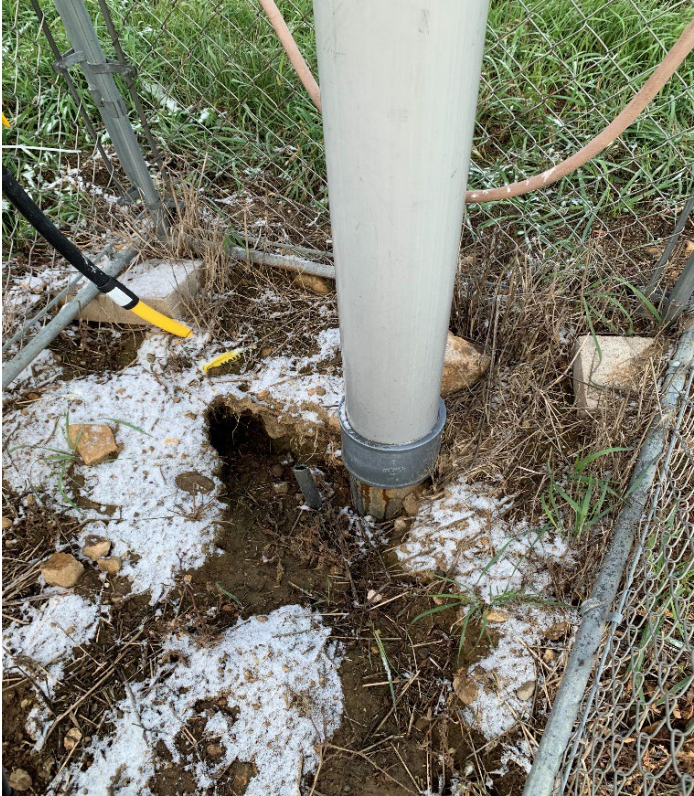
Client Name: Wisconsin Department of Natural Resources (WDNR)		Site Location: Refuse Hideaway Landfill Middleton, WI	Project No.: TRC # 457573
Photo No. 5	Date 10/31/2023

Description <u>Southern Landfill Extents</u> GW-2 and GW-4 have burrowing from wildlife inside fencing.

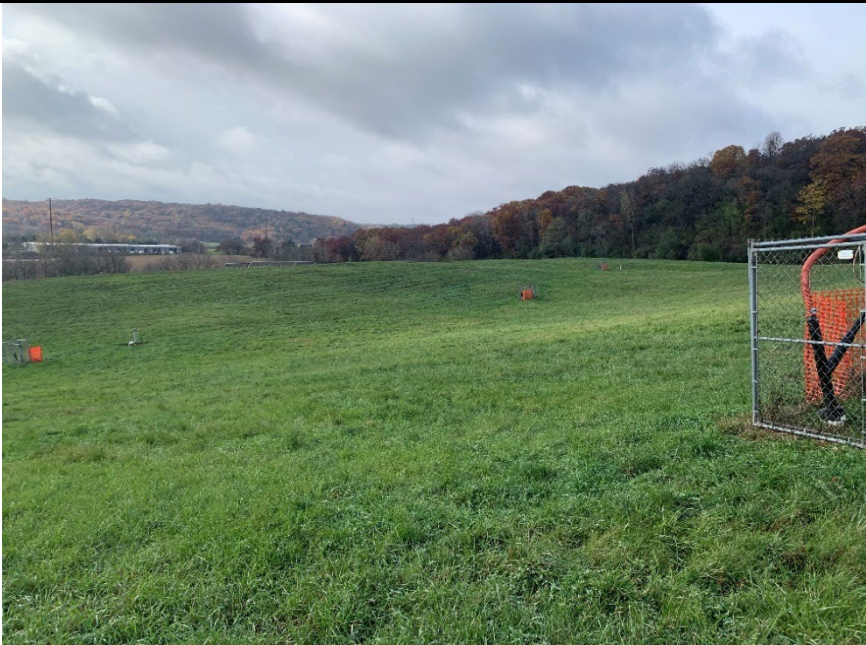
Client Name: Wisconsin Department of Natural Resources (WDNR)		Site Location: Refuse Hideaway Landfill Middleton, WI	Project No.: TRC # 457573
Photo No. 7	Date 10/31/2023

Description <u>Northern Landfill Extents:</u> Cap remains in good condition with full vegetation cover.
