Subject: Refuse Hideaway Landfill
November 2023 Operation Monitoring and Maintenance Activities

Client Name: Wisconsin Department of Natural Resources (WDNR)	Site Location: Refuse Hideaway Landfill Middleton, WI	Project No.: TRC # 457573
---	--	-------------------------------------

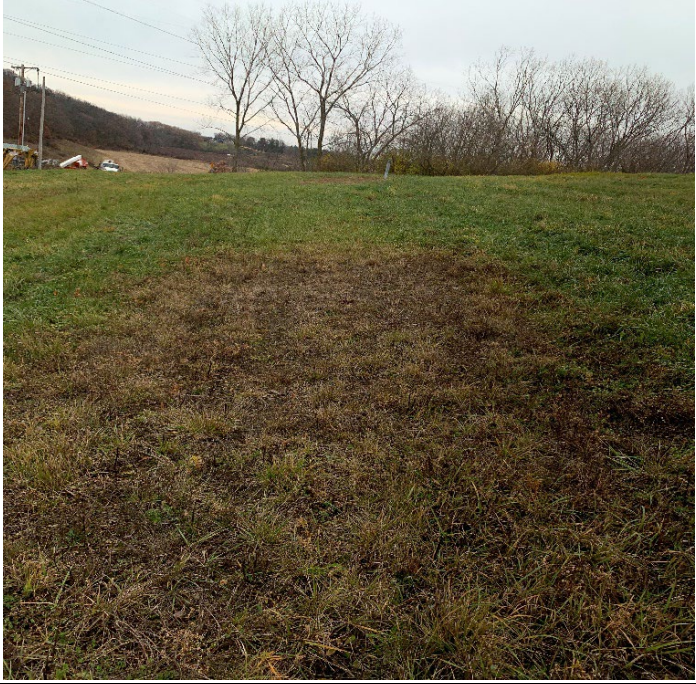
Photo No. 1	Date 11/20/2023

Description <u>Eastern Drainage Ditch:</u> Bare spots are present to the north, above the drainage way and will likely require reseeding.

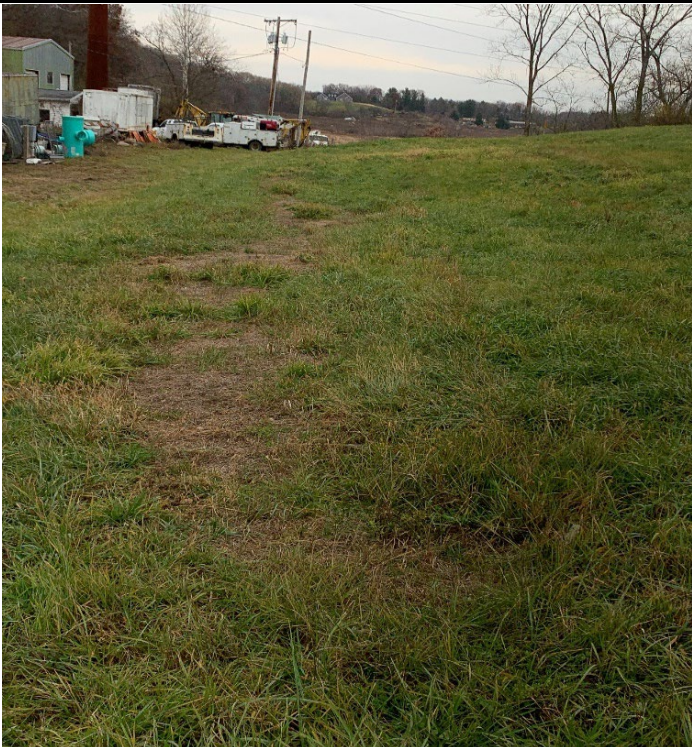
<p>Extent of vegetation cover:</p> <p>Vegetation cover is acceptable over the majority of the site. Various areas were reseeded and ground cover was applied in the fall of 2022. Some bare spots were observed (see photo #3 and #4). Per discussion with the WDNR, TRC will evaluate the areas in Spring of 2024 and apply seed as needed at that time.</p>
<p>Significant erosion:</p> <p>No evidence if significant erosion was observed at the site.</p>
<p>Repeated erosion:</p> <p>No evidence if significant erosion was observed at the site.</p>
<p>Vegetation die-off:</p> <p>Areas at the west drainage ditch and east drainage ditch previously showed signs of vegetation die-off and were reseeded in the fall of 2022. Ground cover in these areas remains and TRC will continue to monitor and apply seed as needed in 2024. (see photo #1).</p>
<p>Maintain surface water conveyances and the sedimentation basin by completing the following:</p> <p>Inspect drainage ditches for erosion, blockages, and vegetation, describe and note any issues:</p> <p>Evidence of erosion at the eastern drainage ditch above the sediment basin was observed. Vegetation is in place, but ruts are starting to form (See photo #2). TRC will continue to monitor the area.</p>

Description <u>Eastern Landfill Extents</u> Reseeding and ground cover was previously applied in the Fall of 2022. Some bare spots remain and will likely require reseeding.

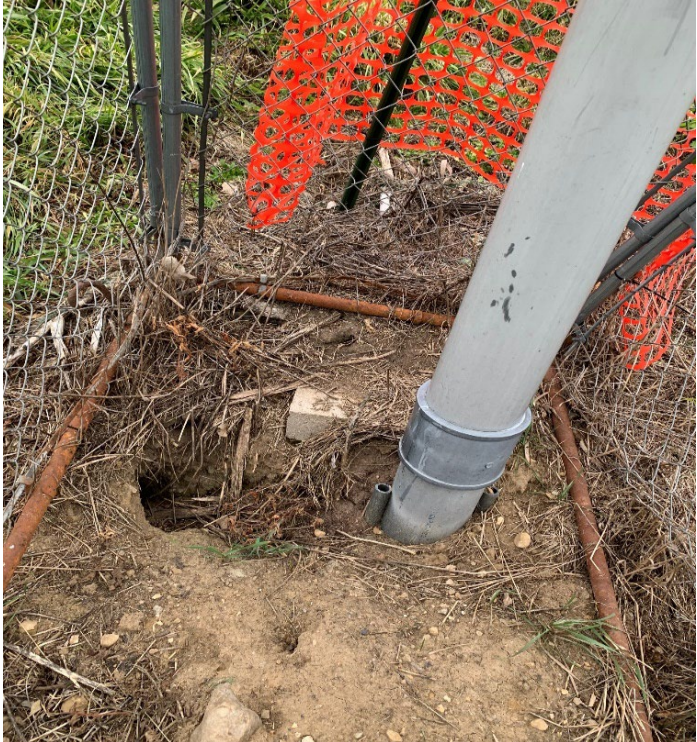
Description <u>Southern Landfill Extents</u> GW-2 and GW-4 have burrowing from wildlife inside fencing.

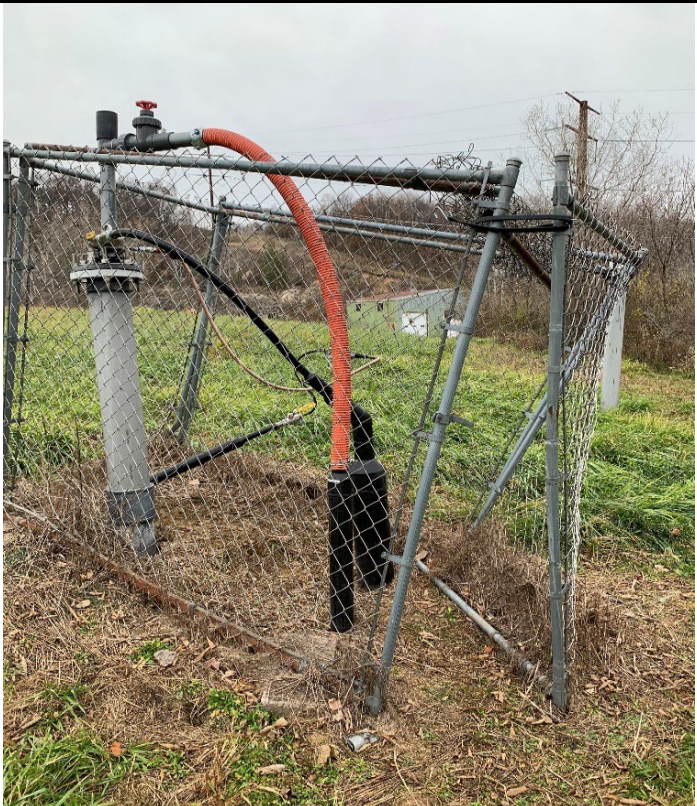
Photo No. 6	Date 11/20/2023

Description <u>Southern Landfill Extents:</u> GW-1 protective fencing is falling apart. Fencing still provides protection during mowing operations. GW-1 protective fencing is in the same condition as GW-2.

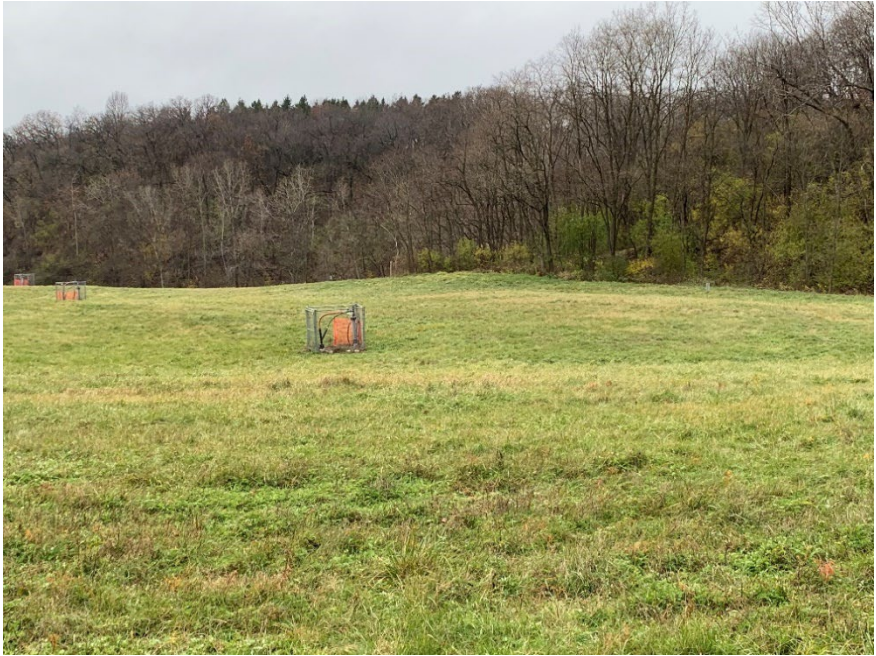
Description <u>Northern Landfill Extents:</u> Cap remains in good condition with full vegetation cover.
