Subject: Refuse Hideaway Landfill
April 2024 Operation Monitoring and Maintenance Activities

TRC completed the following operation, monitoring, and maintenance activities at the Refuse Hideaway Landfill (the Site) in Middleton, WI in April 2024.

Attachment 2
Photographic Log

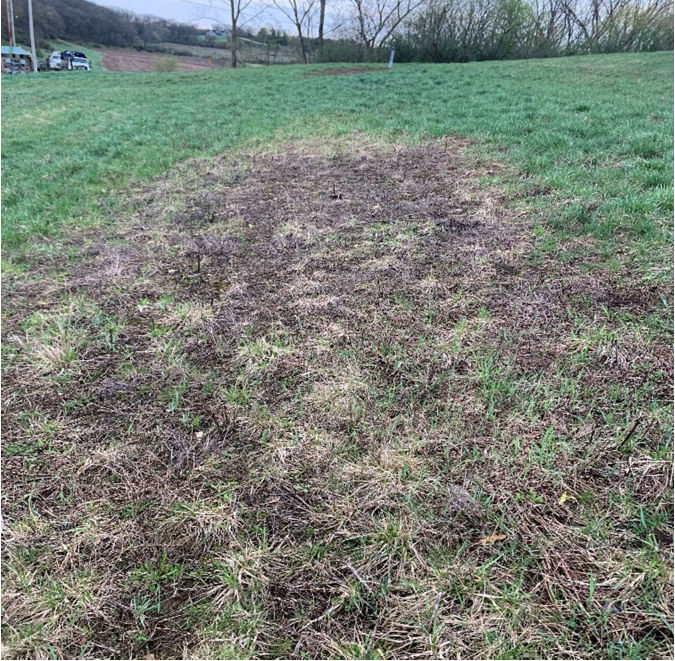
Client Name: Wisconsin Department of Natural Resources (WDNR)		Site Location: Refuse Hideaway Landfill Middleton, WI	Project No.: TRC # 457573
Photo No. 1	Date 4/18/2024

Some bare spots were observed (see photo #1, #3 and #4).

Description <u>Eastern Drainage Ditch:</u> Bare spots are present to the north, above the drainage way and will require reseeding.			
Photo No. 2	Date 4/18/2024

Per discussion with the WDNR, TRC will apply seed and erosion mat in May 2024 in select areas.

TRC will continue to monitor and apply seed in select areas in May 2024. (see photo #1, #3, #4).

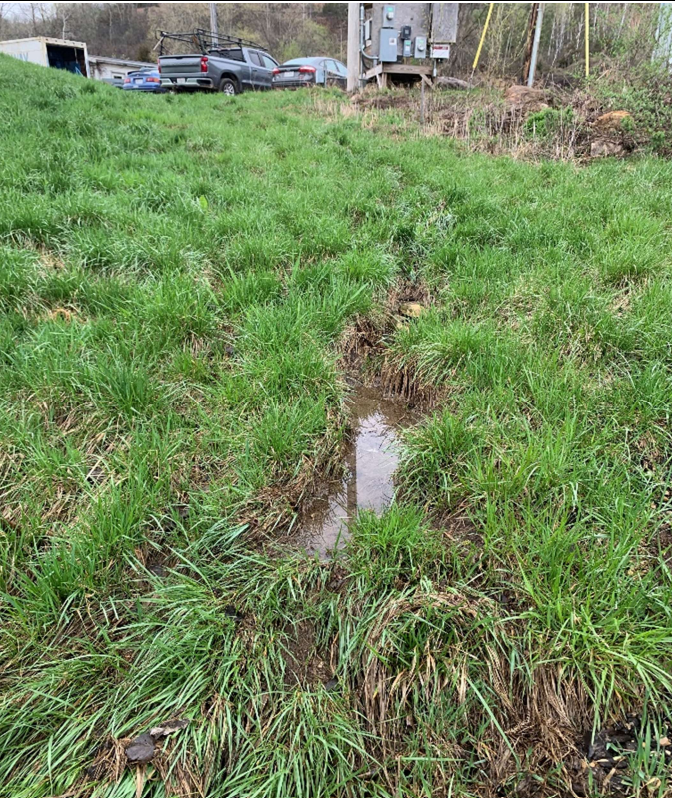
No evidence if significant erosion was observed at the site. However, evidence of erosion at the eastern drainage ditch above the sediment basin continues to get worse.

Evidence of erosion at the eastern drainage ditch above the sediment basin continues to get worse when heavy rain events occur.

Evidence of erosion at the eastern drainage ditch above the sediment basin was observed. Vegetation is in place, but ruts are starting to form (See photo #2).

Description <u>Eastern Drainage Ditch:</u> Evidence of erosion starting to occur at the north portion of the eastern drainage ditch leading to the sediment basin. Vegetation is still intact but ruts are starting to form.

TRC will continue to monitor the area.

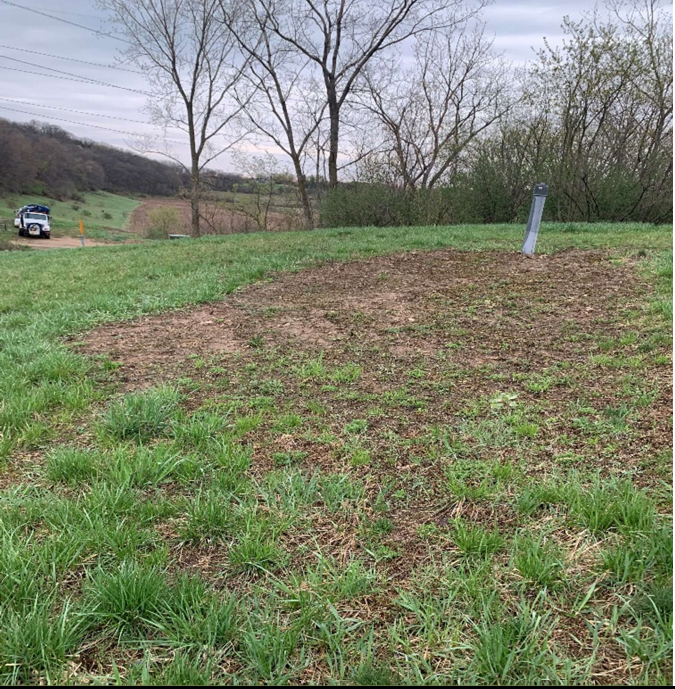
Client Name: Wisconsin Department of Natural Resources (WDNR)		Site Location: Refuse Hideaway Landfill Middleton, WI	Project No.: TRC # 457573
Photo No. 3	Date 4/18/2024

Description <u>Eastern Landfill Extents</u> Reseeding and ground cover was previously applied in the Fall of 2022. Some bare spots remain and will require reseeding.			
Photo No. 4	Date 4/18/2024

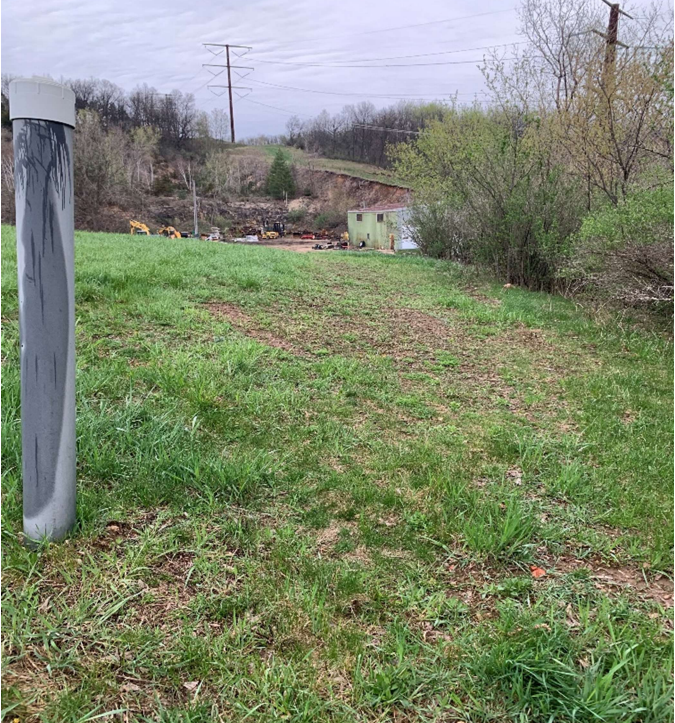
Description <u>Eastern Landfill Extents</u> Reseeding and ground cover was previously applied in the Fall of 2022. Some bare spots remain and will require reseeding.

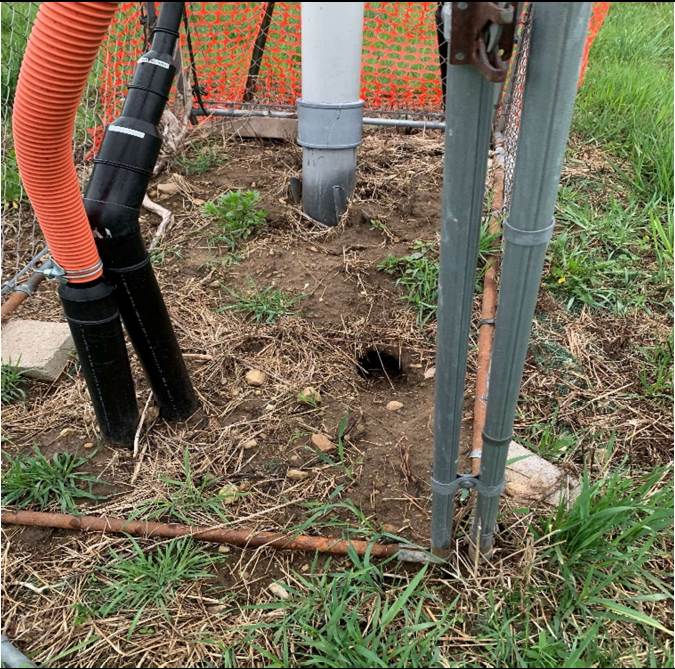
Photo No. 5	Date 4/18/2024

- GW-2 and GW-3 on the south side have wildlife burrowing inside the fencing. GW-13 on the north side has burrowing outside the fence. (see photo #5)

Description <u>Southern Landfill Extents</u> GW-2, GW-3 have burrowing from wildlife inside fencing. GW-13 has burrowing from wildlife outside fencing.

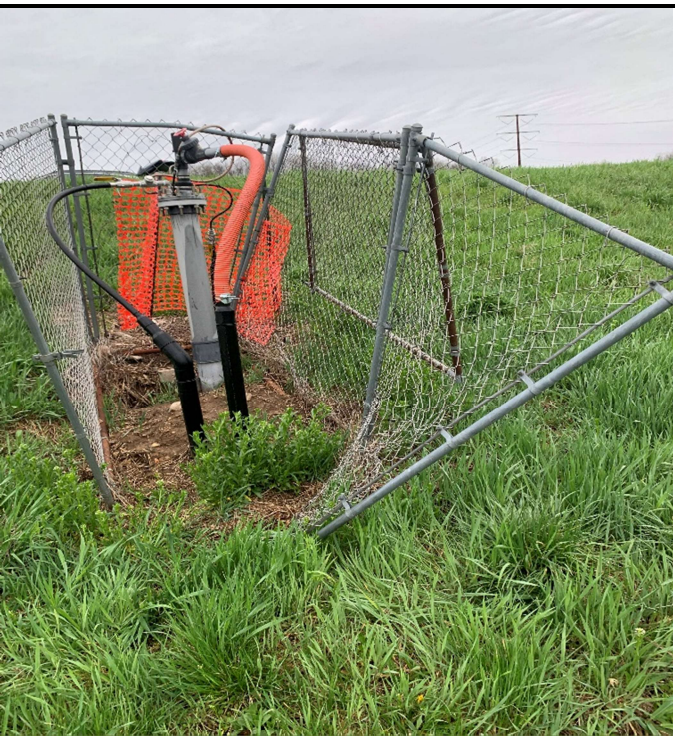
Photo No. 6	Date 4/18/2024

- Fencing around GW-1 and GW-2 is damaged but still provides well protection from mowing operations (see photo #6).

Description <u>Southern Landfill Extents:</u> GW-2 protective fencing is falling apart. Fencing still provides protection during mowing operations. GW-1 protective fencing is in the same condition as GW-2.

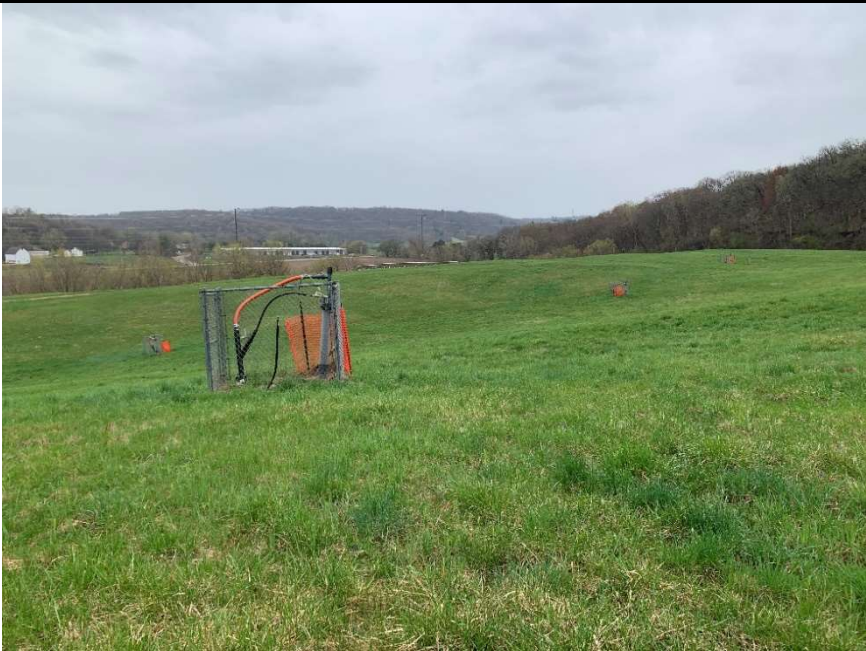
Vegetation cover is acceptable over the majority of the site (see photo #7). Various areas were reseeded and ground cover was applied in fall of 2022.

Description <u>Northern Landfill Extents:</u> Cap remains in good condition with full vegetation cover.
