June 21, 2024

Subject: Refuse Hideaway Landfill
May 2024 Operation Monitoring and Maintenance Activities

Attachment 2
Photographic Log

Client Name: Wisconsin Department of Natural Resources (WDNR)	Site Location: Refuse Hideaway Landfill Middleton, WI	Project No.: TRC # 457573
---	--	-------------------------------------

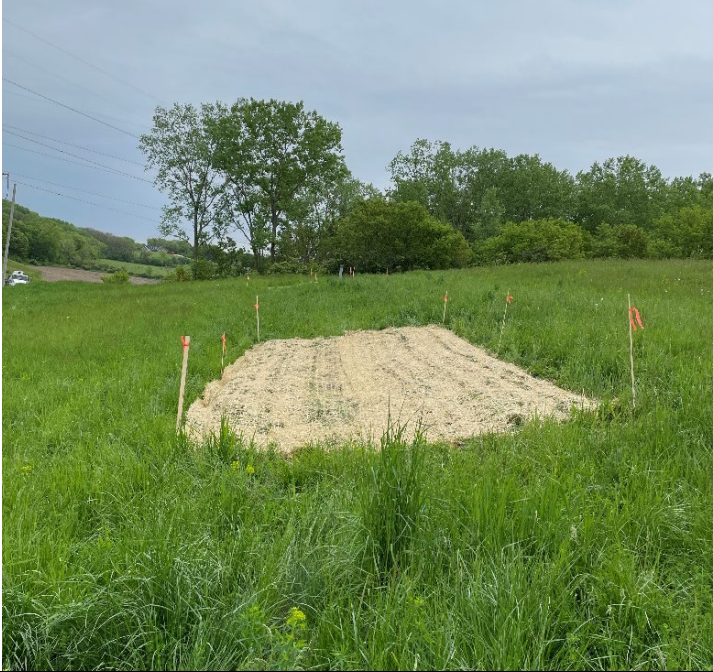
Areas at the west drainage ditch and east drainage ditch previously showed signs of vegetation die-off and were reseeded in May of 2024.

Photo No. 1	Date 5/14/2024	<div style="border: 1px solid black; padding: 5px;"> <p>Description</p> <p><u>Eastern Drainage Ditch:</u> Reseeding and erosion matting was completed in May 2024 for select areas of the landfill where bare soil was present.</p> </div>

TRC will continue to monitor these areas. (see photo #1).

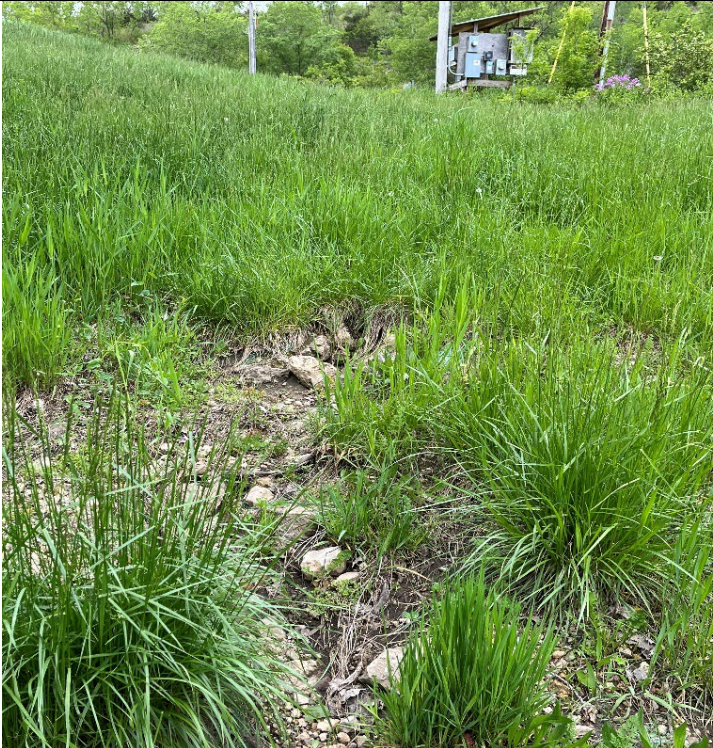
No evidence if significant erosion was observed at the site. However, evidence of rutting long the eastern drainage ditch above the sediment basin continues and conditions have not shown improvement since the previous inspections.

Evidence of erosion at the eastern drainage ditch above the sediment basin continues to get worse when heavy rain events occur.

Evidence of erosion at the eastern drainage ditch above the sediment basin was observed. Vegetation is in place, but ruts are starting to form (See photo #2). TRC will continue to monitor the area.

Photo No. 2	Date 5/14/2024	<div style="border: 1px solid black; padding: 5px;"> <p>Description</p> <p><u>Eastern Drainage Ditch:</u> Erosion is present along the north portion of the eastern drainage ditch leading to the sediment basin. Vegetation is still intact, but ruts are starting to form.</p> </div>

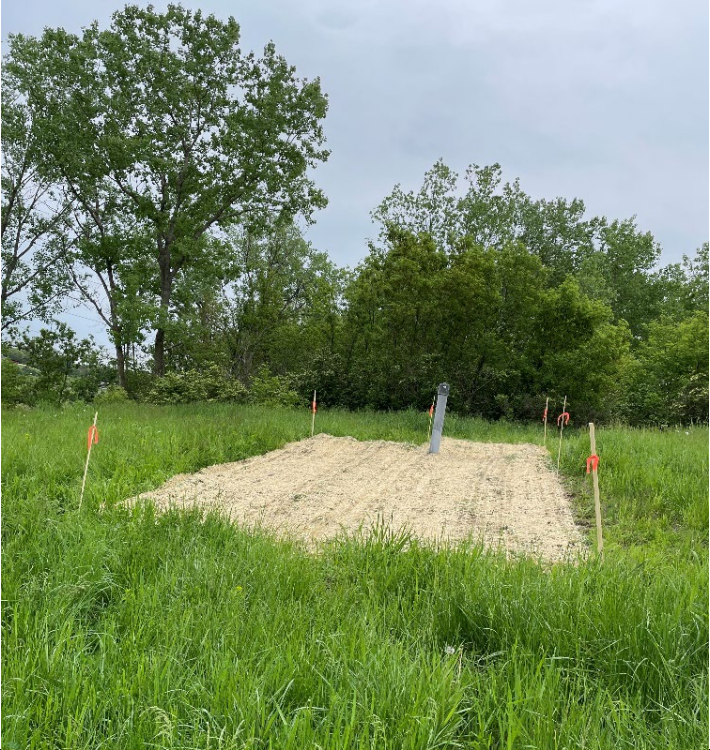
Client Name: Wisconsin Department of Natural Resources (WDNR)		Site Location: Refuse Hideaway Landfill Middleton, WI	Project No.: TRC # 457573
Photo No. 3	Date 5/14/2024

Description <u>Eastern Landfill Extents</u> Reseeding and erosion matting for select areas with bare soil was completed in May of 2024.			
Photo No. 4	Date 5/14/2024

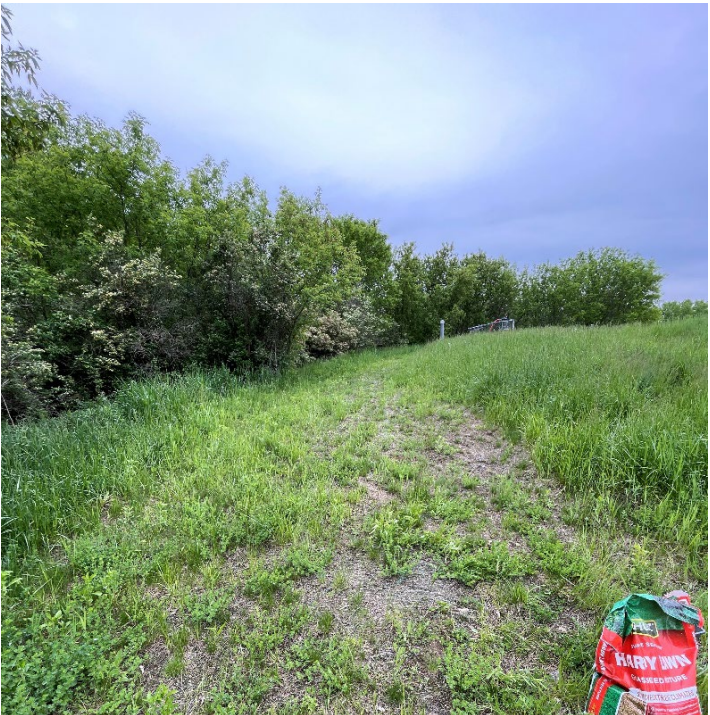
Description <u>Eastern Landfill Extents</u> Reseeding of bare spots was conducted in May of 2024.

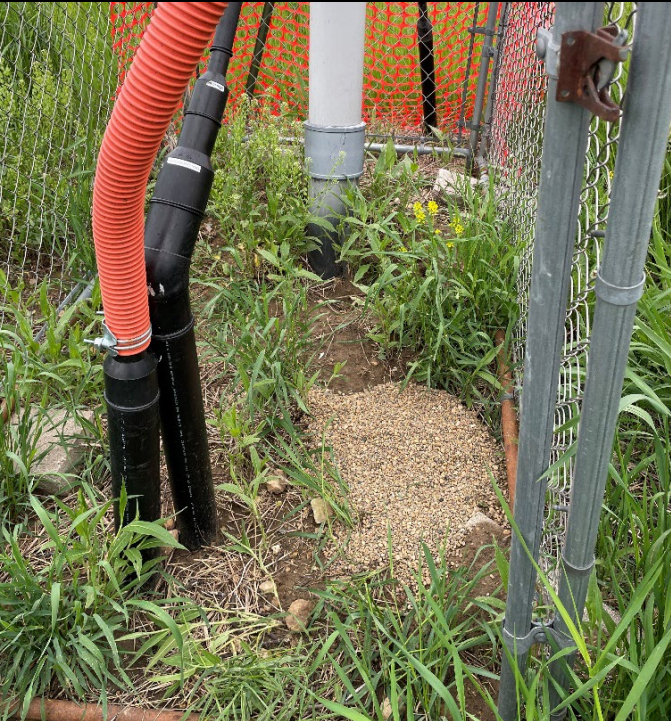
Client Name: Wisconsin Department of Natural Resources (WDNR)		Site Location: Refuse Hideaway Landfill Middleton, WI	Project No.: TRC # 457573
Photo No. 5	Date 5/14/2024

-GW-2 and GW-3 on the south side of the landfill have wildlife burrowing inside the protective fencing. GW-13 on the north side of the landfill has burrowing outside the protective fence. All burrows were filled in with gravel in May 2024 (see photo #5)

Description <u>Southern Landfill Extents</u> GW-2, GW-3 have burrowing from wildlife inside protective fencing and GW-13 has burrowing from wildlife outside fencing. All wildlife burrows were filled with gravel in May 2024.

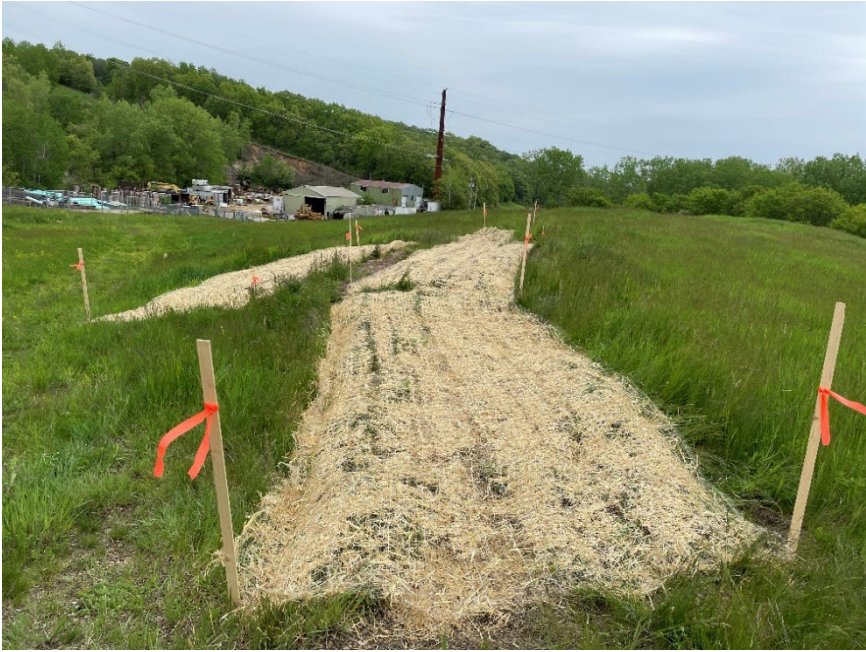
Client Name: Wisconsin Department of Natural Resources (WDNR)		Site Location: Refuse Hideaway Landfill Middleton, WI	Project No.: TRC # 457573
Photo No. 7	Date 5/14/2024

Description <u>Landfill Extents:</u> Reseeding and erosion matting was completed in May of 2024 for select areas of the landfill where bare soil was present.
