SUBJECT: Tri-Annual Facility Inspection Report
Bid Item #1
Stoughton City Landfill
FID # 113005950 - License #133
BT² Project #1764

**Operation and Maintenance Report
Passive Gas Vent Monitoring
Stoughton City Landfill / BT² Project #1764**

**Operation and Maintenance Periodic Inspection Report
Stoughton City Landfill
Stoughton, Wisconsin**

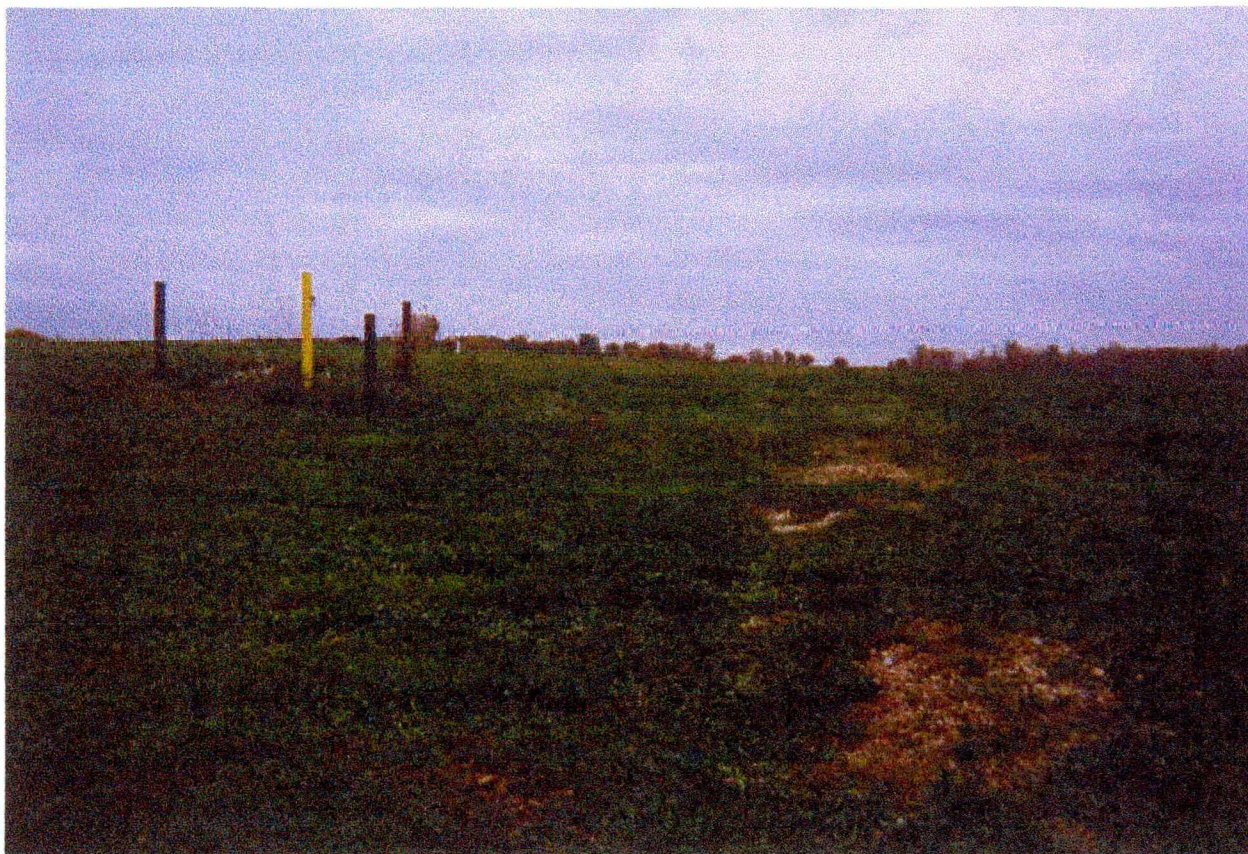
Figure 1

Vegetative cover on landfill after mowing.
October 5, 2000

Final Cover Vegetation and Slope: BT², Inc. has hired *Sunset Restoration, LLC* from Stoughton, WI to provide mowing services at the landfill. The first of two mowing of the cover occurred on July 12, 2000. The clover was cut to a height of less than 12 inches. No signs of erosion, settlement, or subsidence. No evidence of burrowing animals observed on the cover.

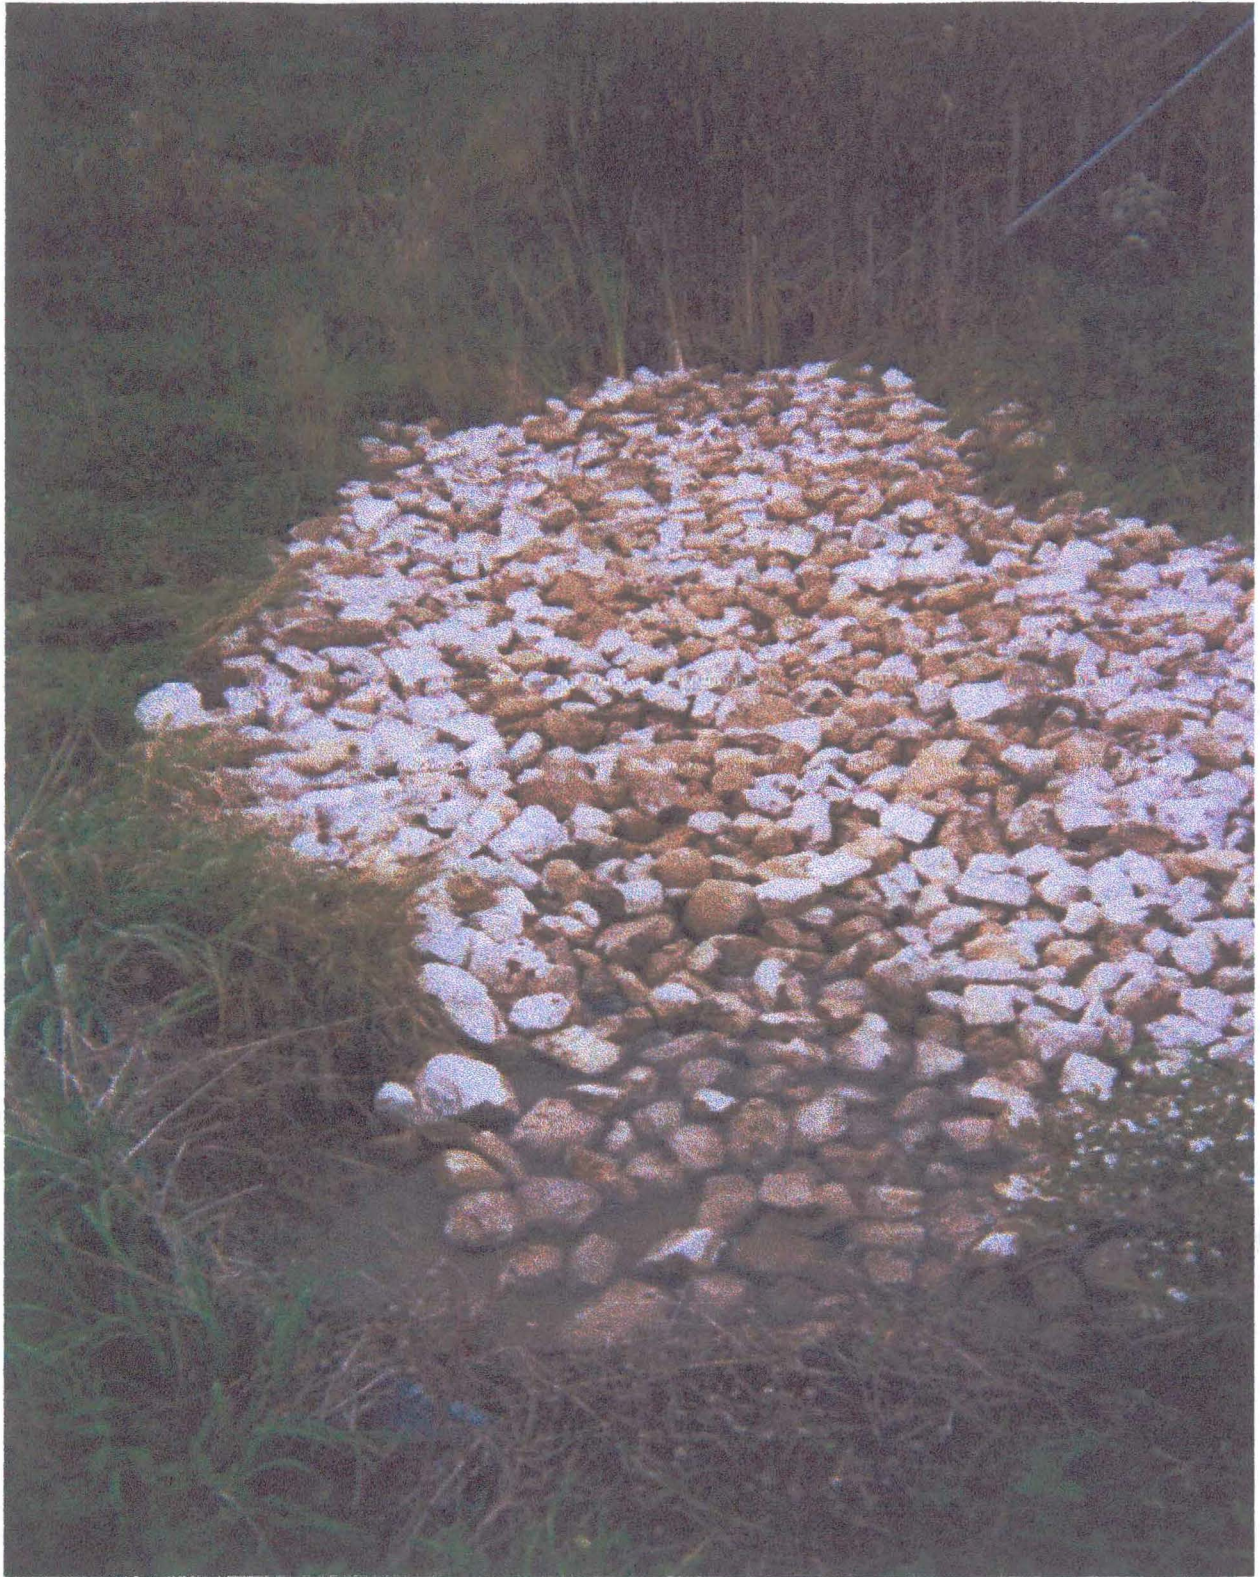
Figure 2

Rip-rap placement at the west culvert
October 5, 2000

Stormwater Drainage Channels: Rip-rap repair and placement services occurred on October 5, 2000 to address the erosion gulleys along the gravel access road (to the north and south) and the discharge point to the east of the main gate. The drainage channel along the northwest edge of the landfill was in good shape on the inspection date. The silt fencing and staking along with the hay bales and staking was removed on October 5, 2000.

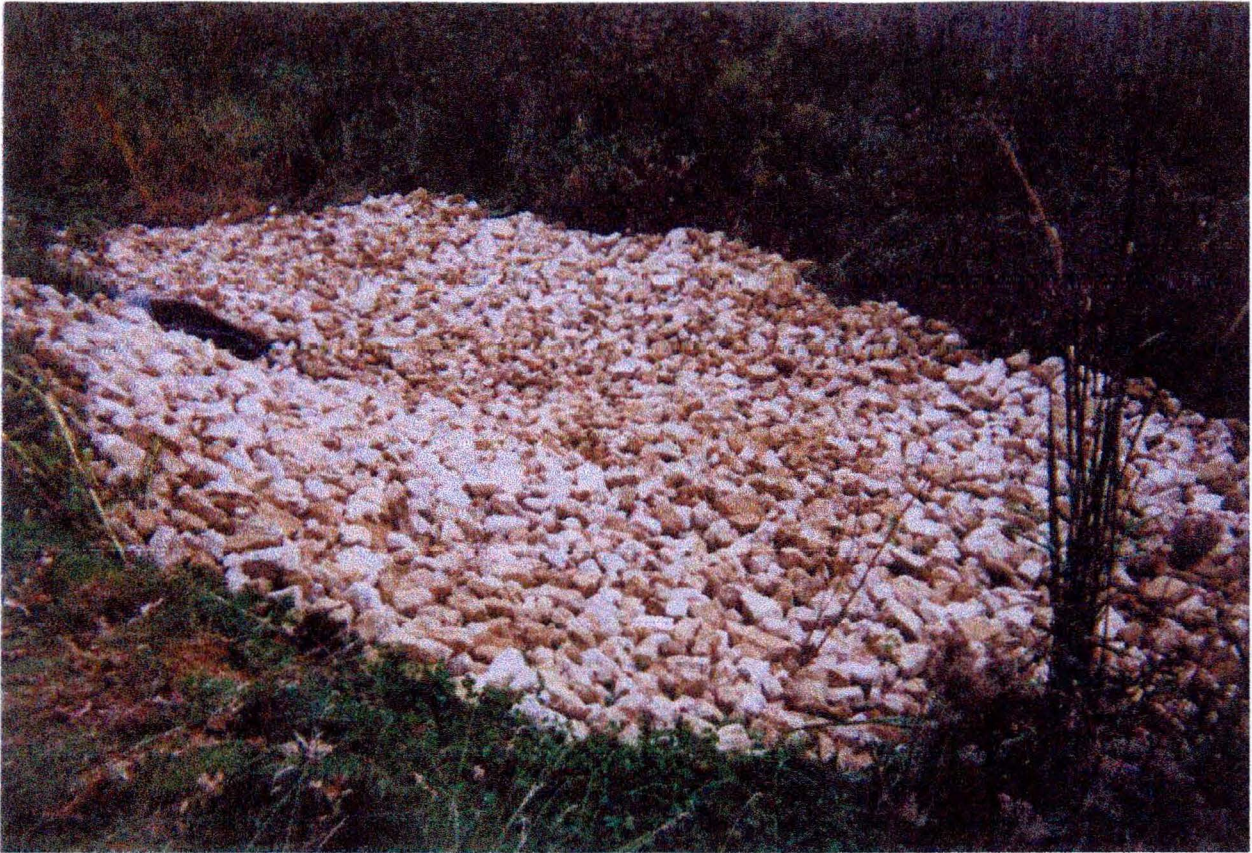
Figure 3

Stormwater Drainage Channels: An erosion gully is observed to have formed along the south side of the gravel access road at the point where the storm sewer pipe discharges to the second drainage channel. Significant ponding is occurring on the north side of the same access road along with cattail growth. Rip-rap placement services will be addressed in a Change Order. The drainage channel along the northwest edge of the landfill is in good shape. The silt fencing in place along the northwest edge of the landfill is no longer needed. Also, the hay bales inside and outside the fencing are no longer needed and the removal of both the silt fence and the hay bales will be discussed with the WDNR Project Manager.

Rip-rap placement on the north side of the gravel access road on the southern edge of the landfill.

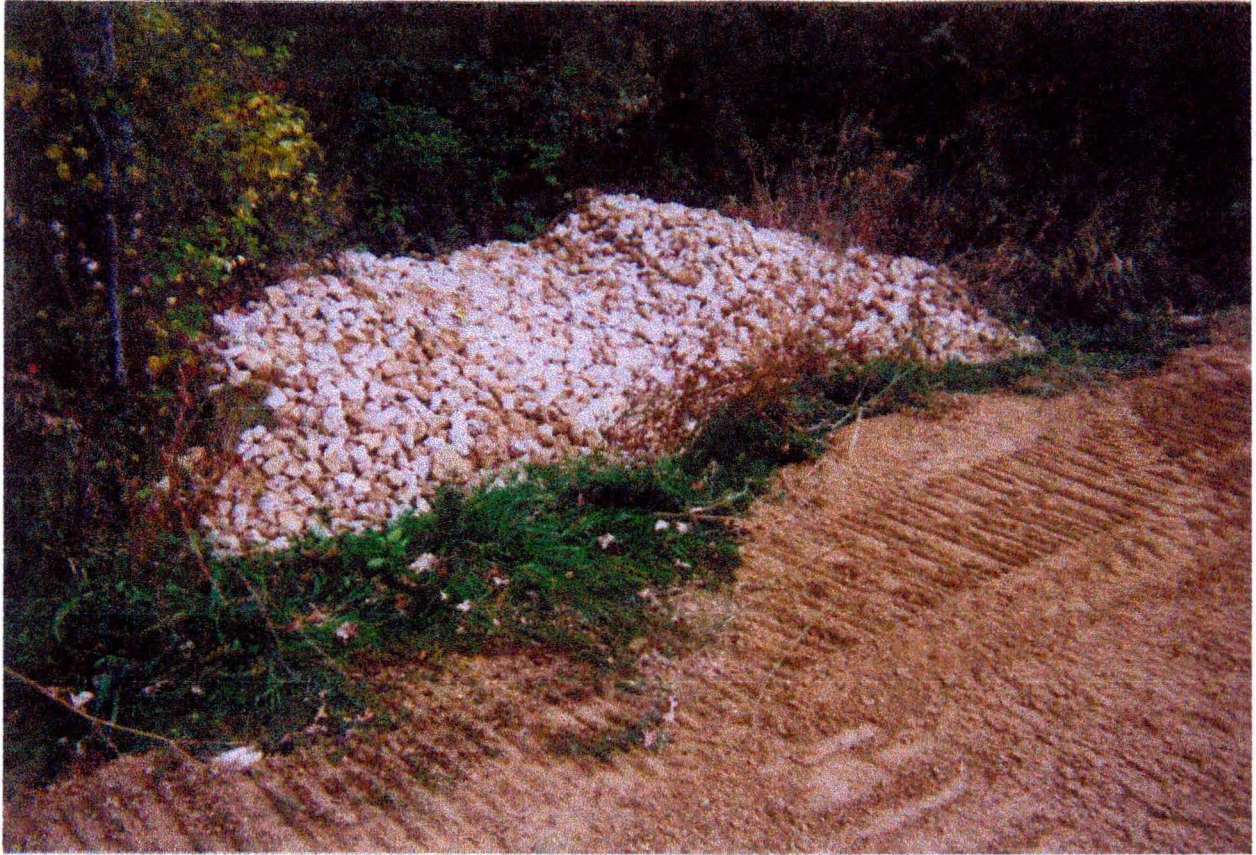
Figure 4

Stormwater Drainage Channels: The erosion gully along the south side of the gravel access road at the point where the storm sewer pipe discharges to the second drainage channel is still present and will be repaired. The ponding on the north side of the same access road will also be repaired. The drainage channel along the northwest edge of the landfill is in good shape. Removal and proper disposal of both the silt fence and the hay bales will be done. Ponding was noticed in the runoff culvert to the east of the main gate. Rip-rap placement will be conducted to repair this area.

Rip-rap placement at the storm water culvert on the south side of the gravel access road on the southern edge of the landfill.
October 5, 2000
