**THIRD FIVE-YEAR REVIEW REPORT FOR
STOUGHTON CITY LANDFILL SUPERFUND SITE
City of Stoughton, Dane County, Wisconsin**

**Prepared by
Wisconsin Department of Natural Resource for the
U.S. Environmental Protection Agency
Region 5
Chicago, Illinois**

April 2013

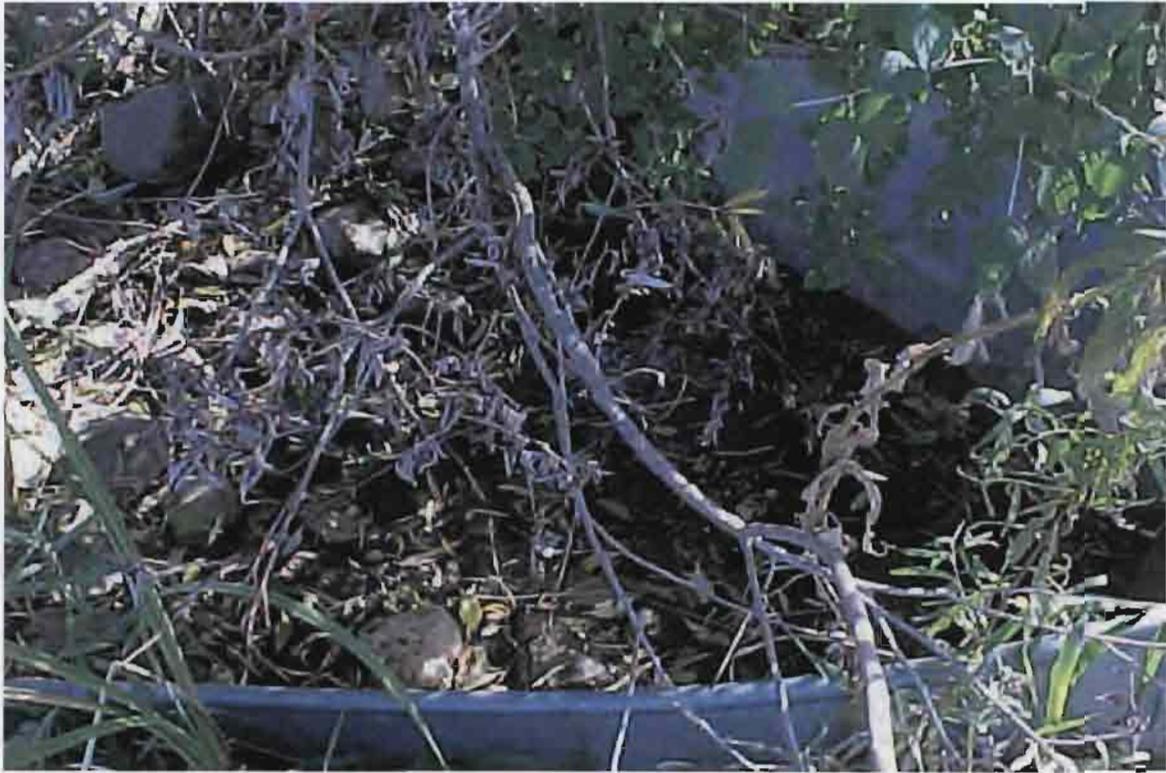
Photo 1. Outlet from culvert. Note no ponding or apparent impediment to flow.

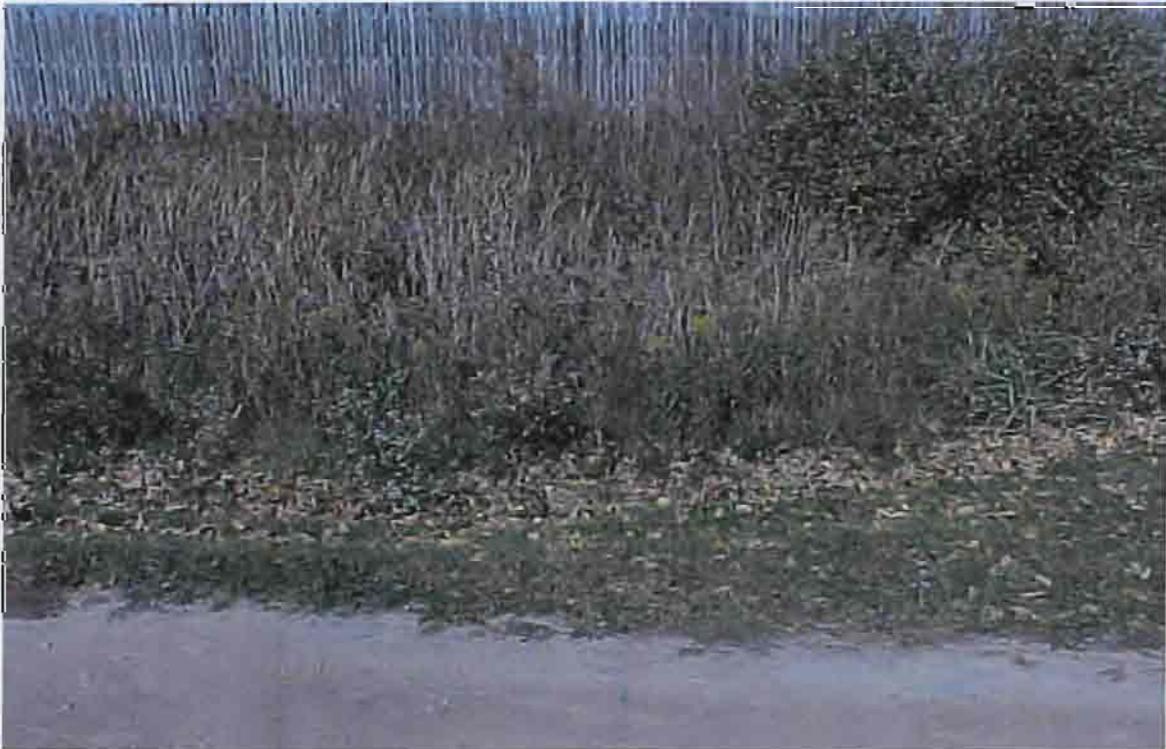
Photo 2. Vegetation in drainage ditch to the S of site outside fence.

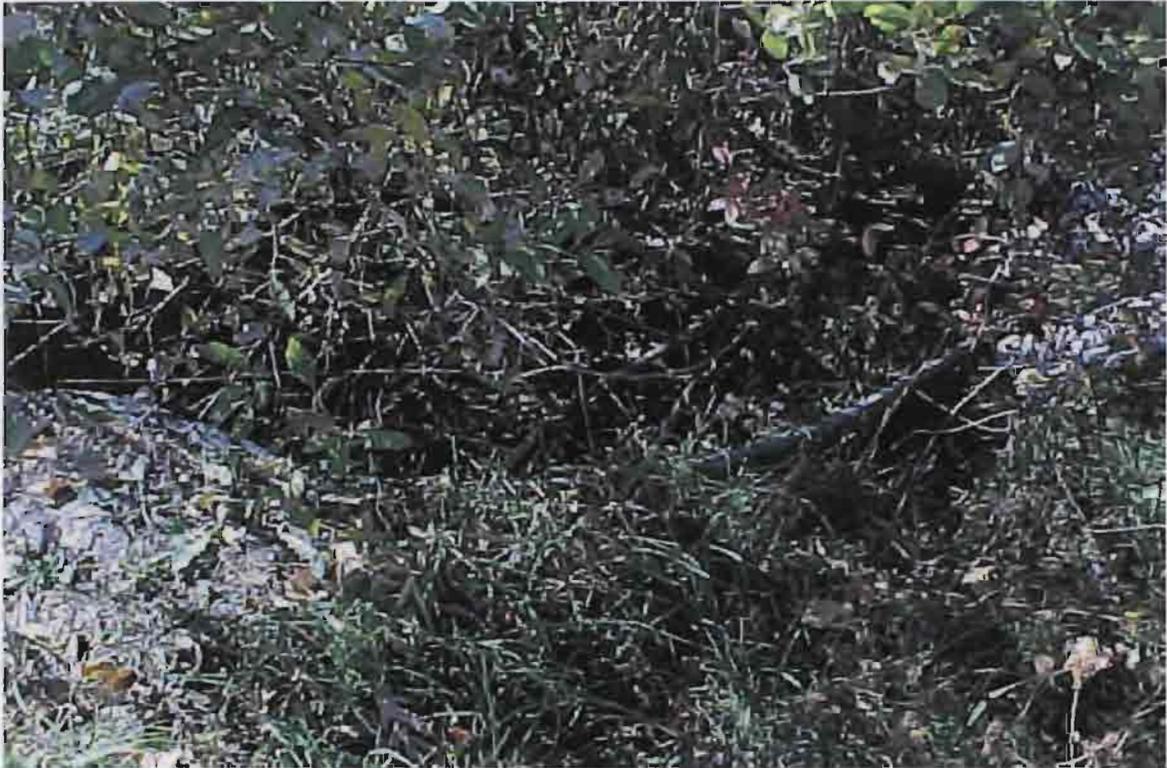
Photo 3. Culvert to S of ditch. There is no apparent impediment to flow through this culvert.

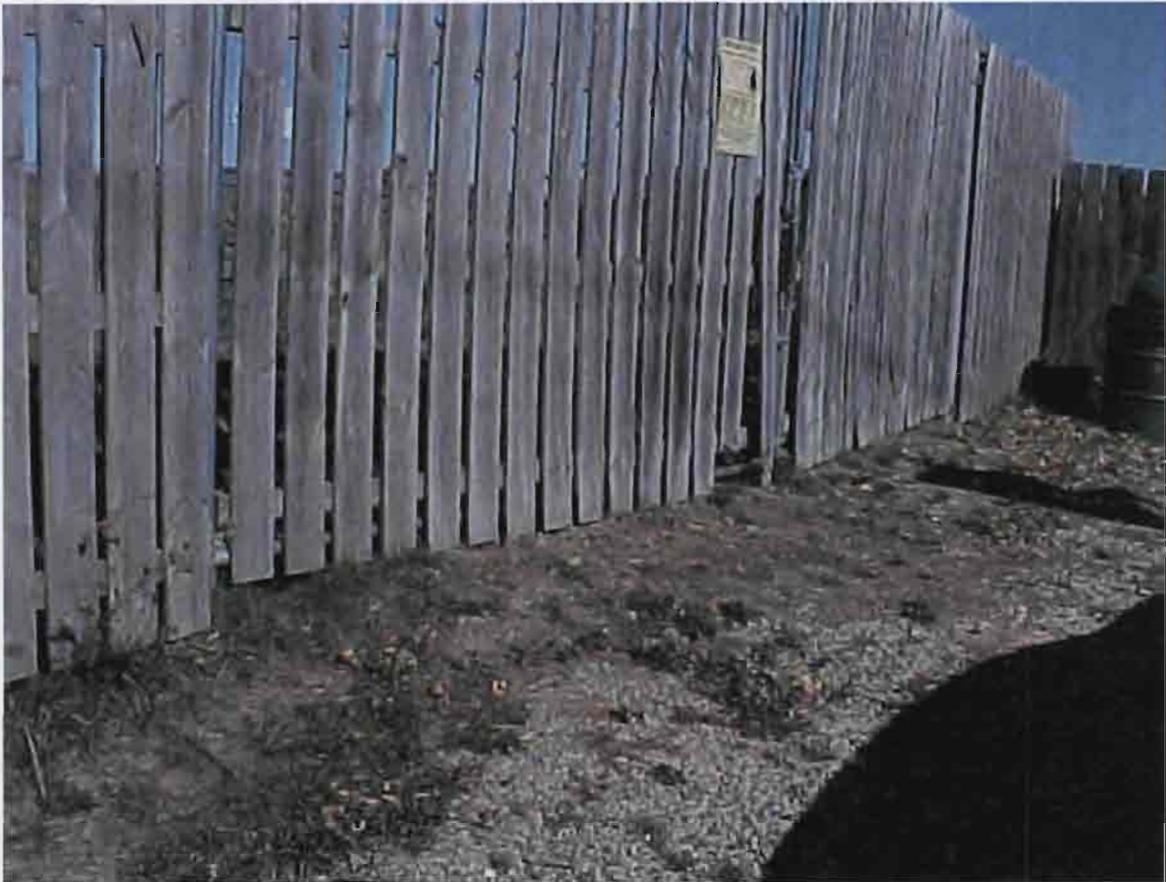
The fence was in good condition. No broken or removed boards on the wood slat fence were found. Some boards had warped near the main gate and had become somewhat detached at the bottom. Apparent frost heave has raised the wood fence pole on the west side. A state repair contractor will be tasked to make these repairs. The chain-link fence was in good condition. Both access gates were in good condition and the padlocks operated properly. The warning sign on the front gate was noted.

Photo 19. Warped boards near front gate that need to be reattached.

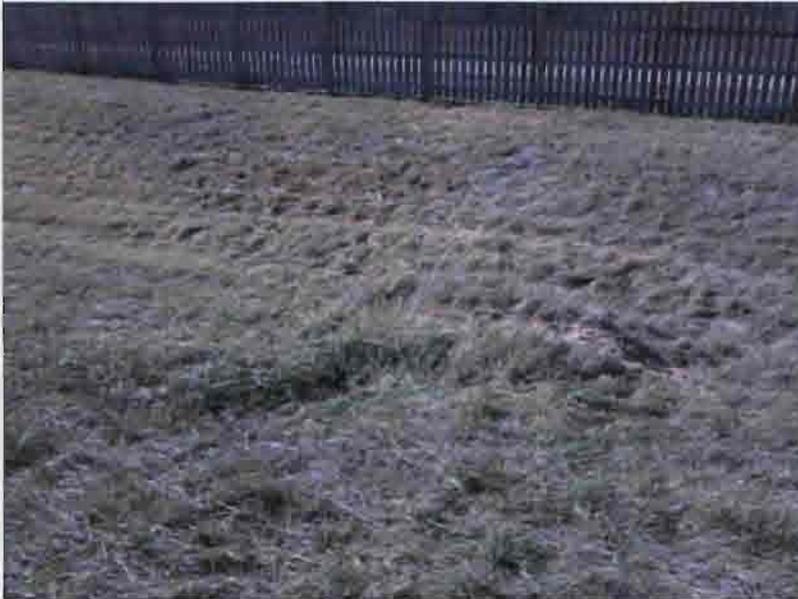
2012-10-003: Gulley and sand pile (w/vegetation) near GV-18
Date: 12-Oct-2012
Time: 1:45 PM
Weather: Sunny, 50 Degrees F.

The landfill cover appeared to be generally in good condition. No bare spots or sparse vegetation were noted. Several animal burrows were noted and one location showed some potential erosion. Woody vegetation was noted near some of the gas vents. A state repair contractor will be tasked to repair the burrows, erosion and remove woody vegetation.

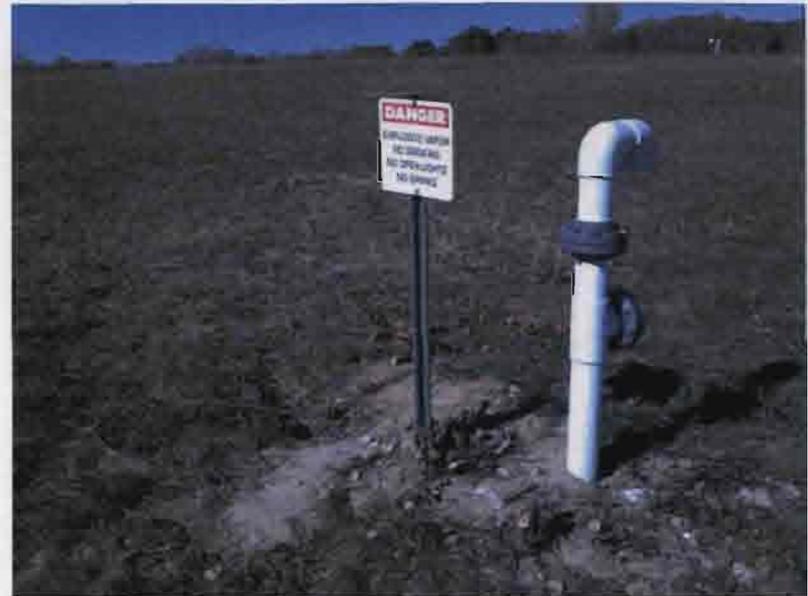
2012-10-004: GV-9 – Animal Burrow, Woody Vegetation
Date: 12-Oct-2012
Time: 12:50 PM
Weather: Sunny, 50 Degrees F.

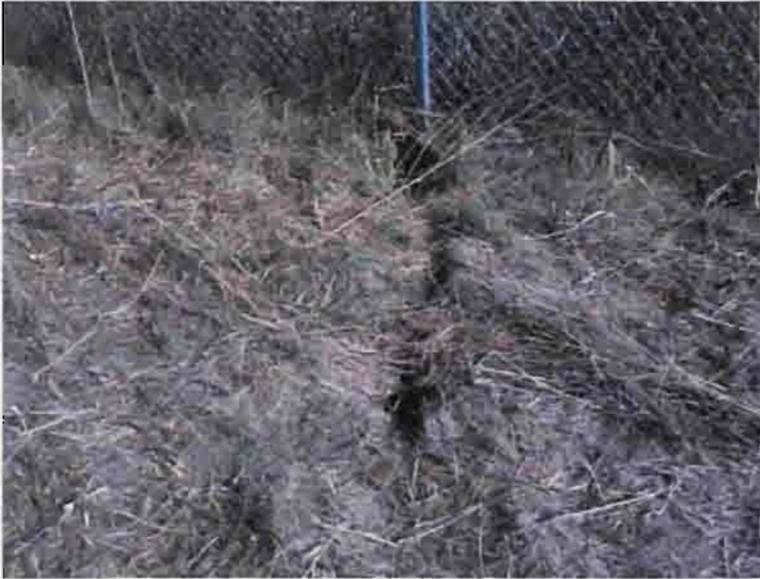
2012-10-005: Animal burrow at perimeter fence near GV-5
Date: 12-Oct-2012
Time: 12:55 PM
Weather: Sunny, 50 Degrees F.

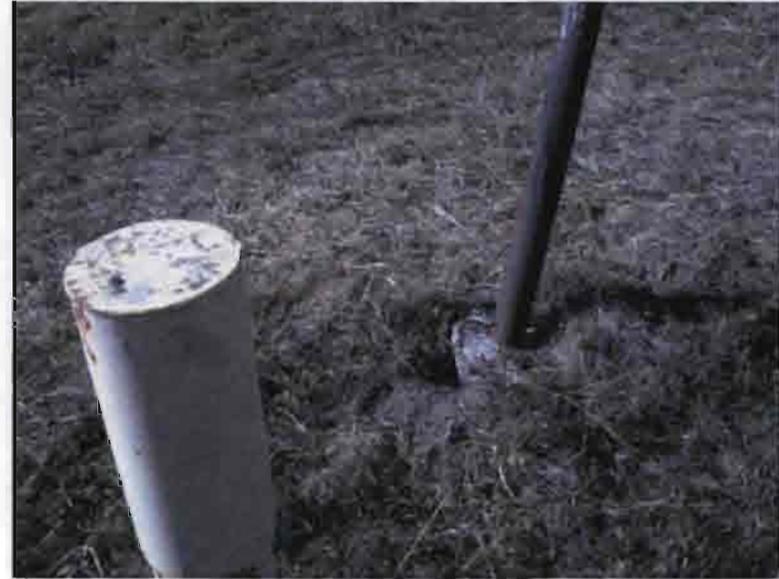
2012-10-006: : Animal burrow near MW-6S
Date: 12-Oct-2012
Time: 12:58 PM
Weather: Sunny, 50 Degrees F.

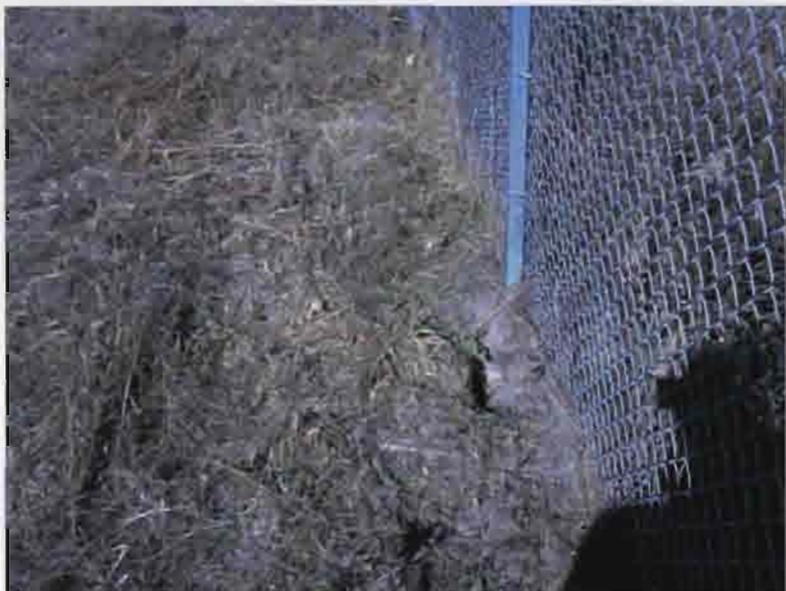
2012-10-007: Animal burrow near MW-6S at fenceline
Date: 12-Oct-2012
Time: 12:59 PM
Weather: Sunny, 50 Degrees F.

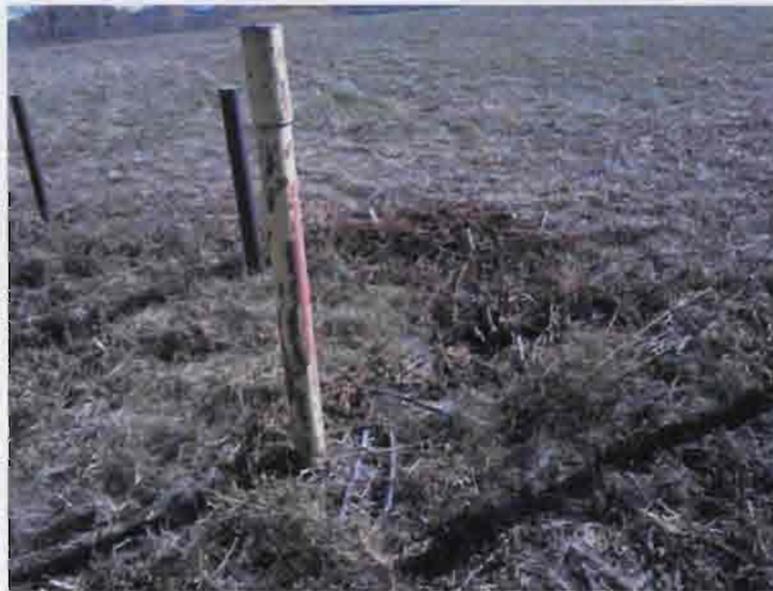
2012-10-008: Woody vegetation near MW-11S
Date: 12-Oct-2012
Time: 1:01 PM
Weather: Sunny, 50 Degrees F.

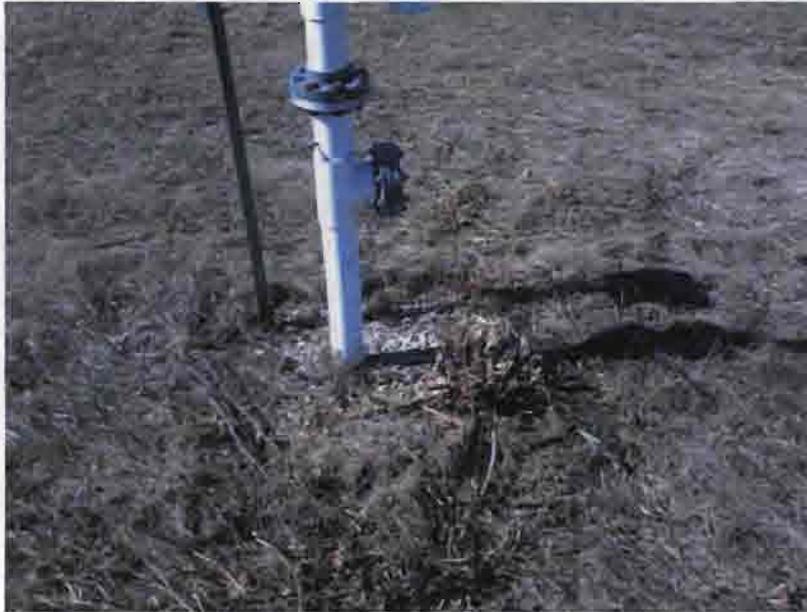
2012-10-009: Woody vegetation near GV-16
Date: 12-Oct-2012
Time: 1:03 PM
Weather: Sunny, 50 Degrees F.

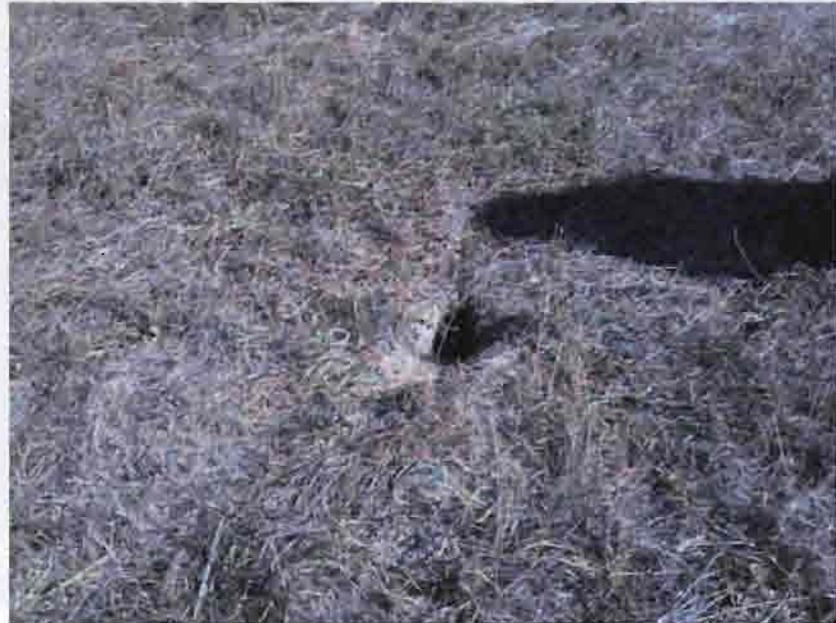
2012-10-010: Animal burrow SE of GV-9
Date: 12-Oct-2012
Time: 1:30 PM
Weather: Sunny, 50 Degrees F.

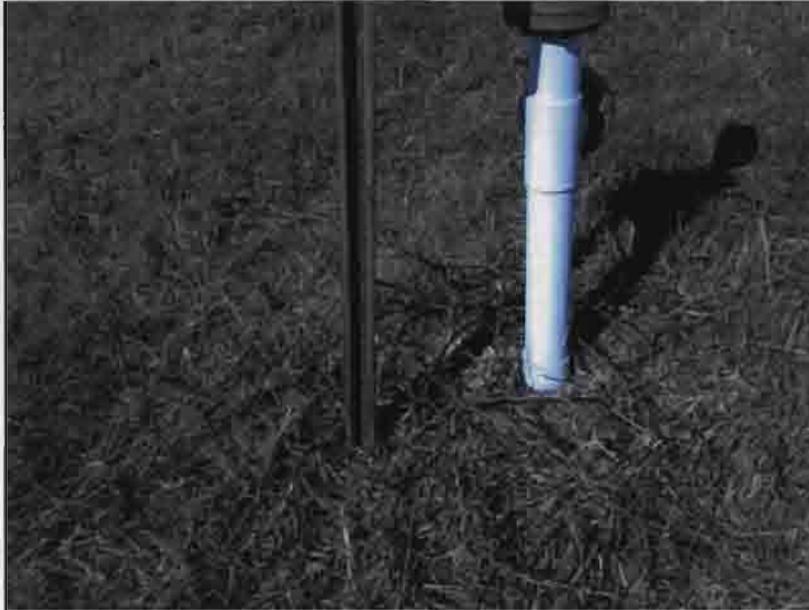
2012-10-011: Woody vegetation near GV-13
Date: 12-Oct-2012
Time: 1:36 PM
Weather: Sunny, 50 Degrees F.

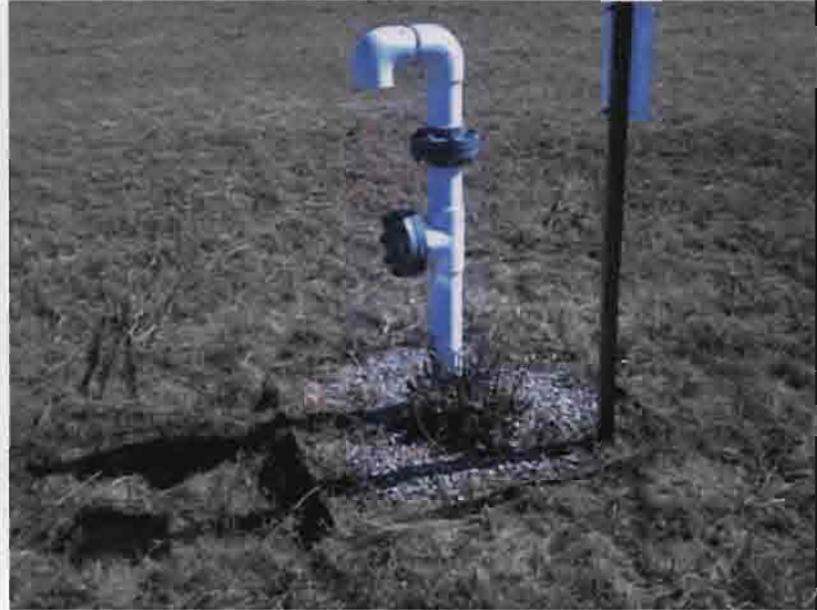
2012-10-012: Woody vegetation near GV-19
Date: 12-Oct-2012
Time: 1:51 PM
Weather: Sunny, 50 Degrees F.

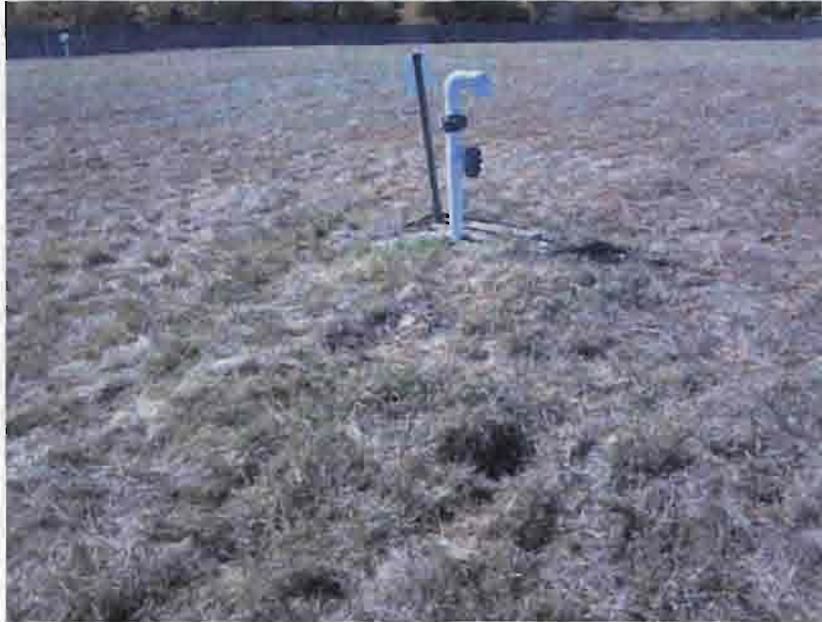
2012-10-013: Animal burrow near GV-12
Date: 12-Oct-2012
Time: 1:59 PM
Weather: Sunny, 50 Degrees F.

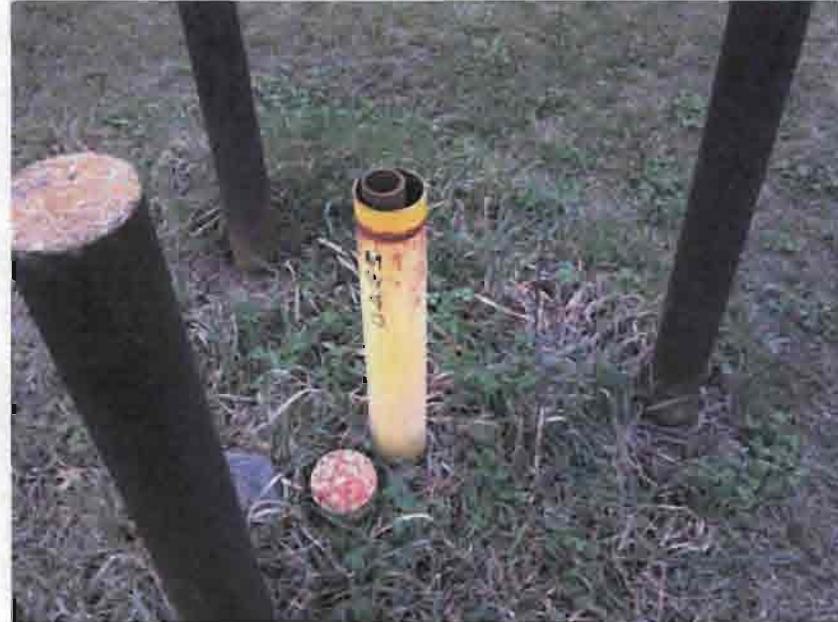
2012-10-014: MW4D – Well casing too high to allow installation of expandable cap
Date: 23-Mar-2012 (Historical photo)
Time: 2:49 PM
Weather: Sunny, 35 Degrees F.

Four monitoring wells need to have their protective caps replaced, which has been delayed due to interference by the length of the protective casing. Also, one of the hinges on a protective cap needs to be replaced. A state repair contractor will be tasked to make these repairs.

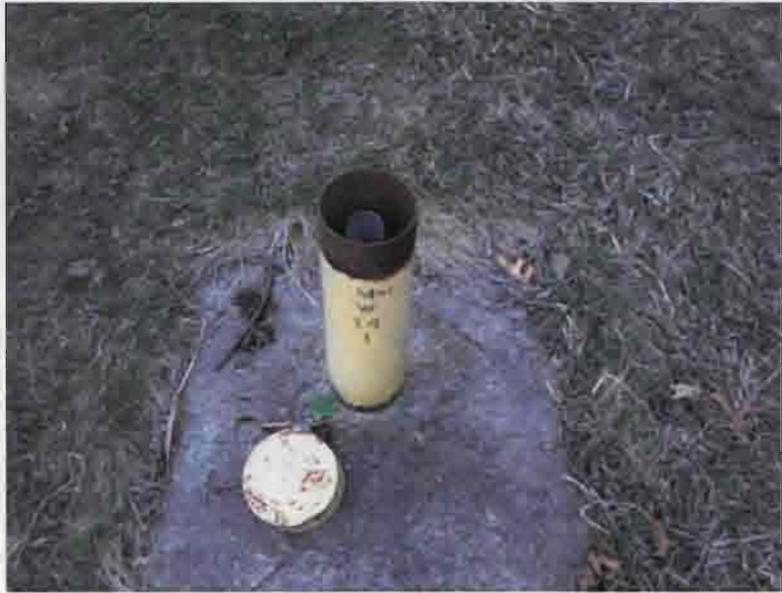
2012-10-015: MW14I – Well casing too high to allow installation of expandable cap

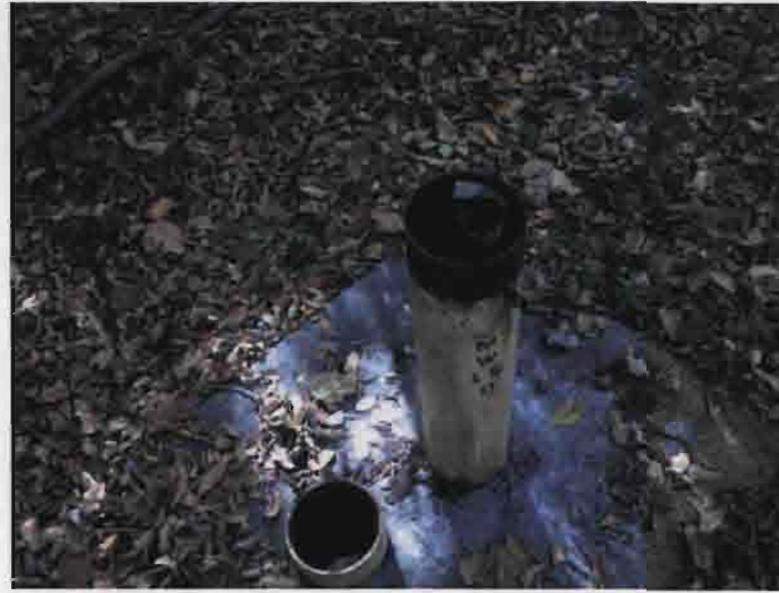
2012-10-016: MW15D – Well casing too high to allow installation of expandable cap

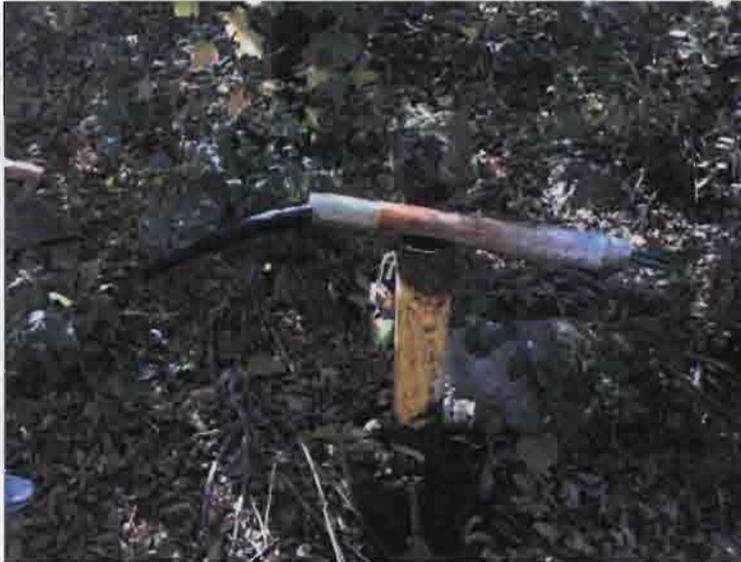
2012-10-017: MW-7B – Broken Well Casing
Date: 12-Oct-2012
Time: 2:26 PM
Weather: Sunny, 50 Degrees F.

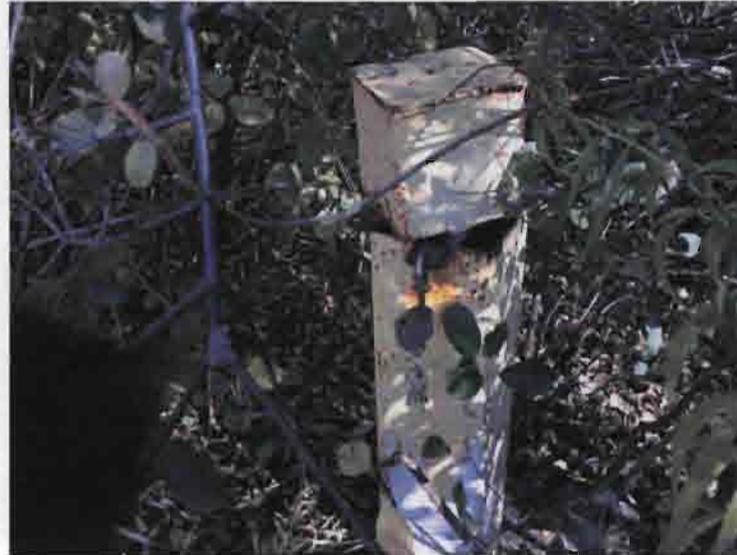
2012-10-018: MW-13S requires new hinge
Date: 12-Oct-2012
Time: 3:22 PM
Weather: Sunny, 50 Degrees F.
