## SCS ENGINEERS

Subject:       Semiannual Facility Inspection Report  
                  Stoughton City Landfill  
                  FID #113005950 – License #133  
                  USEPA ID #WID980901219  
                  WDNR Purchase Order #37000-0000000548

**Operation and Maintenance Semi Annual Inspection Report  
Stoughton City Landfill  
Stoughton, Wisconsin**

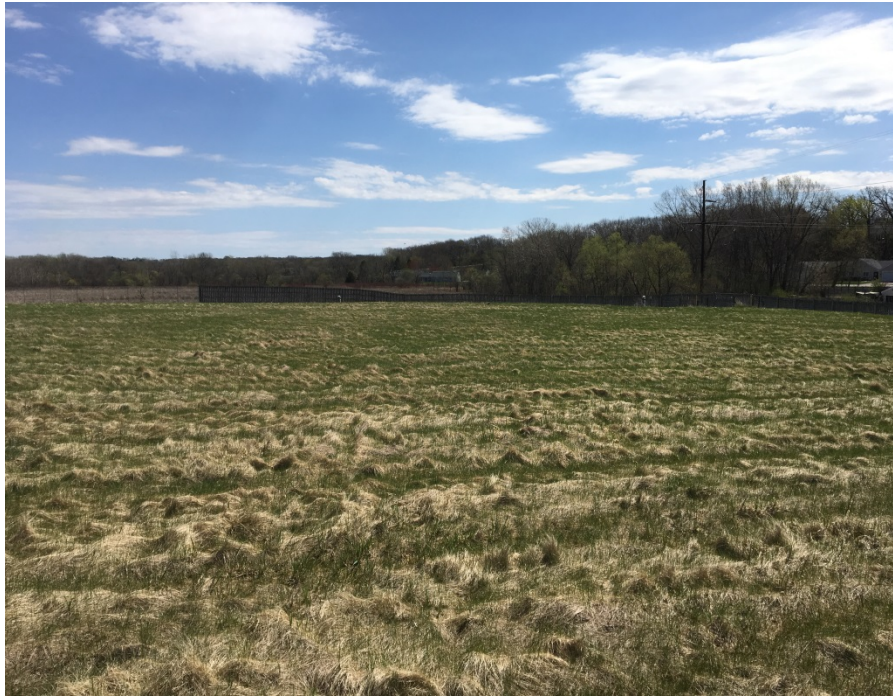
**Photo 1:** Photo facing east just inside the west access gate. Final cover was damp but in good condition.

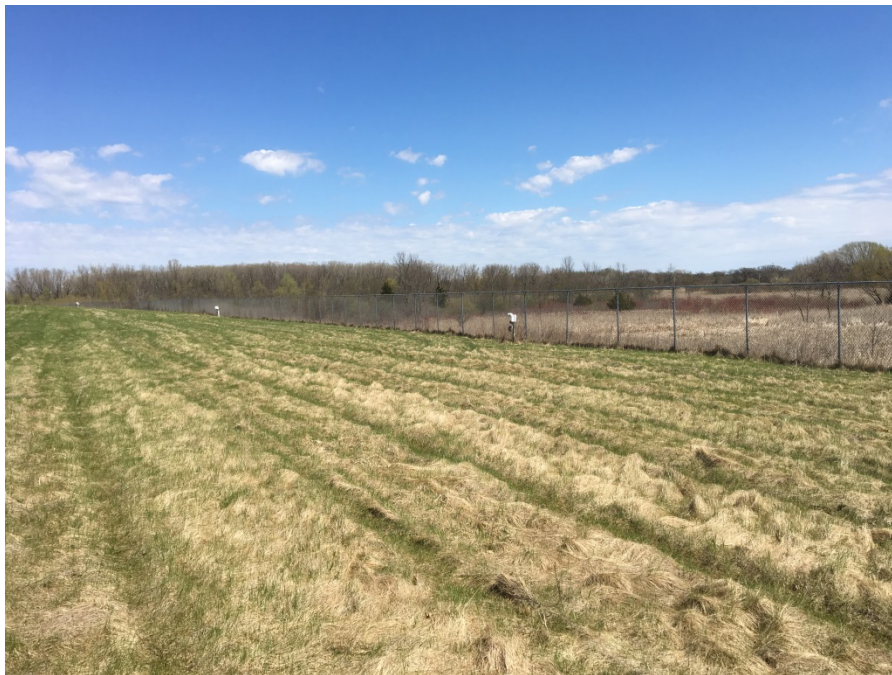
**Photo 2:** Photo facing northeast just inside the south access gate. Final cover was damp but in good condition.

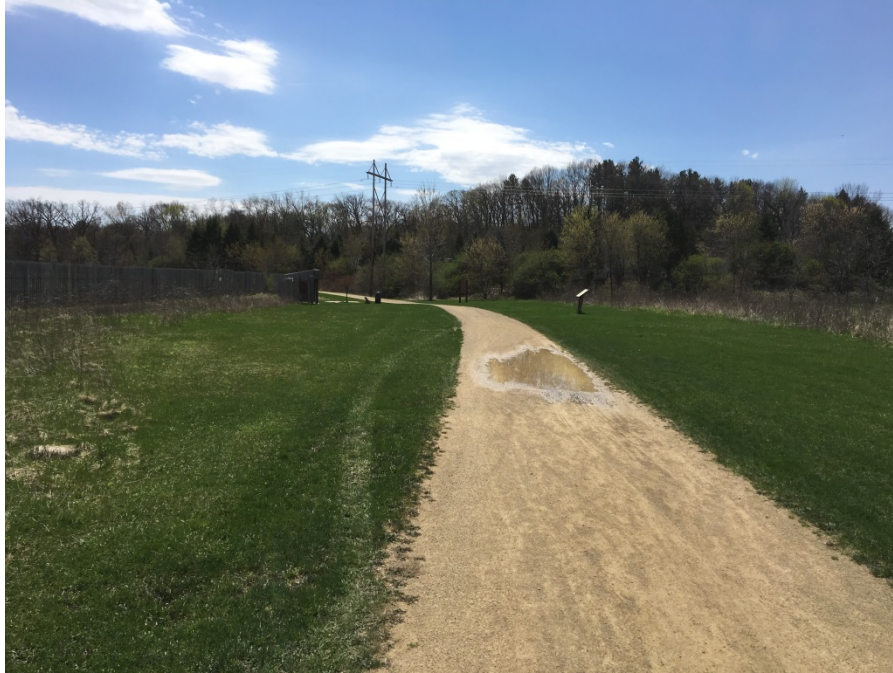
**Access Road** – The site access road was in good condition with no ruts, or erosion noted. Some minor ponding was present on the access road to the south of the west gate entrance, see photo 3 of **Attachment C**. The ponded water is shallow and only in a small isolated area; therefore, immediate maintenance is not required. If access road conditions change, yielding a larger area of ponding or the ponding becomes deeper, the road will need to be regraded.

**Photo 3:** Photo facing south just outside the west access gate. Gravel drive around the west side of the landfill.

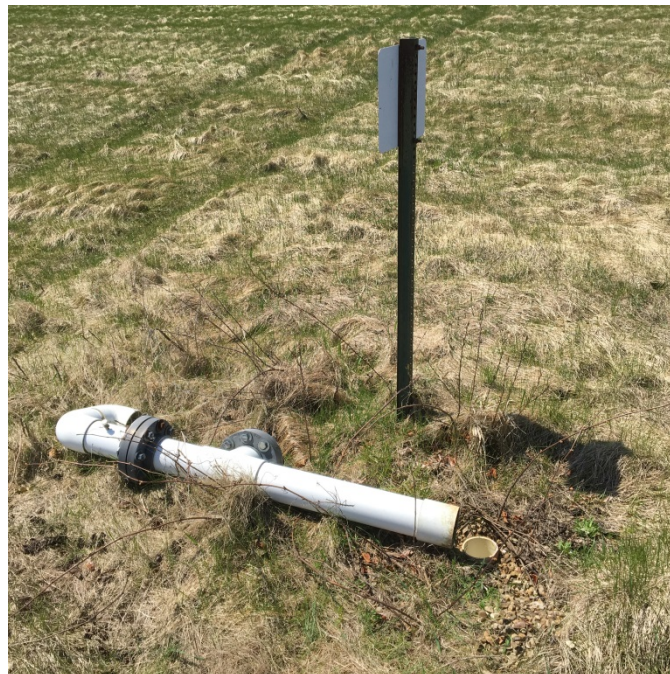
**Landfill Gas Venting System** – Gas vent eight (GV-8) was discovered unconnected, lying on the ground. SCS returned it back into the correct position. GV-8 will be checked during the next site visit to ensure it is in a fixed upright position. No damage was found at any of the remaining gas venting wells, and no stressed vegetation was found near any of the wells. Gas vent well screens were clear, and no further maintenance is needed at this time.

**Photo 4:** Photo facing northwest. Photo taken of GV-8.

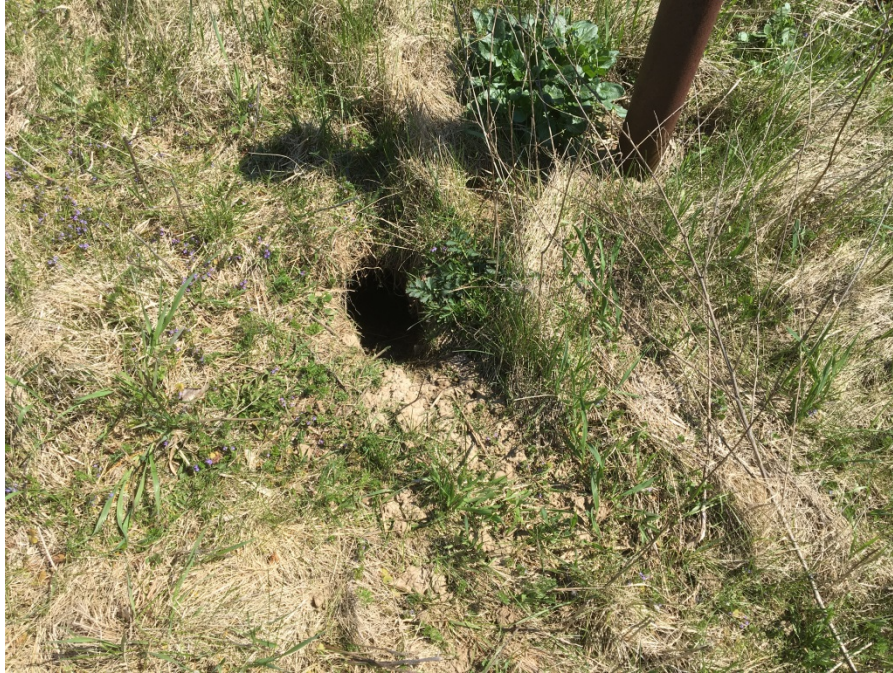
**Photo 5:** Photo facing east near MW-2D. One of the several animal burrows present near MW-2D.

Summary of Deficiencies and/or Corrective Actions: GV-8 was reconnected, trim/remove vegetation in front of culverts (locations shown on attached sheet, look into/resolve animal burrows, trim vegetation in front of west gate.

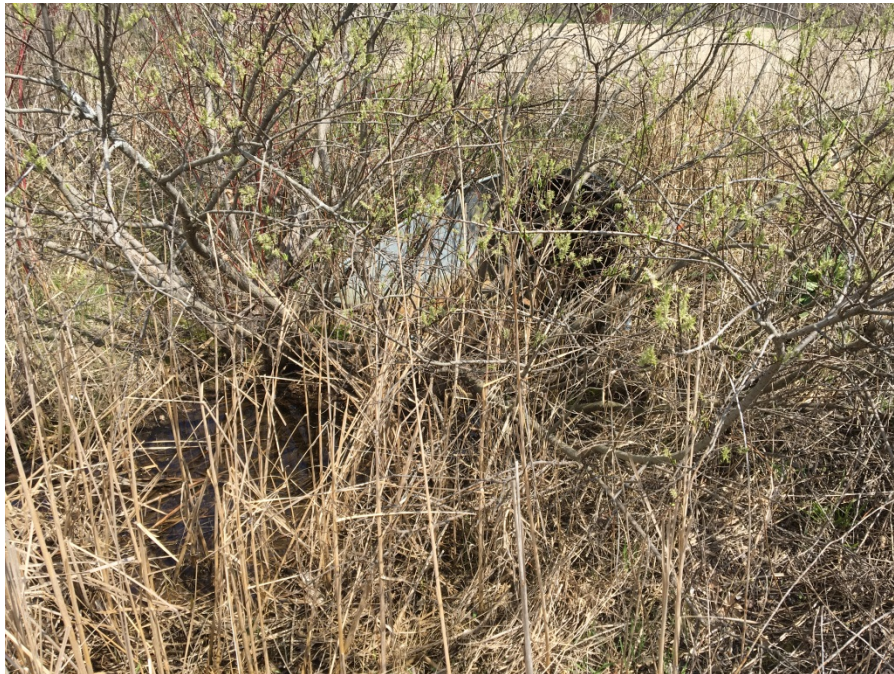
**Storm Water Management System** – No visible erosion was found in the drainage channels. The culverts were undamaged. Dense vegetation was present near many of the culverts restricting flow. A map depicting these culvert locations is included in **Attachment D**. Best management

**Photo 6:** Photo facing east near the south access gate. Dense vegetation in front of the culvert near the south gas entrance.

practices would be to clear this vegetation and debris in front of the culverts to allow for unrestricted storm water flow.

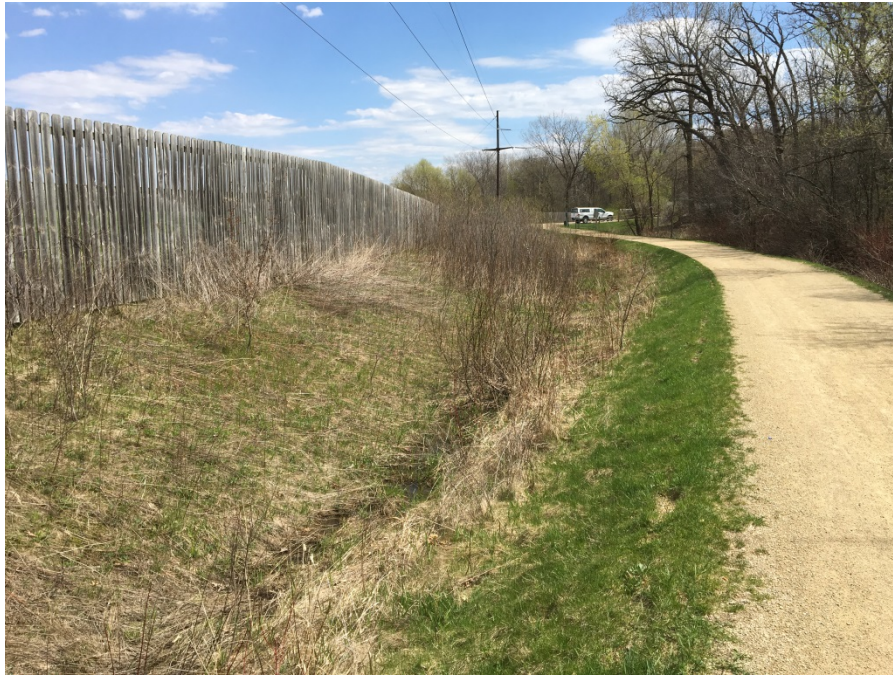
**Photo 7:** Photo facing east on the gravel drive south of the landfill. Site fence, storm water swale, and access road depicted above.

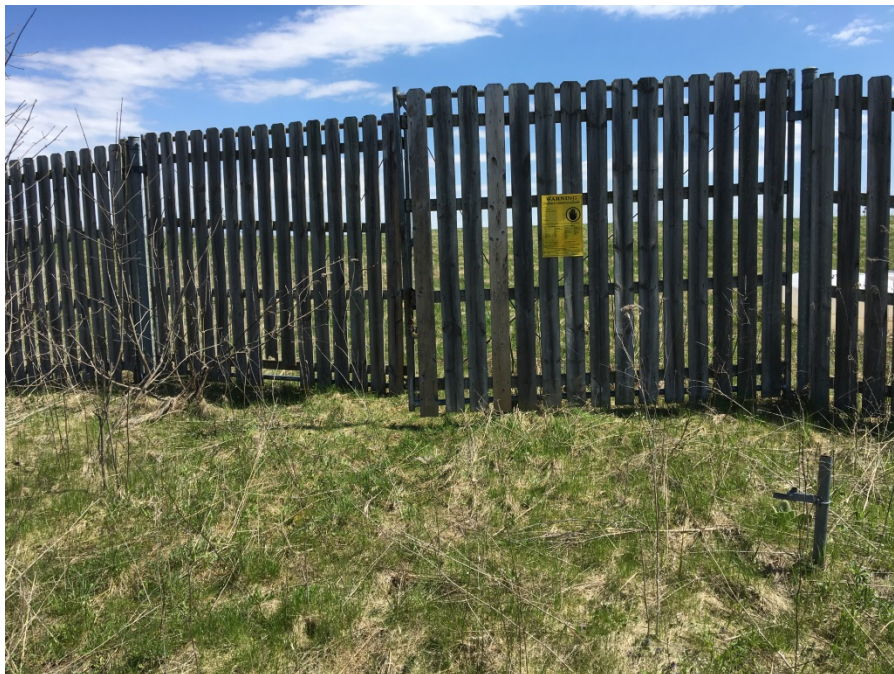
**Photo 8:** Photo facing east just outside the west access gate. Vegetation present in front of west access gate.

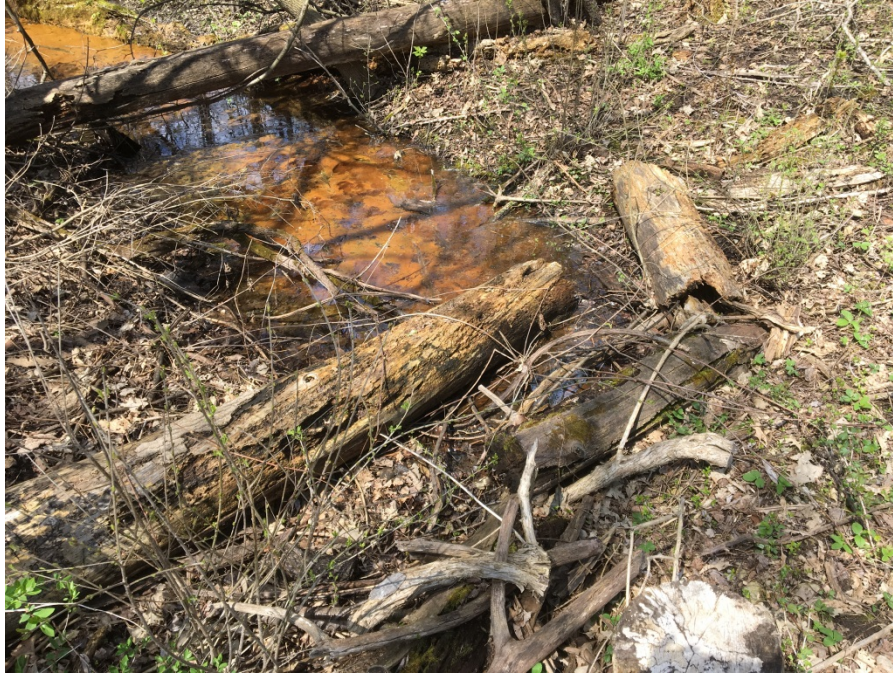
**Photo 9:** Photo facing southeast. Debris restricting flow in a culvert on the north side of the property near the MW-13 cluster.

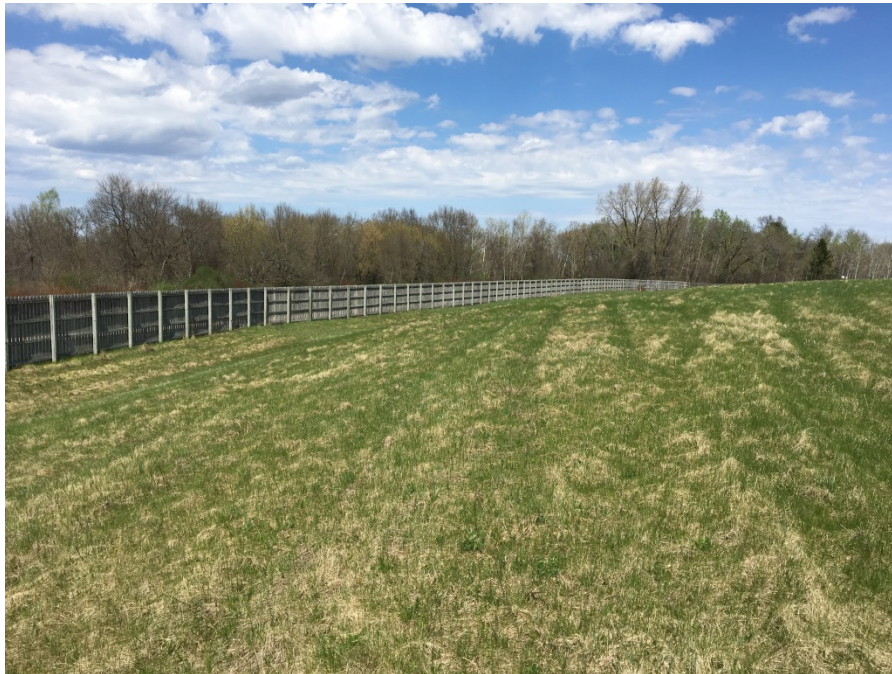
**Photo 10:** Photo facing north just inside the west gate. Final cover and fence depicted above.
