Subject: Semiannual Facility Inspection Report
 Stoughton City Landfill
 FID #113005950 – License #133
 USEPA ID #WID980901219
 WDNR Purchase Order #37000-0000000548

**Semiannual Facility Inspection Report
Stoughton City Landfill – April 2, 2018
SCS Engineers Project No. 25216022.00**

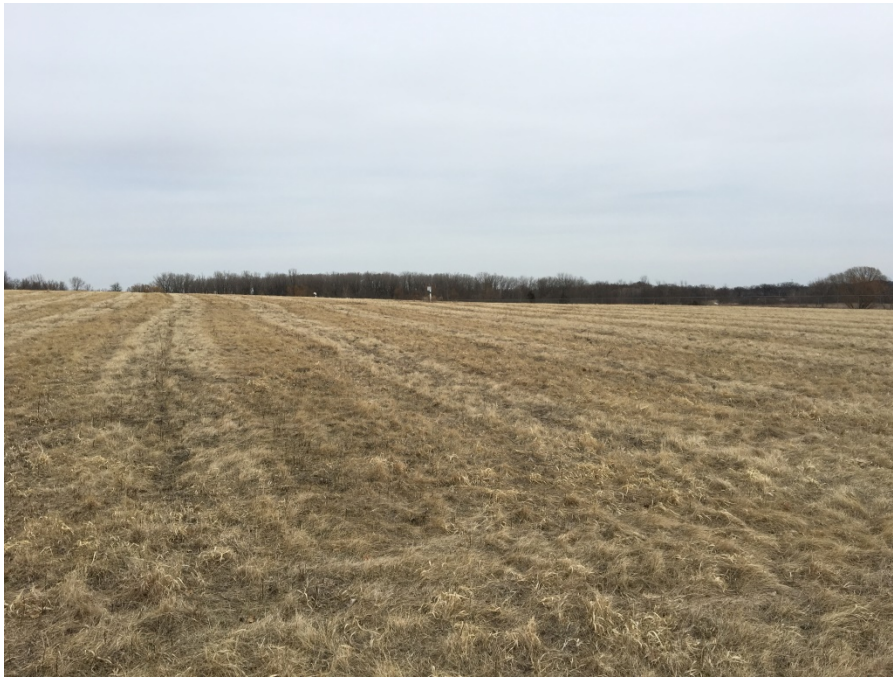
Photo 1: Photo taken just inside the south access gate. Final cover vegetation was in good condition and of the appropriate length (looking north).

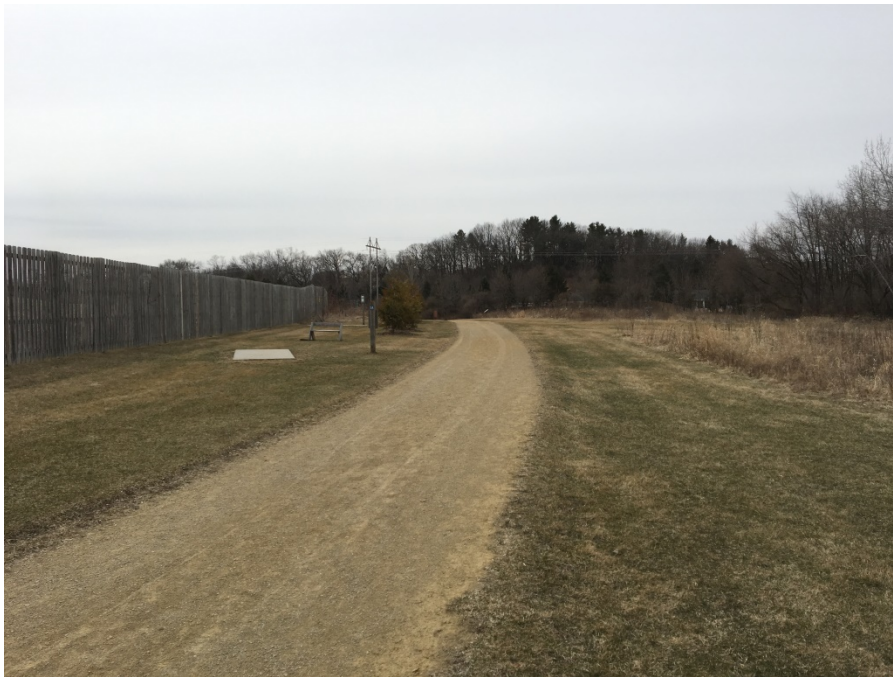
Access Road – The site access road was wet but in good condition with no ruts, or erosion noted. No standing water was observed on the site access road.

Photo 2: Gravel drive on the west side of the landfill (looking south).

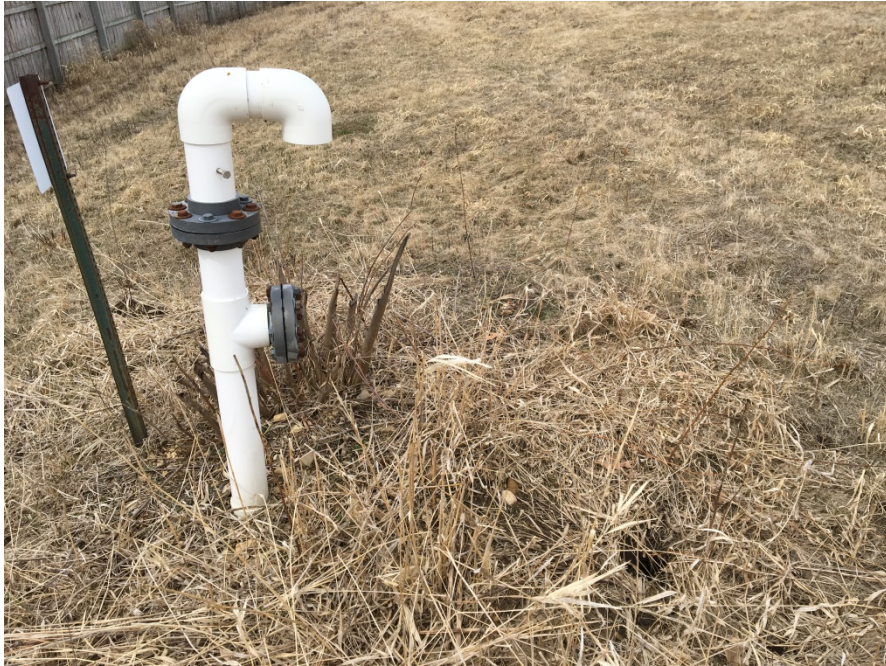
Landfill Gas Venting System – No damage was found at any of the gas venting wells, and no stressed vegetation was found near any of the wells. Gas vent well screens were clear. SCS will attach labels to the gas vents for easy identification this summer.

Photo 3: GV-11 is functional but missing an identification label (looking west).

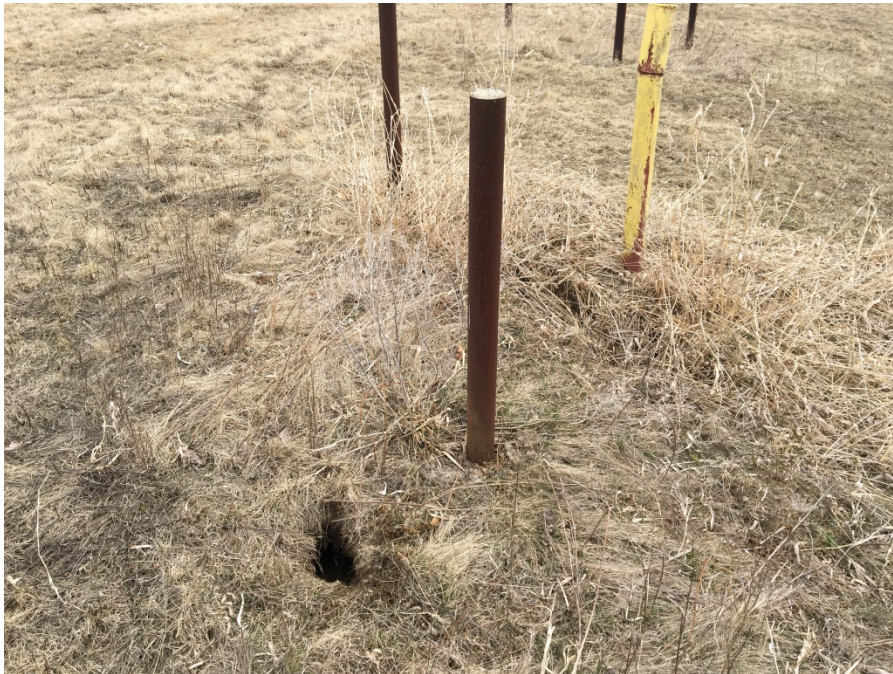
Landfill Cover – The vegetative cover across the landfill was in good condition. No bare spots, signs of erosion, or sparse vegetation were found (photographs in **Attachment C**). Several shallow, erosive channels were observed on the east cover slope; these channels were less than 0.5 feet deep and do not require maintenance. Several small burrow holes were present near MW-2D and GV-11. The burrow holes appear shallow, and there is no evidence that the cap has been compromised.

Photo 4: Animal burrow present near MW-2D (looking down).

Evidence of Burrowing Animals	Damage to final cover, evidence of waste.	2	Fill burrow holes near MW-2D and GV-11 with soil. Burrow holes appear to be shallow, no evidence that the cover has been compromised.
Stormwater Drainage Channels	Gullies, erosion, debris, culvert blocked.	2	Several large shrubs impeding storm water flow into the culvert near the south entrance gate.
Landfill Gas Venting System	Damaged or blocked vent risers, stressed vegetation.	2	Landfill gas vents should be labeled.
Access Road	Ponding, rutting, erosion.	1	Access road in good condition no issues observed.
Cover Mowing and Tall Vegetation Removal (October Inspection Only)	Mowing and tall vegetation removal done to specified vegetation hight, any missed areas	1	Vegetation is an acceptable height on landfill cap.

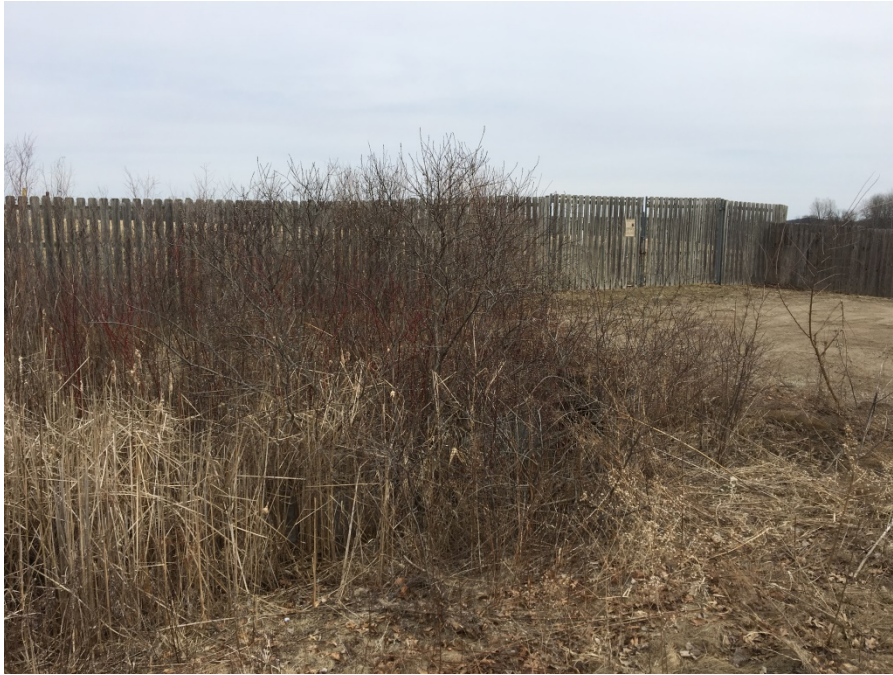
Storm Water Management System – No visible erosion was found in the drainage channels. The culverts were undamaged. Dense vegetation, including large shrubs, is present near many of

Photo 5: Large shrubs inhibiting water flow into culvert near the south gate entrance (looking northeast).

the culverts restricting flow. A map depicting these culvert locations is included in **Attachment D**. SCS will clear this vegetation and debris in front of the culverts in early spring/summer 2018.

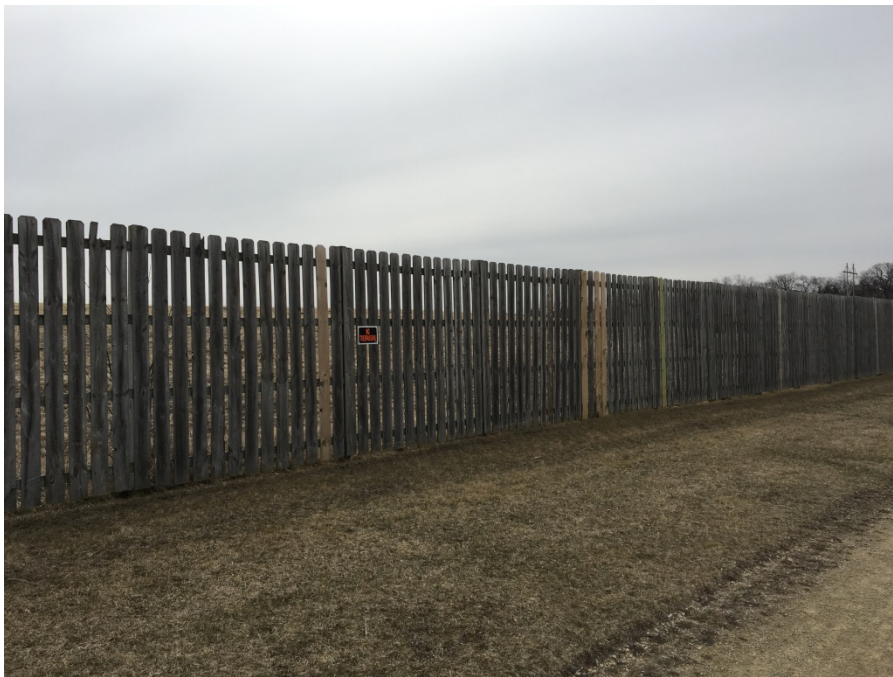
Perimeter Security Fencing – The chain-link fencing on the north and east sides of the site were in good condition. Both access gates are in good condition, and the padlocks operated properly. Signage was present and legible on both access gates. The wooden perimeter fence was in good condition; broken slats were recently replaced along the west side of the landfill. “No Trespassing” signs were posted along the west perimeter fence near the disc golf course.

Photo 6: West perimeter security fencing depicted; slats were recently replaced and new signage “NO TRESPASSING” was posted (Looking southeast).

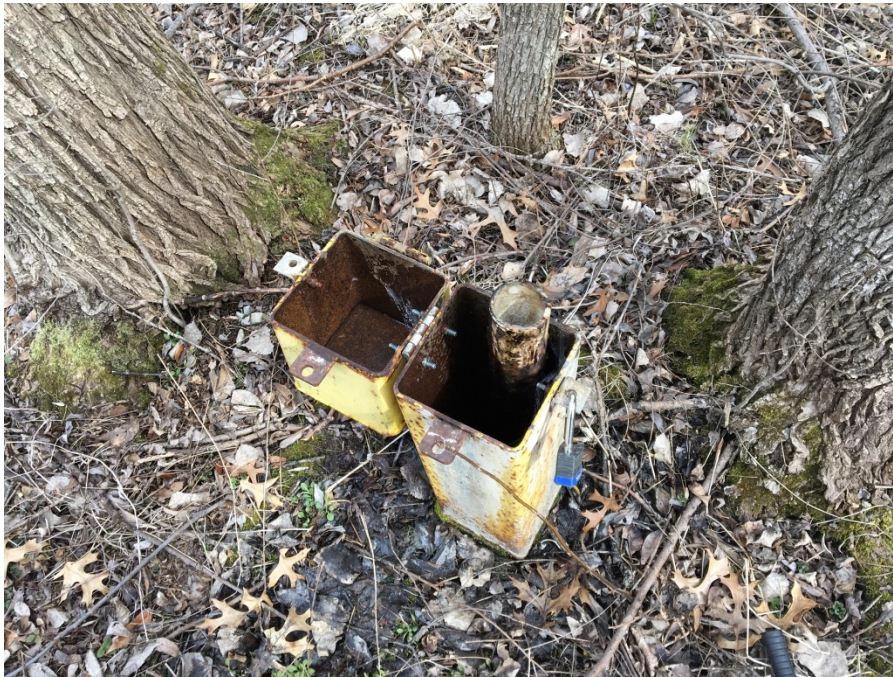
Photo 7: MW-10I casing flooded with water (looking down).

Monitoring Wells and Wellhead Covers – We found no sign of tampering or damage at any of the site monitoring wells. All monitoring wells were properly covered and locked. Identification markings were missing or illegible on some of the monitoring wells. SCS will attach permanent labels to all monitoring wells this summer. Four artesian monitoring wells: OW-2, MM-7I, MW-10I, and MW-13I were flowing. Standing water was present around the wells and the casings were corroding. SCS will plug and cap the artesian wells this summer.

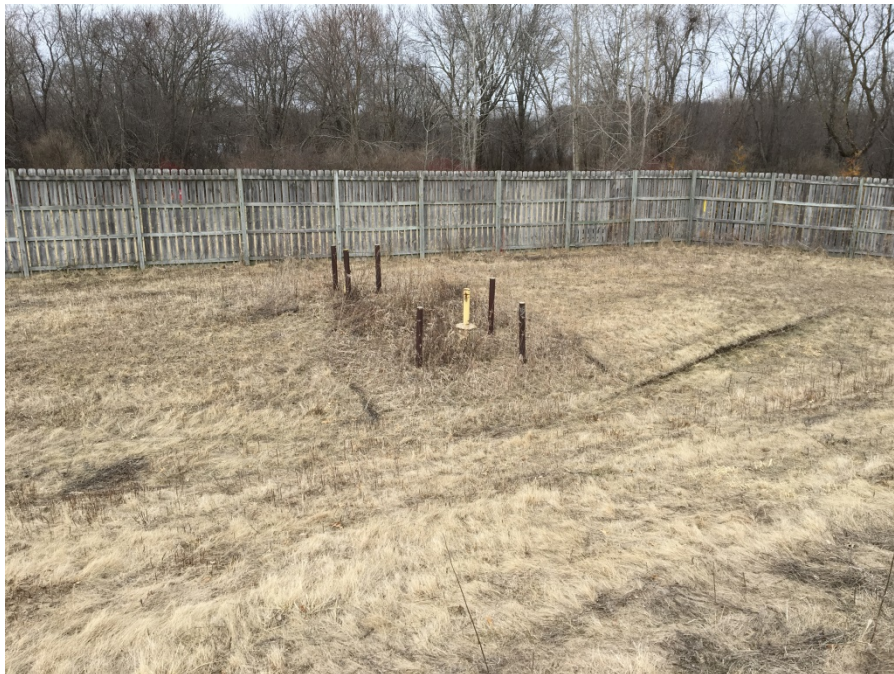
Photo 8: MW-5 cluster depicted; wells locked and no signs of tampering (looking west).

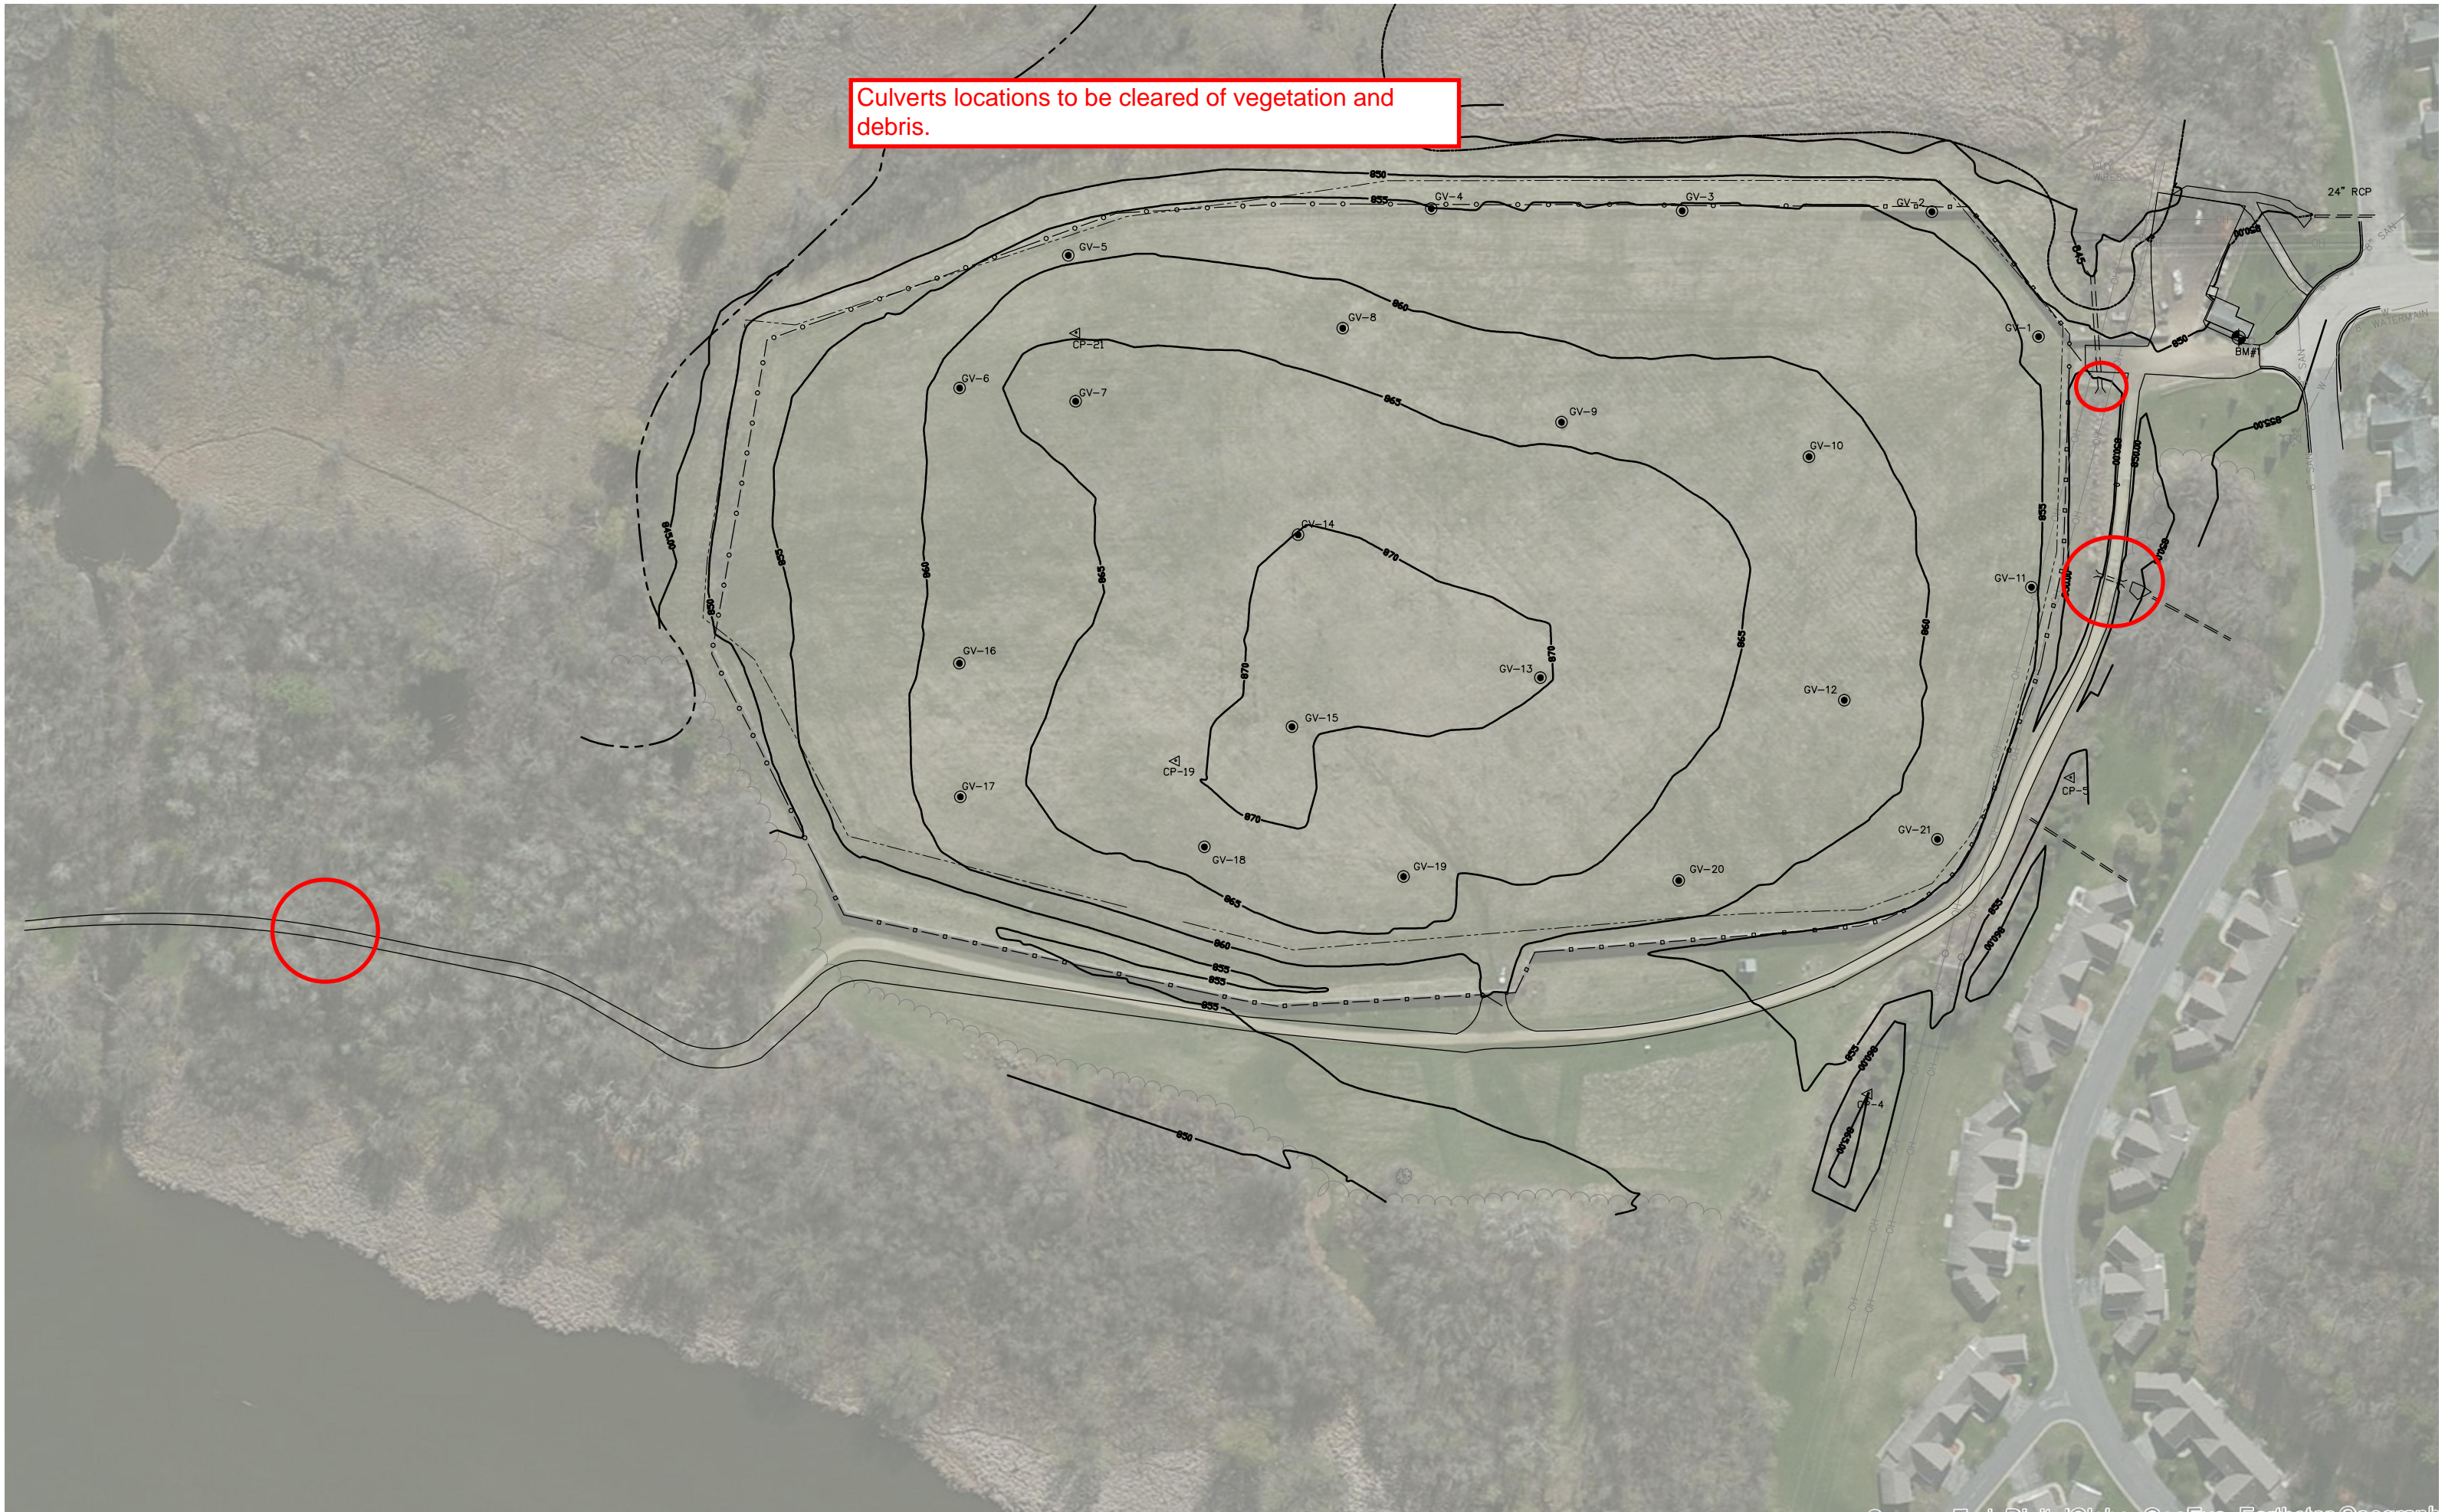
Culvert Maintenance Locations

Culverts locations to be cleared of vegetation and debris.
