Subject: Semiannual Facility Inspection Report
Stoughton City Landfill
FID #113005950 – License #133
USEPA ID #WID980901219
WDNR Purchase Order #37000-0000000548

**Operation and Maintenance Semi Annual Inspection Report
Stoughton City Landfill
Stoughton, Wisconsin**

Attachment C
Photograph Log

Stoughton City Landfill
Stoughton, Wisconsin
SCS Engineers Project #25216022.00

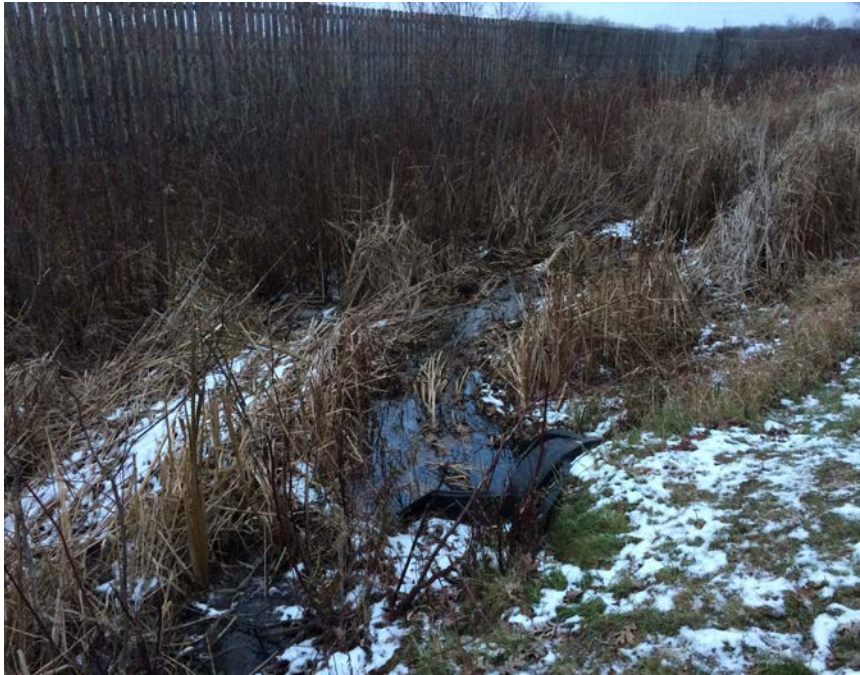
Storm Water Management System – No significant erosion was identified in the drainage channels, and the culverts were intact. Vegetation in the perimeter drainage ditch, outside the capped area of the Site, is slowing storm water flow (**Attachment C, Photo 1**).

Photo 1: Vegetation by culvert on south side of landfill.

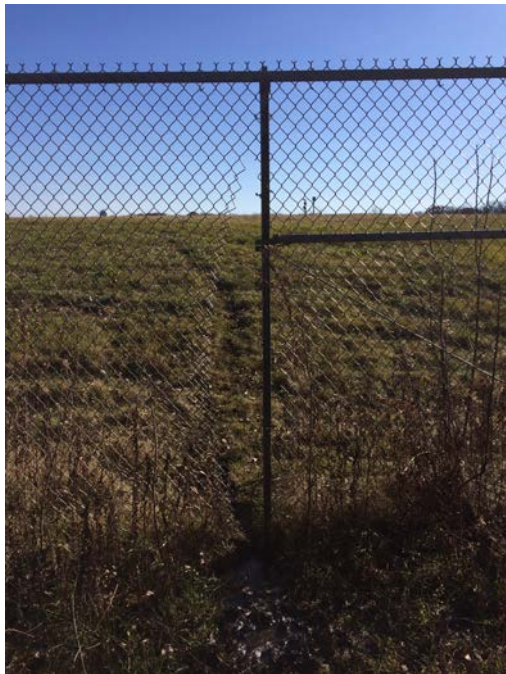
Perimeter Security Gates and Fencing – Both access gates are in good condition, and the padlocks operated properly. Signage was present and legible on both access gates. Several line posts associated with the perimeter fencing are not plumb, likely from frost heaving. The chain link fence on the north side of landfill, just east of the wooden perimeter fence (**Attachment C - Photo 2**), has been cut.

Photo 2: Hole in fence at northwest corner of landfill by end of wooden fence.

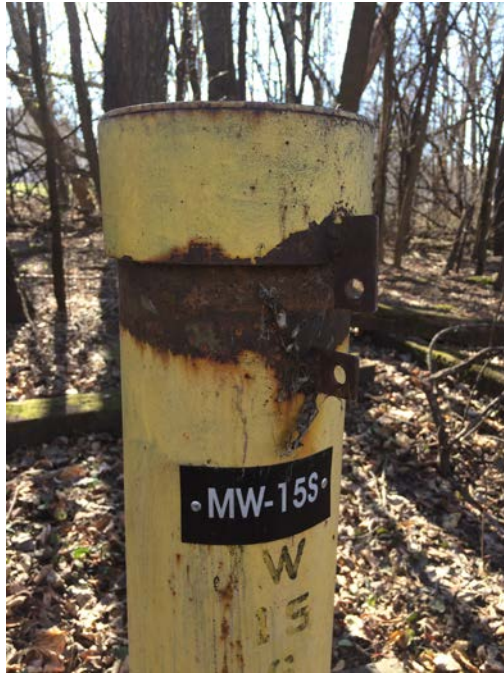
Monitoring Wells and Wellhead Covers – Except for wells MW-15S, MW-15D, MW-15I, MW-8S, and MW-14I, the groundwater monitoring wells at the Site were locked and in acceptable condition. The identified monitoring wells are not able to be locked due to settling of the protective casing (i.e., protop), which leaves the well sticking up above the top of the protop (**Photos 3, 4, 5, and 7**).

Photo 3: MW-15S - casing needs to be cut in order to lock.

Summary of Deficiencies and/or Corrective Actions: Artesian wells are flowing and need packers installed. Well casings need to be cut down and protops locked. Three gas probes and one well need ID plates.

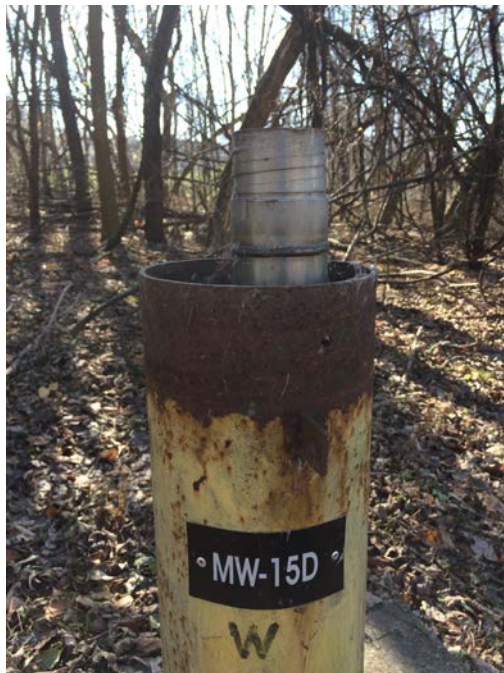
Photo 4: MW15-D - casing needs to be cut.

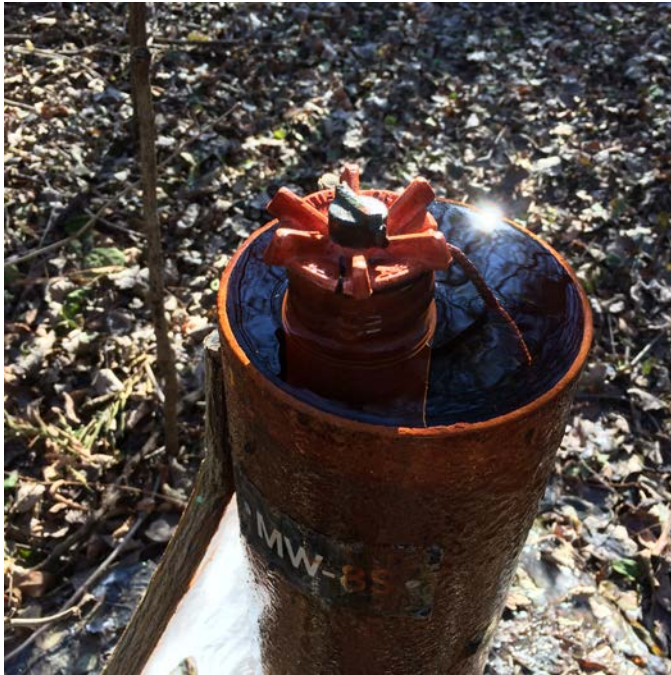
Groundwater was flowing from the top of three wells: MW8S, MW-8B, and MW-8I (**Photos 5 and 6**). These wells were not flowing in June 2018, when mechanical packers were installed on three artesian flowing wells (MW-OW2, MW-10I, and MW-13I).

Photo 5: MW 8-S - Artesian flowing, casing needs to be cut down.

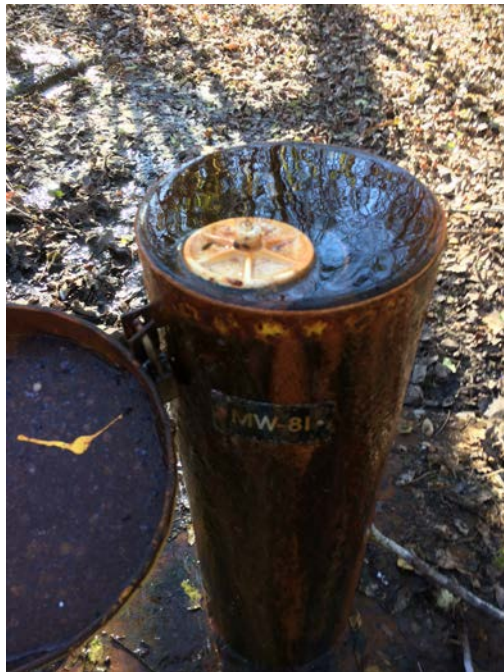
Photo 6: MW-8I - Artesian flowing.

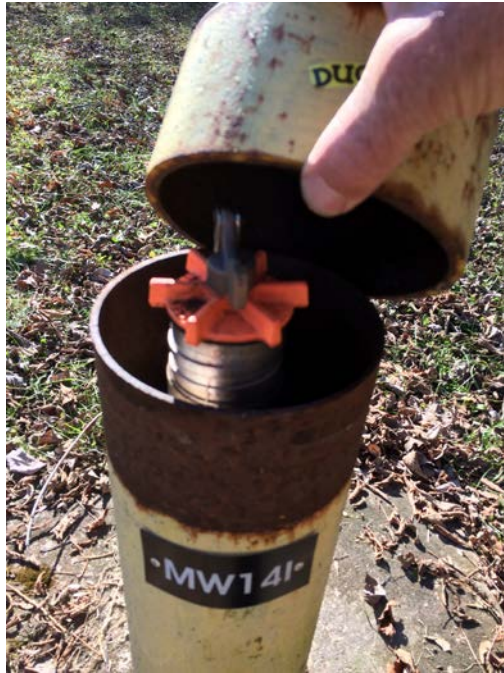
Photo 7: MW-14I – Casing needs to be cut.
