May 20, 2019
File No. 25219092.00

Subject: First 2019 Semi-annual Facility Inspection Report
Stoughton City Landfill
FID #113005950 – License #133
USEPA ID #WID980901219
WDNR Purchase Order #37000-0000010307

Operation and Maintenance Semi Annual Inspection Report
April 25, 2019

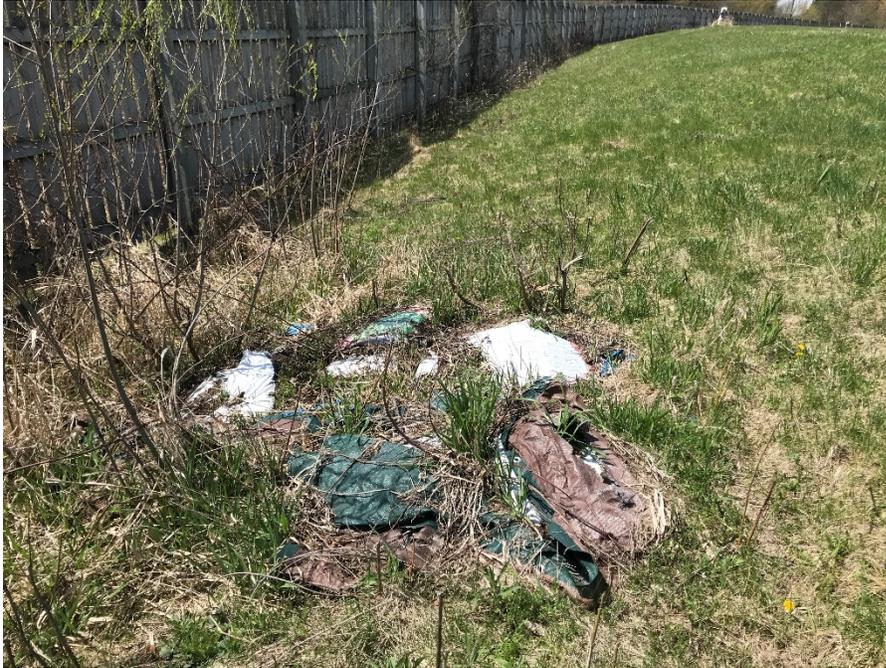
A photograph of the area near GV-18 is included in **Attachment C** (i.e., the Photograph Log). Although likely outside the landfill limits, SCS staff also noted woody vegetation in the vicinity of the tarped soil bags near MW-2S that were intended for use in repairing the small areas of the cover and are in poor condition (**Photo 1, Attachment C**), and another area of woody vegetation surrounding the MW-11 nest (**Photo 4, Attachment C**). The woody vegetation should be removed in conjunction with the annual mowing of the Site. The soil from the bags should be spread in the ruts or other areas of the Site, and the bags (i.e., trash) properly disposed of.

Photo 1: Unused soil bags and tarp in poor condition near MW-2S. Nearby woody vegetation.

Summary of Deficiencies and/or Corrective Actions: Remove excess vegetation surrounding GW-11 wells. Remove tarp and soil bag material near MW-2S. See attached photos.

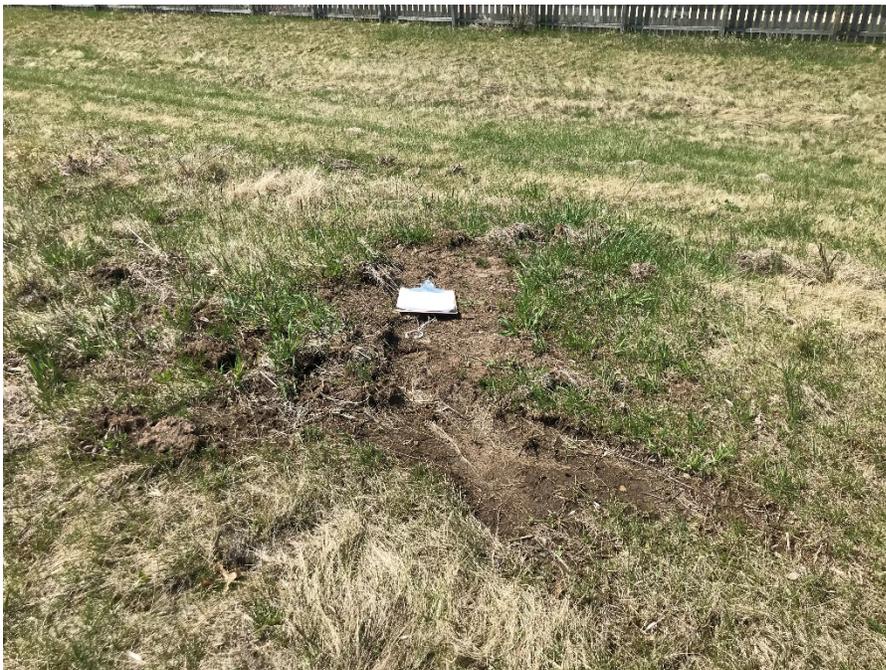
- a small area of approximately 5 square feet north of GV-18 where vegetation was not present
- minor ruts in several areas on the cap

Photo 2: Bare patch approximately 5 sq. ft. north of GV-18. Clipboard for scale.

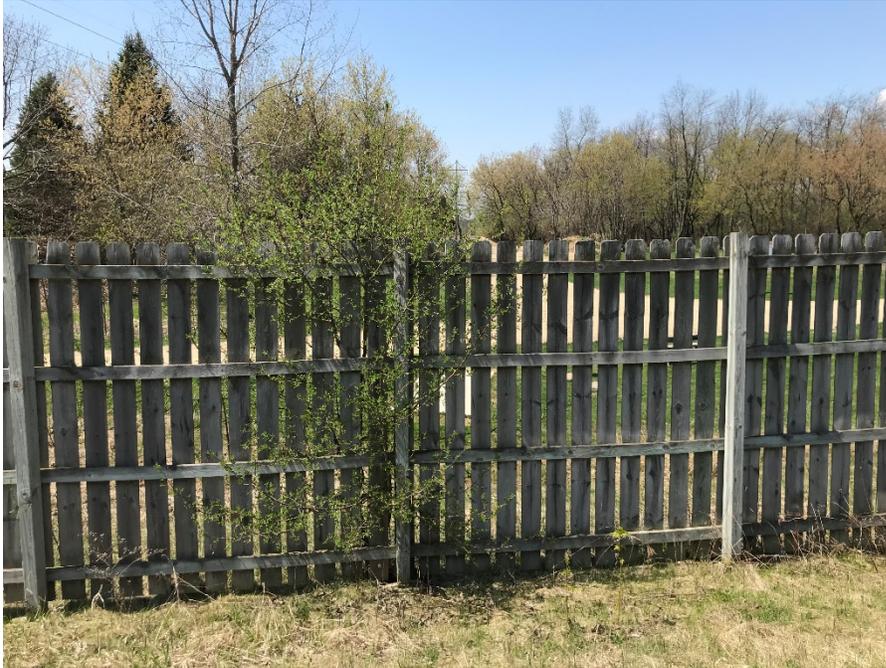
The wooden perimeter fence was in good condition; however, trees growing under the fence along the north and west sections may cause future damage (**Photo 3, Attachment C**). This woody vegetation should also be removed in conjunction with the annual mowing event.

Photo 3: Tree encroachment may damage fence in future. Multiple instances of encroachment along north and west sections of fence.

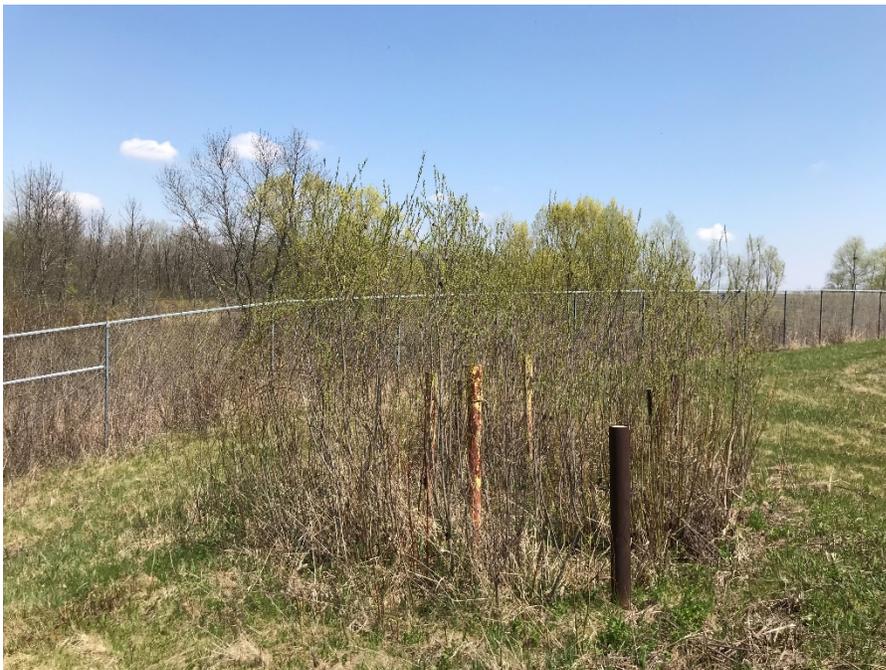
Photo 4: Thick woody vegetation surrounding MW-11 nest.

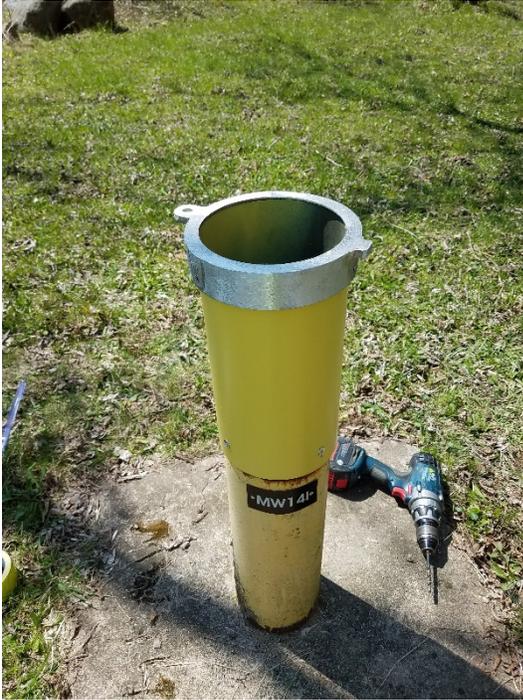
Photo 5: MW-14I Repair

Monitoring Wells and Wellhead Covers – SCS staff measured the depth to water at 25 groundwater monitoring wells, and collected samples from 13 of those wells, during the period of April 25 to 26, 2019. SCS staff collected data for field parameters and sent samples to Eurofins TestAmerica for laboratory analysis. The field and laboratory data will be presented and reviewed in the annual report for the Site. SCS also repaired wells MW-15S, MW-15D, MW-15I, MW-8S, and MW-14I during that period by extending the protective casings and replacing the caps and padlocks, so the wells could be locked. Photographs of the repaired wells are included in **Attachment C**.

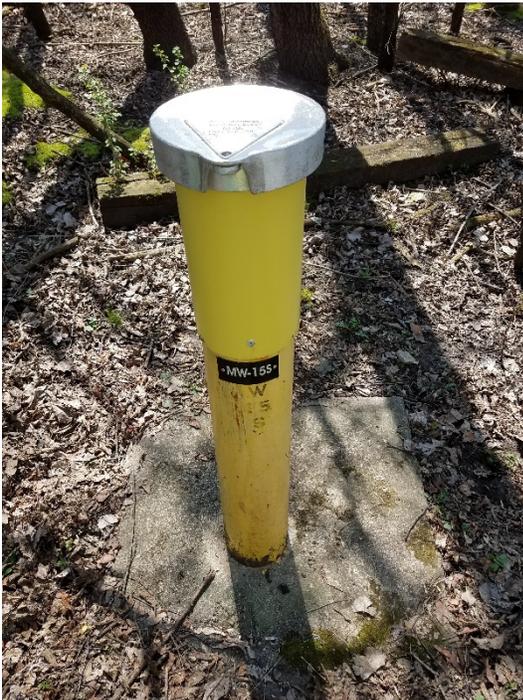
Photo 6: MW-15S Repair

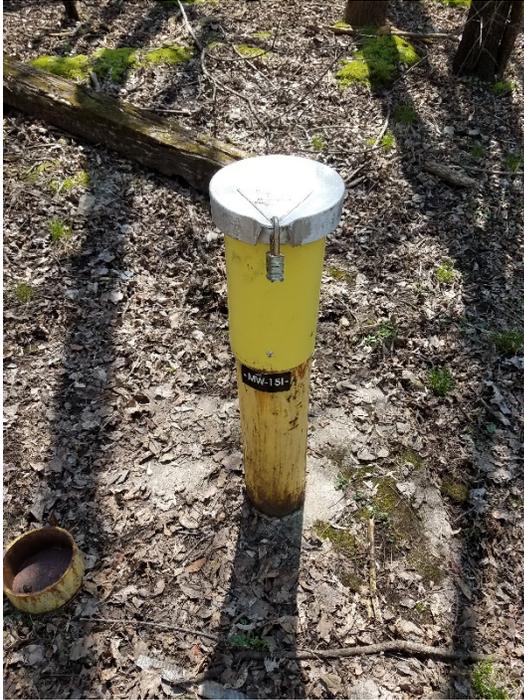
Photo 7: MW-15I Repair

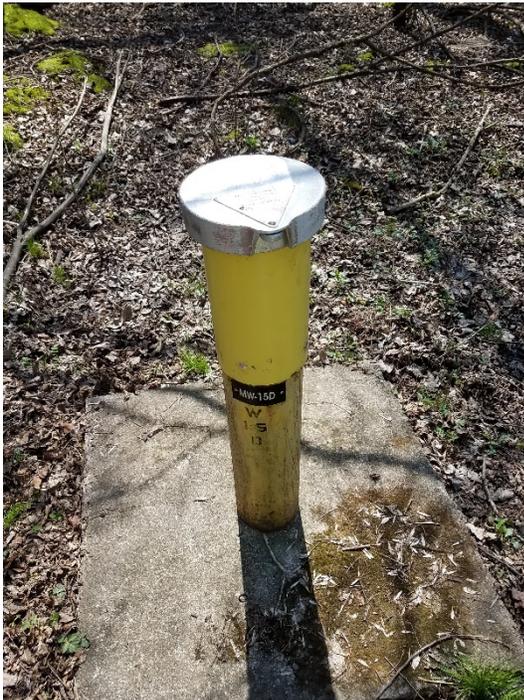
Photo 8: MW-15D Repair

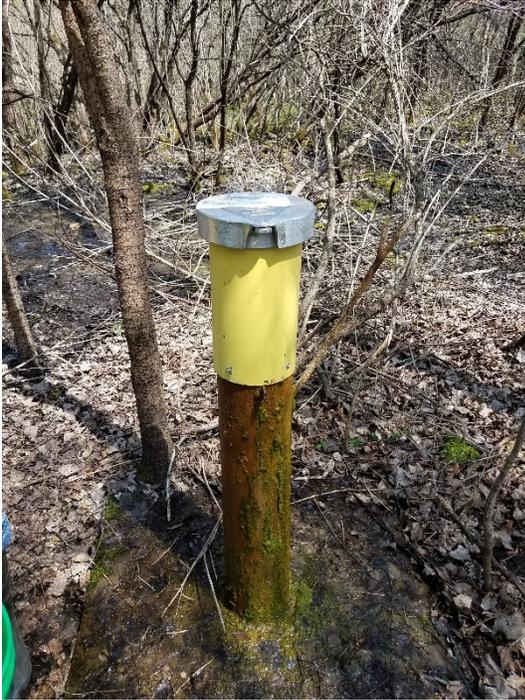
Photo 9: MW-8S Repair
