SCS ENGINEERS

November 14, 2017
File No. 25216022.00

Subject: Semiannual Facility Inspection Report
 Stoughton City Landfill
 FID #113005950 – License #133
 USEPA ID #WID980901219
 WDNR Purchase Order #37000-0000000548

**Semiannual Facility Inspection Report
Stoughton City Landfill – October 27, 2017
SCS Engineers Project No. 25216022.00**

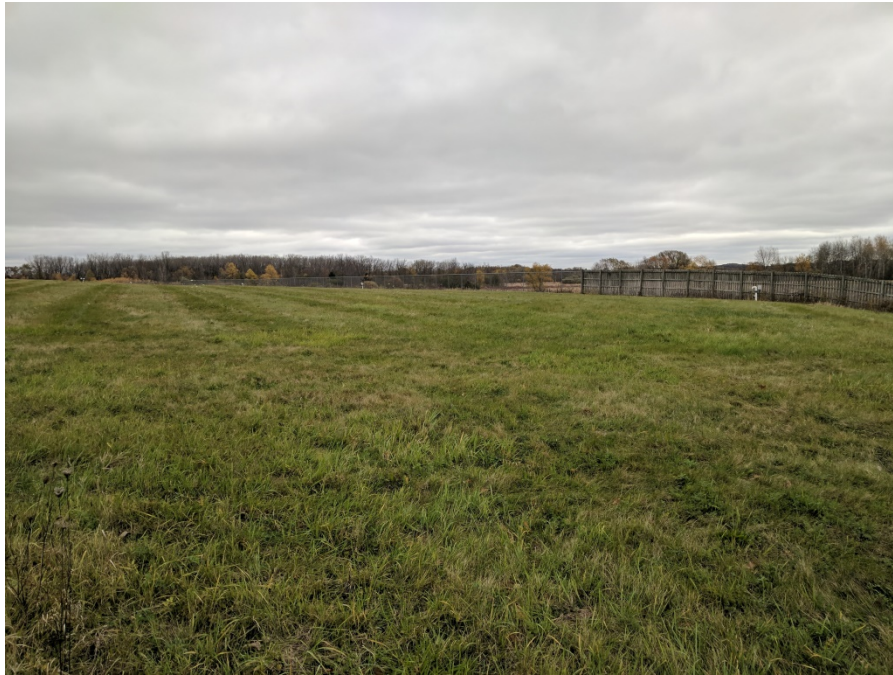
Landfill Cover – The quality of the vegetative cover across the landfill was in very good condition. The annual cover mowing of the facility occurred on August 31, 2017. No bare spots, signs of erosion, or sparse vegetation were found (photographs in **Attachment C**). No drainage gullies were apparent on the cover. No rutting was observed as noted in the last semiannual inspection on May 2, 2017. Several small burrow holes were present near MW-2D. The burrow holes appear shallow and there is no evidence that the cap has been compromised.

Photo 1: Photo taken just inside the south access gate. Final cover vegetation was in good condition and of the appropriate length (Looking north)

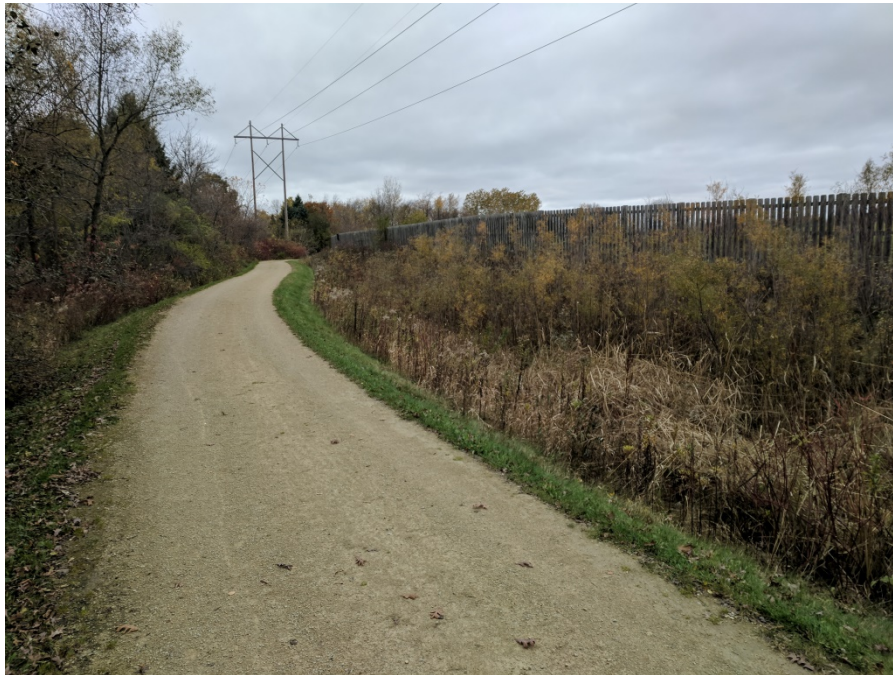
Photo 2: Gravel drive and storm water channel on the south side of the landfill (Looking west)

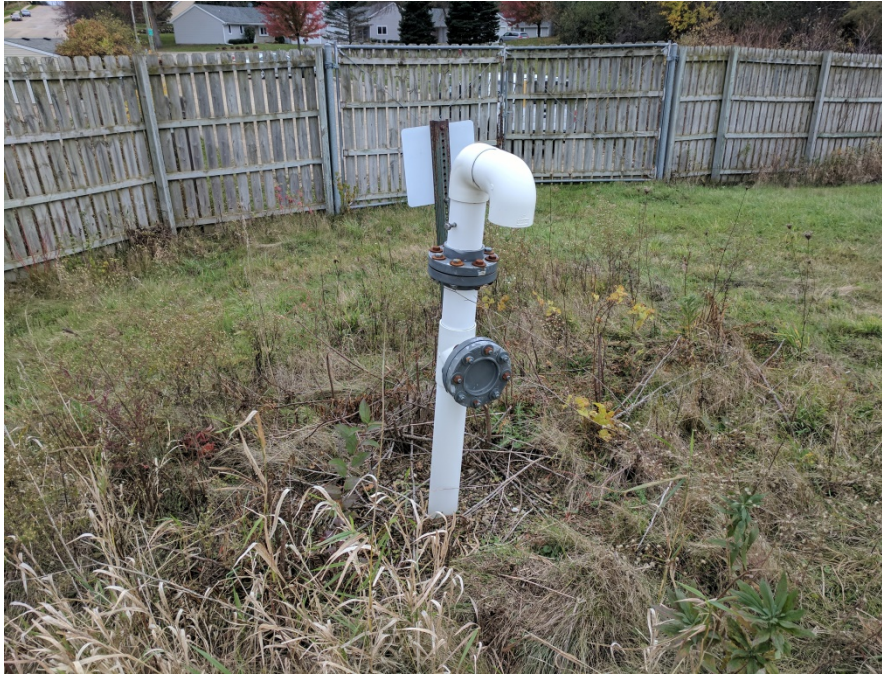
Landfill Gas Venting System – Gas vent eight (GV-8) was inspected and remains in a fixed upright position. No damage was found at any of the remaining gas venting wells, and no stressed vegetation was found near any of the wells. Gas vent well screens were clear. Labels are to be attached to the gas vents for easy identification.

Photo 3: GV-1 is functional but is missing an identification label (Looking south)

Summary of Deficiencies and/or Corrective Actions: Label GV's and MW's, repair slat near GMP-3, cap artesian wells, fill burrow holes near MW-2D, and remove shrubs in drainage way near south entrance gate.

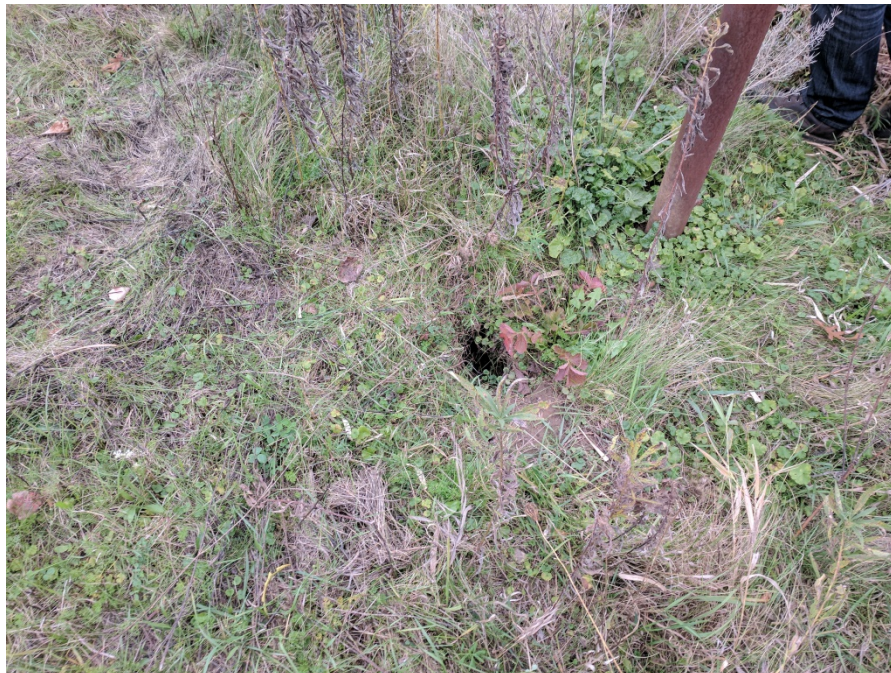
Specific Inspection Items	Potential Problem Areas	Status *	Notes
Perimeter Security Fencing	Broken or missing wood slats, torn chain link fabric.	2	Partial slat missing on the SW fence line neat GMP-3. Additional signage along the west perimeter fence near the disc golf hole.
Entrance Gate and Locking Mechanism	Lock broken/missing, mechanism inoperative.	1	Lock present and functional.
Monitoring Wells and Wellhead Covers	Signs of tampering, casing damaged, lock missing.	2	Cap artesian wells: OW2, 71, 13I. Water is corroding well casings. Label all MW's, only several wells are curently labeled.
Final Cover Vegetation	Bare spots, stressed vegetation, deep rooted vegetation.		Vegetation appear heathly, no bare spots obseved.
Final Cover Slope (explain below)	Gullies, lack of vegetation, subsidence, ponding.	1	No erosion observed, slopes in good conditon.
Evidence of Burrowing Animals	Damage to final cover, evidence of waste.	2	Fill burrow holes near MW-2D with soil. Burrow holes appear to be shallow, no evidence that the cover has been compromised.

Photo 4: Animal burrow present near MW-2D (looking down)

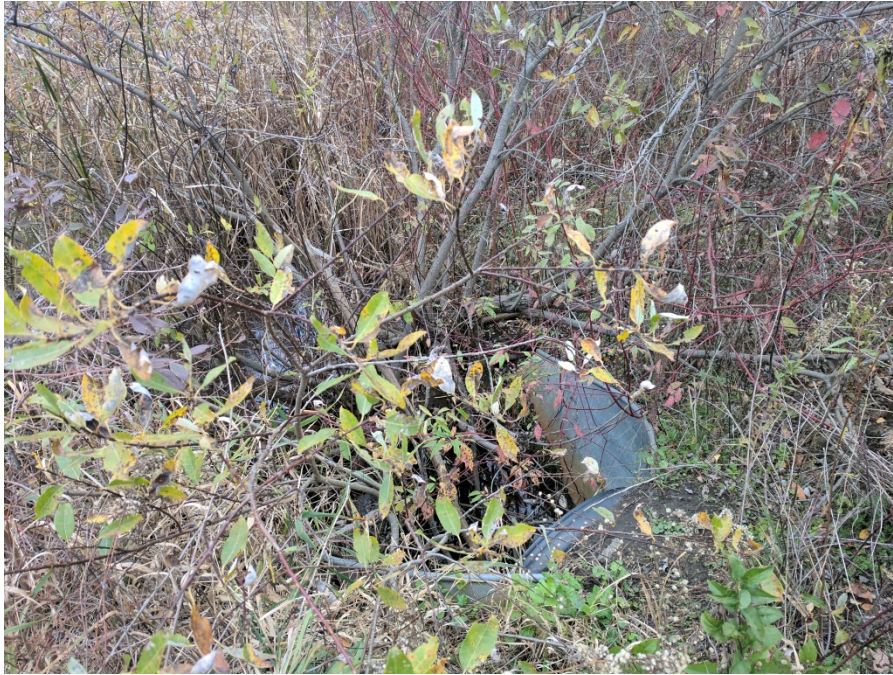
Storm Water Management System – No visible erosion was found in the drainage channels. The culverts were undamaged. Dense vegetation, including large shrubs, are present near many of the culverts restricting flow. A map depicting these culvert locations is included in **Attachment D**. Best management practices would be to clear this vegetation and debris in front of the culverts to allow for unrestricted storm water flow.

Stormwater Drainage Channels	Gullies, erosion, debris, culvert blocked.	2	Several large shrubs impeding storm water flow into the culvert near the south entrance gate.
Landfill Gas Venting System	Damaged or blocked vent risers, stressed vegetation.	2	Landfill gas vents should be labeled.
Access Road	Ponding, rutting, erosion.	1	Access road in good condition no issues observed.
Cover Mowing and Tall Vegetation Removal (October Inspection Only)	Mowing and tall vegetation removal done to specified vegetation hight, any missed areas	1	Vegetation is an acceptable height on landfill cap.

Photo 5: Large shrubs inhibiting water flow into culvert near the south gate entrance (Looking west)

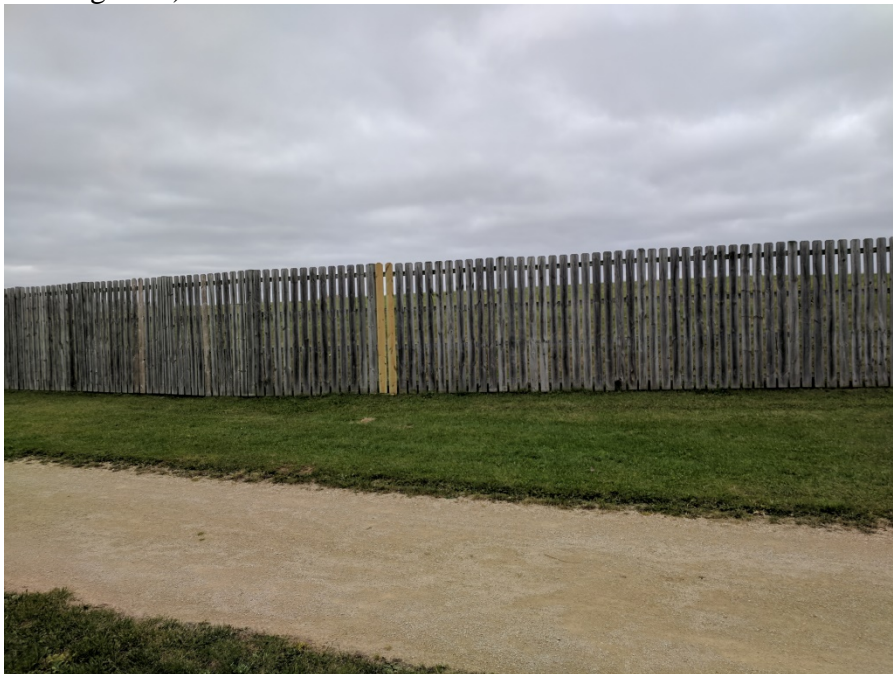
Perimeter Security Fencing – The chain-link fencing on the north and east sides of the site were in good condition. Both access gates are in good condition, and the padlocks operated properly. Signage was present and legible on both access gates. The wooden perimeter fence was in good condition with the exception of one broken slat located on the southwest side of property.

Photo 6: West perimeter security fencing depicted, slats were recently repaired (Looking east)

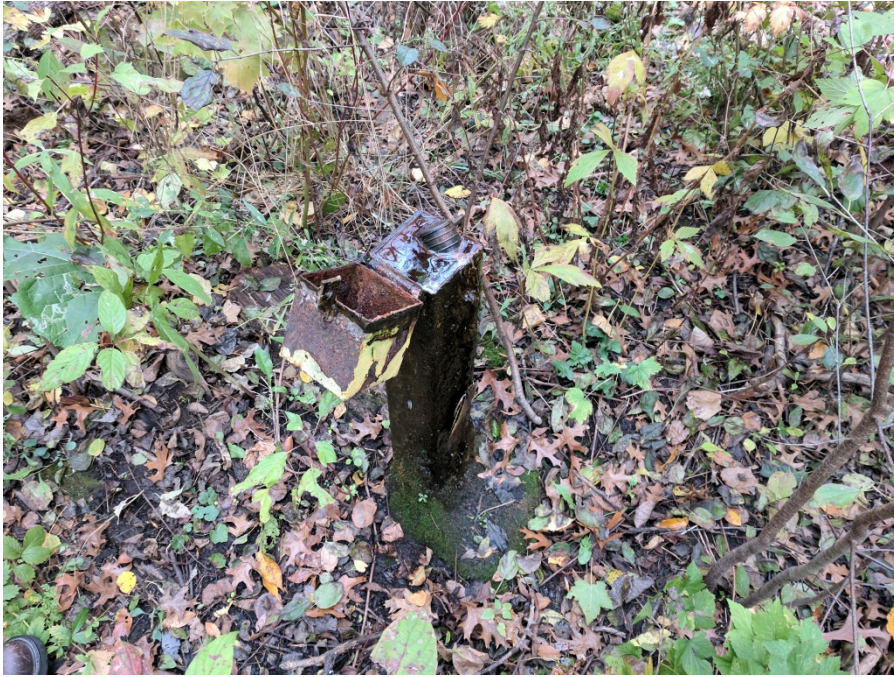
Monitoring Wells and Wellhead Covers – No signs of tampering or damage were found at any of the site monitoring wells. All monitoring wells were properly covered and locked. Identification markings were missing or illegible on some of the monitoring wells. All un-marked monitoring wells should be labeled during the next monitoring event. Three artesian monitoring wells: OW-2, MM-7I, and MW-13I were flowing. Standing water was present around the wells and the casings were corroding. Best management practices would be stop, or greatly reduce, water flowing from the wells by property capping the wells.

Photo 7: OW-2 casing flooded with water, well plug was floating (Looking down)

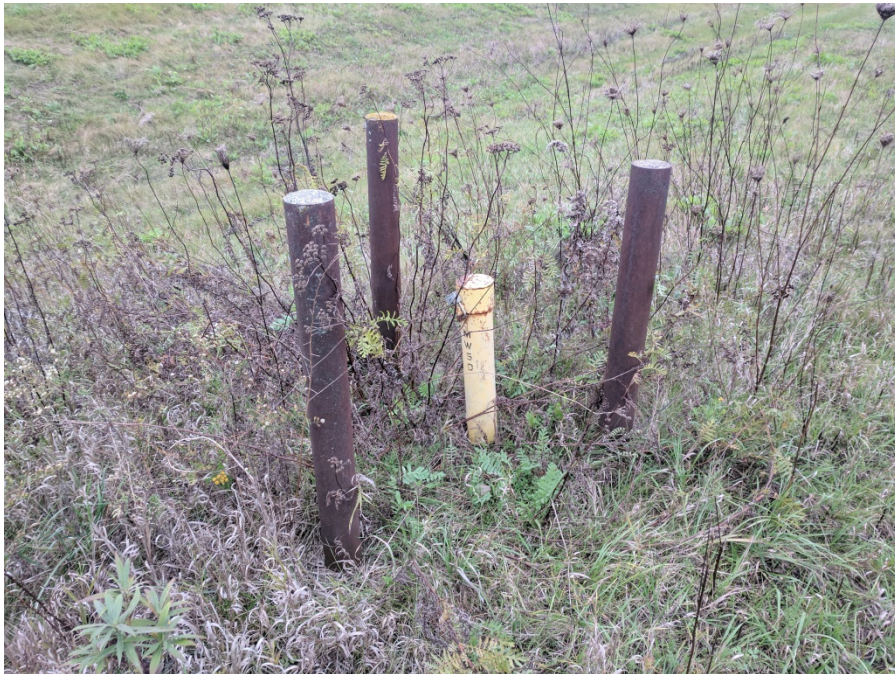
Photo 8: MW-5D depicted, well locked and no signs of tampering (Looking east)

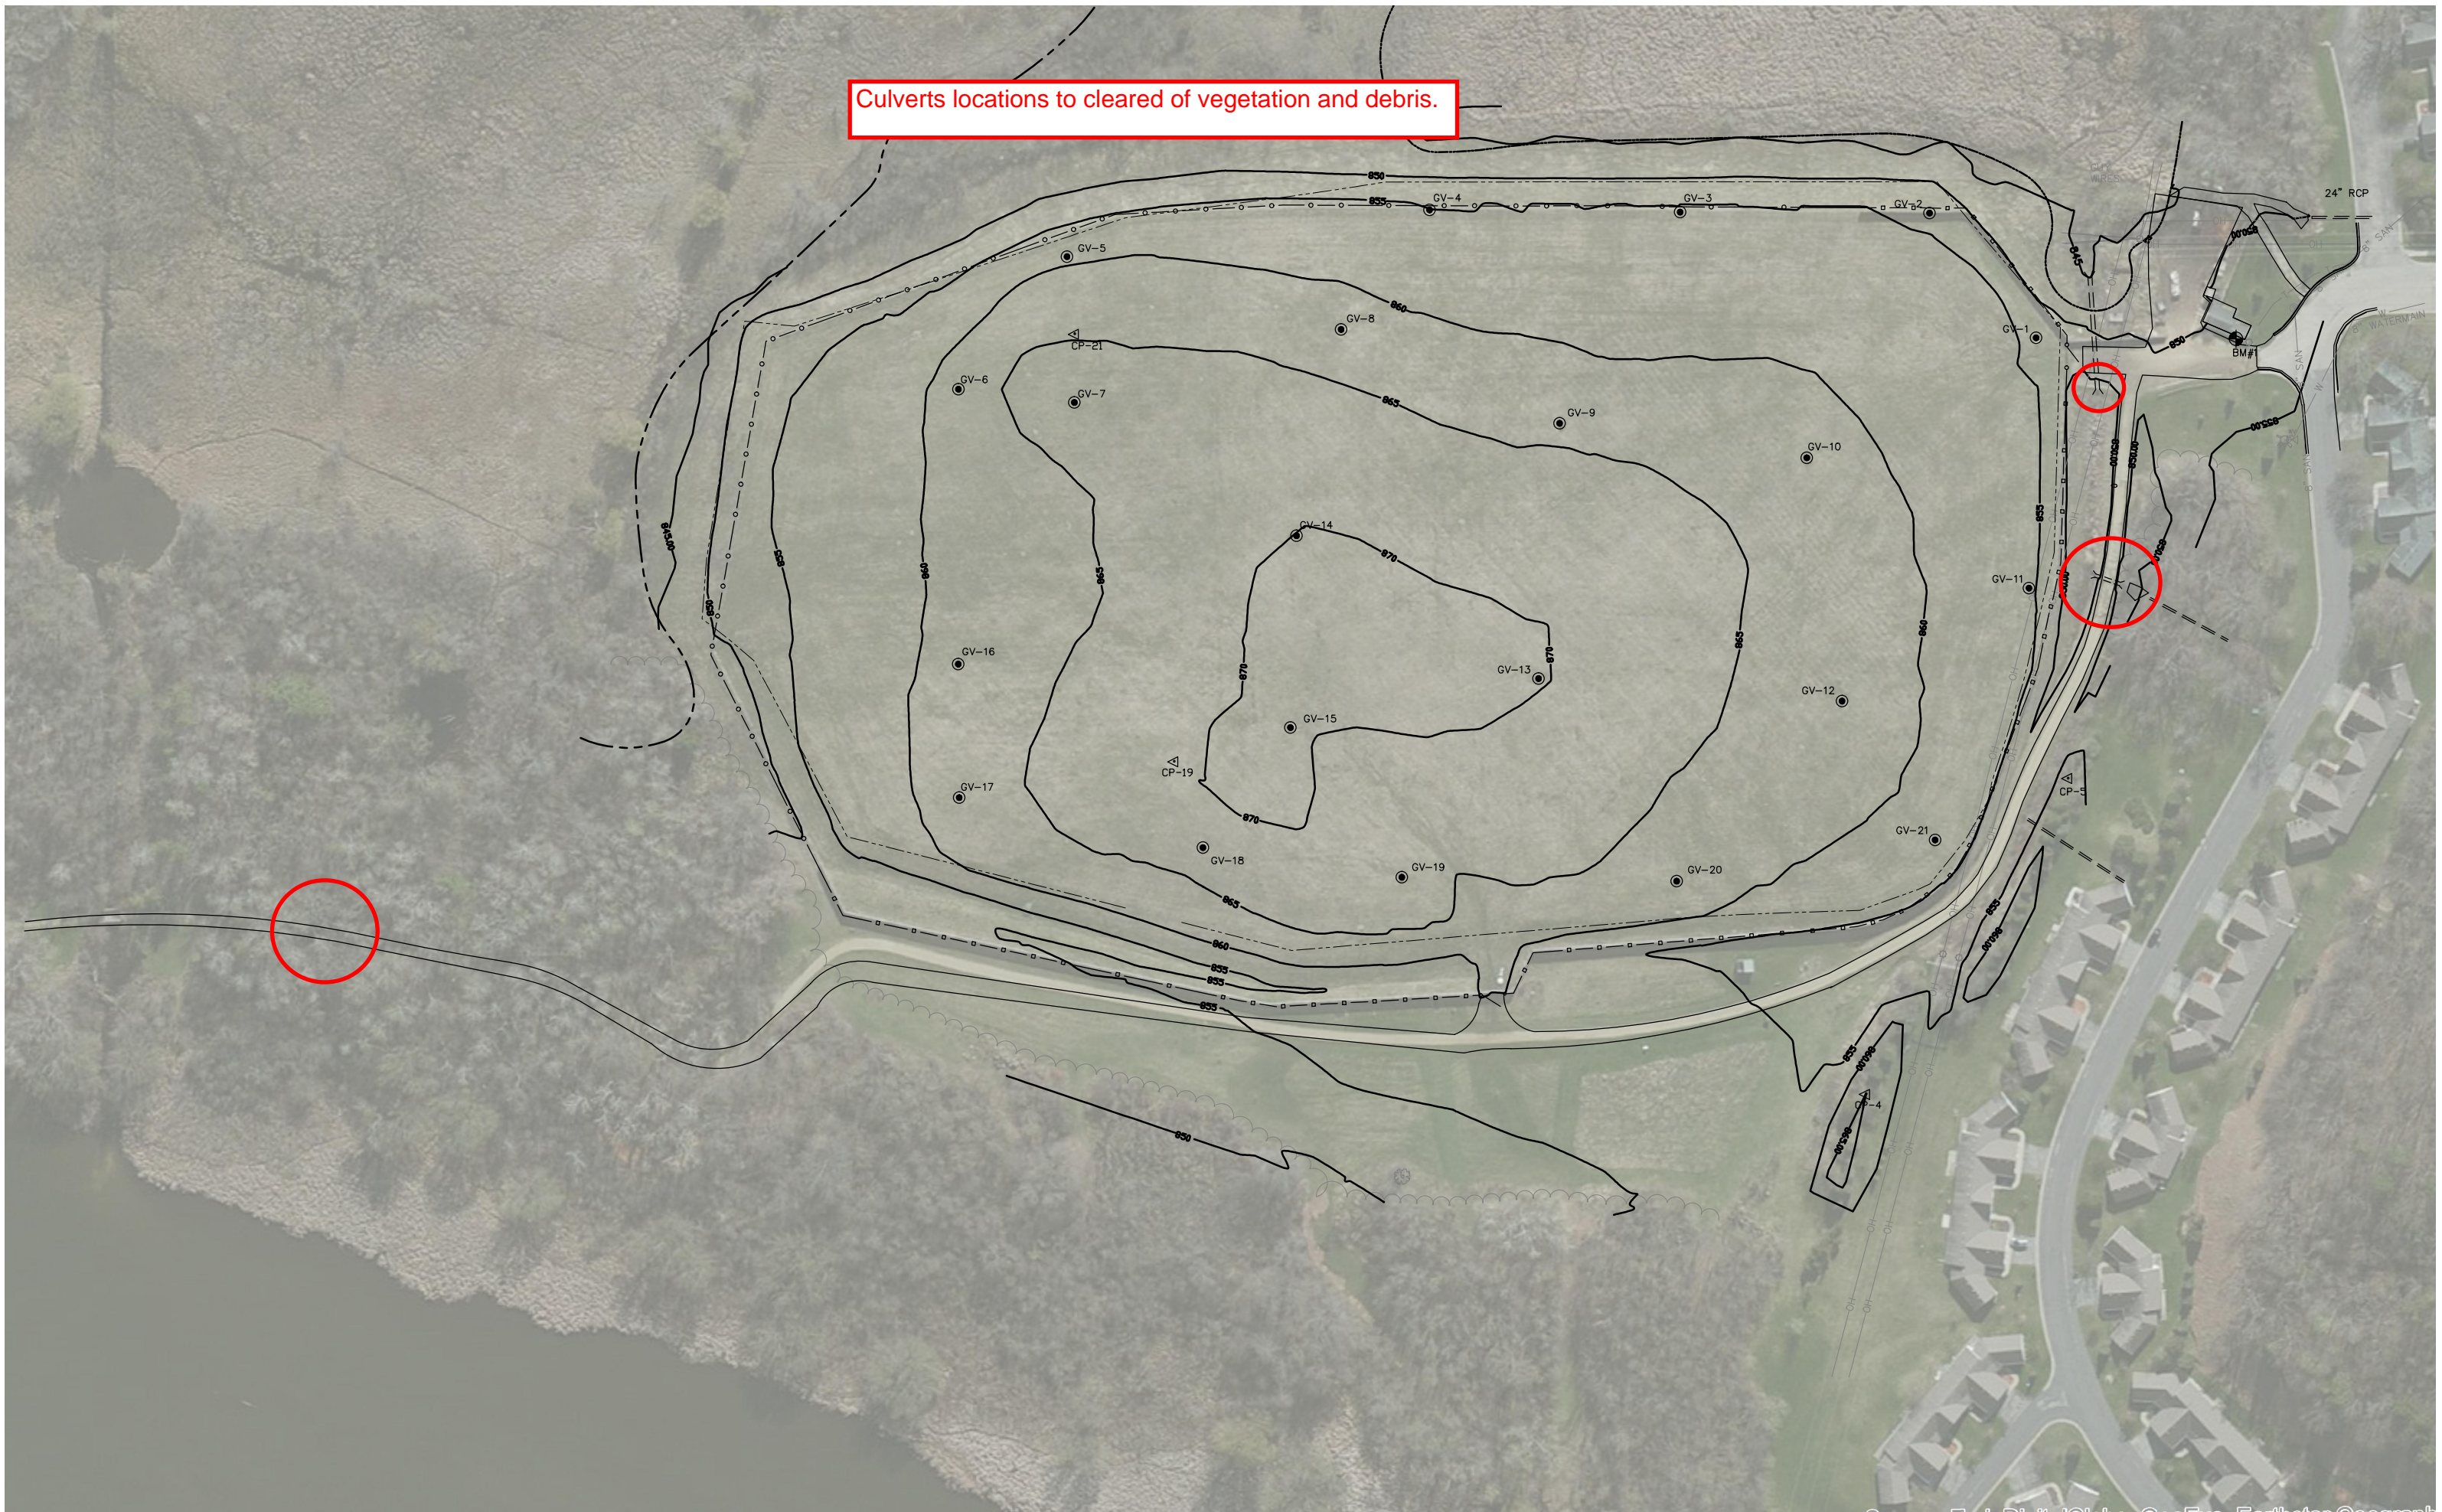
Culvert Maintenance Locations

Culverts locations to cleared of vegetation and debris.
