December 3, 2019
File No. 25219092.00

Subject: Second 2019 Semi-annual Facility Inspection Report
Stoughton City Landfill
FID #113005950 – License #133
USEPA ID #WID980901219
WDNR Purchase Order #37000-0000010307

Operation and Maintenance Semi Annual Inspection Report
October 02, 2019

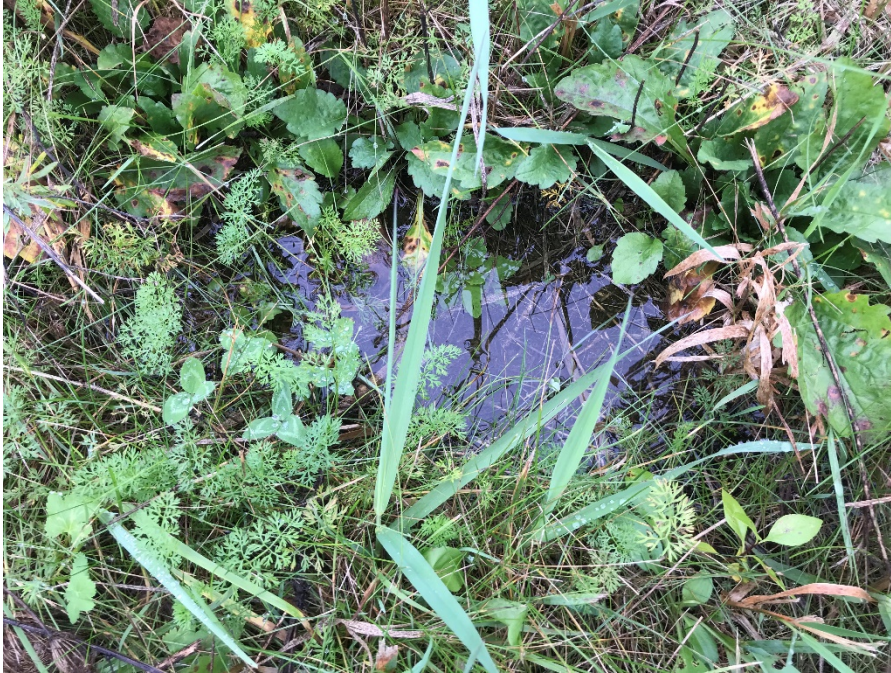
- A few small areas of surface water ponding were present (**Attachment C, Photo 1**). The ponded water had not adversely affected the vegetation, thus is not significant.
- Woody vegetation was present in several limited areas on landfill surface, including near GV-11 and MW-11.

Photo 1: Slight surface water ponding on landfill cap after recent storm events (looking down).

These items should be monitored in the future and appropriate action taken if necessary.

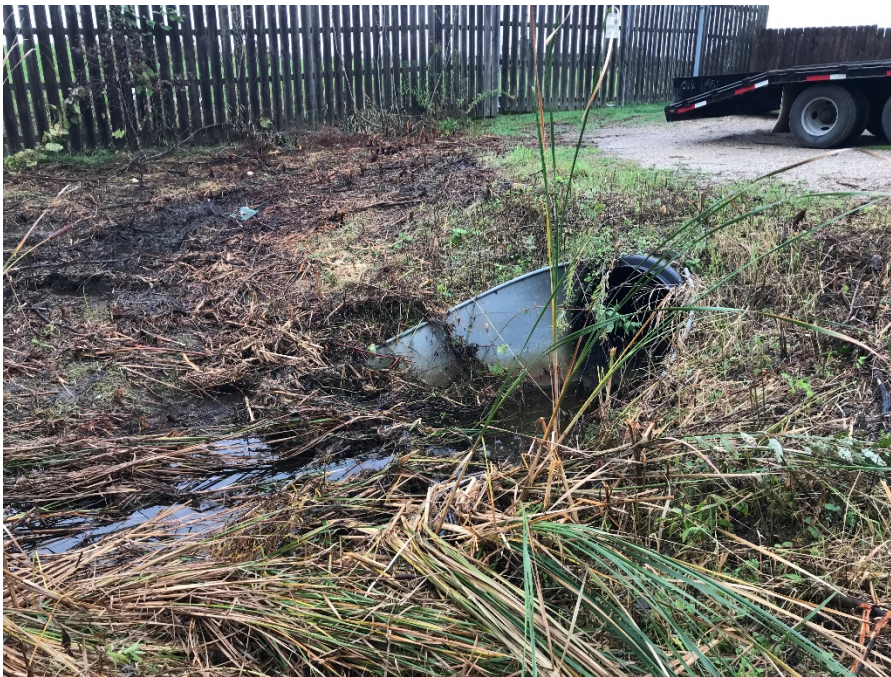
Storm Water Management System – No visible erosion was noted in the drainage channels. The culverts were undamaged and unobstructed. A subcontractor had removed the woody vegetation noted in the previous semi-annual report from the storm water ditch (**Attachment C, Photo 2**).

Photo 2: View of culvert outside of southeast gate recently cleared of vegetation (looking northeast).

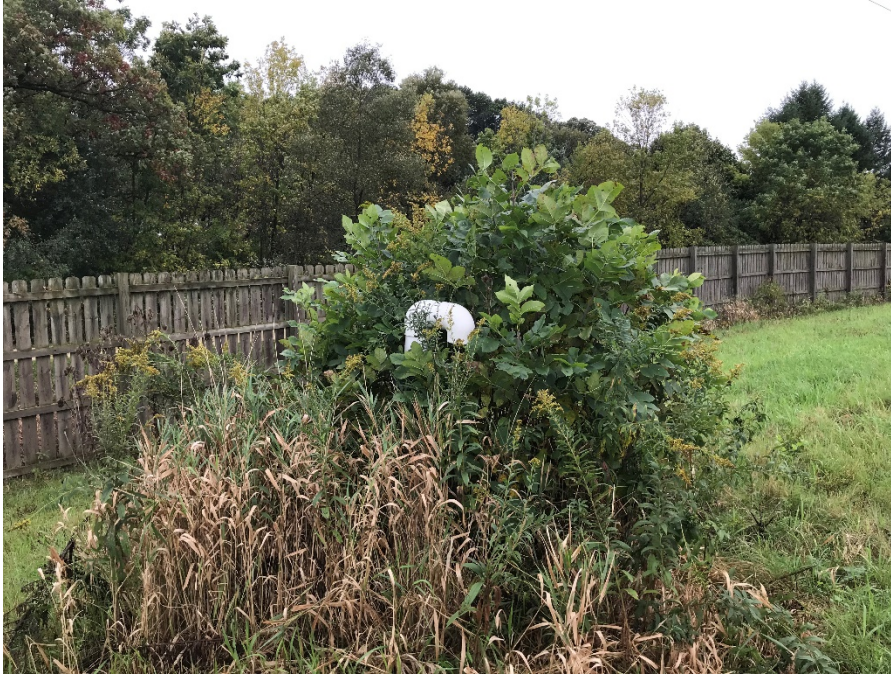
Landfill Gas Venting System – The gas venting wells were intact, and no stressed vegetation was identified in the vicinity of the wells. Woody vegetation is growing in the vicinity of GV-11 (**Attachment C, Photo 3**) and GV-8 is slightly out of plumb but appears to be undamaged (**Attachment C, Photo 4**).

Photo 3: Woody vegetation in the vicinity of GV-11 (looking southwest).

Summary of Deficiencies and/or Corrective Actions: Need to replace wooden slat in fence and remove obstructive vegetation around MW-11 and GV-11.

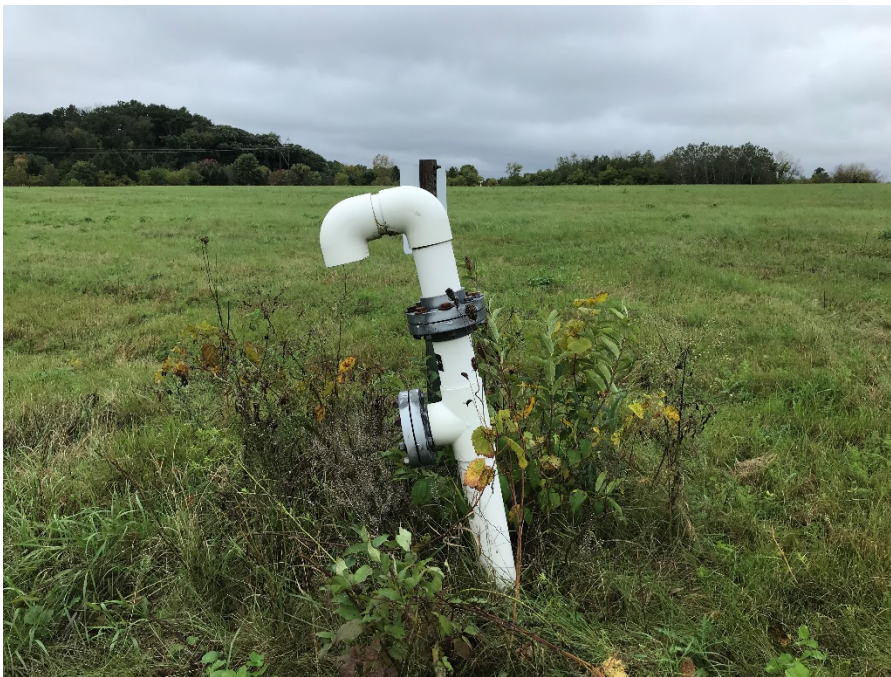
Photo 4: GV-8 slightly out of plumb, though apparently functional (looking west).

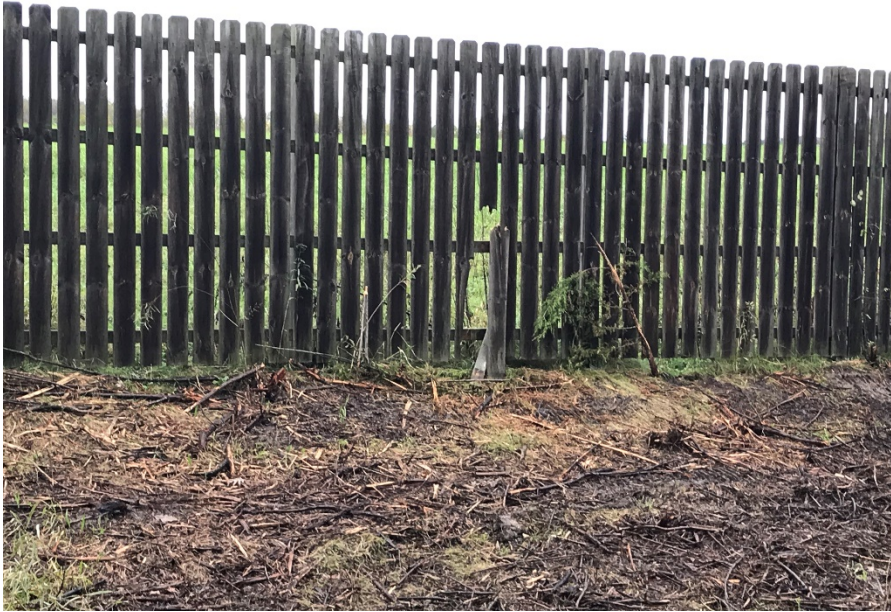
A portion of a slat was broken from the wooden perimeter fence on the south side (**Attachment C, Photo 5**) of the site. The remainder of the wooden fence was in good condition.

Photo 5: View of broken wood slat in south side fence (looking north).

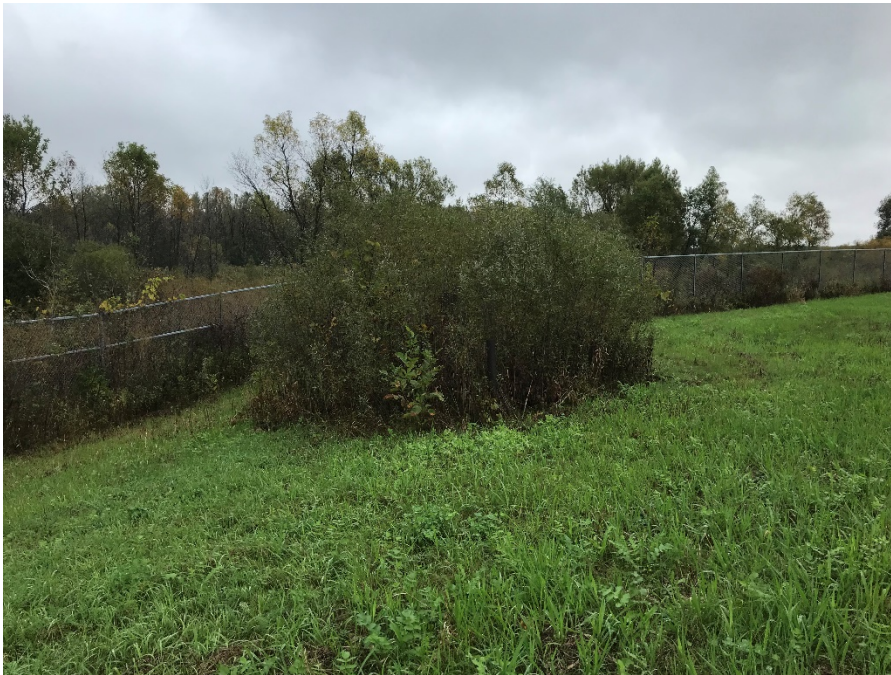
Photo 6: Thick woody vegetation in the vicinity of MW-11 nest (looking northeast).

Monitoring Wells and Wellhead Covers – Woody vegetation is present in the vicinity of the MW-11 nest (**Attachment C, Photo 6**). The woody vegetation should be removed in 2020.
