May 14, 2020

Subject: 2020 Semi-annual Inspection Report – First Report
Stoughton City Landfill, Stoughton, Dane County, Wisconsin
USEPA ID #WID980901219; WDNR BRRTS #02-13-000880

Operation and Maintenance Semi-Annual Inspection Report

Photographic Log

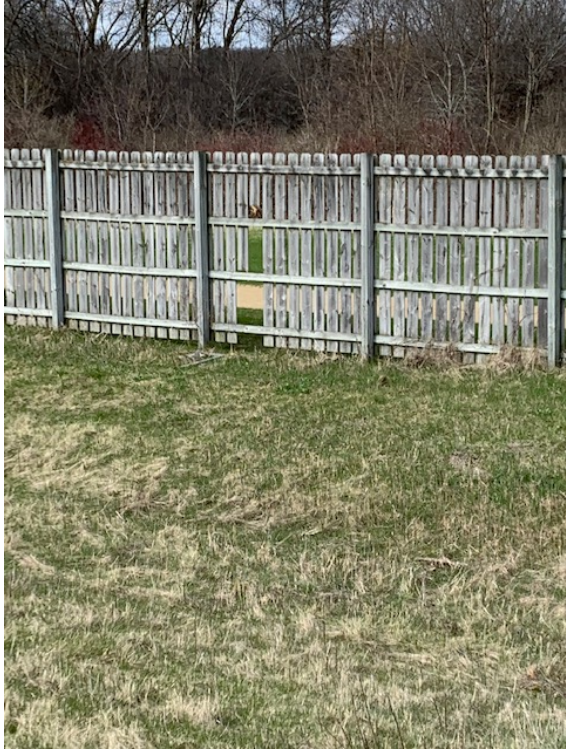
Client Name: Wisconsin Department of Natural Resources		Site Location: Stoughton City Landfill	Project No.: 375007
Photo No. 1	Date 4/15/2020

The chain link fence that surrounds a portion of the landfill was in good condition. It was noted that there is no fabric along the chain link fence. There are two wood slats that have been broken off along the west side of the landfill and the fence will need to be repaired. The gate was in good condition and the lock was functioning.

Time: 10:13 Weather: Sunny / 37°F Description: Wood slat fence along the western side of the landfill has two broken slats. Photographer: <i>Wesley J Braga</i> <hr/> Wes Braga

TRC recommends that the wood slat fence be repaired to prevent unauthorized entry and clearing of the woody vegetation around the MW-11 nest. Per the request for proposal document, TRC can assist with these issues or the City of Stoughton can be notified to address the issues. TRC also recommends replacing select locks that are not functioning or determining if another key is available for access. The condition of the artisan monitoring wells should be further discussed to determine if action is required to prevent groundwater from flowing to the ground surface surrounding the wells.

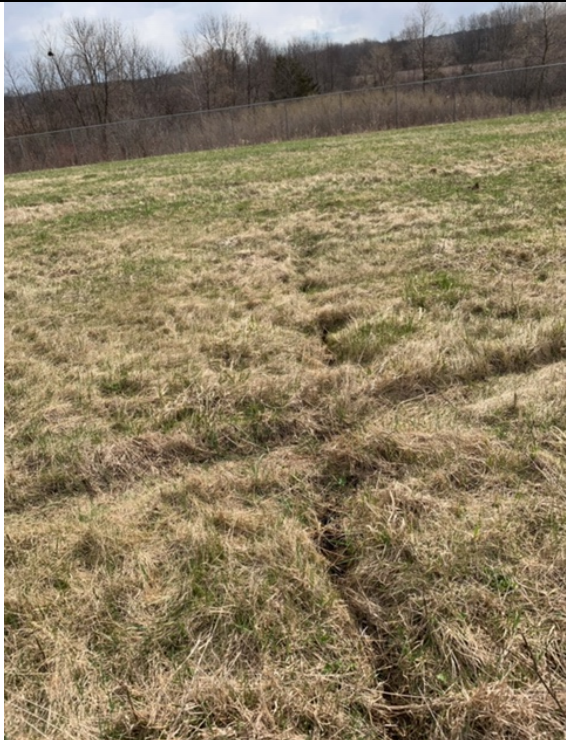
Photo No. 2	Date 4/14/2020

No issues were observed with the landfill cover that require immediate maintenance. Some large vegetation was observed to be growing around the MW-11 well nest and should be removed as time allows. A small depression/gully was noted between gas vents GV-4 and GV-8. The gully is approximately 4-inches in depth by 10-feet in length. There appears to be a small animal burrowing (less than 4-inches) at various spots around the landfill.

Time: 10:31 Weather: Cloudy / 34°F Description: A small gully approximately 4-inches deep and 10-foot-long was observed between gas vents GV-4 and GV-6 Photographer: <i>Wesley J Braga</i> <hr/> Wes Braga

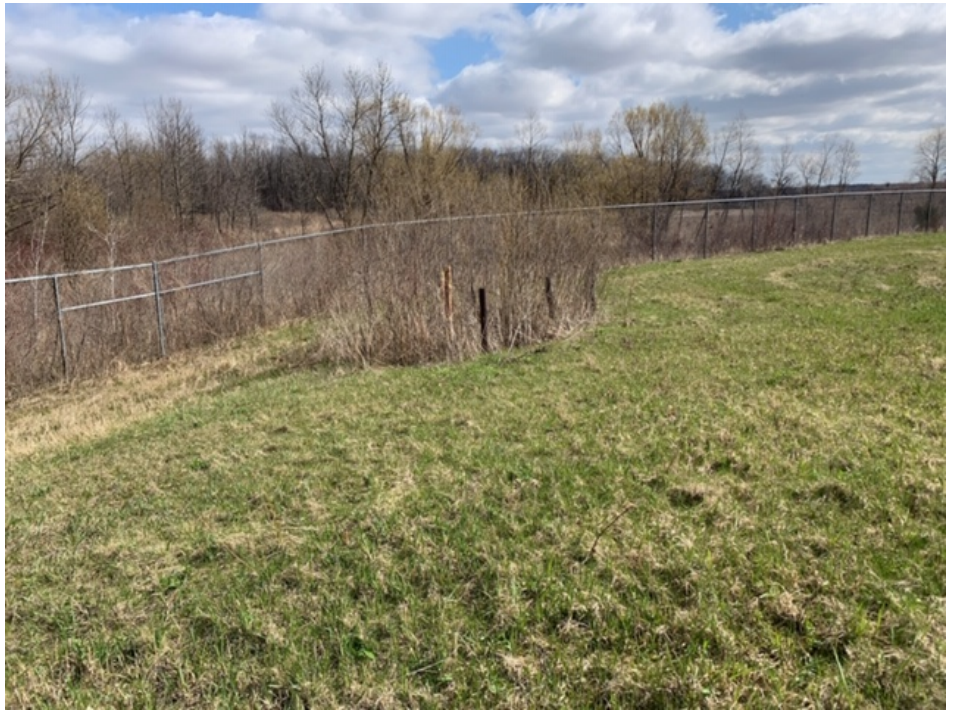
Client Name: Wisconsin Department of Natural Resources		Site Location: Stoughton City Landfill	Project No.: 375007
Photo No. 3	Date 4/15/2020

Time: 10:15			
Weather: Sunny / 37°F			
Description: Woody vegetation observed around the MW-11 well nest.			
Photographer: <i>Wesley J Braga</i>			
Wes Braga
