November 19, 2020

Subject: 2020 Semi-annual Inspection Report – Second Report
Stoughton City Landfill, Stoughton, Dane County, Wisconsin
USEPA ID #WID980901219; WDNR BRRTS #02-13-000880

Operation and Maintenance Semi-Annual Inspection Report

**Stoughton City Landfill
Stoughton, Wisconsin**

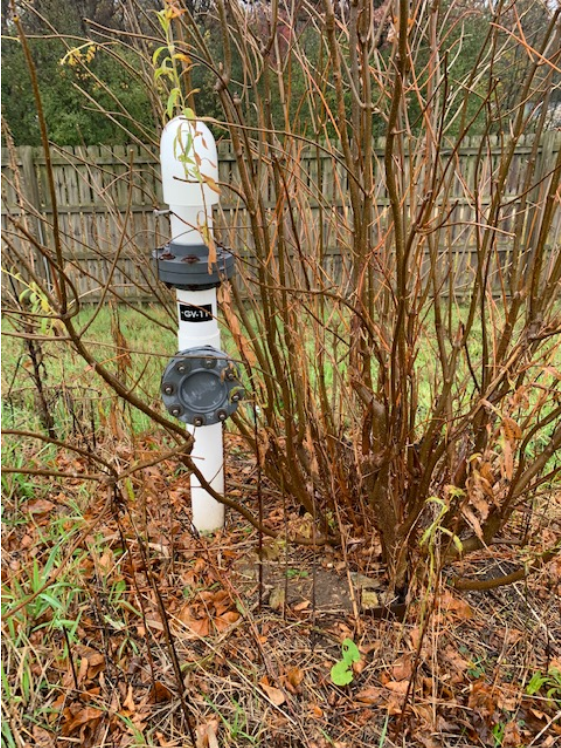
Client Name: Wisconsin Department of Natural Resources		Site Location: Stoughton City Landfill	Project No.: 375007
Photo No. 1	Date 10/22/2020

No issues were observed with the landfill cover that require immediate maintenance. Woody vegetation was observed to be growing around the MW-11 well nest, around GV-11, and along the interior fence line along the west side of the landfill. This vegetation should be removed as time allows. The small depression/gully noted to be between gas vents GV-4 and GV-8 during the April 2020 inspection was not observed in October. There appears to be a small animal burrowing (burrows less than 4-inches) at various spots around the landfill. Annual mowing of the landfill cover was conducted on August 27, 2020.

Time: 11:12 Weather: Cloudy / 46°F Description: Woody vegetation observed around the GV-11 and MW-11 well nest. Photographer: <i>John Roelke</i> <hr/> John Roelke

TRC recommends clearing of the woody vegetation around the MW-11 nest, GV-11, and from along the fence along the west side of the landfill. Per the request for proposal document, TRC can assist with these issues or the City of Stoughton can be notified to address the issues. TRC will provide a cost estimate to replace select locks that are not functioning and to install packers in monitoring wells MW-7I and MW-8I.

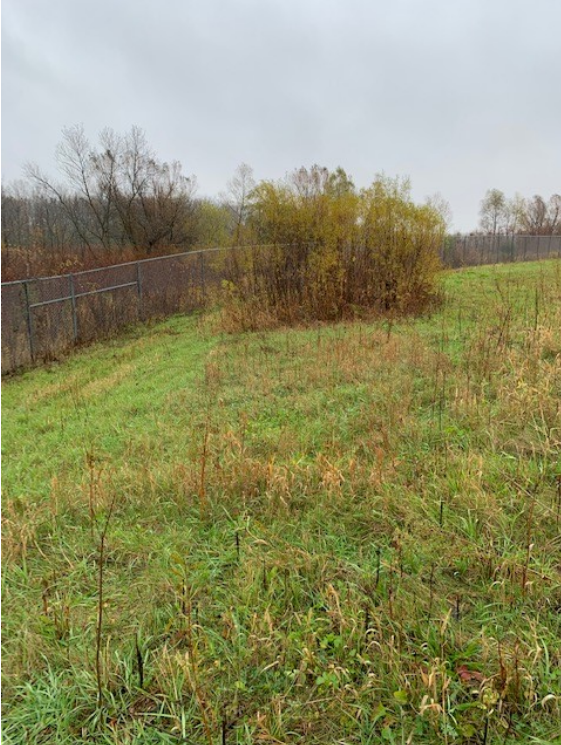
Photo No. 2	Date 10/22/2020

The Site contains 21 gas vents throughout the limits of the landfill. Each vent was inspected by TRC and no issues were noted. Vegetation is present around GV-11, but the vent did not appear to be obstructed.

Time: 11:21 Weather: Cloudy / 46°F Description: Woody vegetation observed around the GV-11 and MW-11 well nest. Photographer: <i>John Roelke</i> <hr/> John Roelke

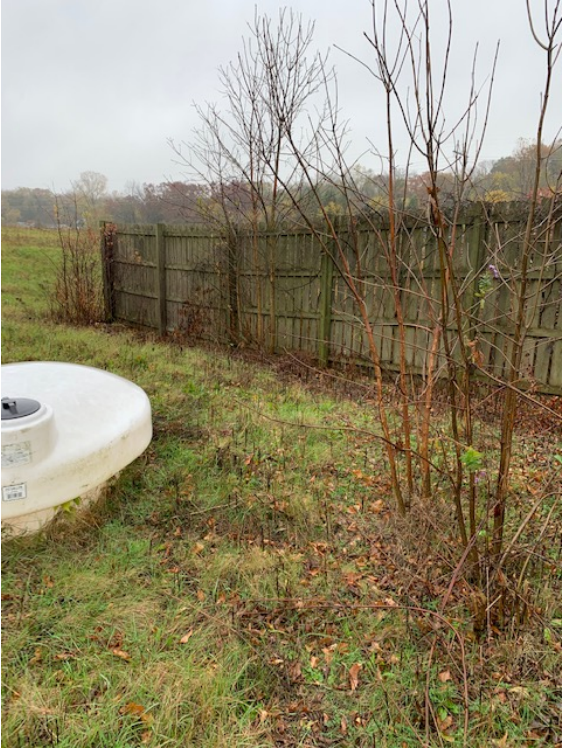
Client Name: Wisconsin Department of Natural Resources		Site Location: Stoughton City Landfill	Project No.: 375007
Photo No. 3	Date 10/22/2020

Time: 11:16 Weather: Cloudy / 46°F Description: Woody vegetation observed along the interior fence along the west side of the landfill Photographer: <i>John Roelke</i> <hr/> John Roelke
