June 28, 2021

Subject: 2021 Semi-annual Inspection Report – First Report
Stoughton City Landfill, Stoughton, Dane County, Wisconsin
USEPA ID #WID980901219; WDNR BRRTS #02-13-000880

Operation and Maintenance Semi-Annual Inspection Report

Stoughton City Landfill
Stoughton, Wisconsin

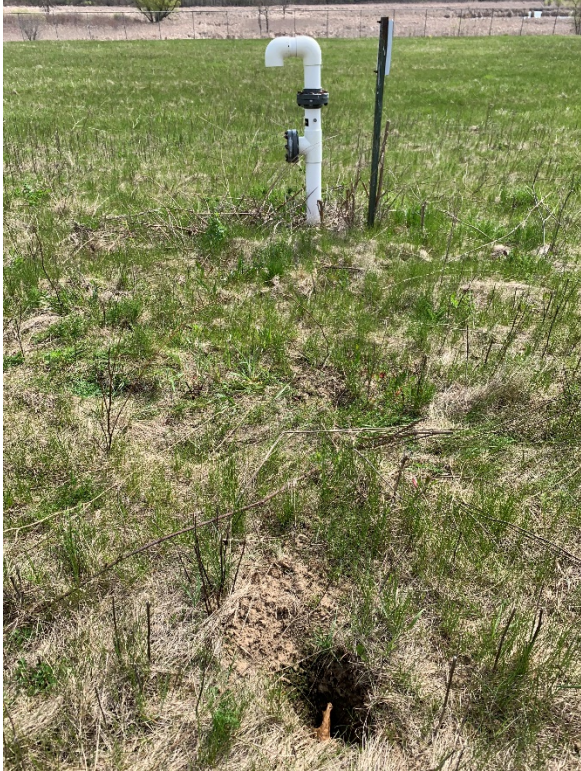
Client Name: Wisconsin Department of Natural Resources		Site Location: Stoughton City Landfill	Project No.: 375007
Photo No. 1	Date 4/28/2021

Time: 11:19 Weather: Sunny/ 58°F Description: Animal burrow on landfill cap near GV-9. Photographer: <i>Wesley J Braga</i> <hr/> Wes Braga

TRC recommends the clearing of the woody vegetation around the MW-11 nest and GV-11 gas vent, as well as reassessing animal burrows following the 2021 mowing event to ensure gas vent seals have not been compromised. Per the request for proposal document, TRC can assist with these issues or the City of Stoughton can be notified to address the issues. .

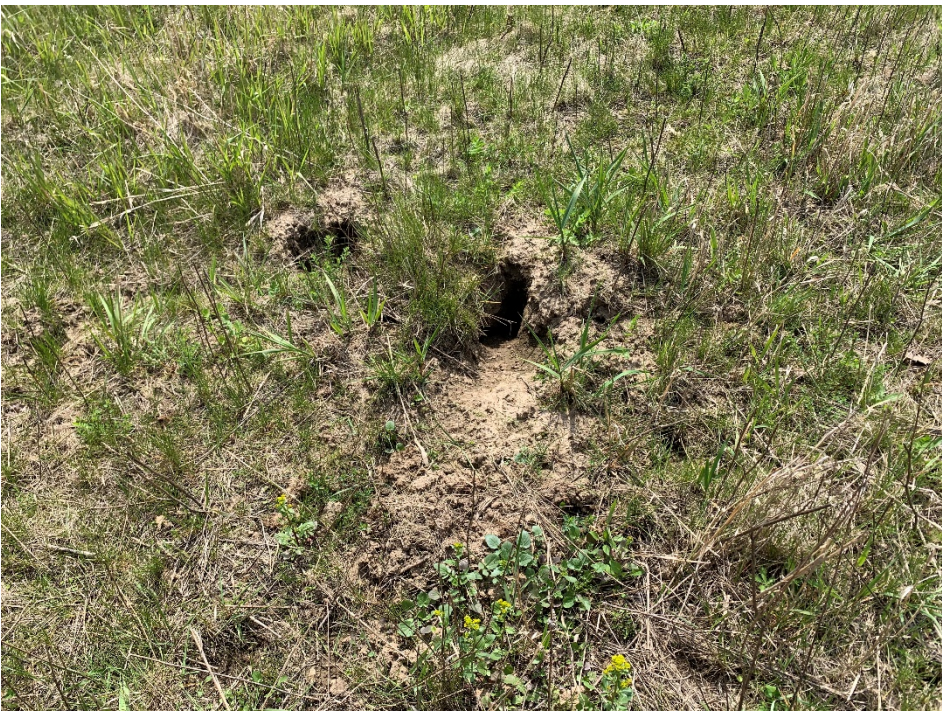
Photo No. 2	Date 4/28/2021

Time: 11:27 Weather: Sunny/ 58°F Description: Animal burrow on landfill cap. Photographer: <i>Wesley J Braga</i> <hr/> Wes Braga

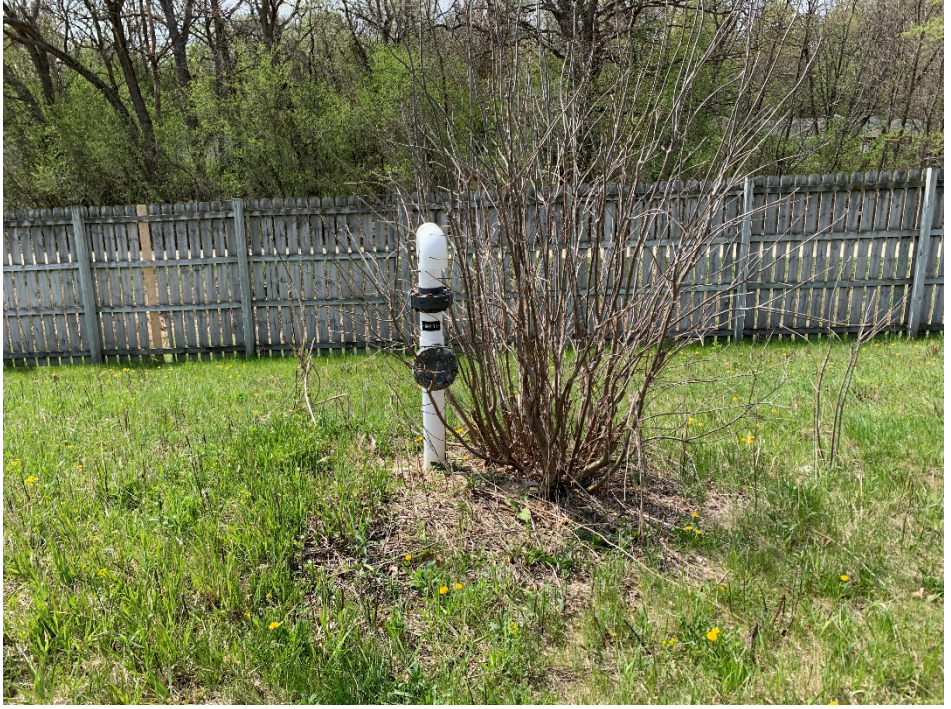
Client Name: Wisconsin Department of Natural Resources		Site Location: Stoughton City Landfill	Project No.: 375007
Photo No. 3	Date 4/28/2021

The Site contains 21 gas vents throughout the limits of the landfill. Each vent was inspected by TRC and no issues were noted. Woody vegetation identified near GV-11, gas vent was unobstructed during the inspection event, however it may become obstructed once the plants leaf out in the spring.

Time: 11:12 Weather: Sunny/ 58°F Description: Woody vegetation near GV-11. May become obstructed once plant leaf out.			
Photographer:
